October 23, 2008

RE: Complaint 200195430  
Spill from Wood 2-43V pit

### **FIELD INSPECTION**

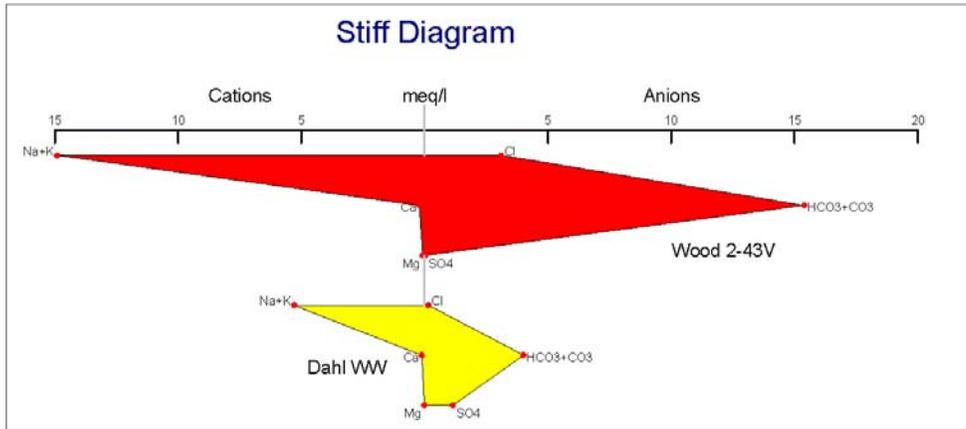
**Figure 1 - Wood 2-43V and Dahl Water Well Comparison**

One means of examining major ion composition of water samples for similarities and/or differences is to plot them on a Stiff diagram. Sodium (Na), potassium (K), calcium (Ca) and magnesium (Mg) are positively charged and are the major cations in most waters. Chloride (Cl), bicarbonate + carbonate ( $\text{HCO}_3 + \text{CO}_3$ ) and sulfate ( $\text{SO}_4$ ) are negatively charged and are the major anions present in most waters. Figure 1 is a Stiff

diagram comparing the chemistry of water produced from your water well (sampled in June 2008) to the chemistry of water produced from the Wood 2-43V. The dominant ions in the CBM produced waters are sodium and bicarbonate. Sulfate is at very low concentrations in the CBM produced waters. The dominant ions in water from you well are also sodium and bicarbonate. Sulfate was a secondary anion in your well water and it was at a very low concentration in the Wood 2-43V water sample. Chloride is a secondary anion in the CBM produced water and is present at a much lower concentration in water from your well. The Raton and Vermejo Formations CBM produced water has several times greater levels of total dissolved solids (TDS) than water from your well which likely draws its water from the younger Poison Canyon Formation.
