RE: Complaint 200278900  
Stormwater and Erosion Control Best Management Practices

Attachments: Attachment 1 - Photographs of the Area Subject to the Complaint  
Attachment 2 - Report of Field Investigation (Ash and Helgeland)  
Attachment 3 - Field Inspection 200310088

## COGIS - Field Inspection Report

API Number: <b>05-071-08459</b>	Name: <b>BLAZER #24-1</b>
Location: <b>SESW 1 32S 67W</b>	Lat: <b>37.28106</b> Long: <b>-104.84185</b>
Operator #:	Operator Name: <b>PIONEER NATURAL RESOURCES USA INC</b>
Inspection Date: <b>5/10/2011</b>	Inspector: <b>PETER GINTAUTAS</b>
Inspection was: <b>Unsatisfactory</b>

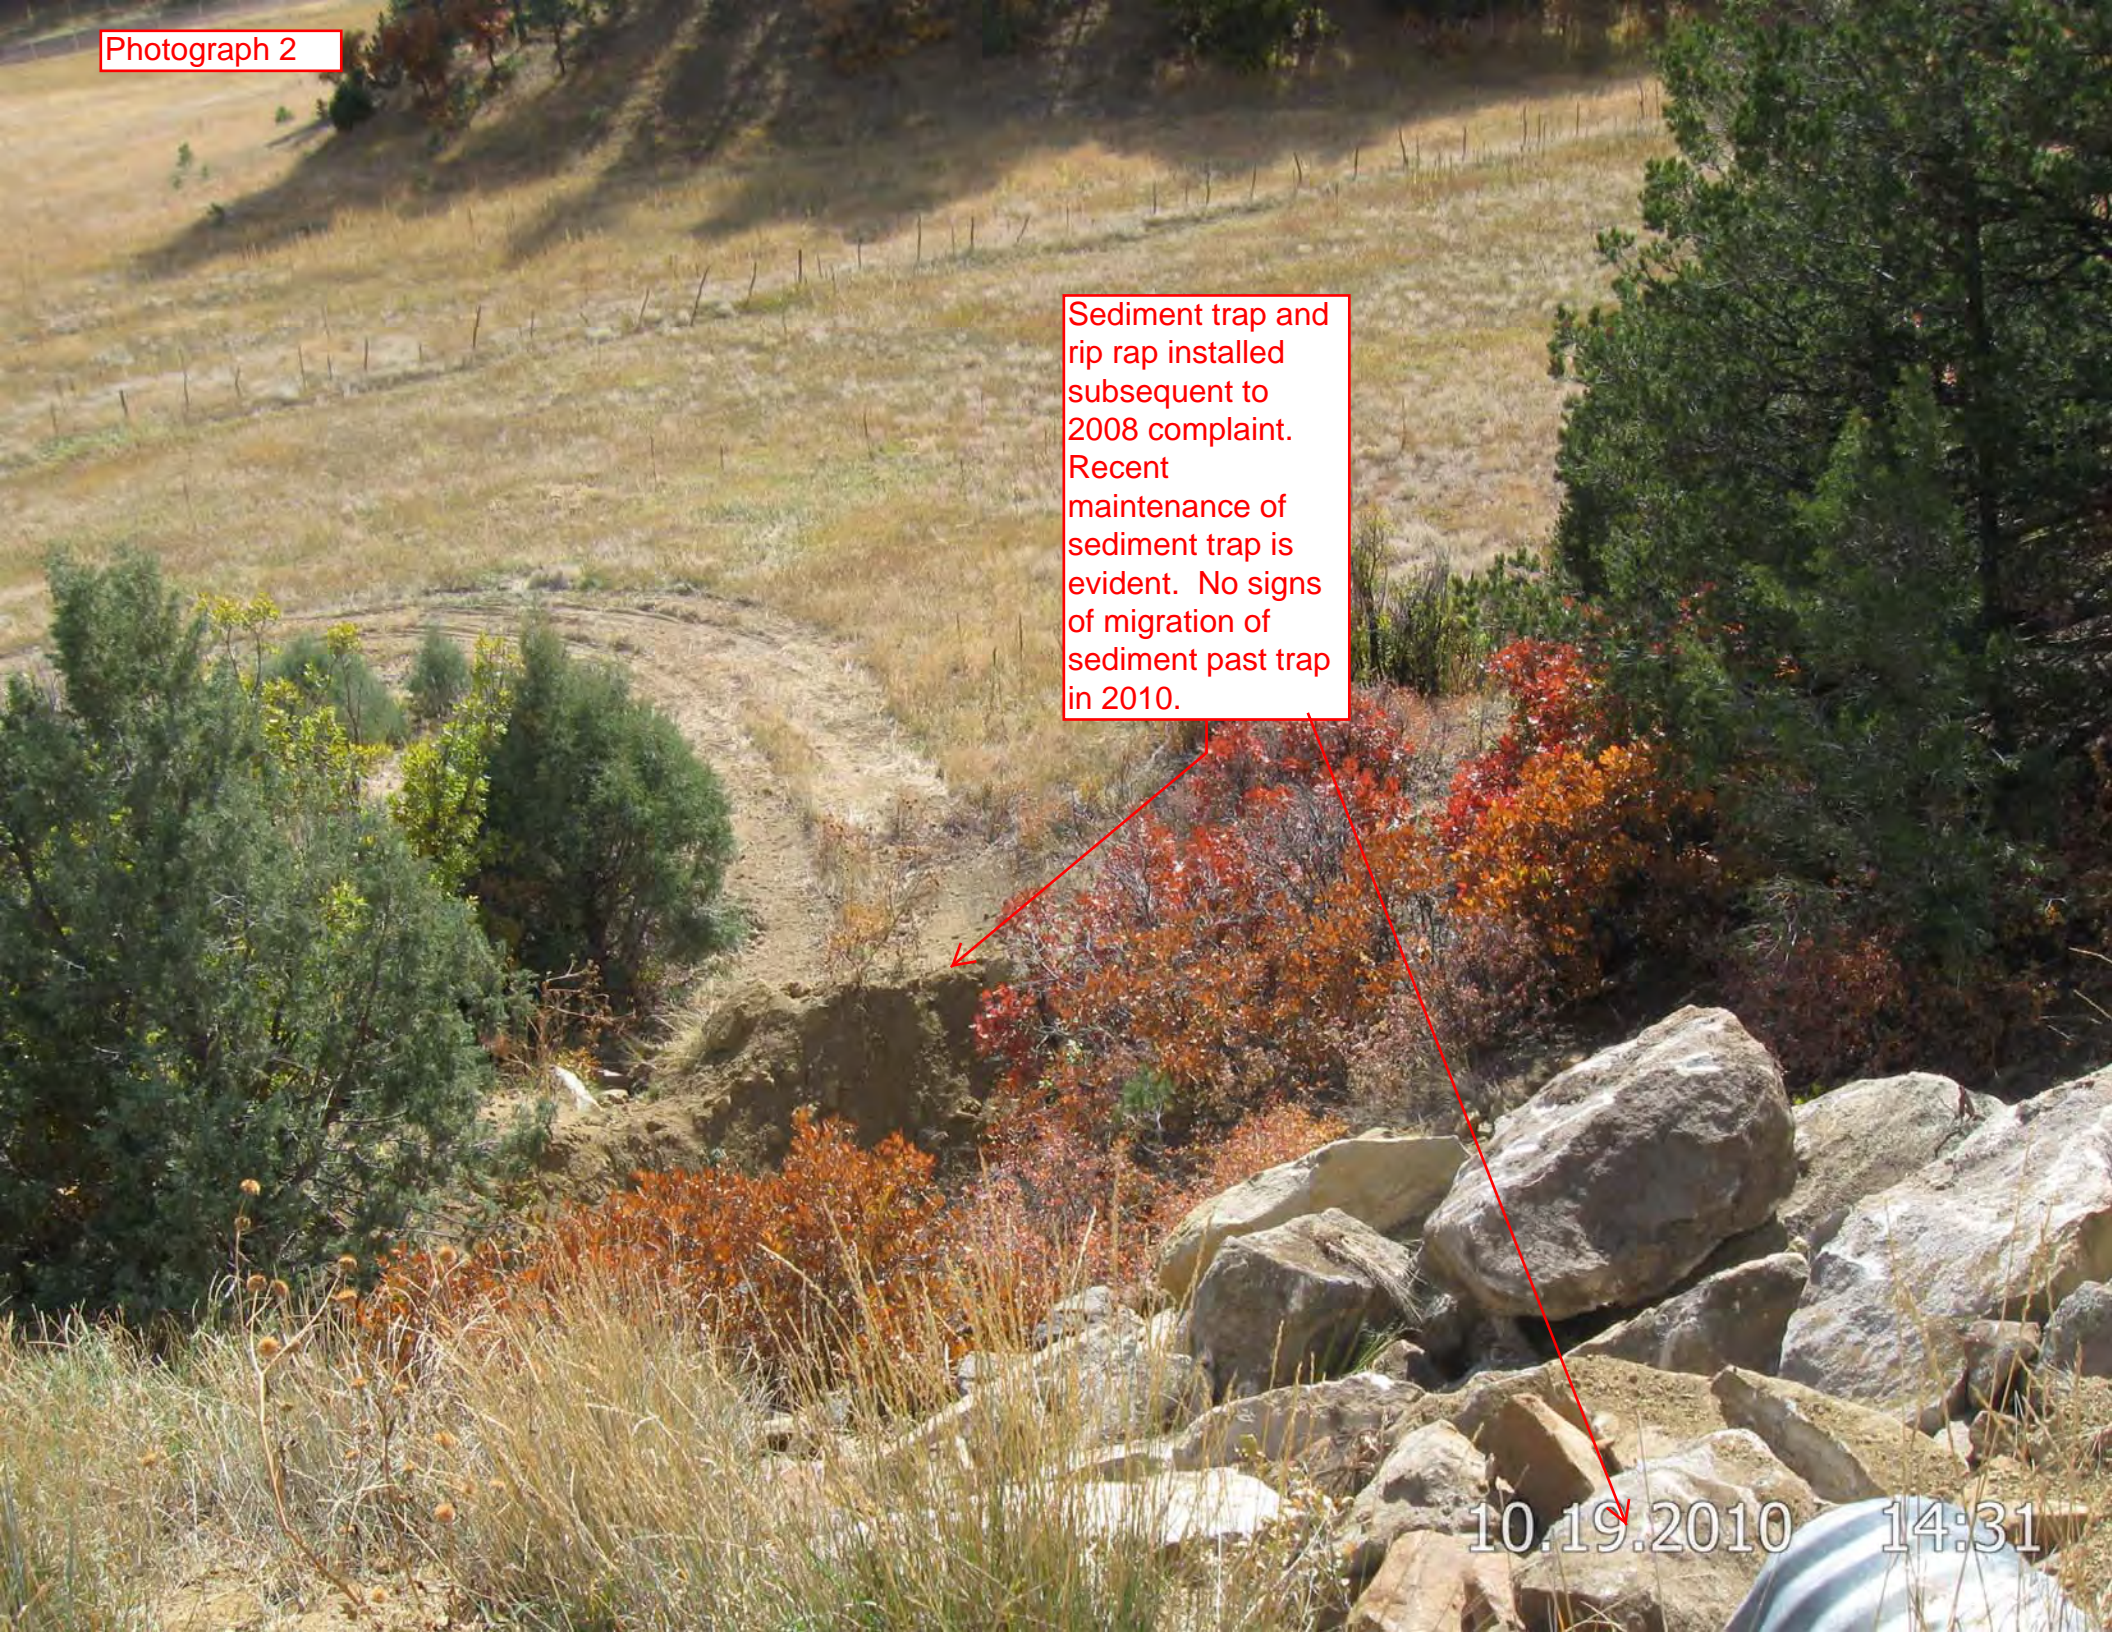
I again visited the area on December 3, 2010 and a photo of alterations to the stormwater and erosion controls had been nearly completed by the operator. Photograph 3 (Attachment 1) shows that new culverts had been installed to lessen the flow through each culvert. In addition, the operator had constructed a filtering and retention area so that sediment would have an opportunity to settle out of stormwater before the water leaves the immediate area of the lease road.

retention and  
filtering BMP

Culvert added to  
divert flow to  
retention and  
filtering area before  
flow reaches  
bottom of road and  
culvert above gate.

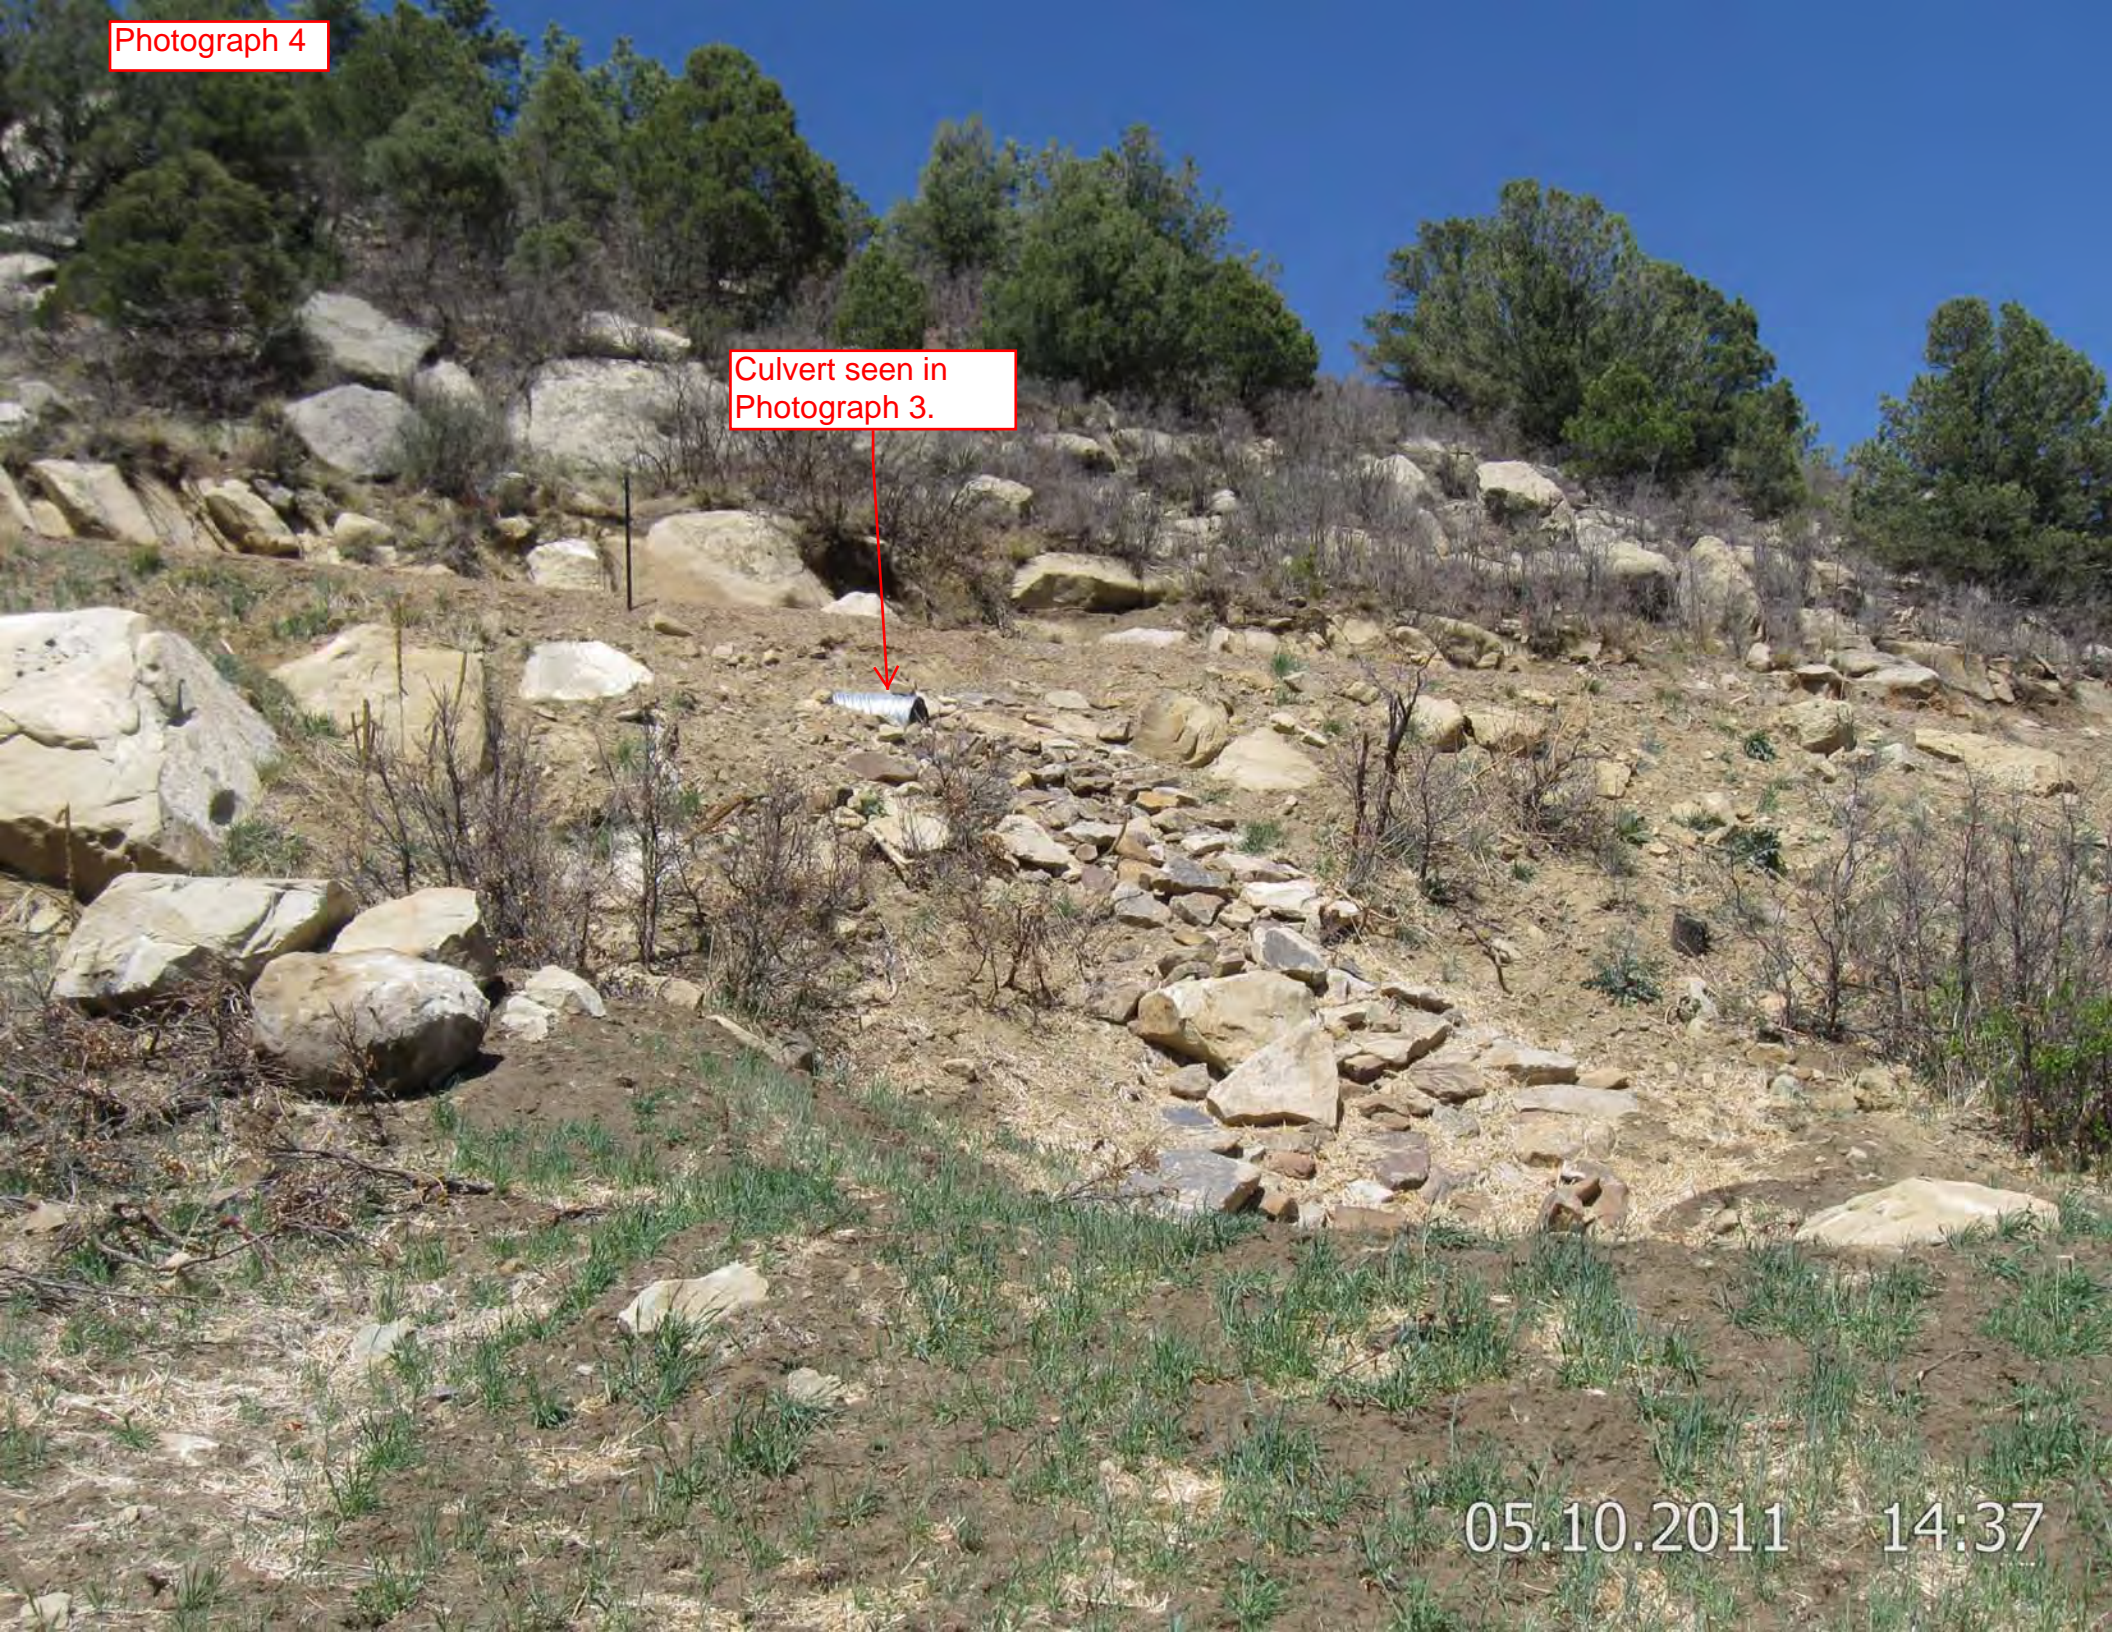
Field Inspection 200310088 (Attachment 3) was conducted on May 10, 2011. During that visit I noted that interim reclamation and revegetation of areas disturbed in the fall of 2010 when Pioneer made improvements to the stormwater management along the lease road. Photograph 4 and Photograph 5 show progress of

Culvert seen in  
Photograph 3.

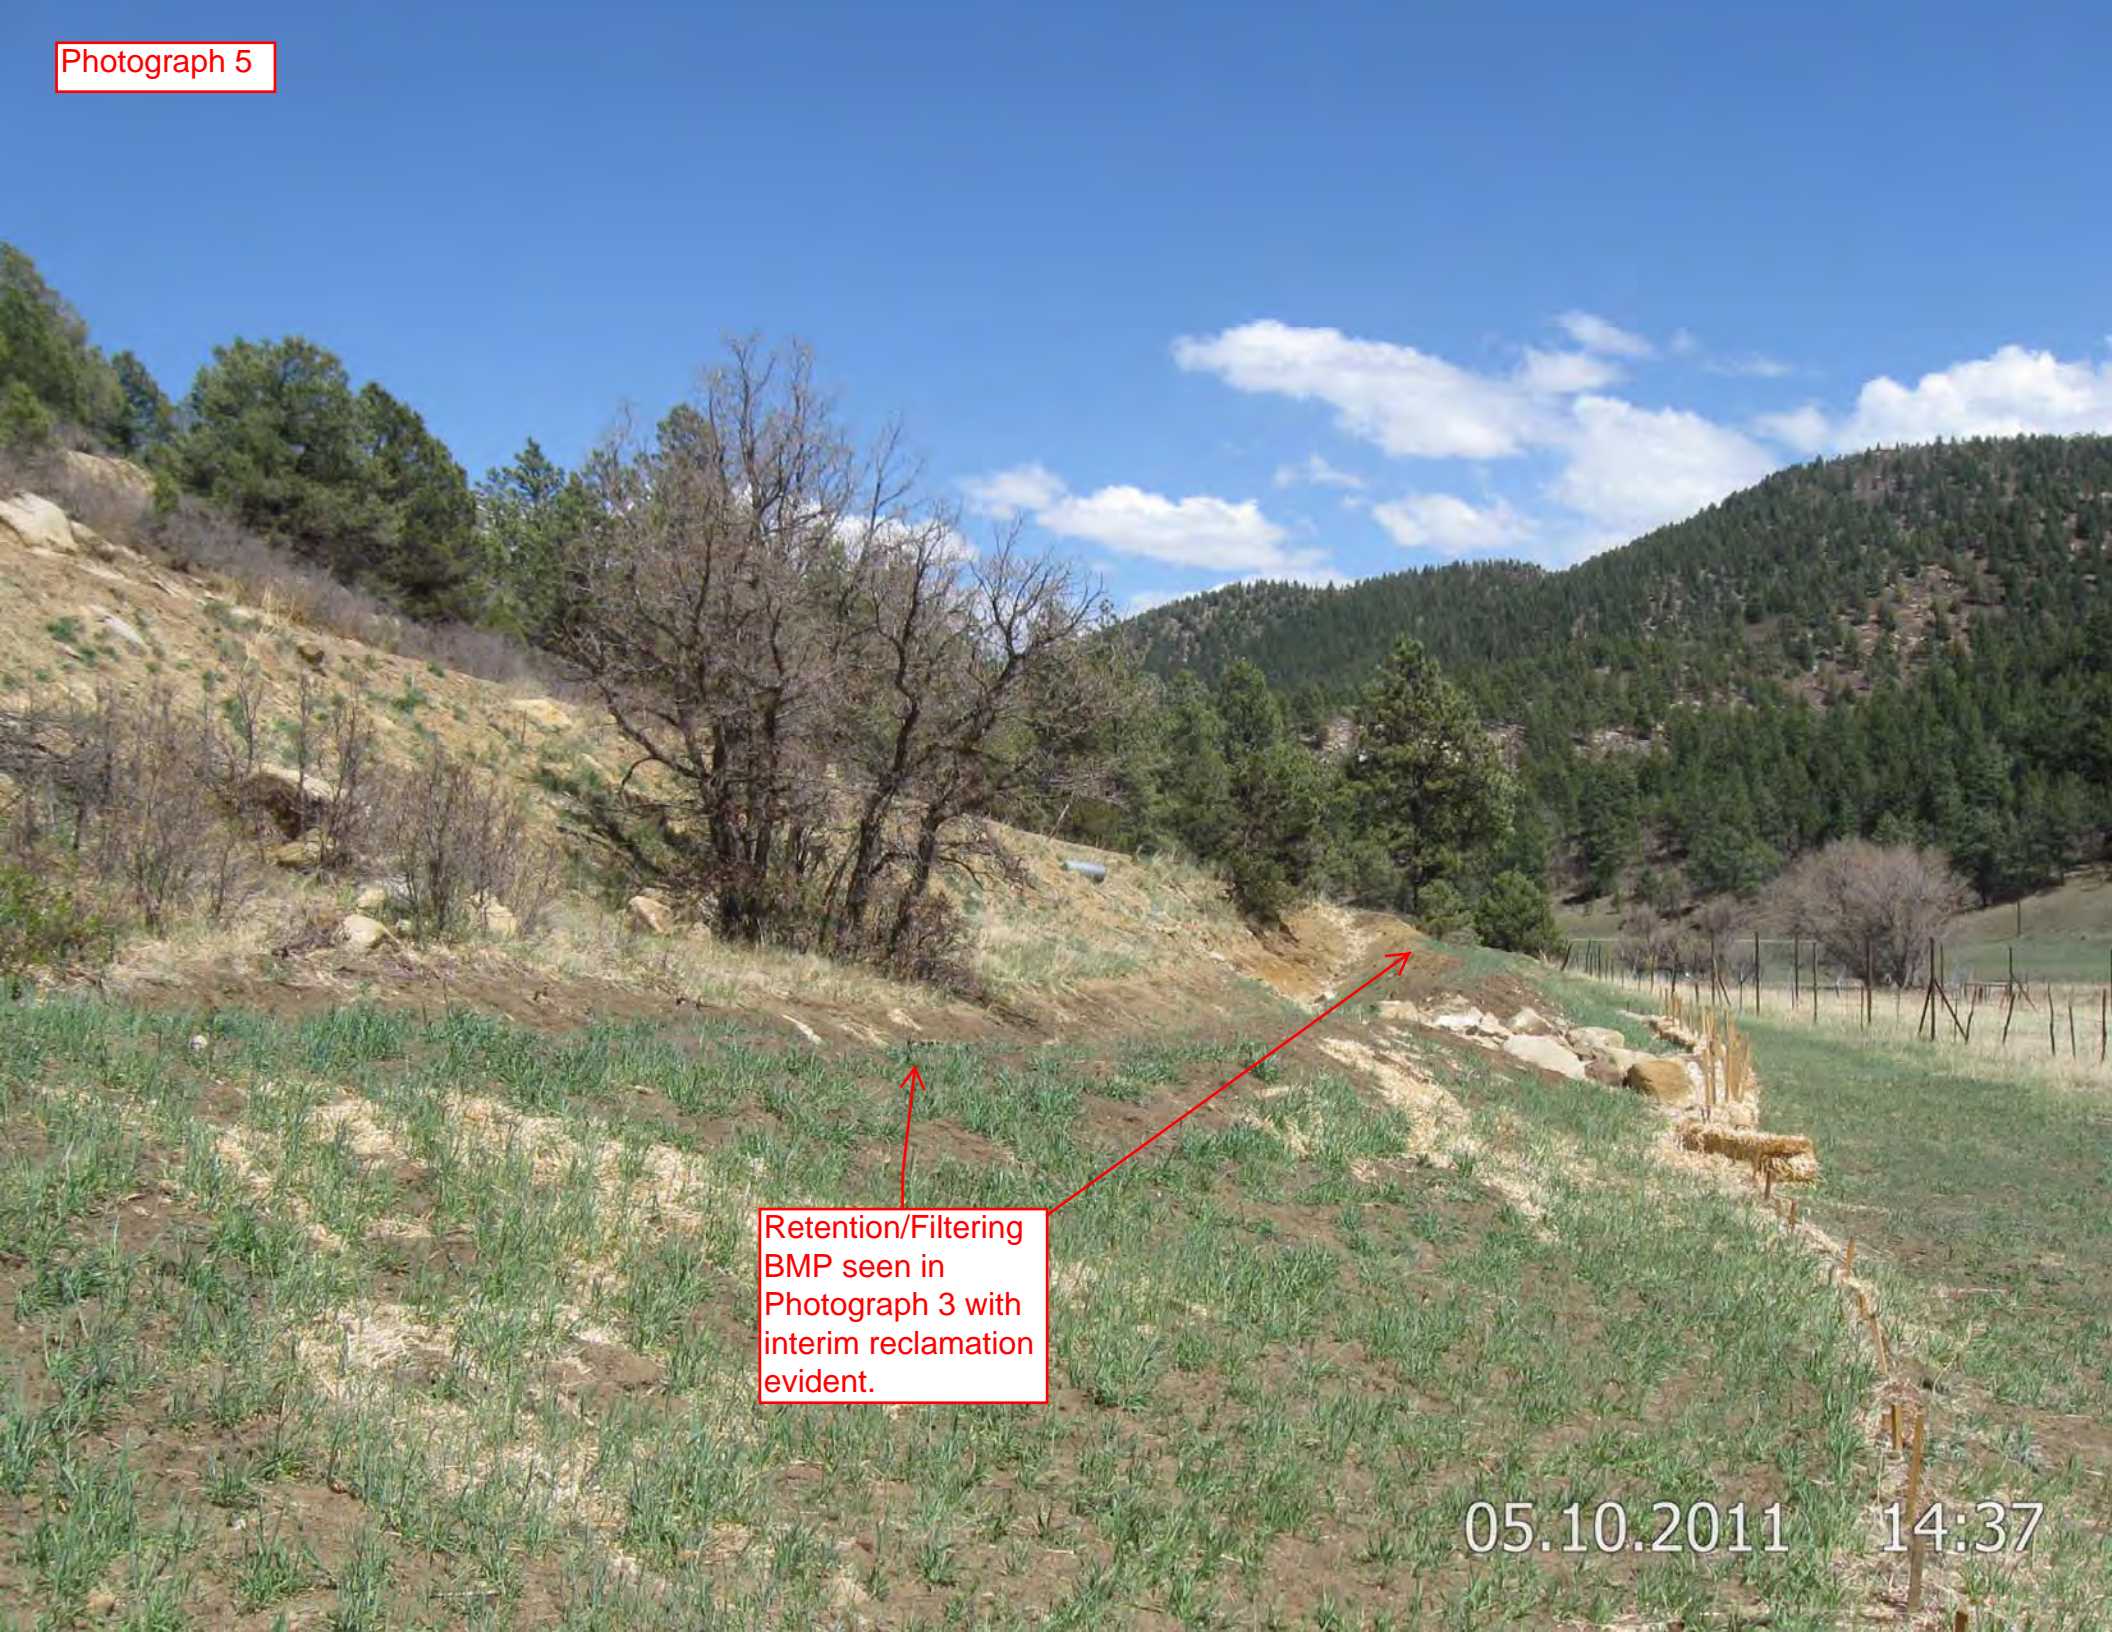
Photograph 5

Retention/Filtering  
BMP seen in  
Photograph 3 with  
interim reclamation  
evident.

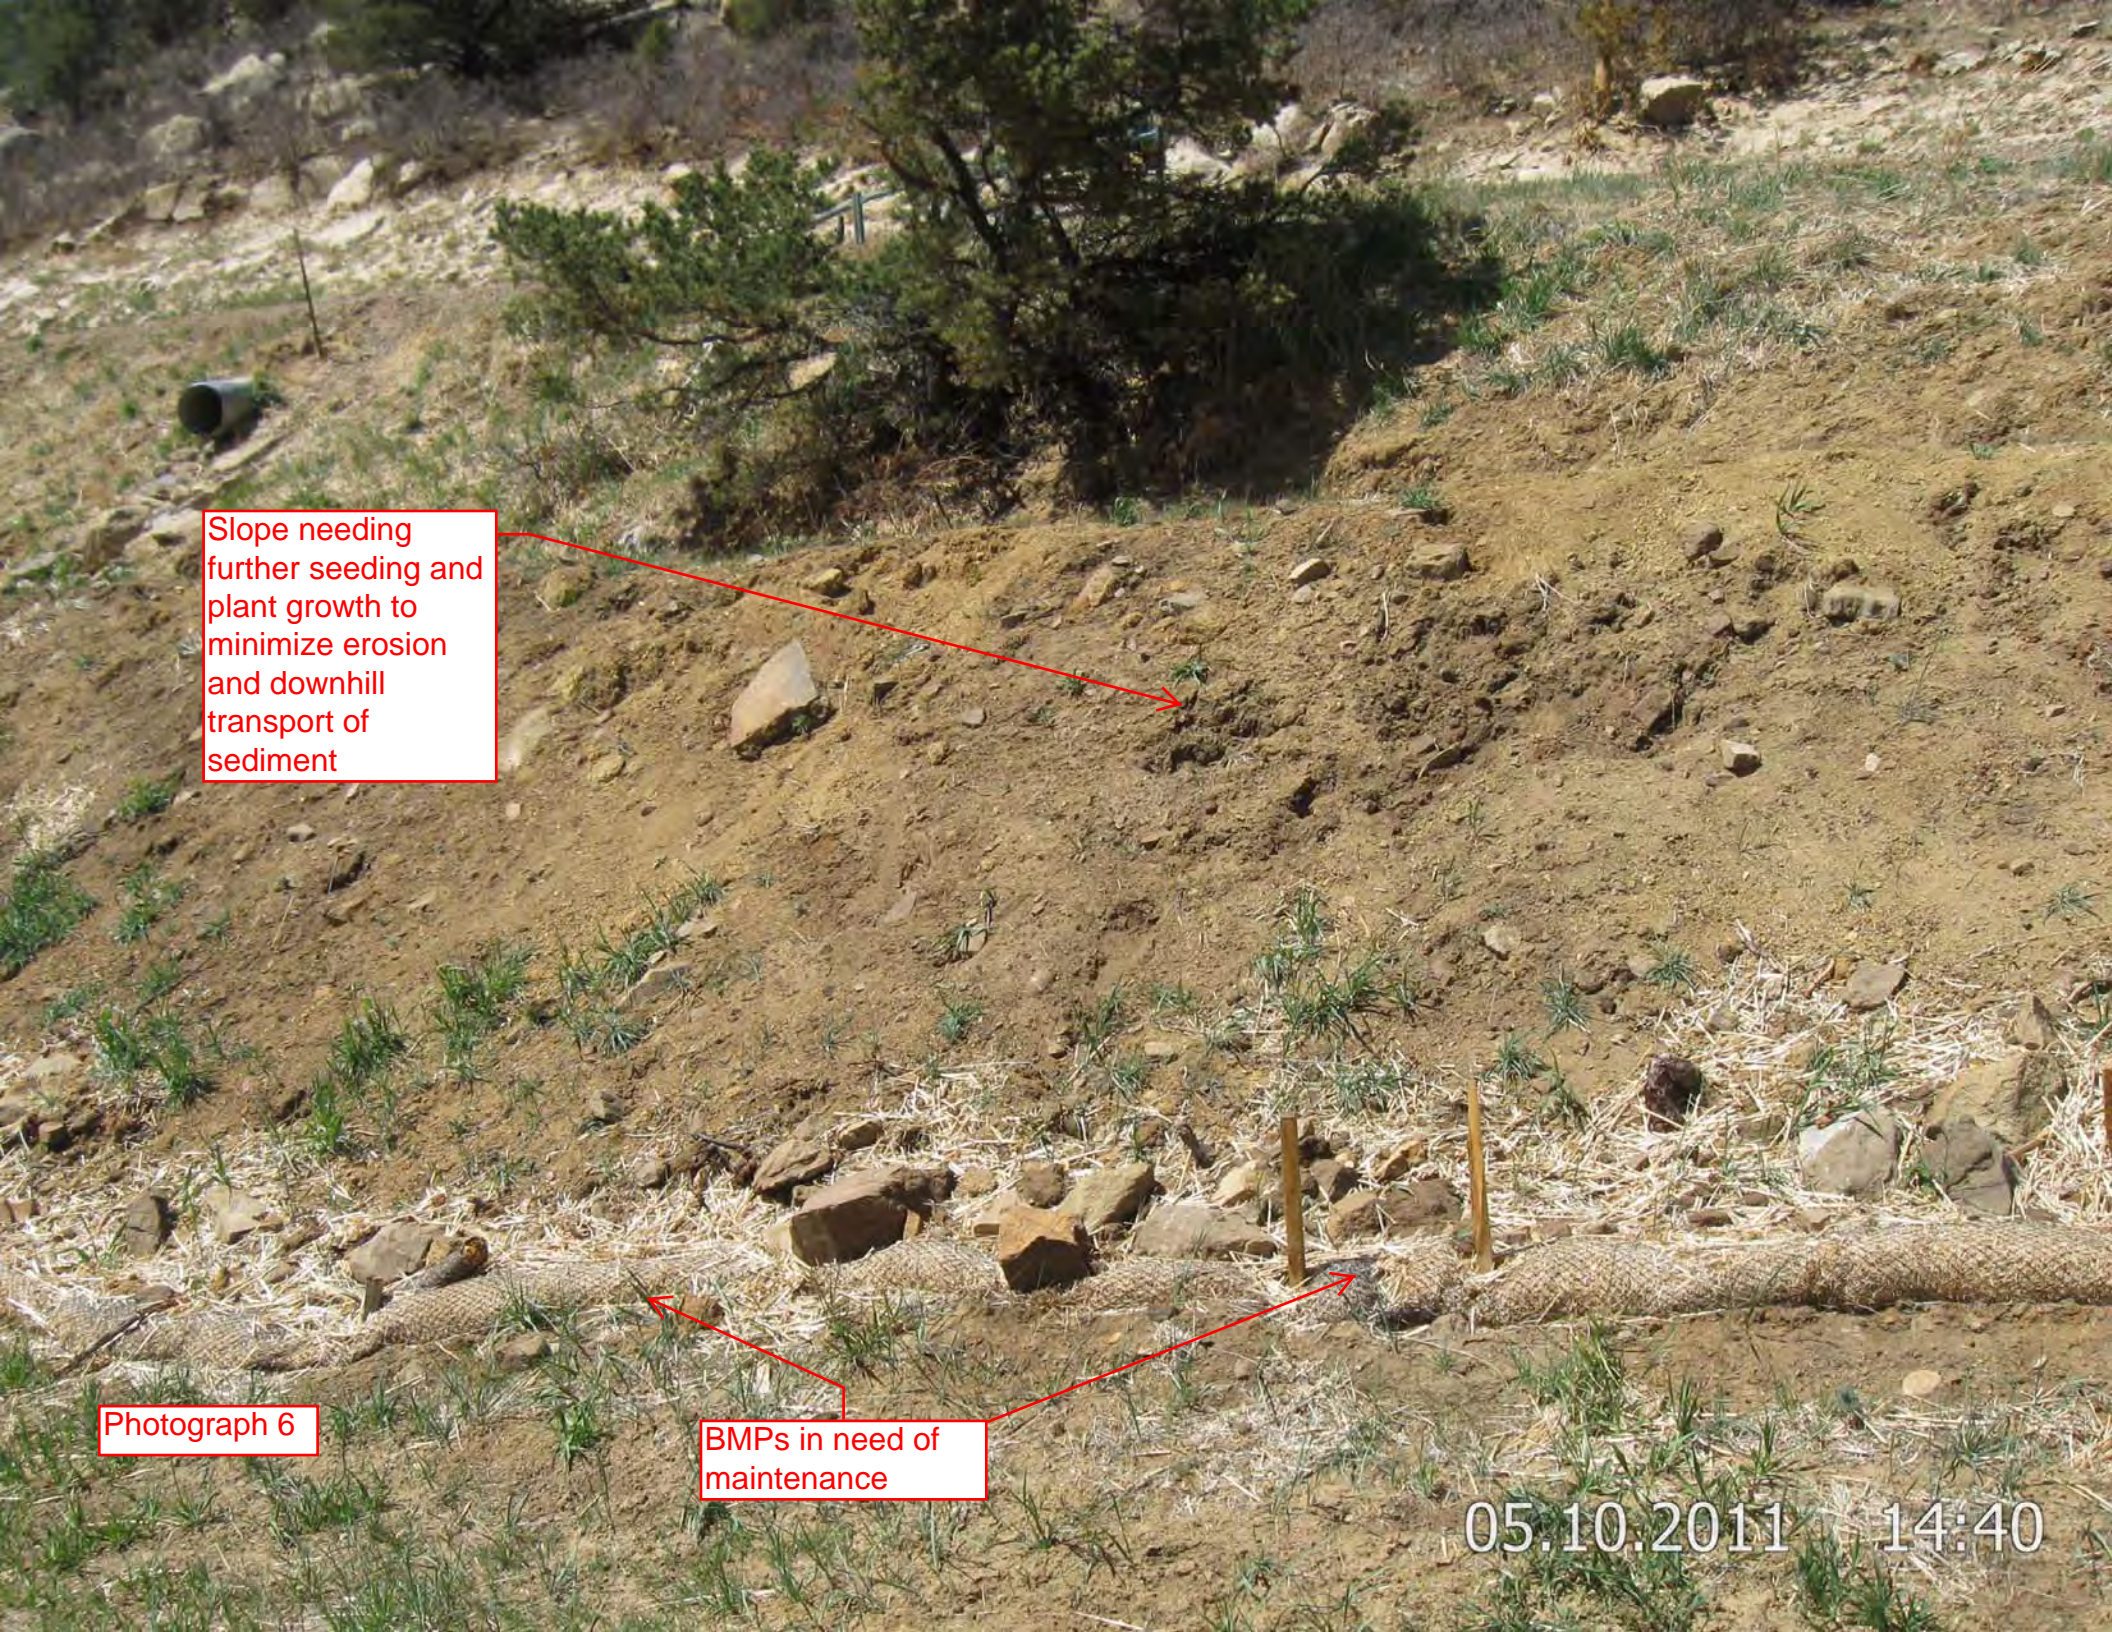
Photograph 6

reclamation efforts at that time. The inspection of the area did show maintenance issues in one portion of the 2010 construction area (Photograph 6 in Attachment 1). The inspection notice required that the operator perform maintenance in certain areas as sediment had come close to overtopping some of the BMPs installed in late fall of 2010. Ms. Ash had noted in her report that maintenance of stormwater controls would be needed and my May 2011 inspection noted that maintenance was now needed and must be performed by the operator.

Slope needing  
further seeding and  
plant growth to  
minimize erosion  
and downhill  
transport of  
sediment

BMPs in need of  
maintenance

Insp. Comment	Inspection/Violation Comments
ACTION	PERFORM MAINTENANCE AS NEEDED OF EROSION CONTROLS
MISC	INSPECTION OF STORMWATER CONTROLS ALONG LEASE ROAD. STORMWATER CONTROLS IN GOOD CONDITION WITH FEW EXCEPTIONS. BERM BUILT ALONG SOUTH EDGE OF FILTER/INFILTRATION DITCH IS ERODING IN SOME SPOTS WITH SOILS AS DEEP AS WATTLES ARE TALL
