Kimball Creek 14-2D1-995

Inspection DOC# 675200264

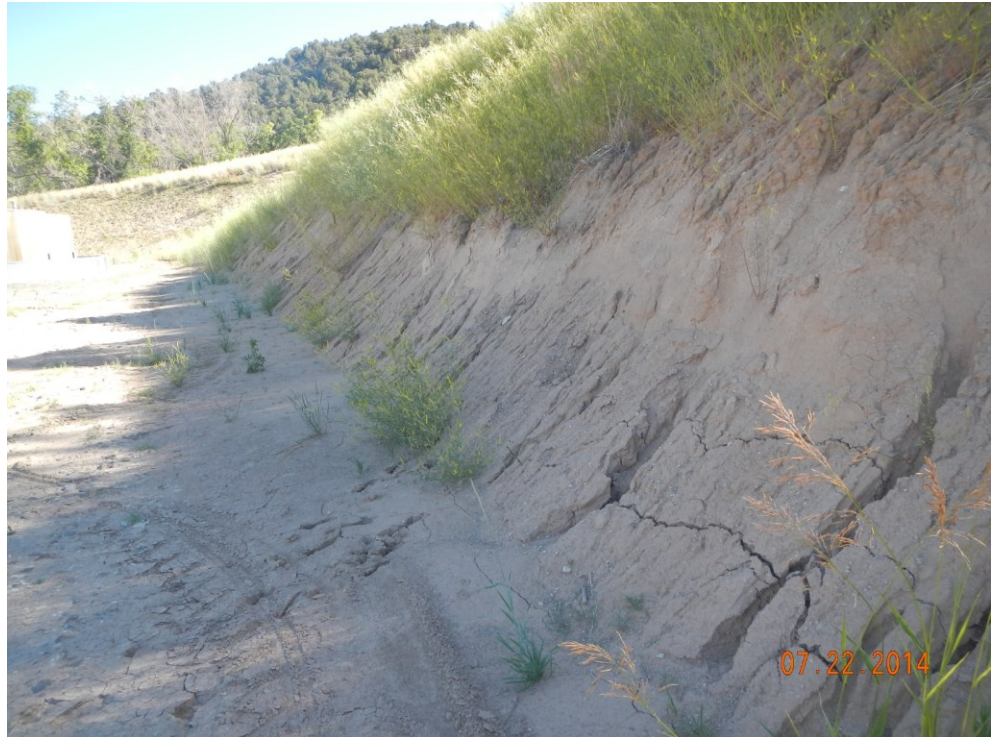
Erosion and rilling
along cut slope.

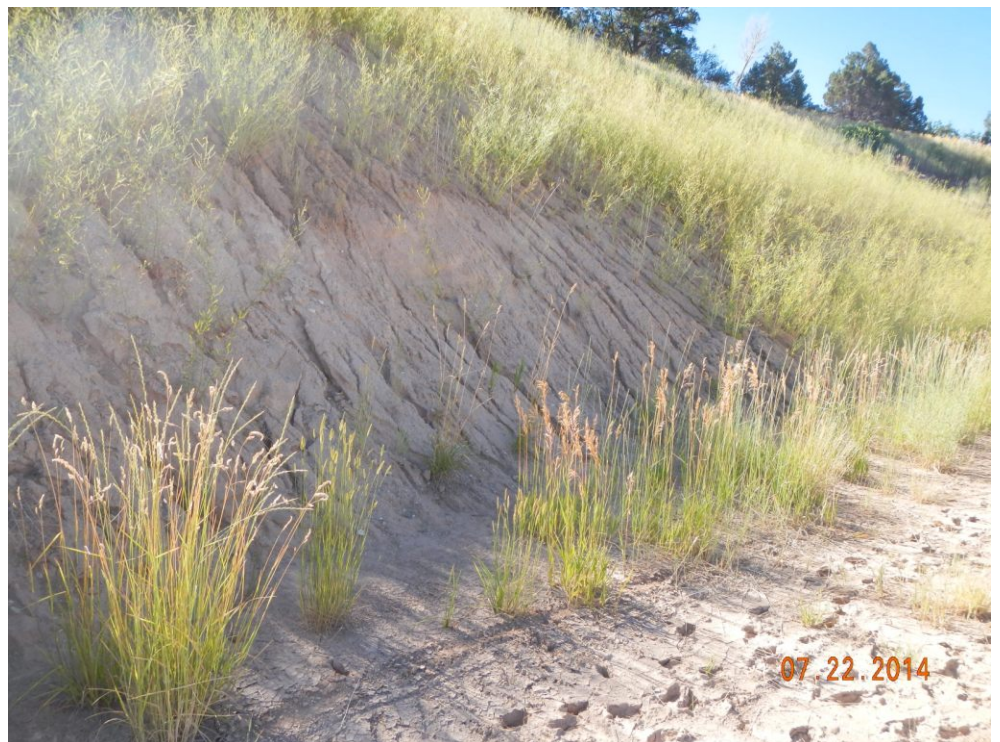
Erosion and rilling
along cut slope.

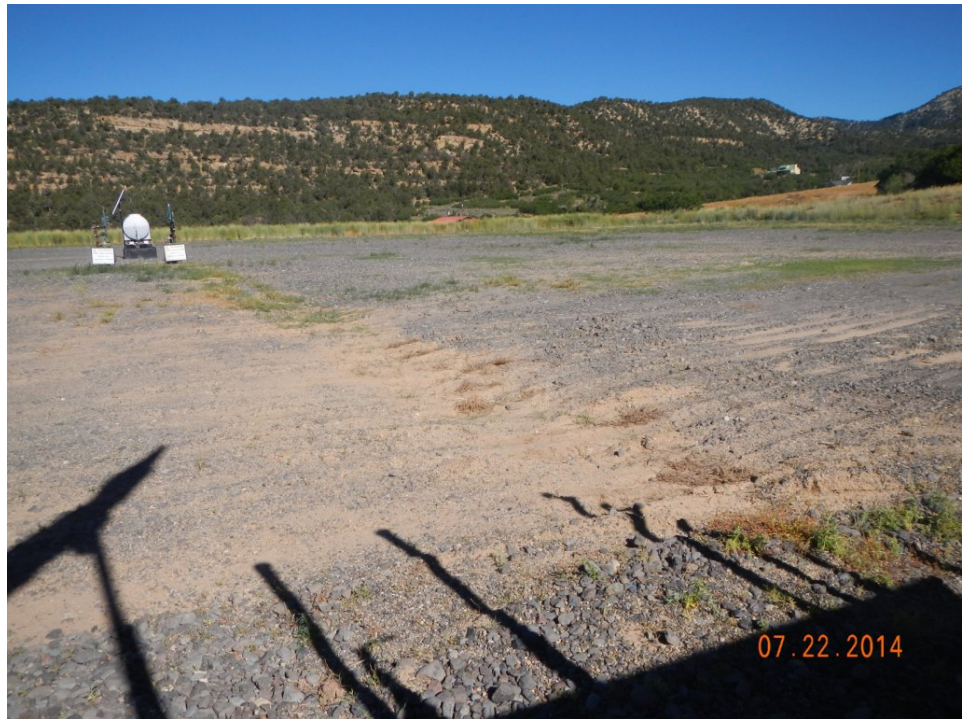
Subsidence over lines
from wellhead to
separator.

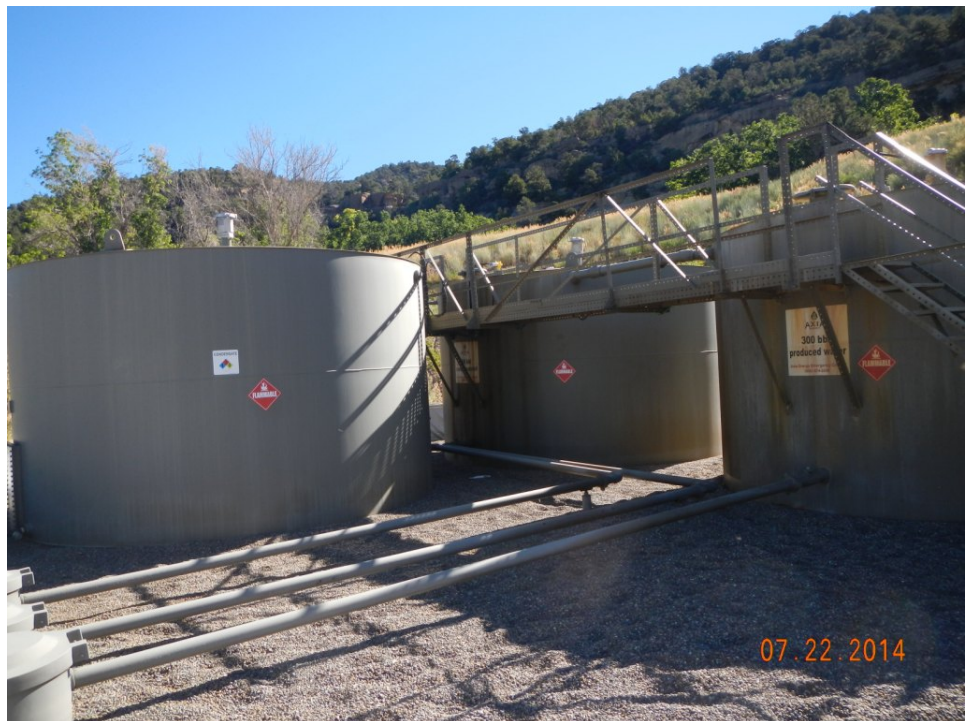
One condensate tank
missing capacity and
operator name.
