Site Photos: API# 05-073-06278

Date: November 20, 2014

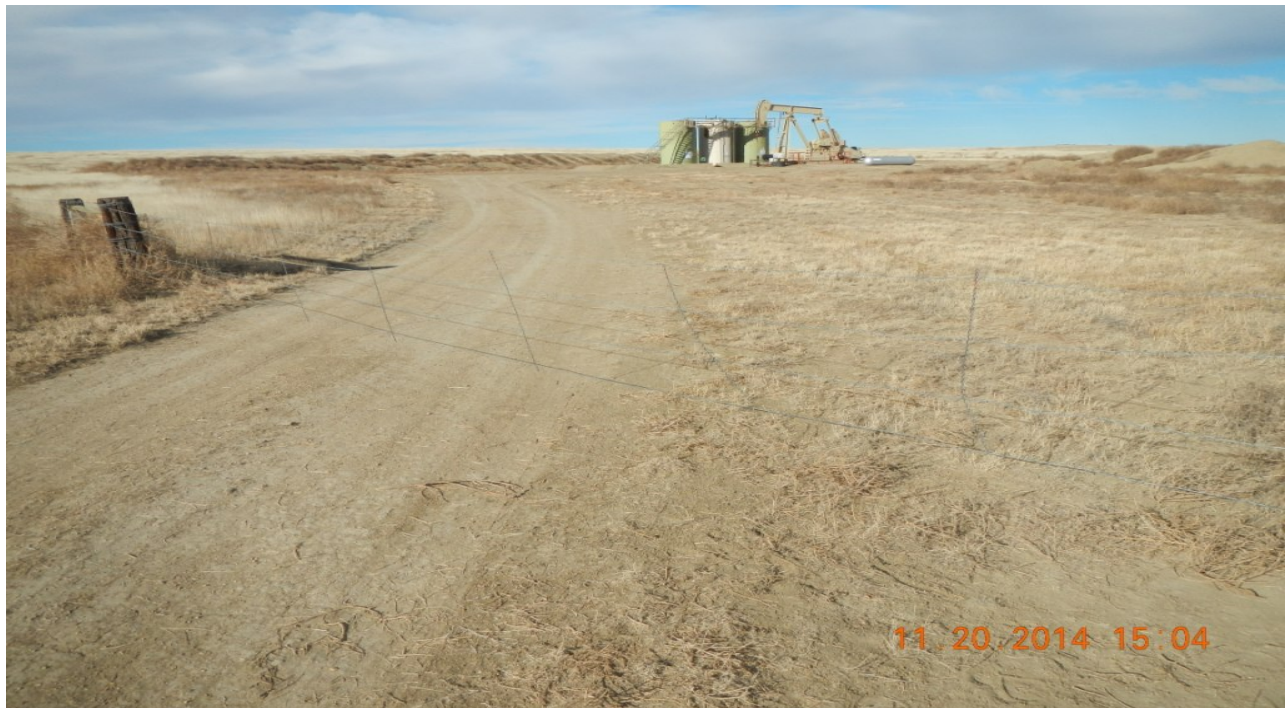
photo 1: Looking North at the location from the access road.

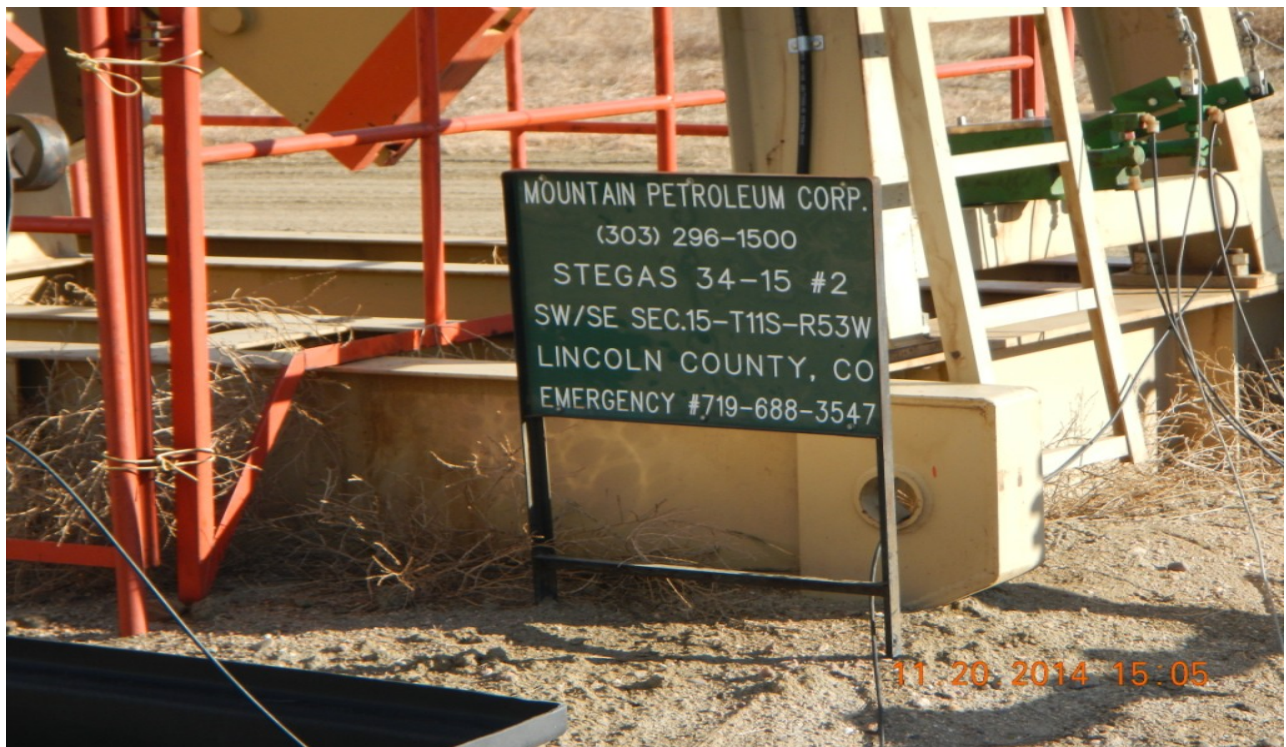
photo 2: Stegas 34-15 #2

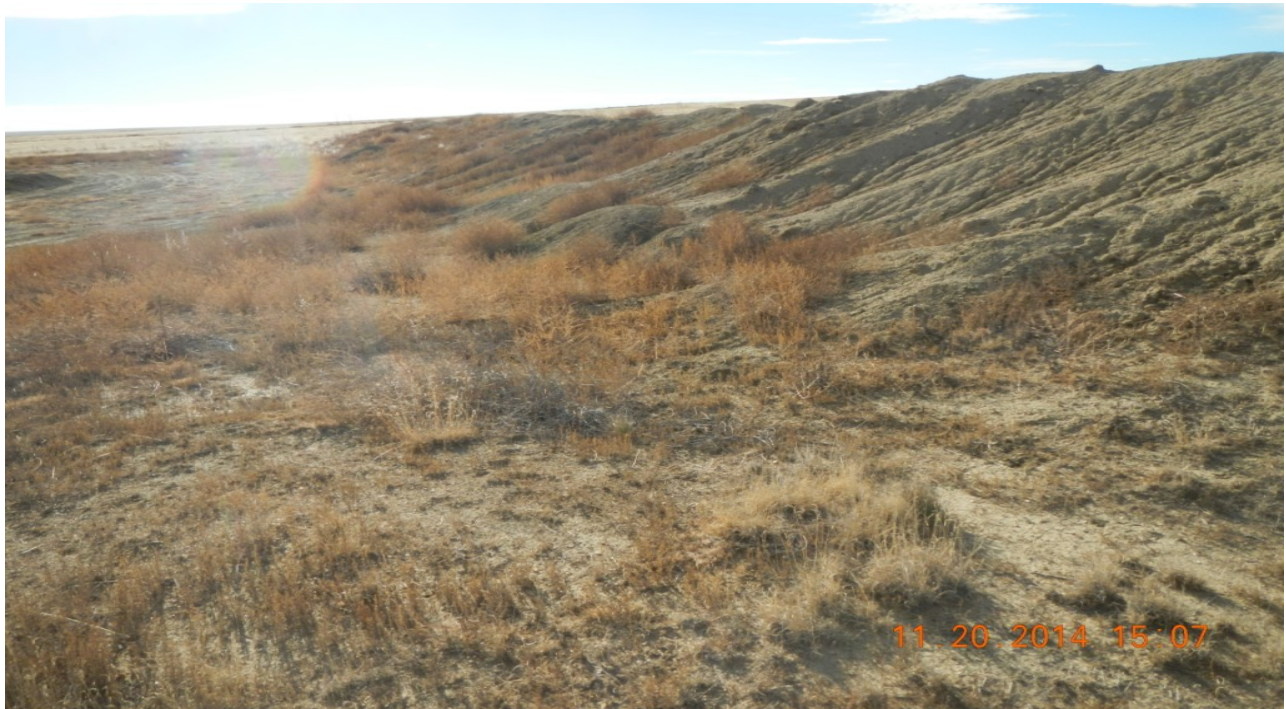
photo 3: Soil stockpiles at the West side of location.

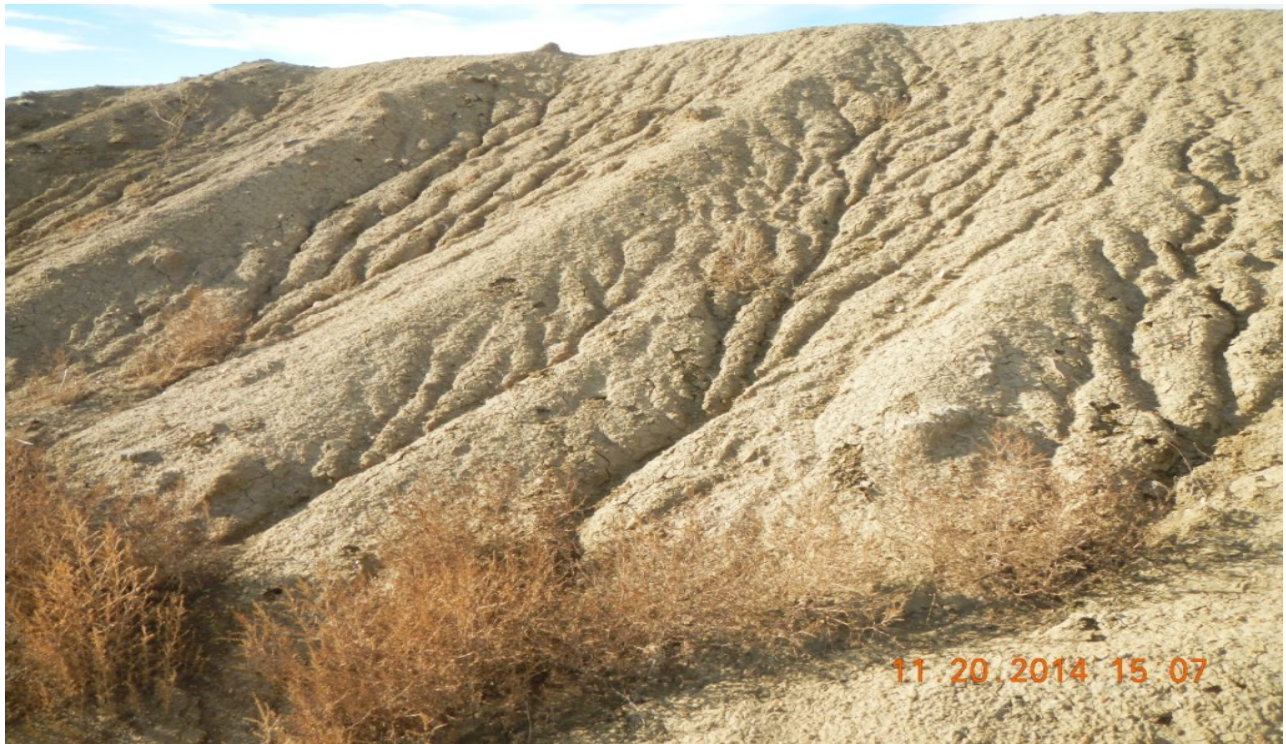
photo 4: Top soil stockpile is being eroded and is not being protected from degradation.

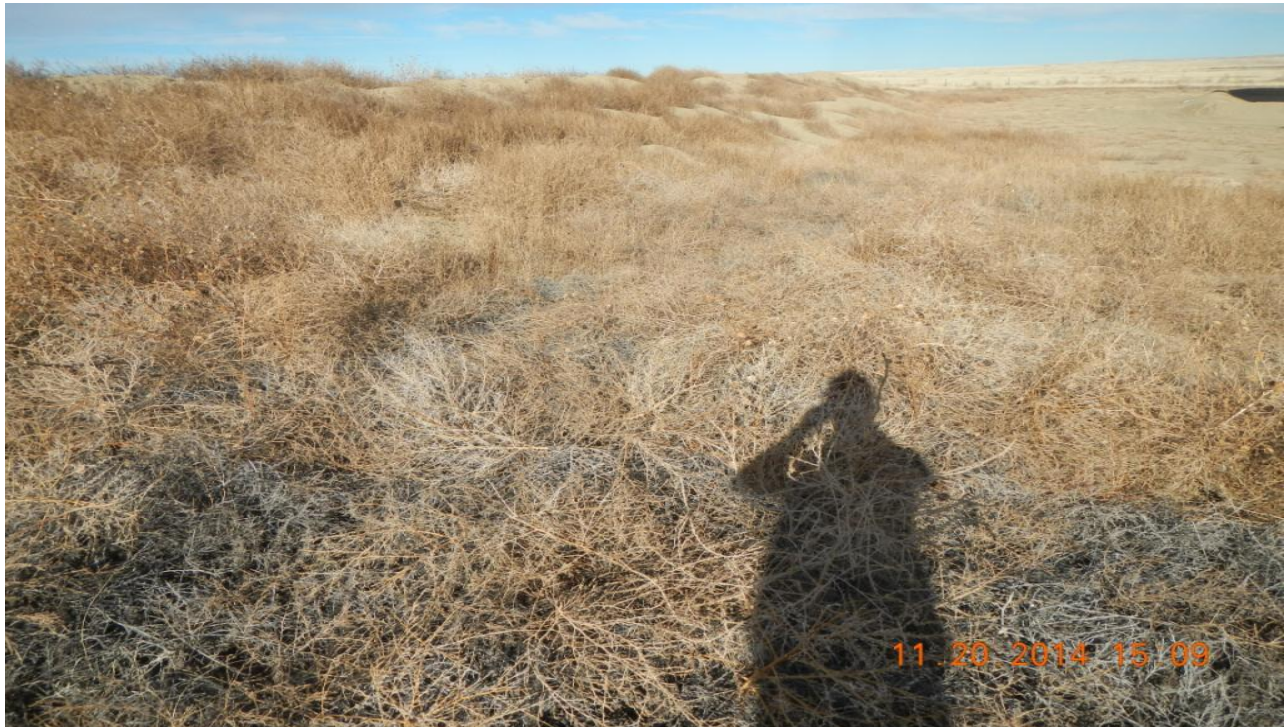
photo 5: Southwest corner of location. Weed growth (Russian thistle) around top soil stockpile.

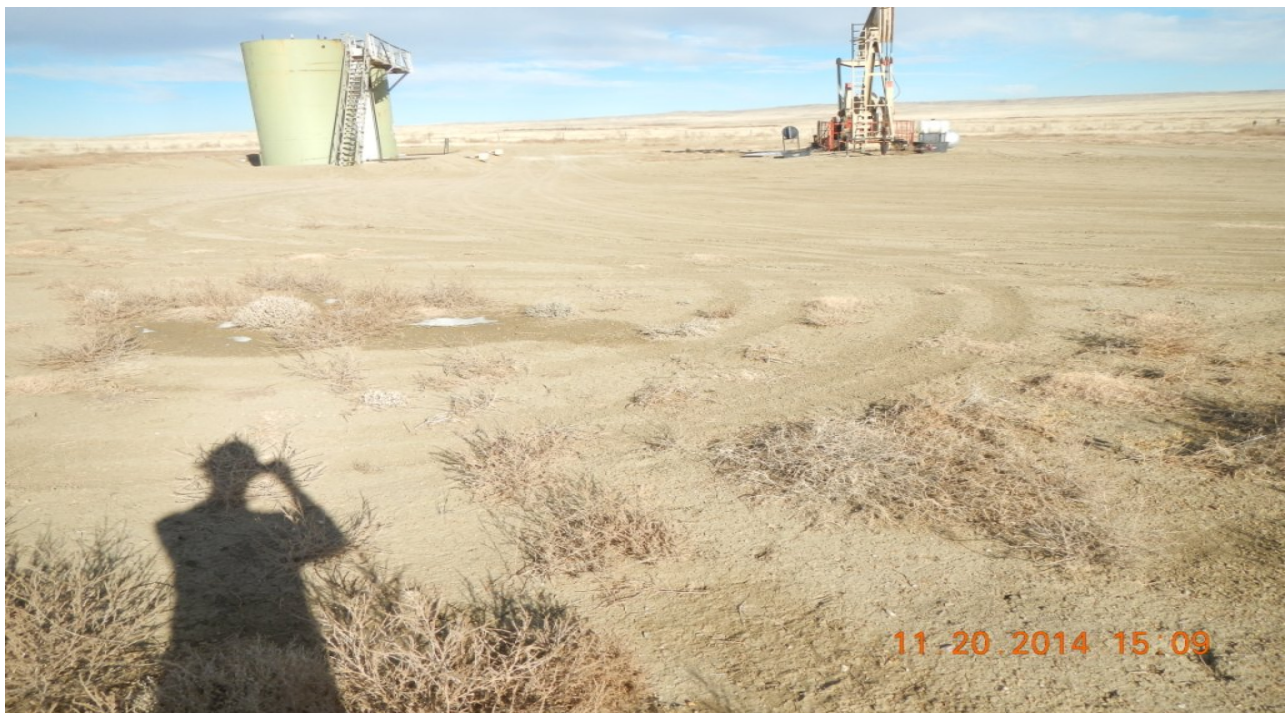
photo 6: South side of location facing North toward production equipment.

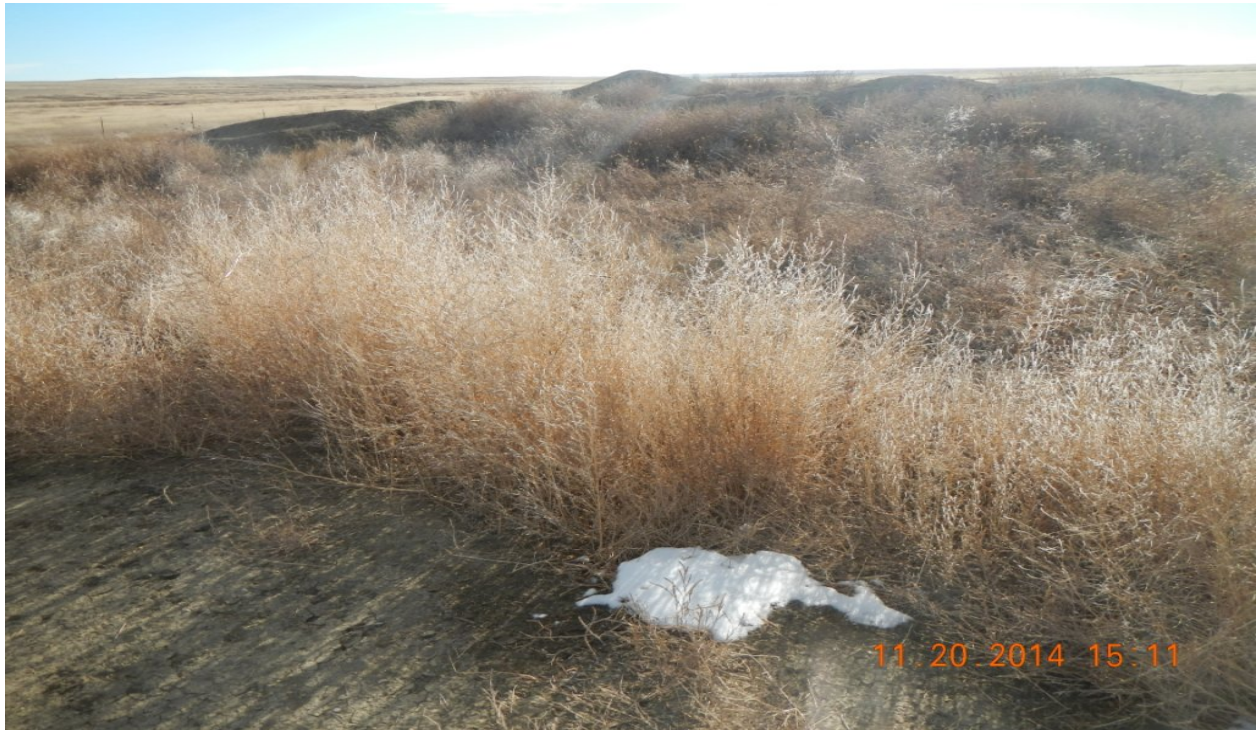
photo 7: Weed growth (kochia) around top soil stockpiles at the East side of location..

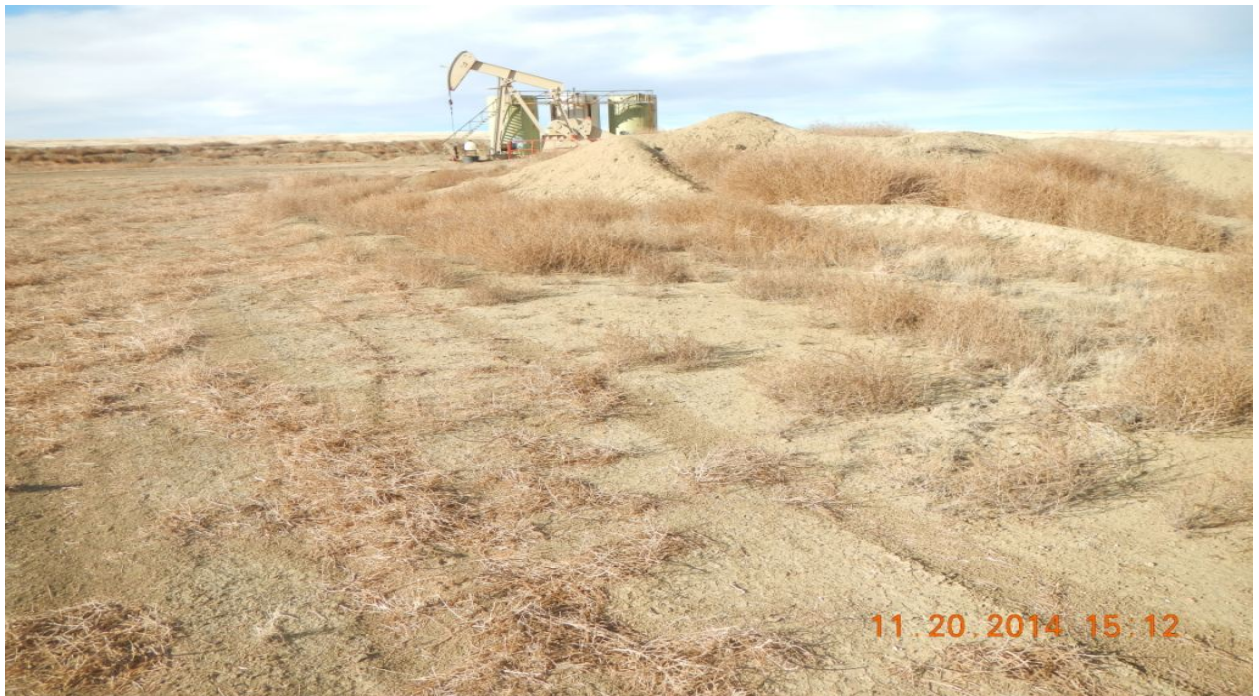
photo 8: Southeast corner of location facing Northwest.

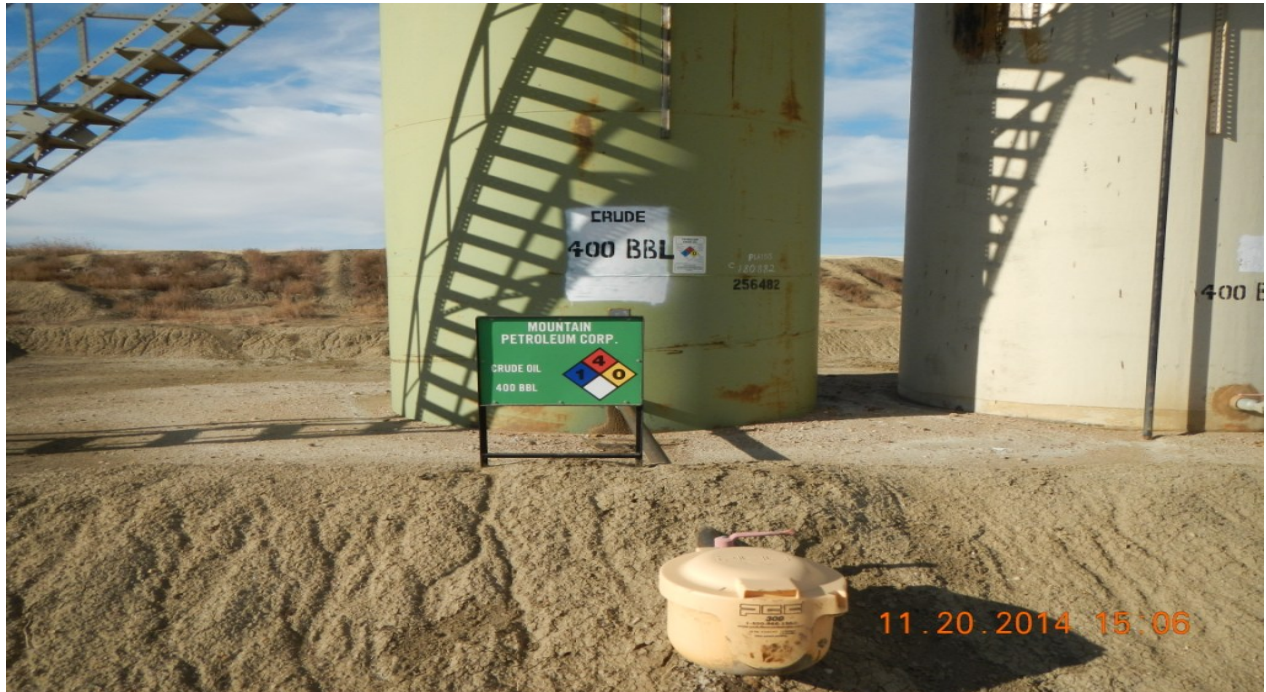
photo 9: Tanks appear to be correctly labeled as required by previous inspection.

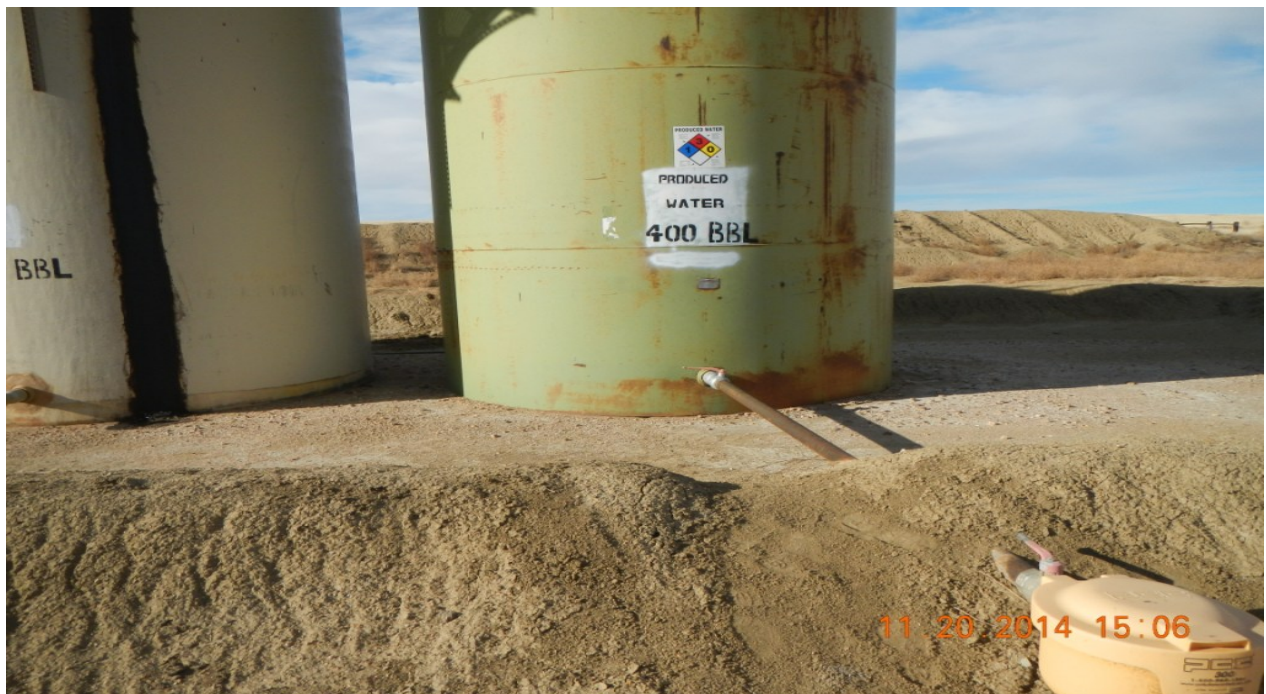
photo 10: Tanks appear to be correctly labeled as required by previous inspection.
