Love Ranch Centralized E&P Waste Annual Report  
Piceance Creek Facility  
Facility ID: 149012

Centralized E&P Waste Management Facility

Love Ranch Evaporation Pond

COGCC Facility No. 149012

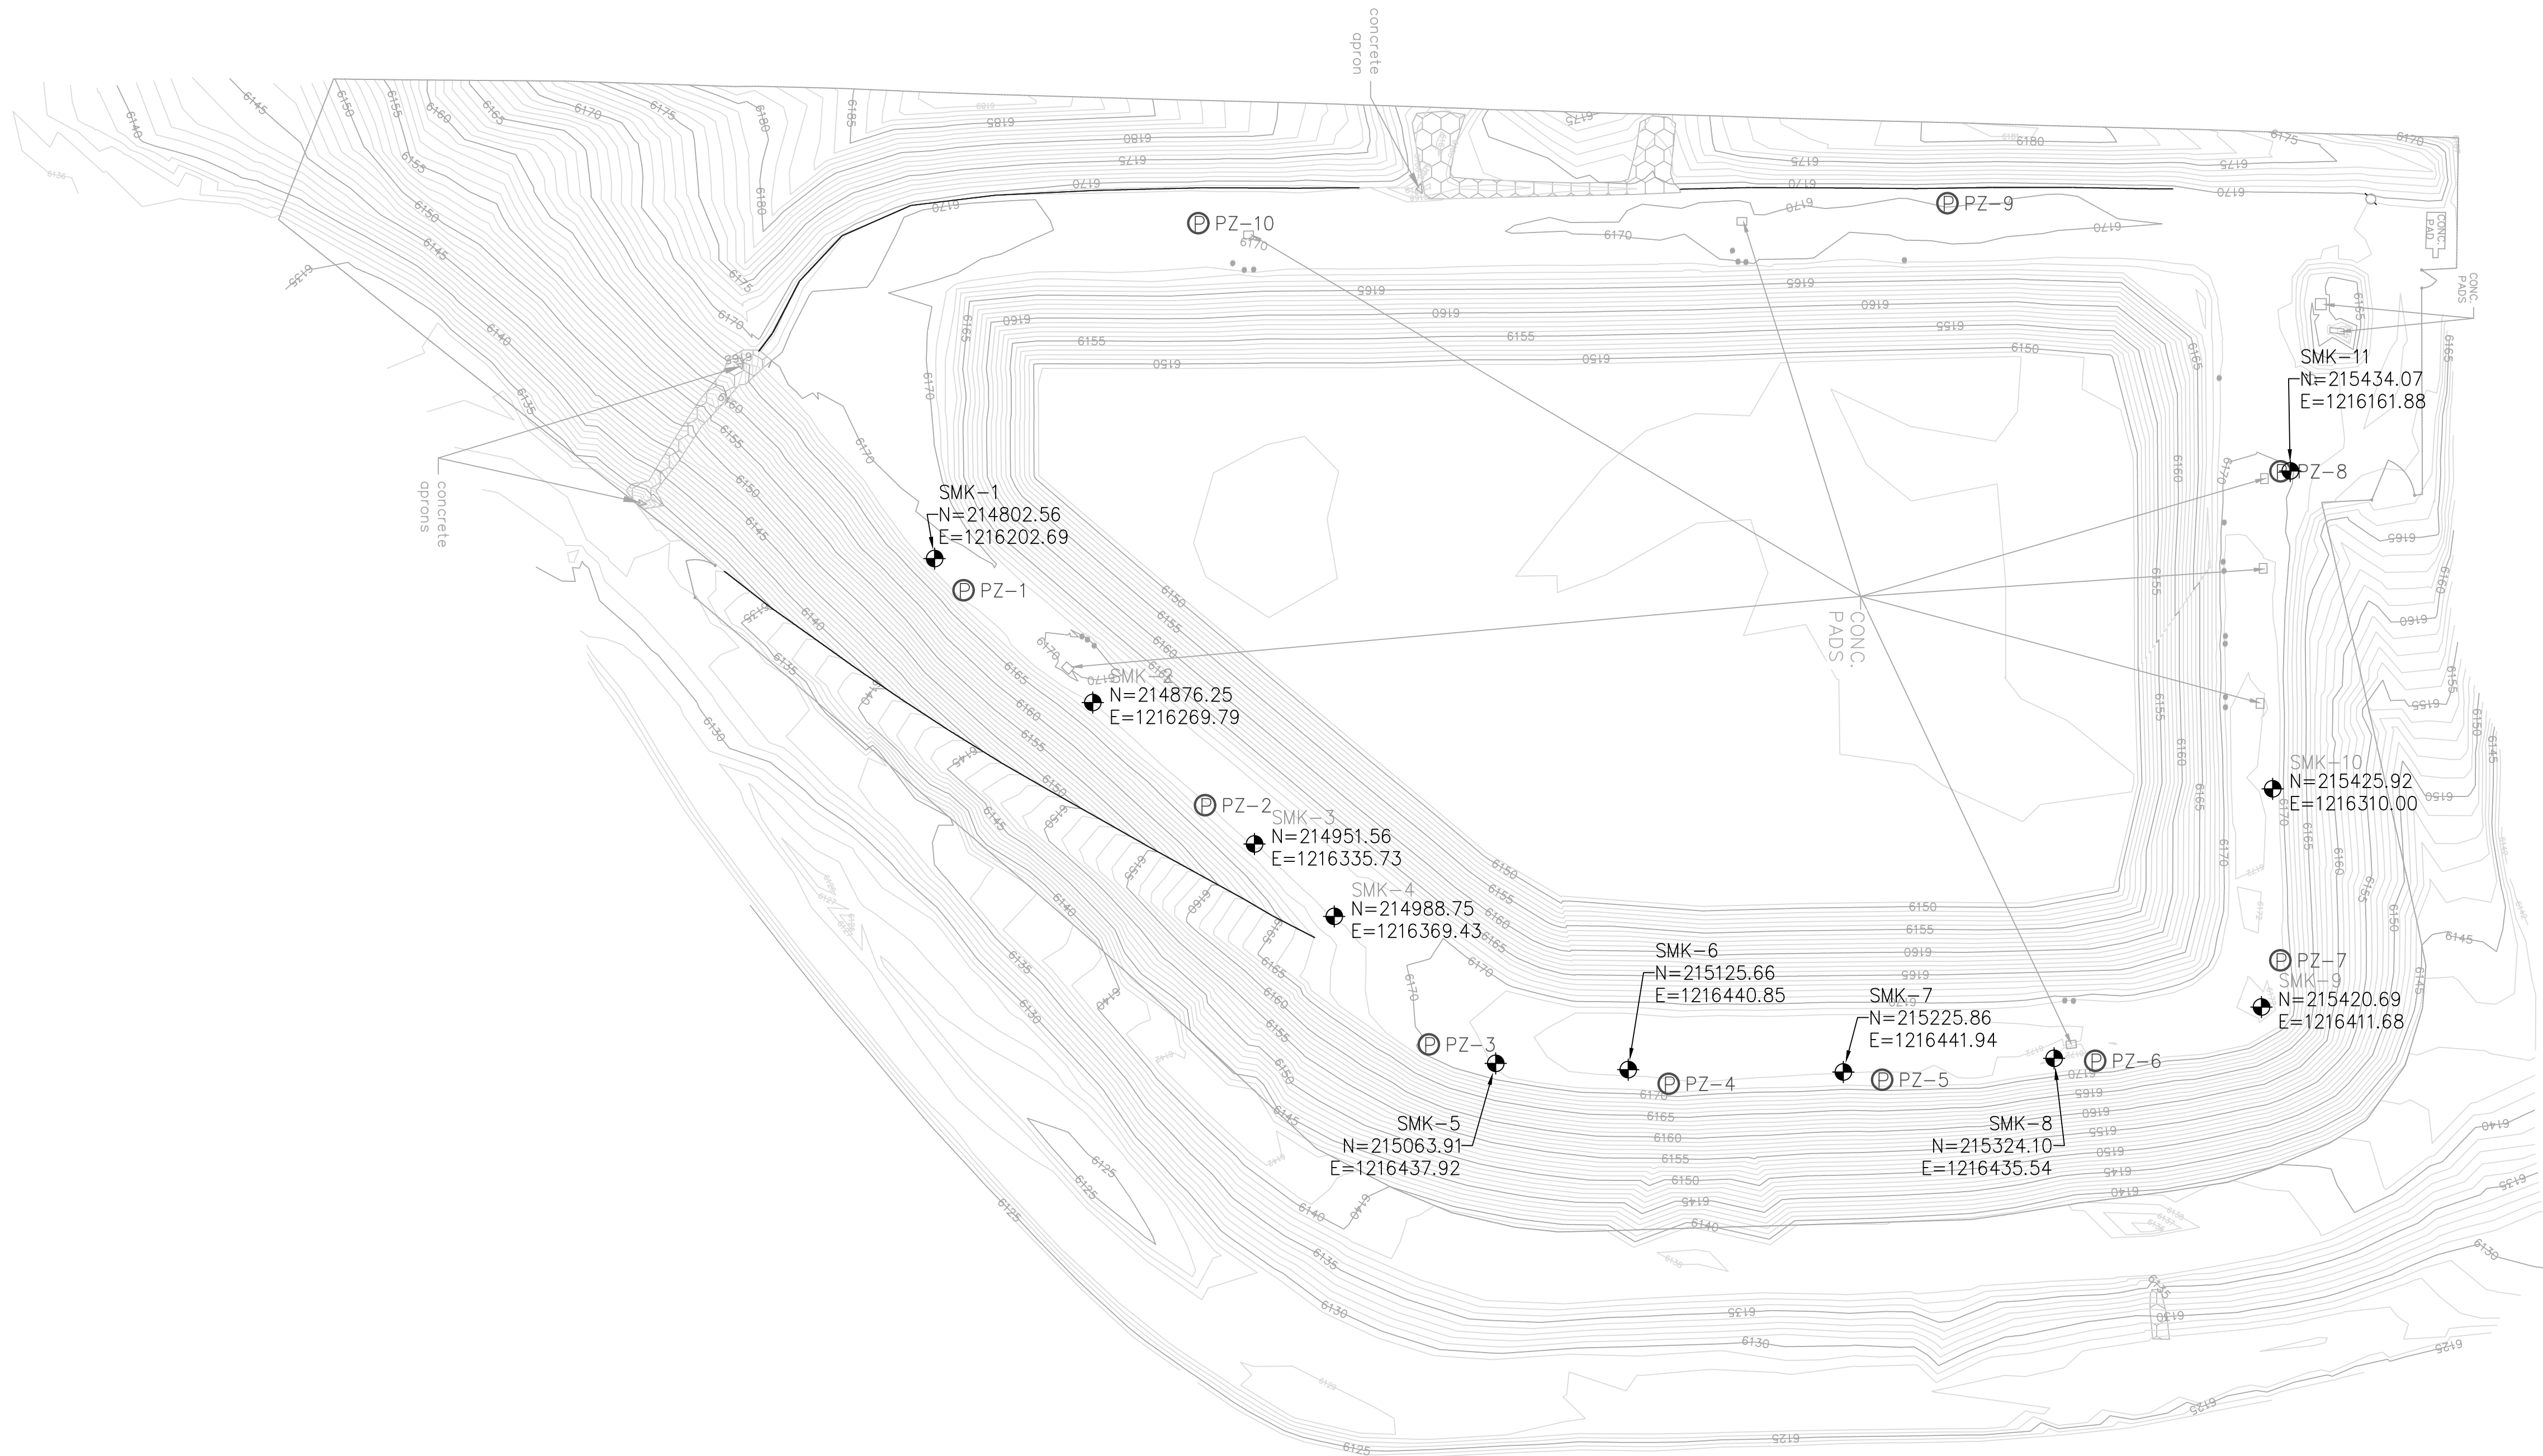
LOVE RANCH EVAPORATION POND SITE PLAN AS CONSTRUCTED PICEANCE CREEK					
PICEANCE CREEK FIELD			RIO BLANCO COUNTY, COLO.		
DIVISION	FIELD	FACILITY	CLASS	TYPE	SEQUENCE
CO	1022	330	00	C	220
					P

1. The settlement monuments were surveyed on October 21, 2014 using a Leica Series 1200 Differential GPS unit. Please see attached Figure 1 for a summary of settlement monitoring data to date, and to attachment 1 for the location of the settlement monuments.

1. Current monitoring in the piezometers indicates a trace (<0.03 ft) of water in the bottom of the 1-inch PVC in PZ-4, PZ-5, PZ-6 and PZ-9. Piezometers PZ-1; PZ-2; PZ-3; PZ-7 and PZ-8 showed no presence of water. The only measurable amount of water was found in PZ-10, located along the cut slope southwest of the pond, with 0.06 feet (< 1.0 inches). During the 2014 monthly monitoring events of the piezometers, only PZ-10 had any measurable water ranging from 0.06 feet to a maximum of 0.09 feet (<1.1 inches). See the attached Figures 2 and 3 for the Piezometer Inspection Report Form and to Attachment 1 for the location of these piezometers.
