On July 3, 2015 COGCC Environmental Staff (Alex Fischer) conducted an environmental field inspection of the Texas Tea of Colorado LLC., (Texas Tea) Pace #2, API 05-123-08720 Facility. This was a result of an inquiry from Anadarko Petroleum regarding an alleged flow line leak. Mark Markley and Charles Chase from Anadarko were on location at 07:45 and Don Morgan, contract pumper for Texas Tea on location at 08:55. Weather was sunny and temperature was about 70 degree Fahrenheit at time of Inspection. The well was SI at this time. Anadarko provided access to their compressor facility where the alleged flow line leak occurred. A meter house was removed and temporally relocated where exposed flow lines were observed in an open excavation. The following is a summary:

July 3, 2015 COGCC Environmental field inspection of Texas Tea of Colorado LLC (Texas Tea) Pace # 2 API 05-123-08720.

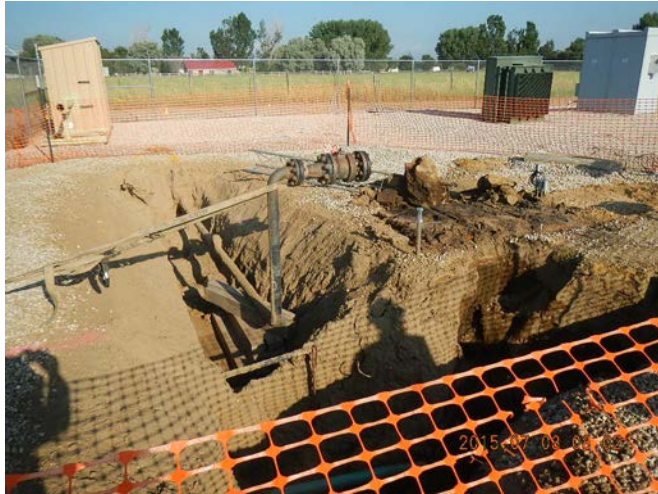
- The area beneath the meter house and communications tower indicated visual discoloration of the soil from the fiberglass flow line upward to the ground surface with what appeared to be more concentrated discoloration from the flow to about 2 feet above the line.

Footprint of where meter shed was located. Stained soil.

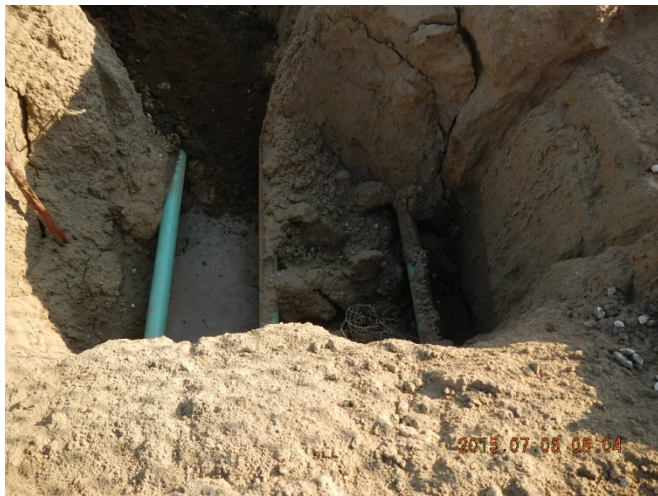
- Three (3) 3-inch steel flow lines that Anadarko identified as Encana's were exposed approximately 5-feet below ground surface (bgs). Anadarko stated that these lines has sound integrity. Unsure if these lines were active or SI at time of the Inspection.

Encana flow lines.

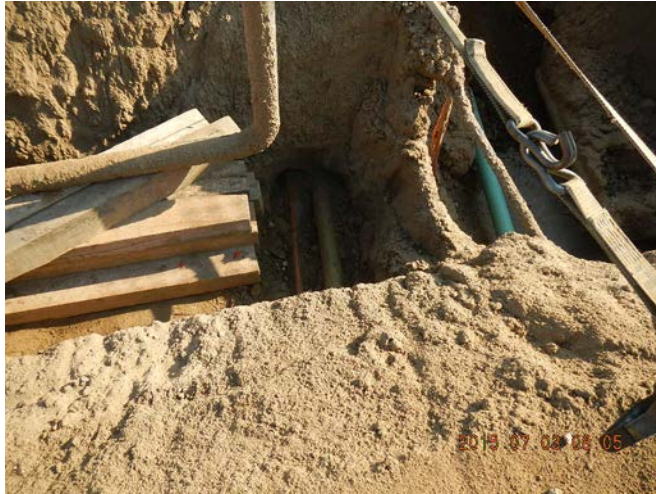
- One (1) 3-inch fiberglass flow line and one (1) one-inch poly line identified as Texas teas were exposed approximately 5-feet below ground surface (bgs). The fiberglass line was located beneath the footprint of the meter house and communication tower. These lines were SI at time of the Inspection.

Texas Tea flowlines immediately to the right of wood cribbing.

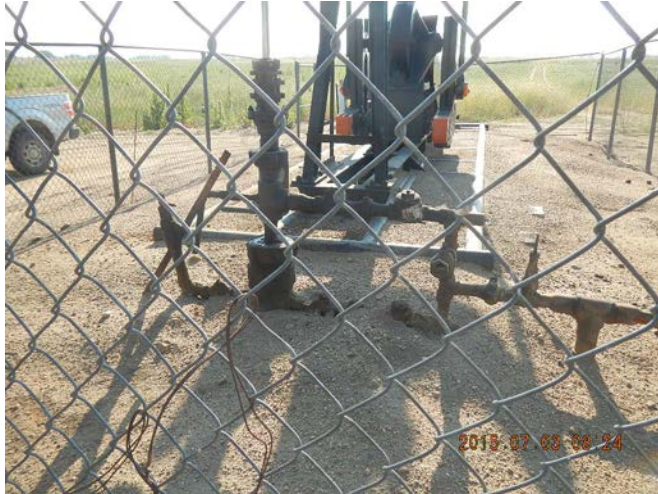
- Pace # 2 well head was SI. Oily material was built up around the stuffing box, around the wellhead and valves, with fresh soil on ground surface, pipes and valves.

Fresh dirt around well head.

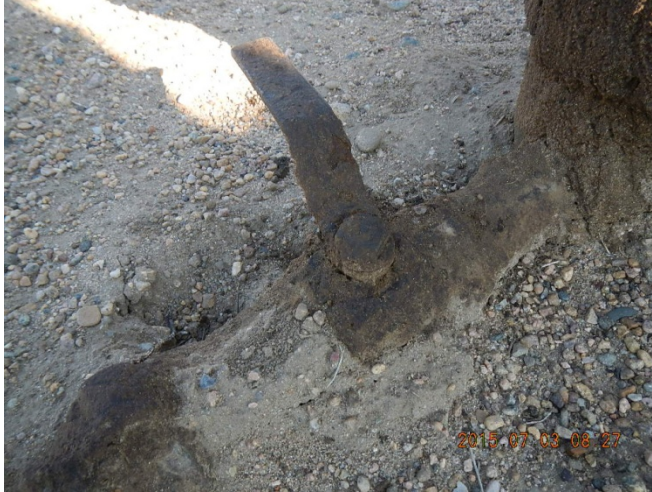
Casing valve.

- Valves were in the OFF position, but it appeared that the casing valve may have turned recently.
- Polish rod has some slight rust and dirt accumulation.

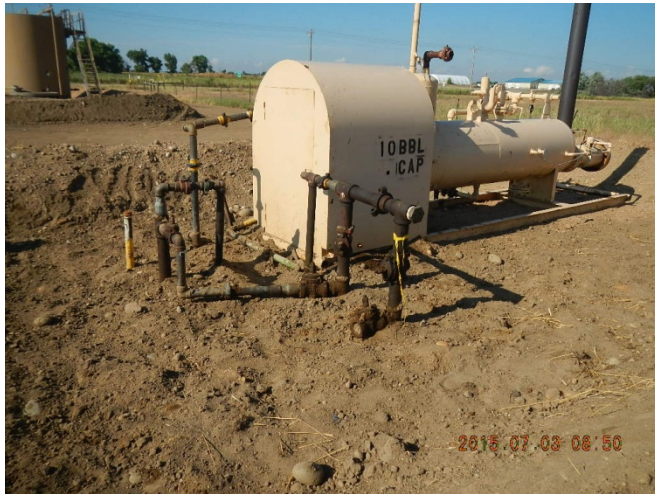
- Oil saturated soil beneath 1/2-inch tube coming out of separator.
- Recent work done as evidence by recent plumbing of fittings (new tape/pipe dope visible).
- Oil stained soil around separator and on north side of berm.
- An approximate 2-cubic yards of oily soil was noted in the weeds north of the separator.
- Oil stains on ground surface (access road) near the separator.

Separator and fittings.

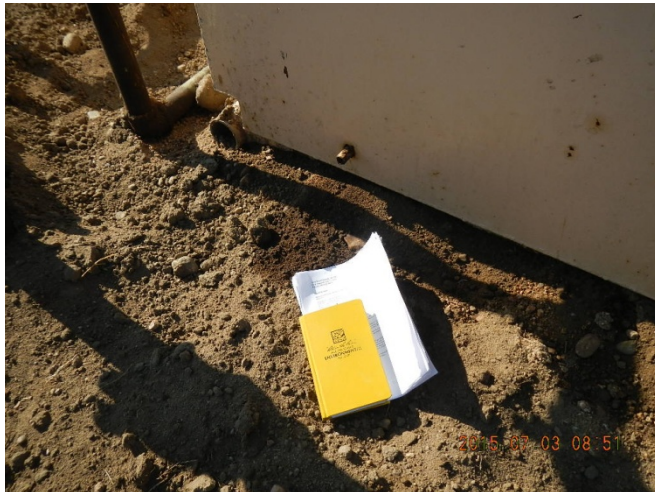
Oily soil beneath line.

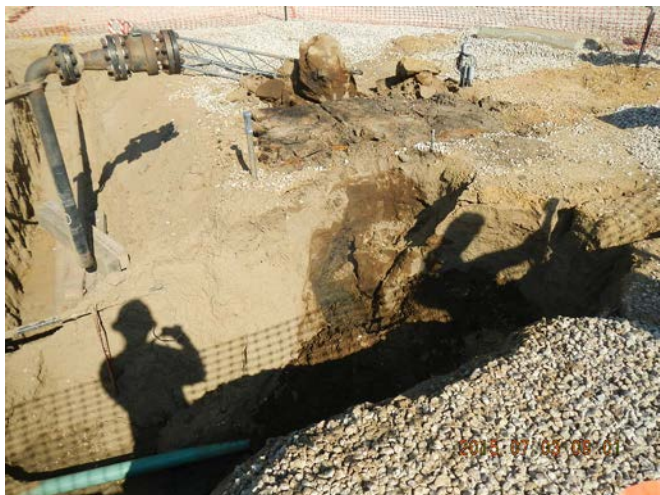
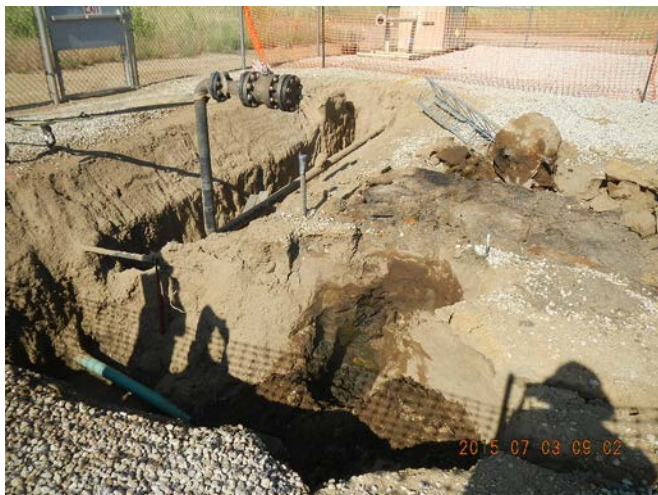
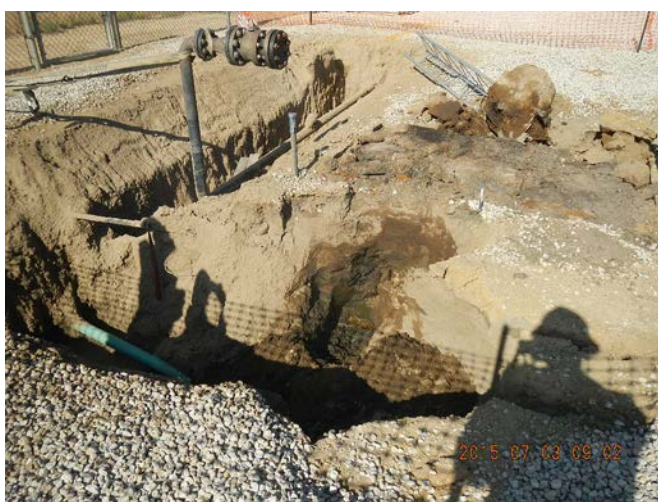
- Birds nests were noted on the pump jack.
- A 5-gallon pail apparently empty was near the pump jack.
- At about 8:56 the Texas Tea line was energized by Mr. Morgan and within approximately 1-minute, gas and fluids were emitting from the fiberglass line. Approximate pressure was 20 PSI. The line was then SI.

Compromised line leaking fluids and gas.

- Alex told Mr. Morgan that Texas Tea was to submit a Form 19 Spill/Release Report, and to provide the COGCC notification prior to day lighting/excavating soil above the line leak to that the COGCC maybe present at that time. John Axelson's contact information was provided.
- Anadarko found a pin hole leak in their flow line located approximately 50-feet east of the Texas Tea tank battery. Repairs were made and the excavation was backfilled. Mr. Chase provided Spill Report Document Number 400861293 and indicated that they will be conducting a subsurface investigation to determine the extent of impact. He stated the groundwater is about 5.5 feet bgs and that groundwater was impacted.

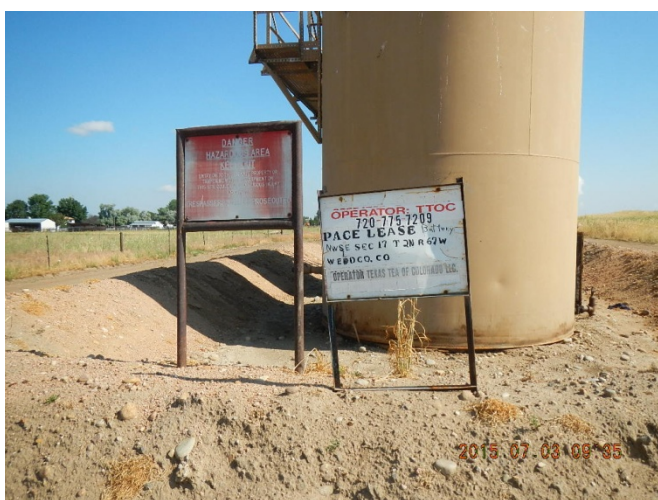
- Appears that soil has been removed as indicated by lower exposed portions of the tanks. Tanks exhibit signs of peeling paint and rust near the lower portion of tanks.
- Manway panels have been recently painted.
- 300-barrel, Tank Number 54023 – valves, fittings, bull plug leaking as evident of soil staining beneath valve. This valve was in off position and locked out.
- 300-barrel, Tank Number 54021 – This valve was off position but not locked out.
- Trash (oily rag) located on the east side of Tank Number 54023.

Tank battery.

With the apparent shallow groundwater (5-6 feet bgs) subsurface site investigation(s) and assessments should be conducted to verify that groundwater has not been impacted in the vicinity of the tank battery, horizontal separator, and compromised line location.

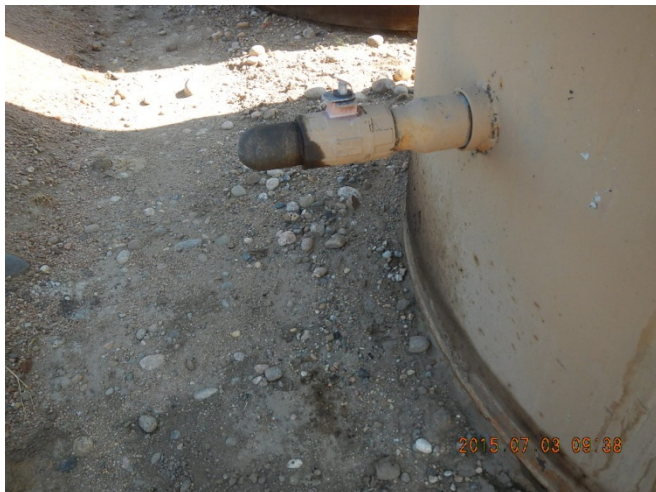
Leaking fittings. Tank Number 54023.

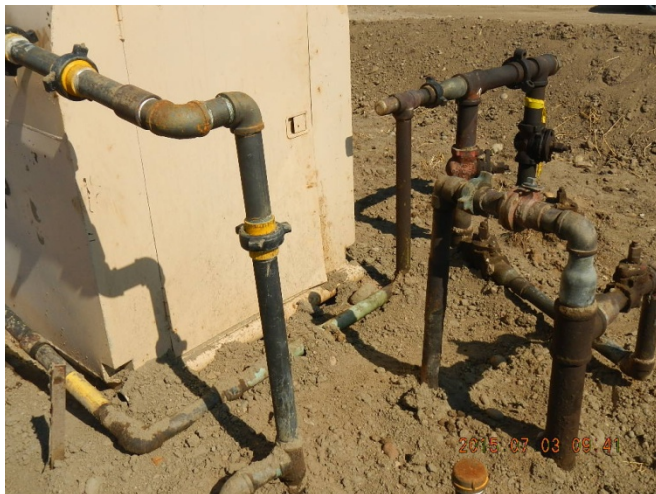
Separator plumbing.

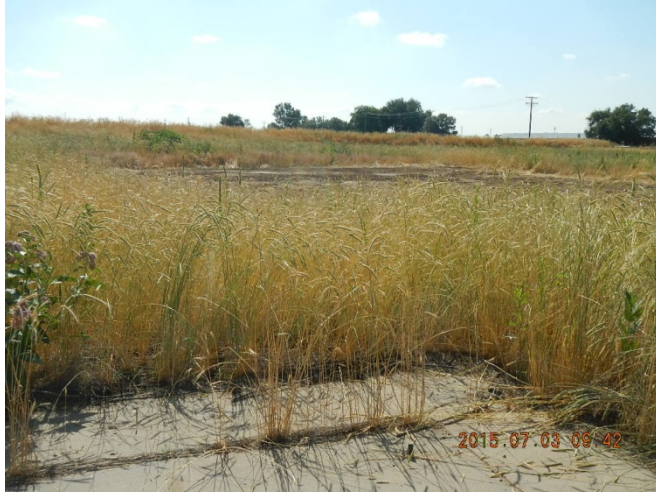
Former compressor pad. Disturbed area in background is location of Anadarko line leak, Fm 19 4001861293.

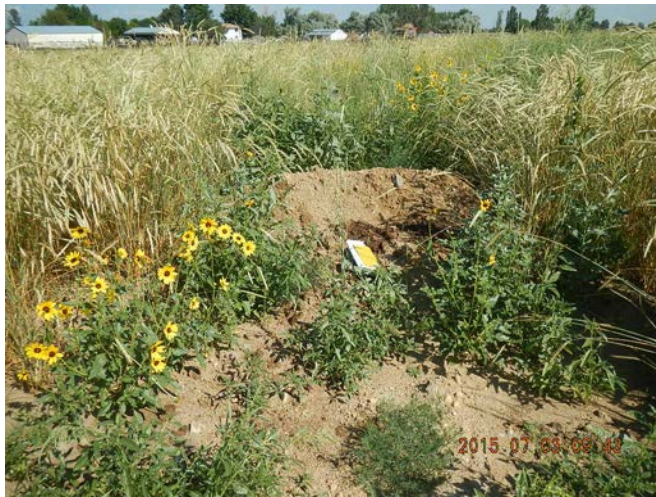
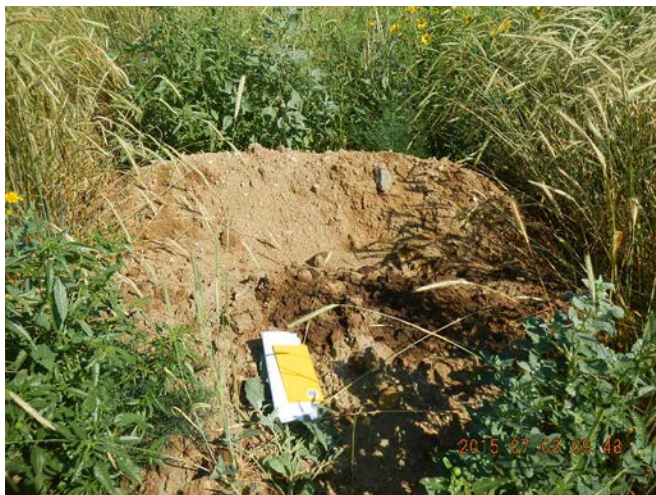
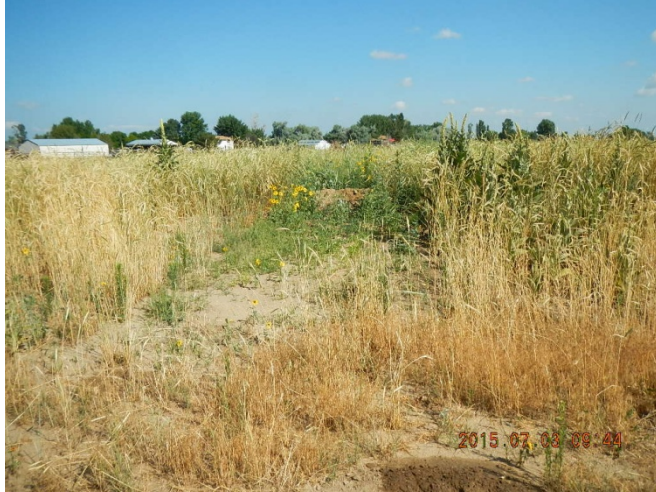
App. 2 yds of oily soil north of separator.

App 2 yds of oil soil. Oil stained ground beneath date and time stamp.
