## Final Reclamation Inspection

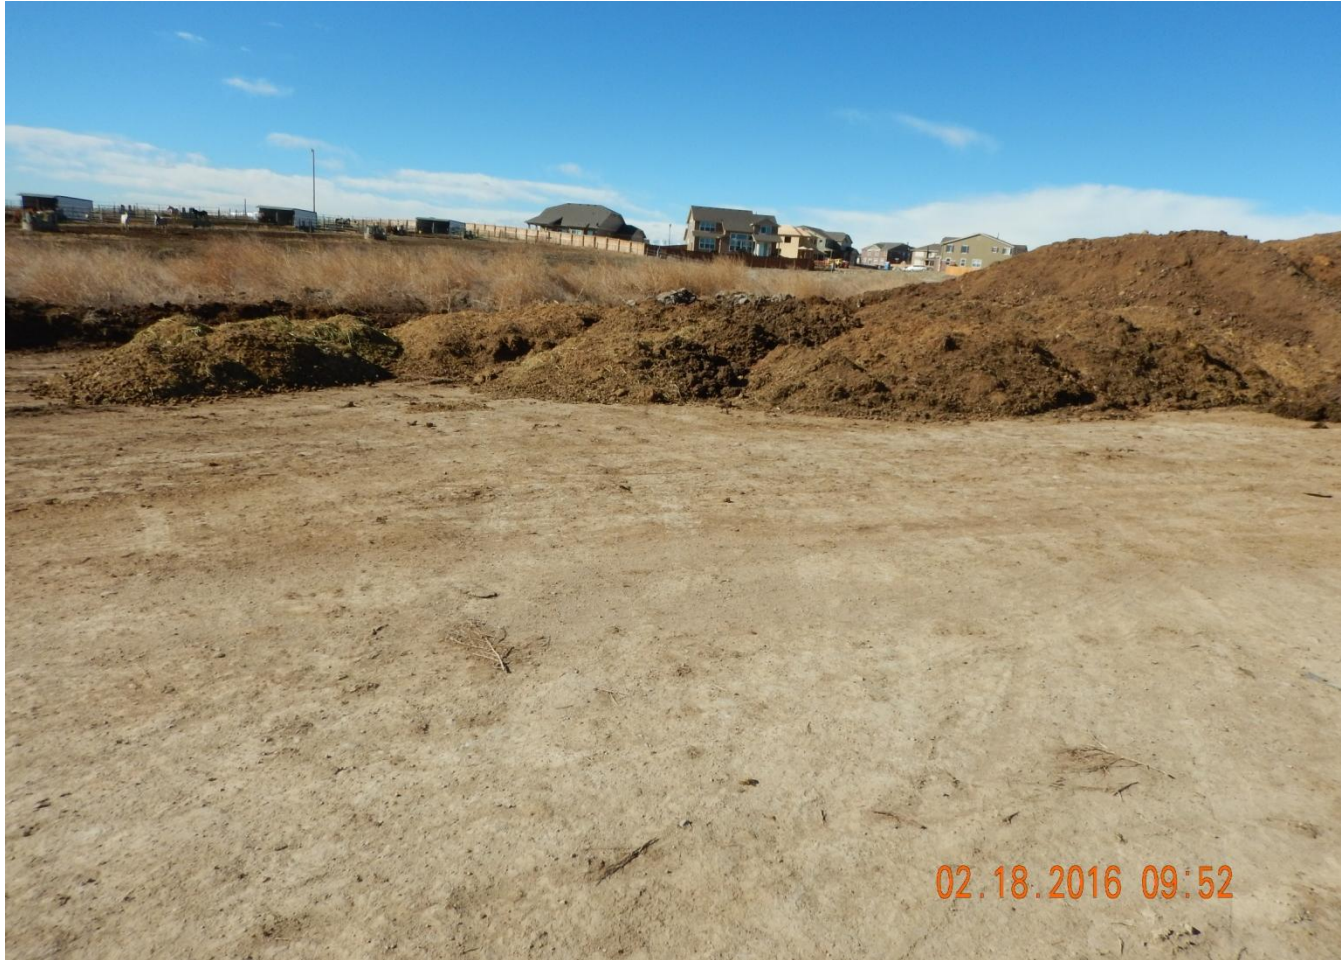
**Photo 1.** Photo taken from southern location, facing West. Location is being used by private landowner as a horse mucking area. Area has *Kochia* sp. growing throughout area. No stormwater controls in place. Appears there could be runoff into the pond down slope of the location.

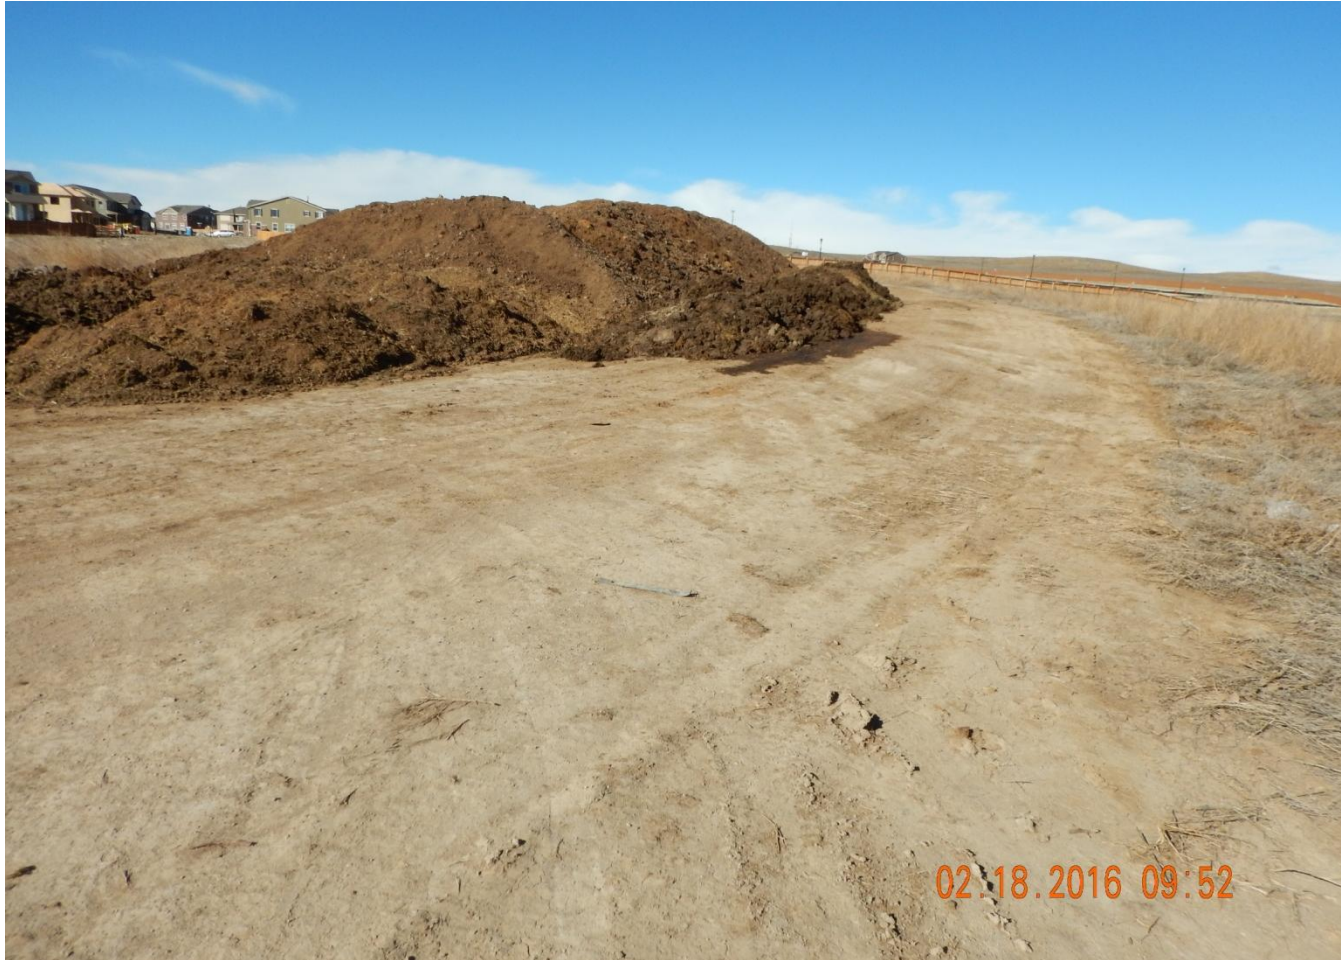
**Photo 2.** Photo taken from southern location, facing North. Location is being used by private landowner as a horse mucking area. Area has *Kochia* sp. growing throughout area. No stormwater controls in place. Appears there could be runoff into the pond down slope of the location.

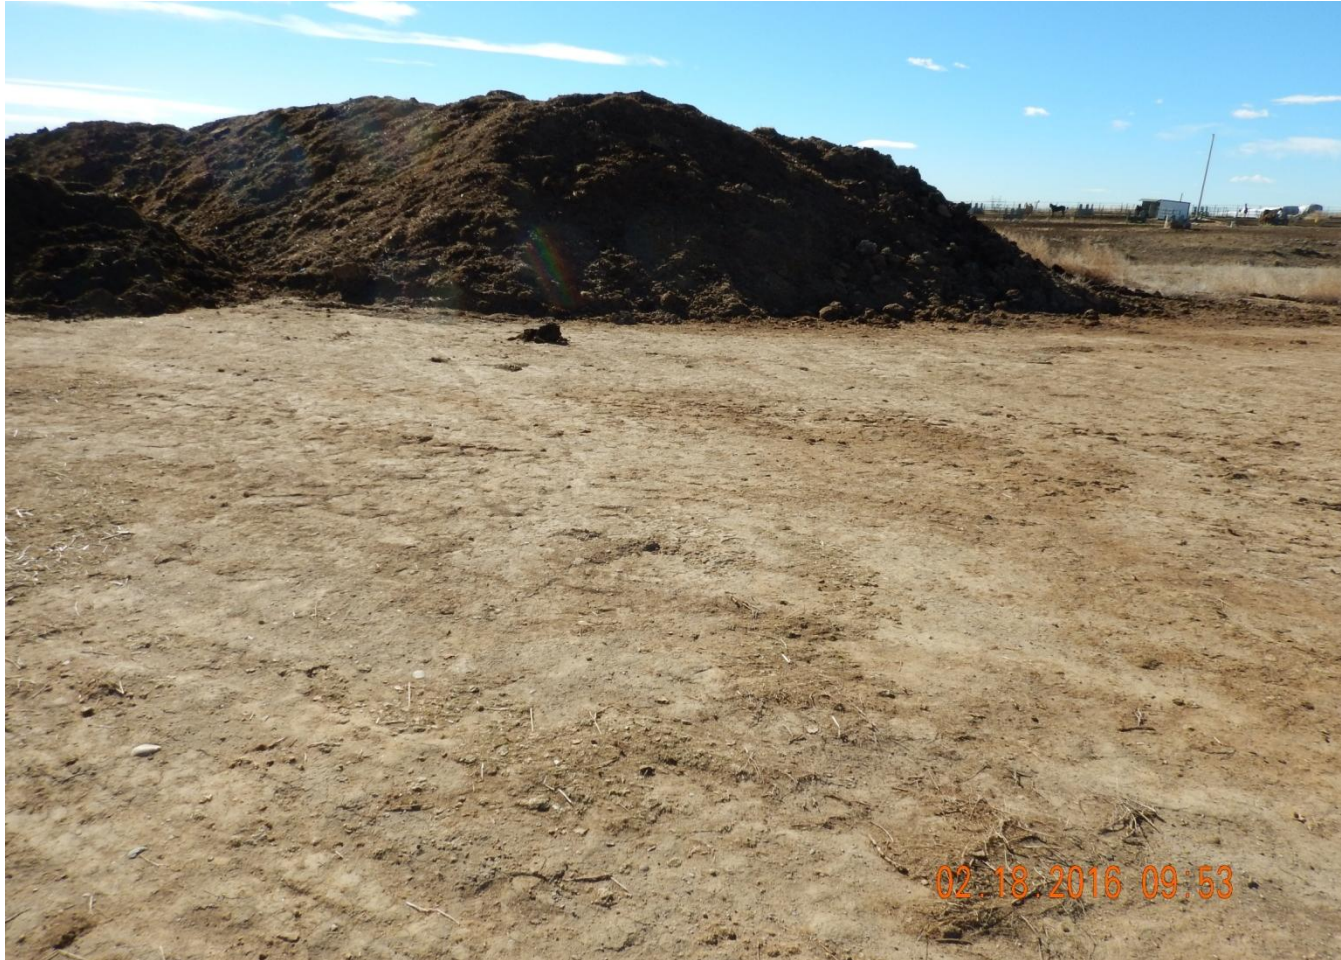
**Photo 3.** Photo taken from northern location, facing South. Location is being used by private landowner as a horse mucking area. Area has *Kochia* sp. growing throughout area. No stormwater controls in place. Appears there could be runoff into the pond down slope of the location.

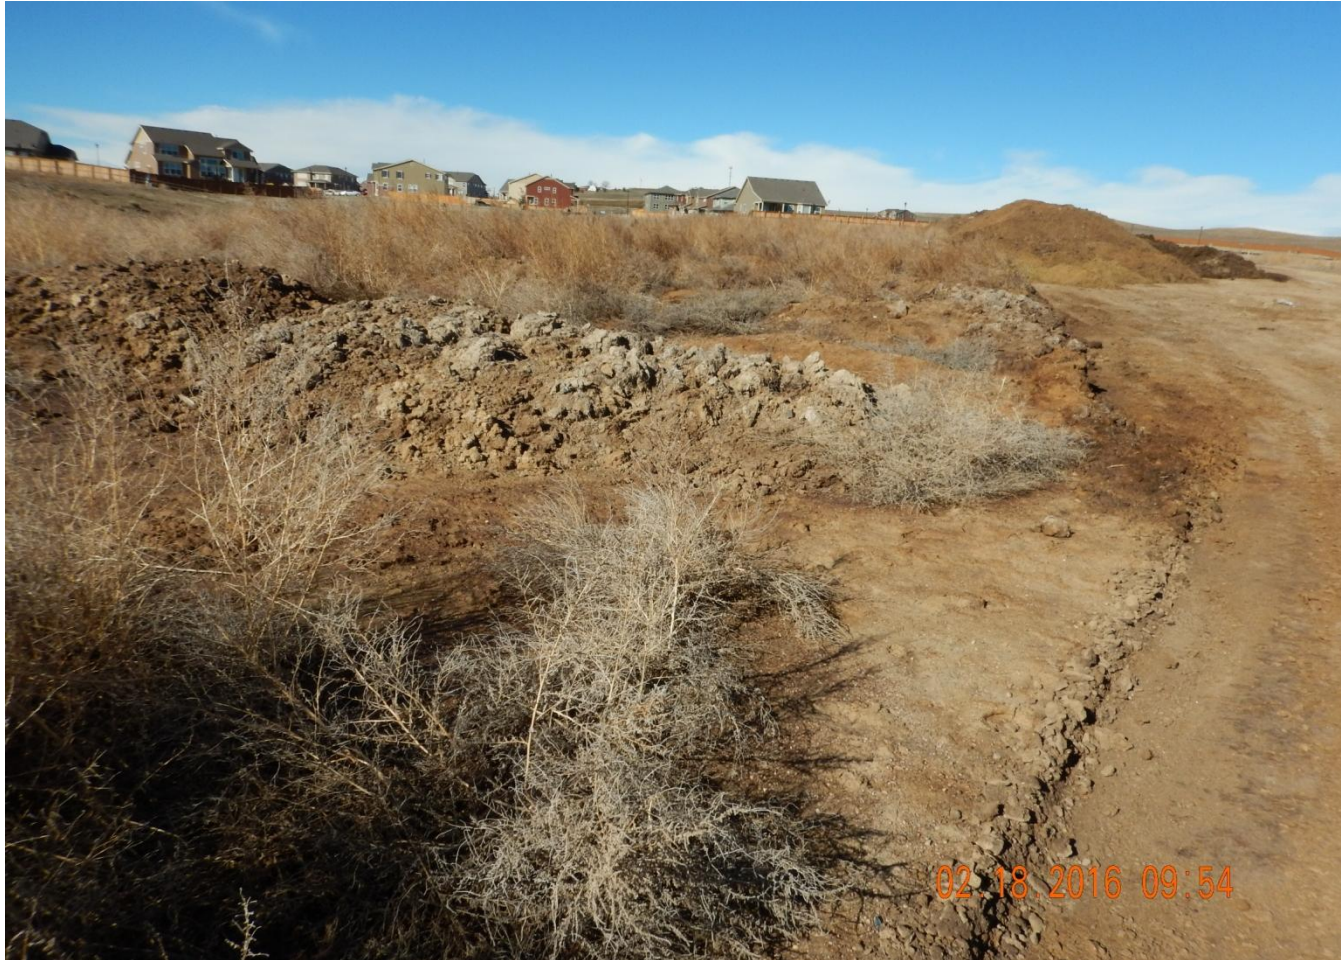
**Photo 4.** Photo taken from southern location, facing North. Photo demonstrates Kochia sp. growing throughout area. No stormwater controls in place. Appears there could be runoff into the pond down slope of the location.
