March 4, 2016

Inspection Photos WPX Potter Loc# 335172

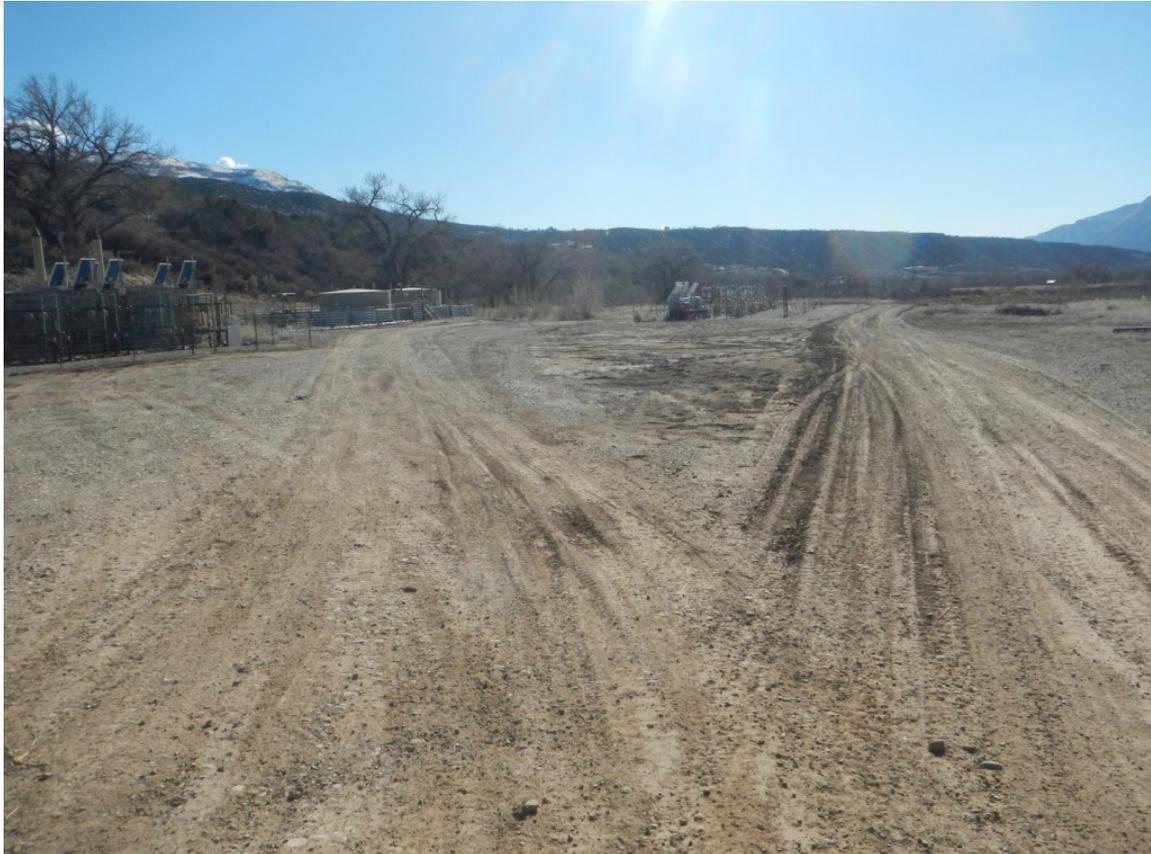
Photo#1: Overview of Location to SW.

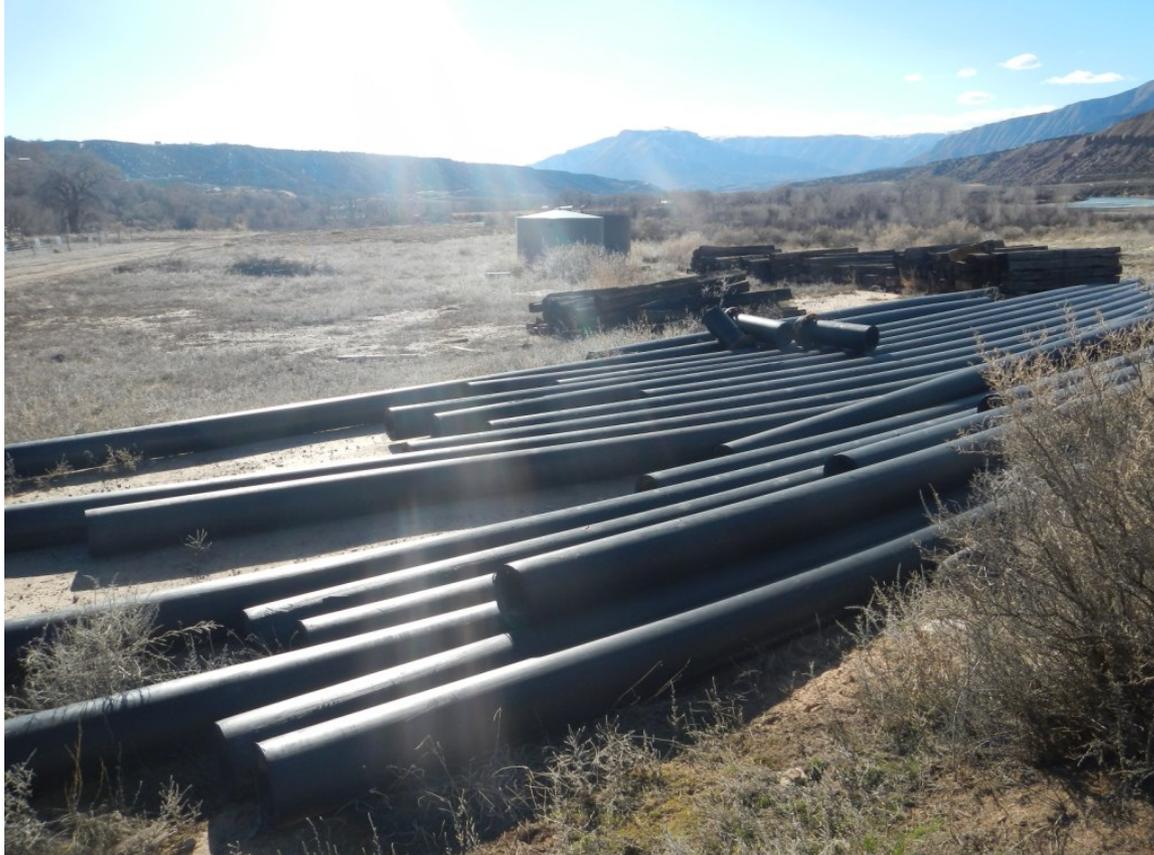
Photo#2: Equipment/Supplies stored on NE portion of Location, subject of Variance request.

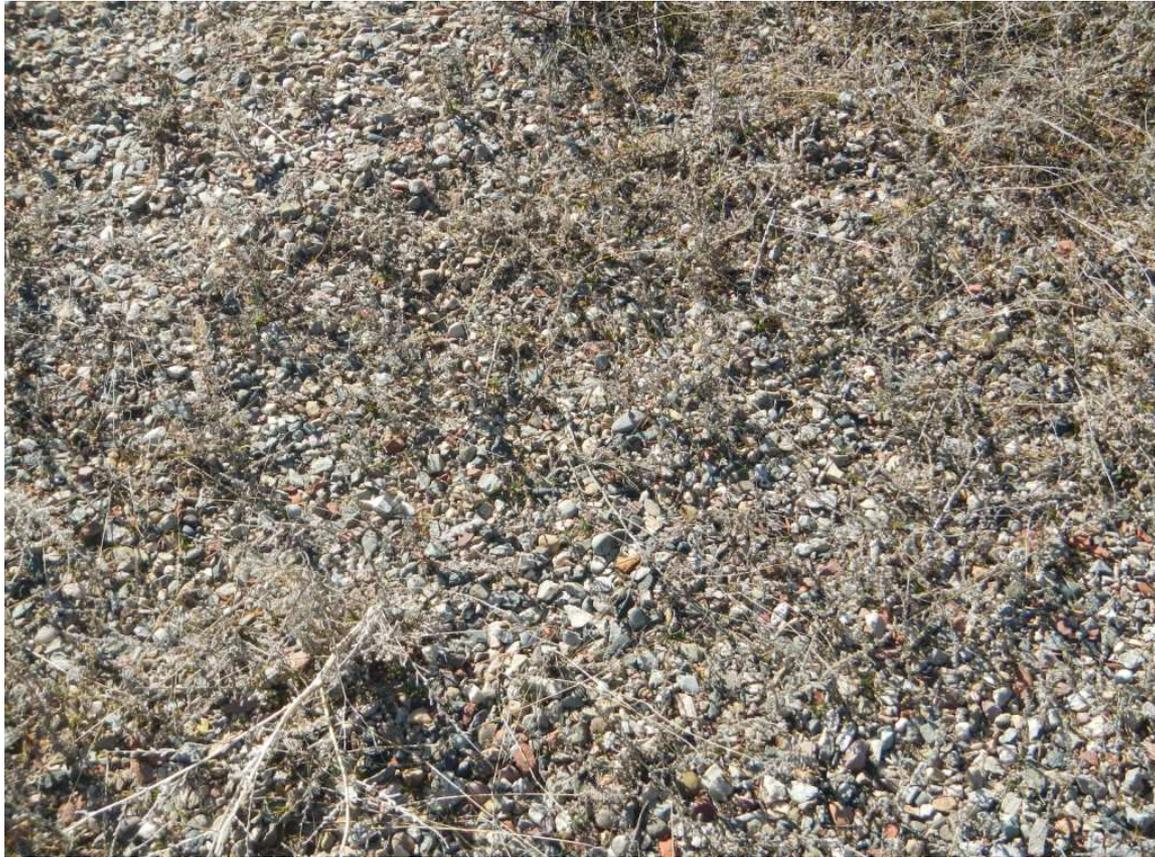
Photo#3: Ground conditions where supplies in previous Photo are Located. Area is compacted and stabilized.

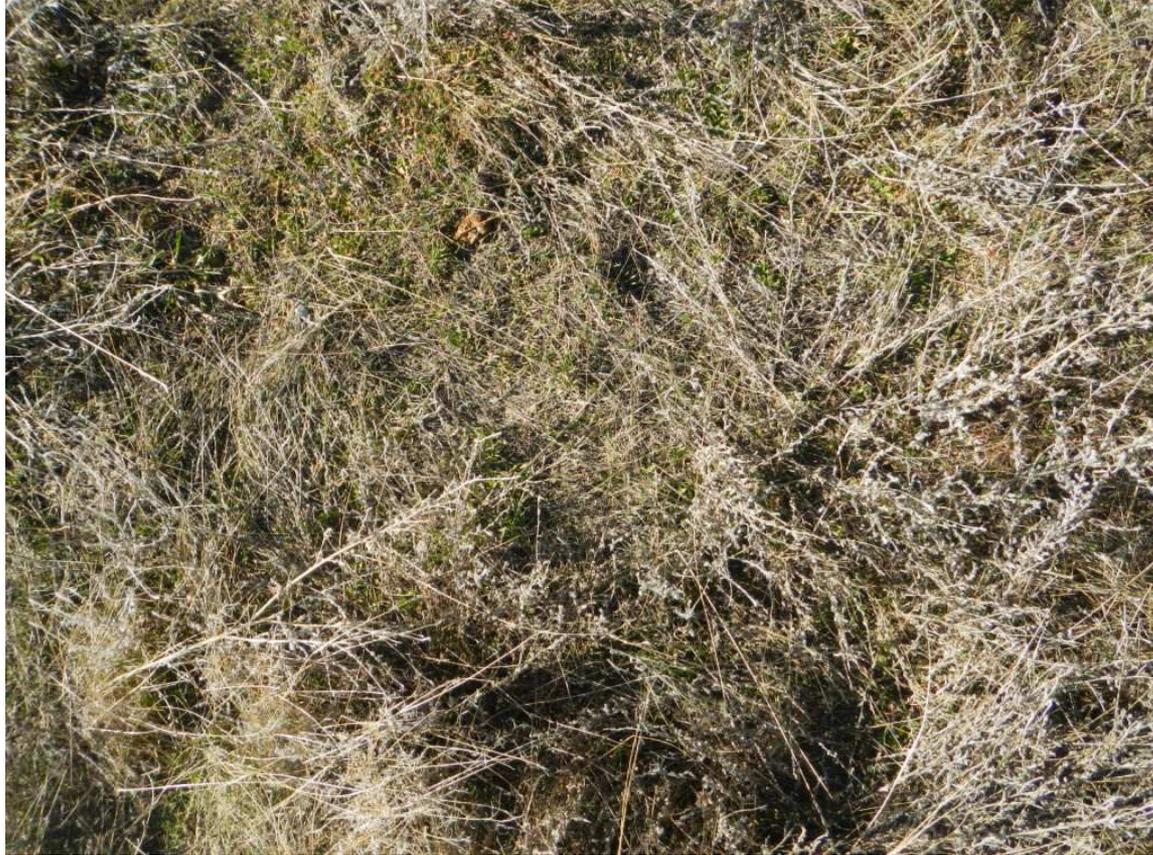
Photo#4: Kochia and Cheat Grass are thriving on the compacted areas.

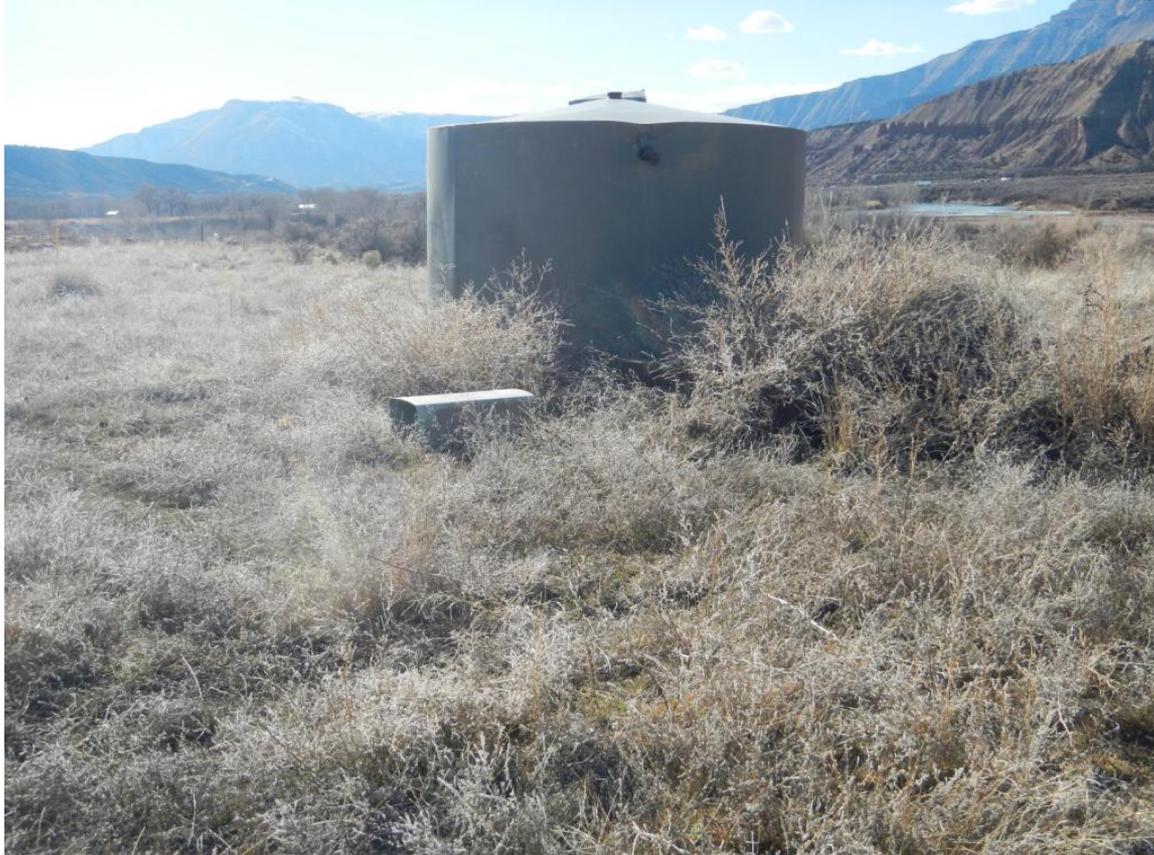
Photo#5: Tank in storage area on Location. Kochia has senesced and become Debris.

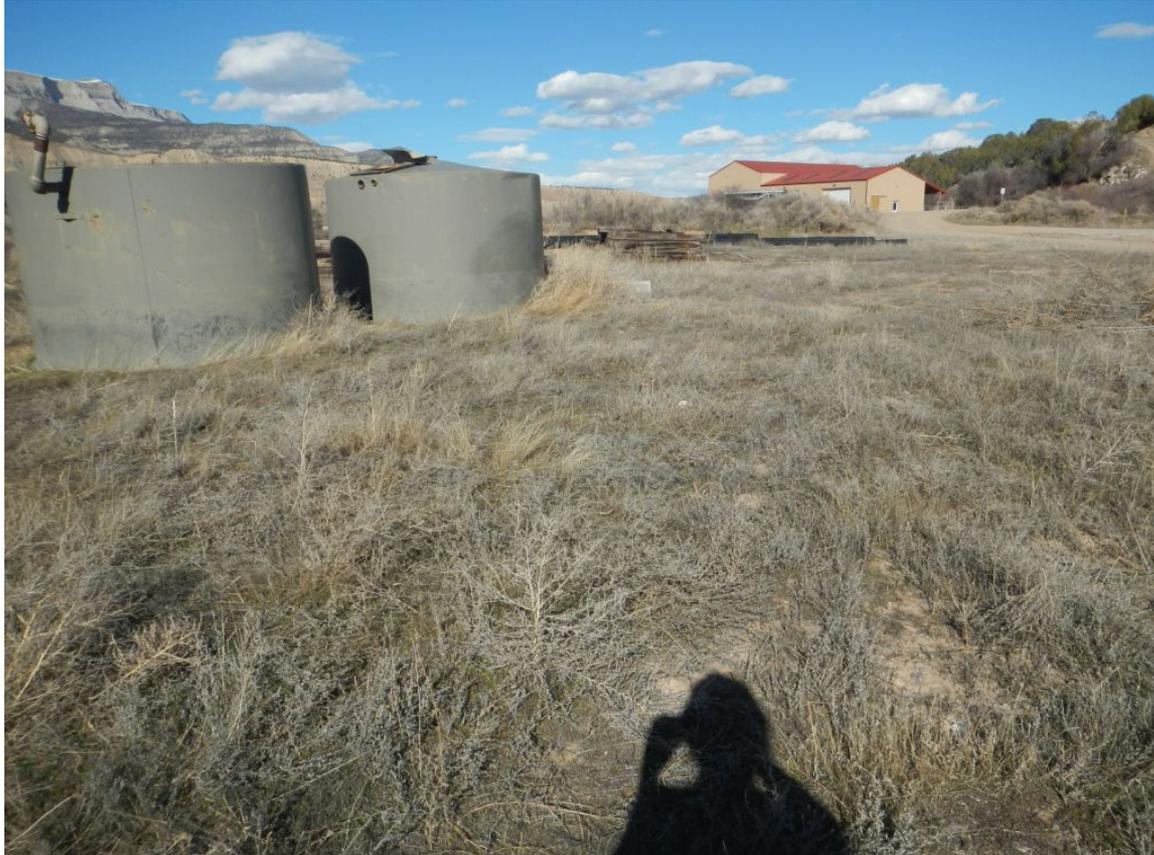
Photo#6: View of Storage Area to NE.

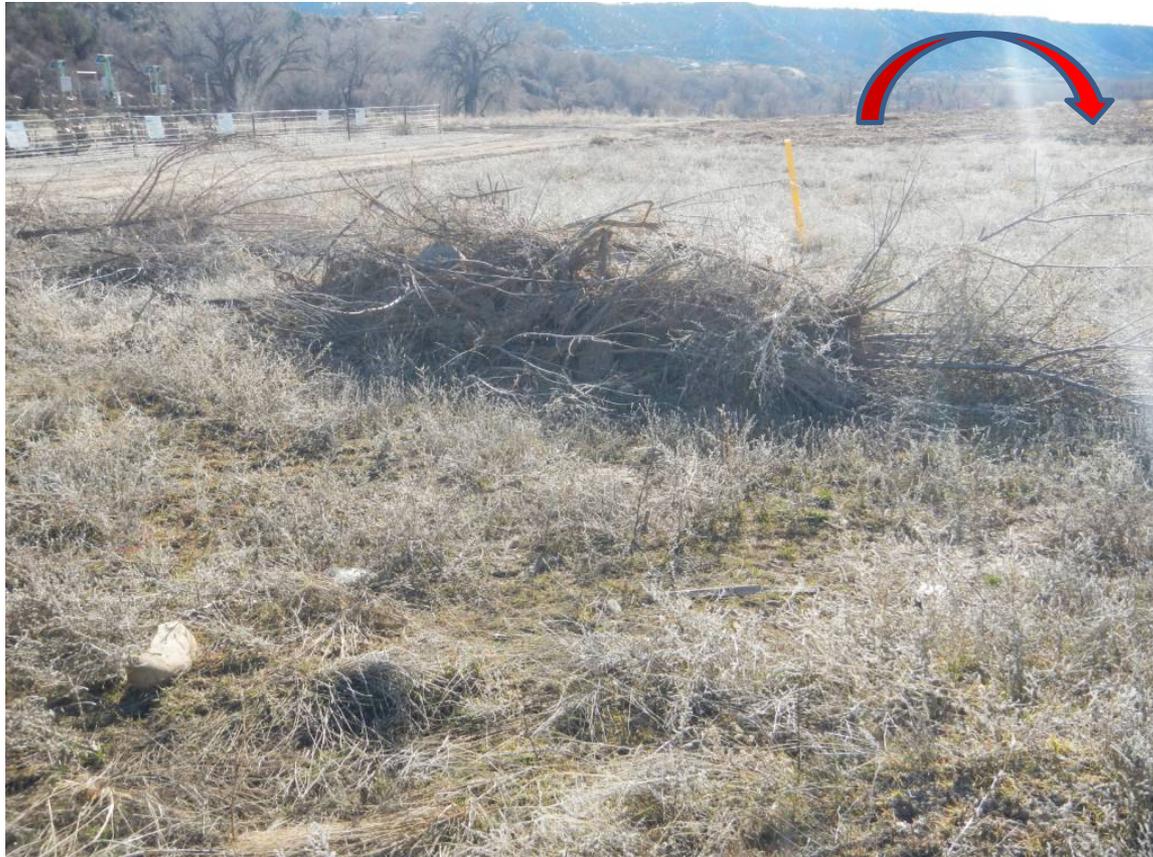
Photo#7: Slash pile in what appears to be un reclaimed Interim Reclamation area along North side of Location. Arrow in background indicates Manure Layer in next Photo.

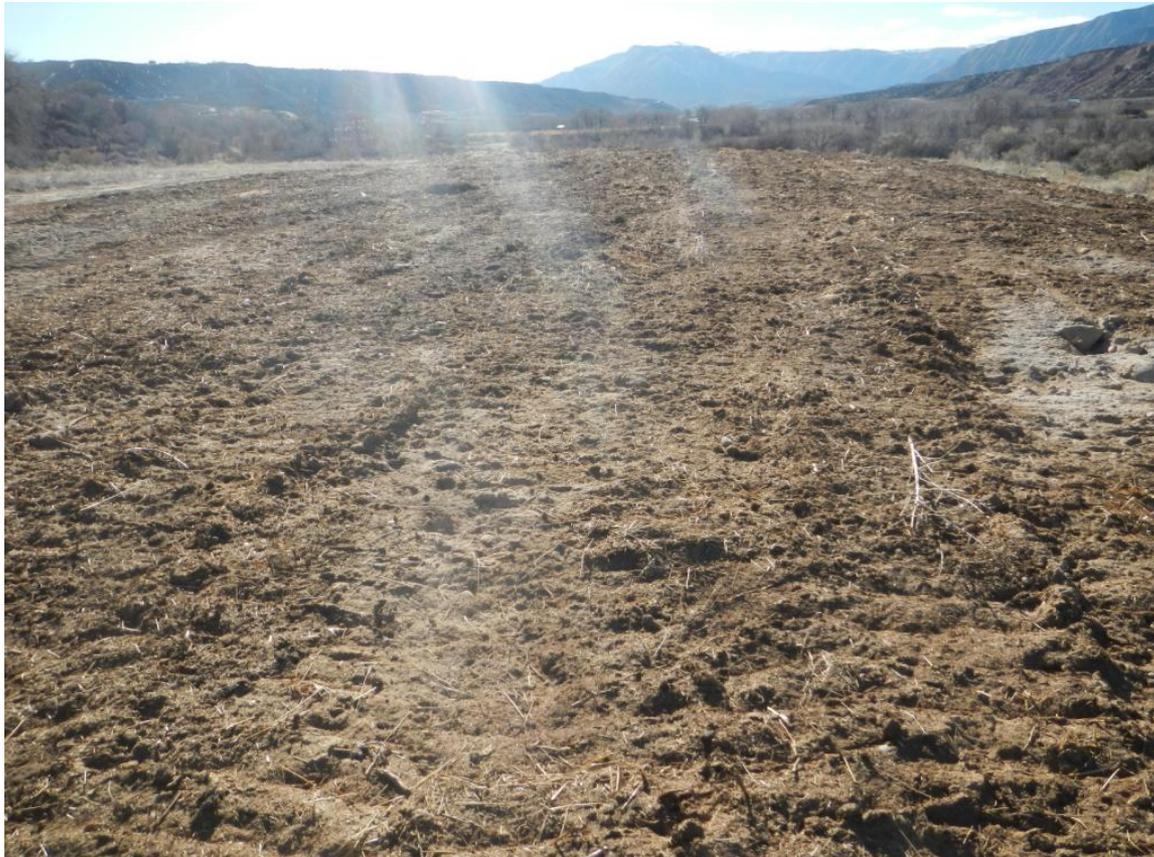
Photo#8: Heavy Tracked Manure Layer, West of Slash pile in previous Photo. Part of Revegetation Project? View to SW

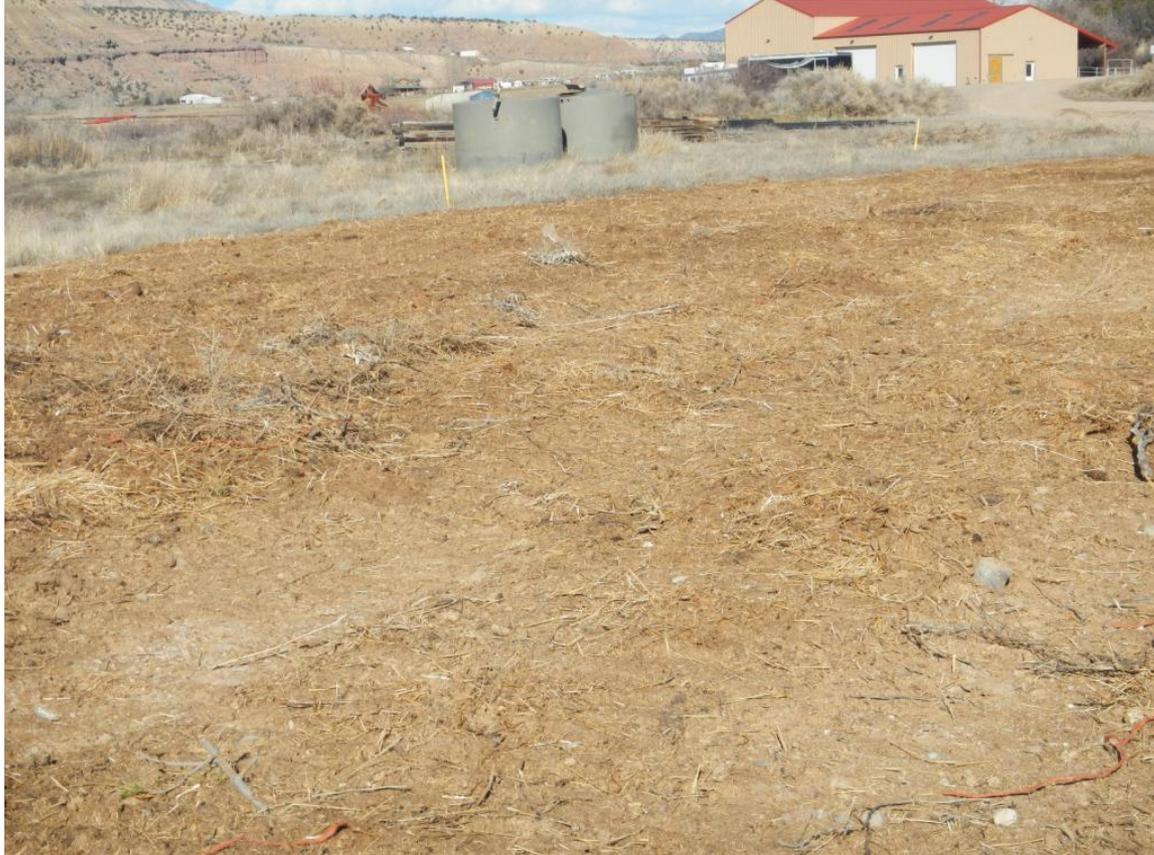
Photo#9: View of Manure Layer to NE.

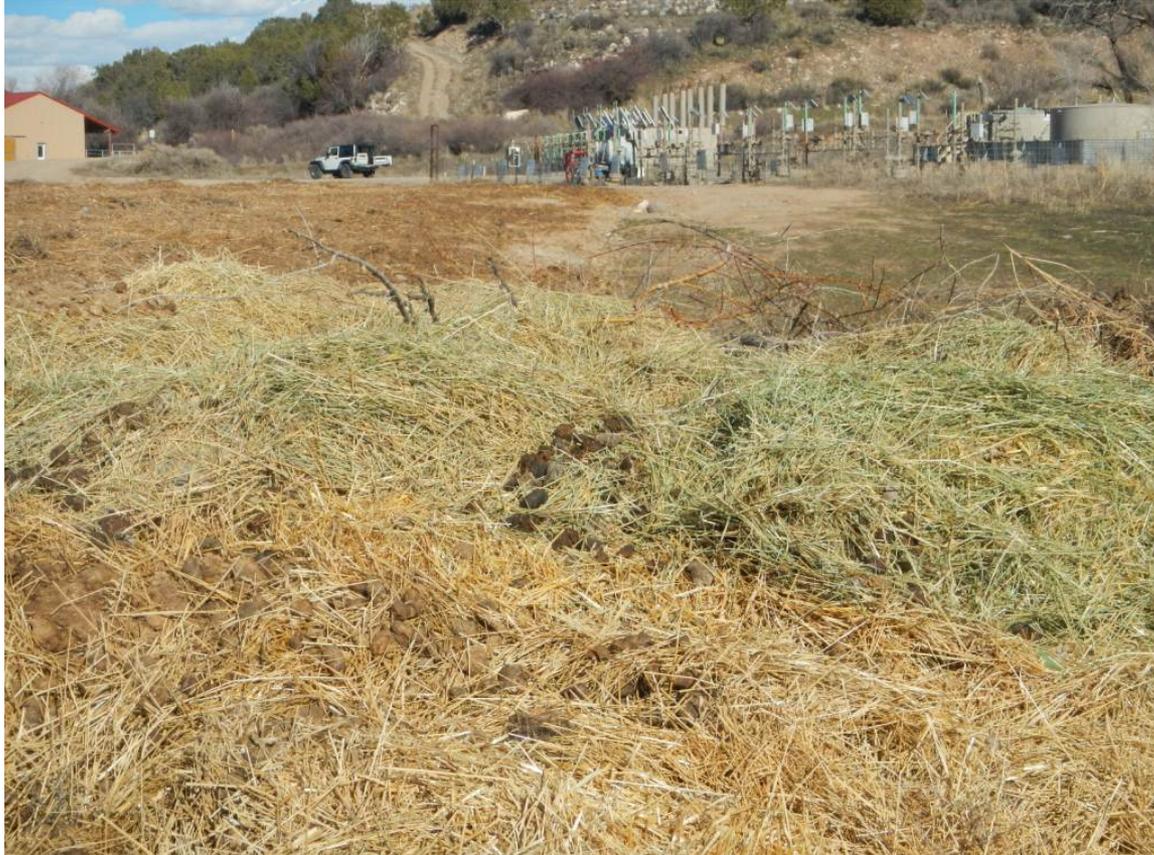
Photo#10: Fresh manure/bedding pile at West end of layered manure strip.

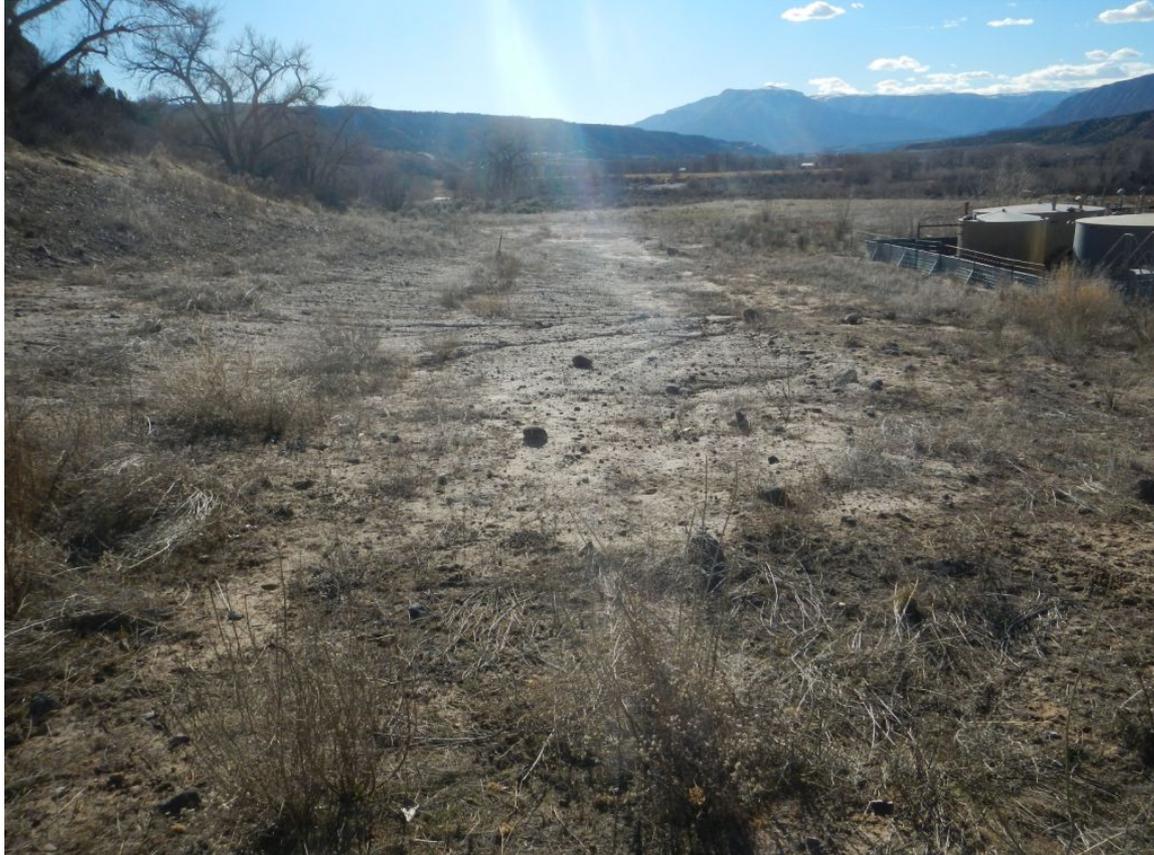
Photo#11: Un reclaimed area along South side of Location.

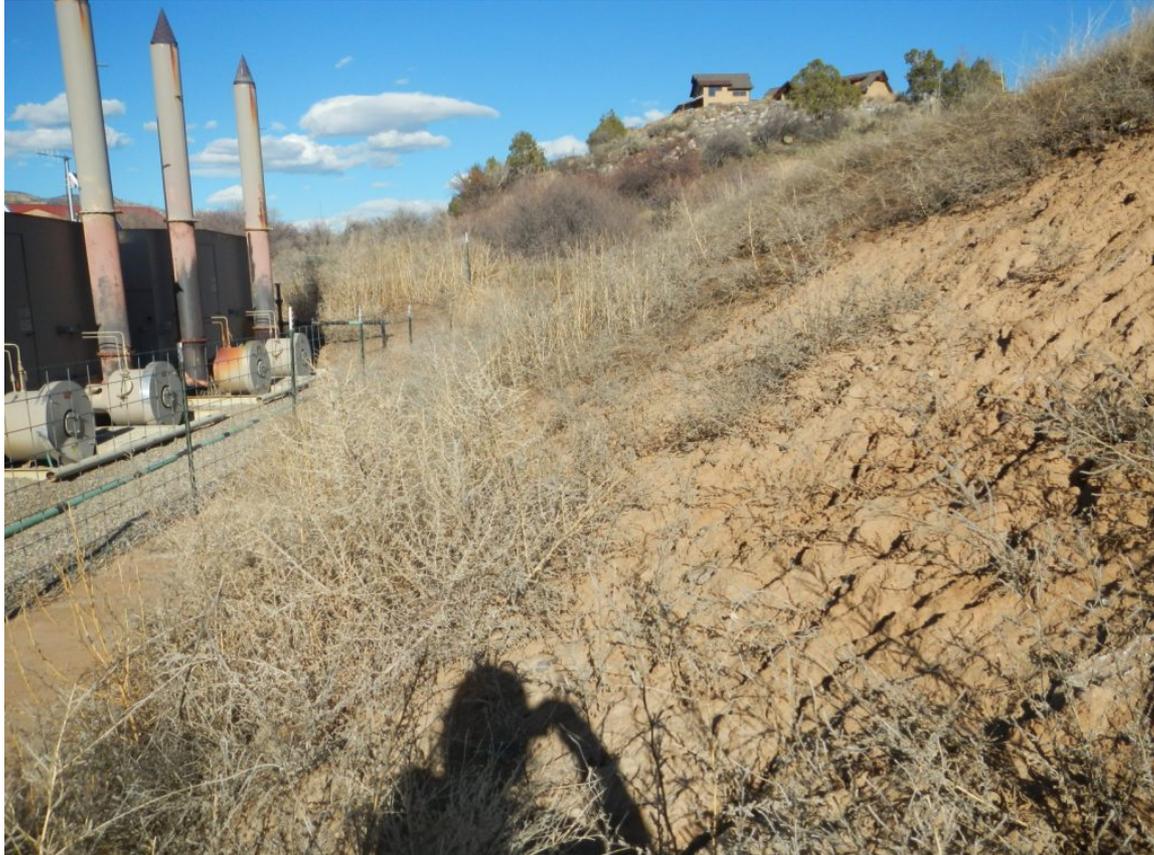
Photo#12: Cut slope area in back of Separators; senesced Vegetation has become Debris.

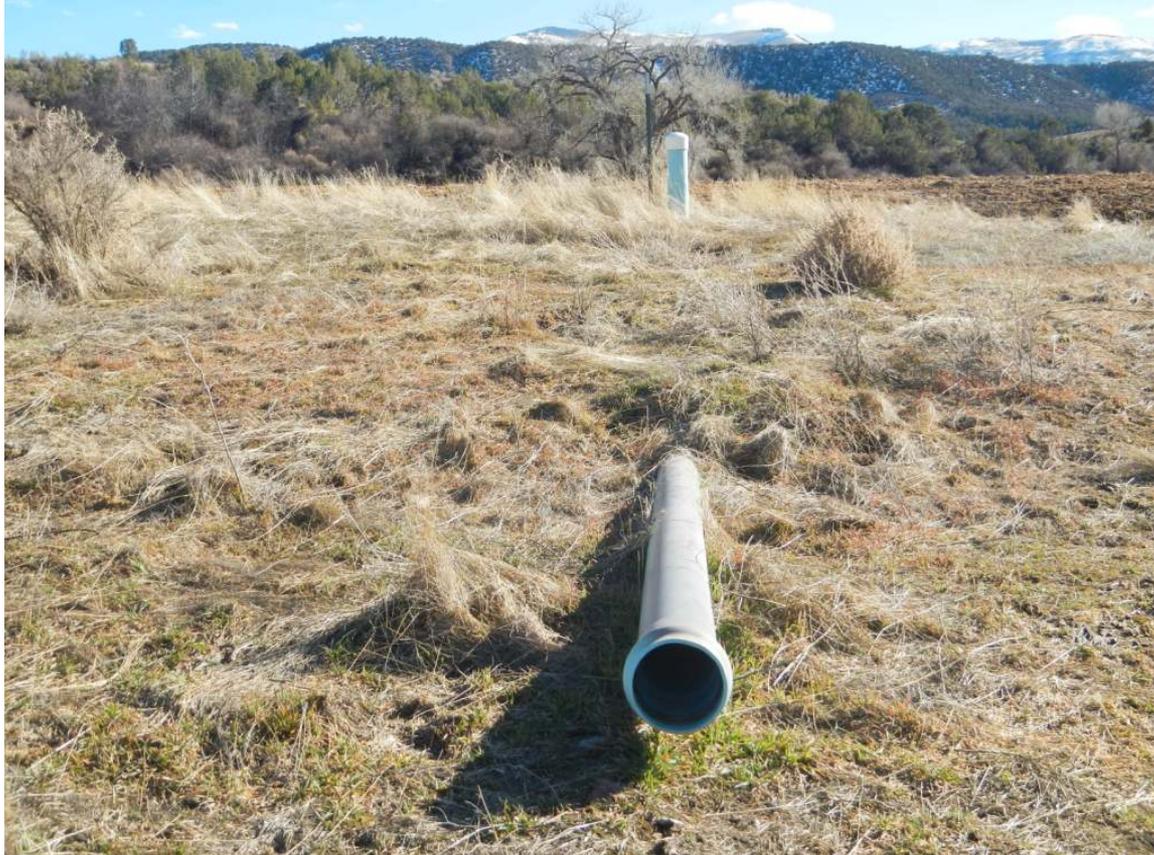
Photo#13: Unidentified Drainage Pipe/Riser located off North edge of Location.
