Construction Inspection

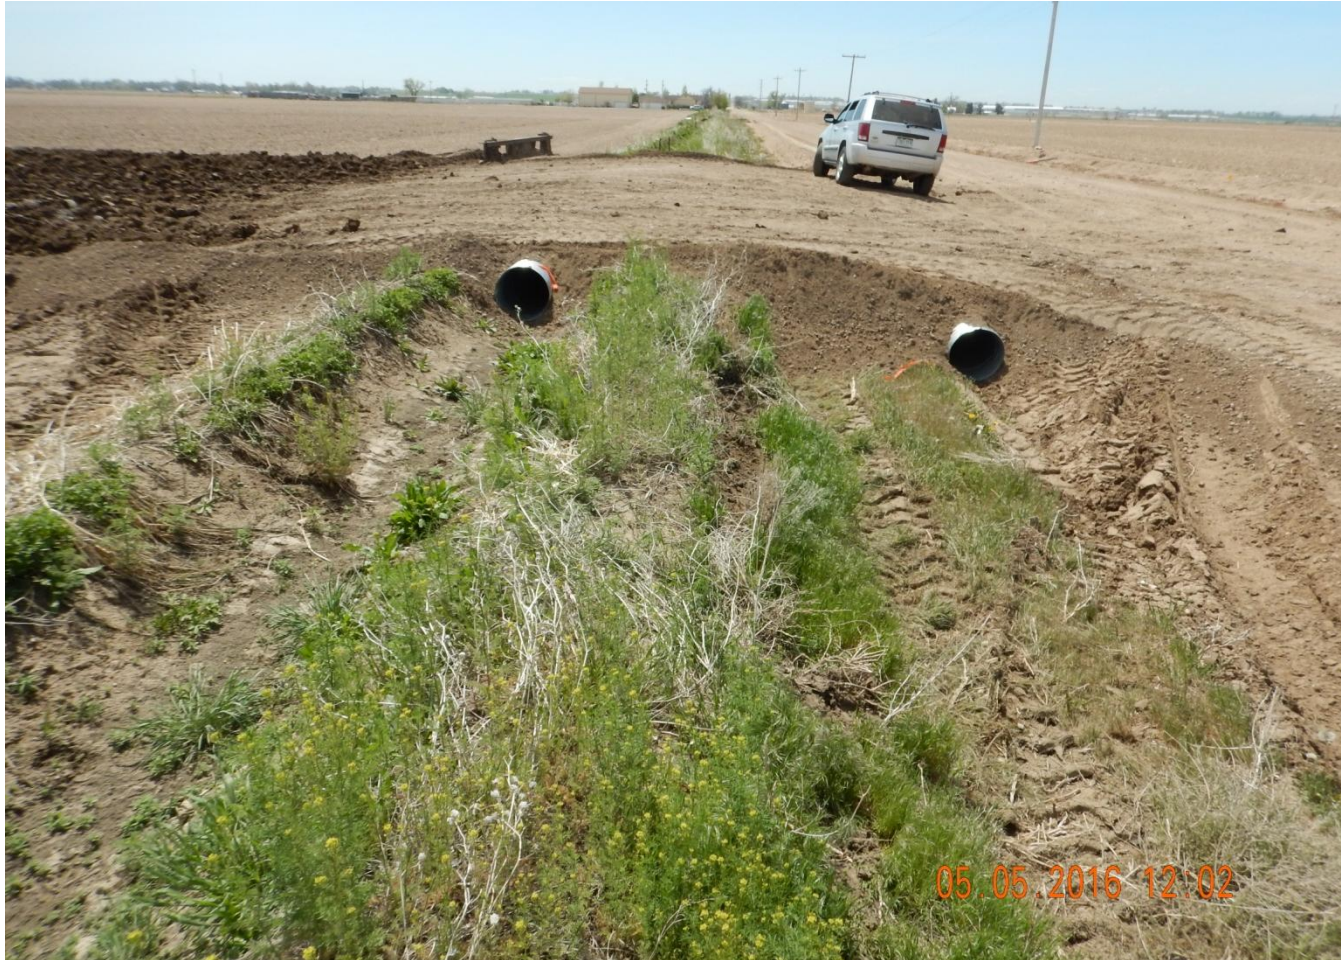
Photo 1. Photo taken from entrance of location, facing South. Culverts installed at entrance.

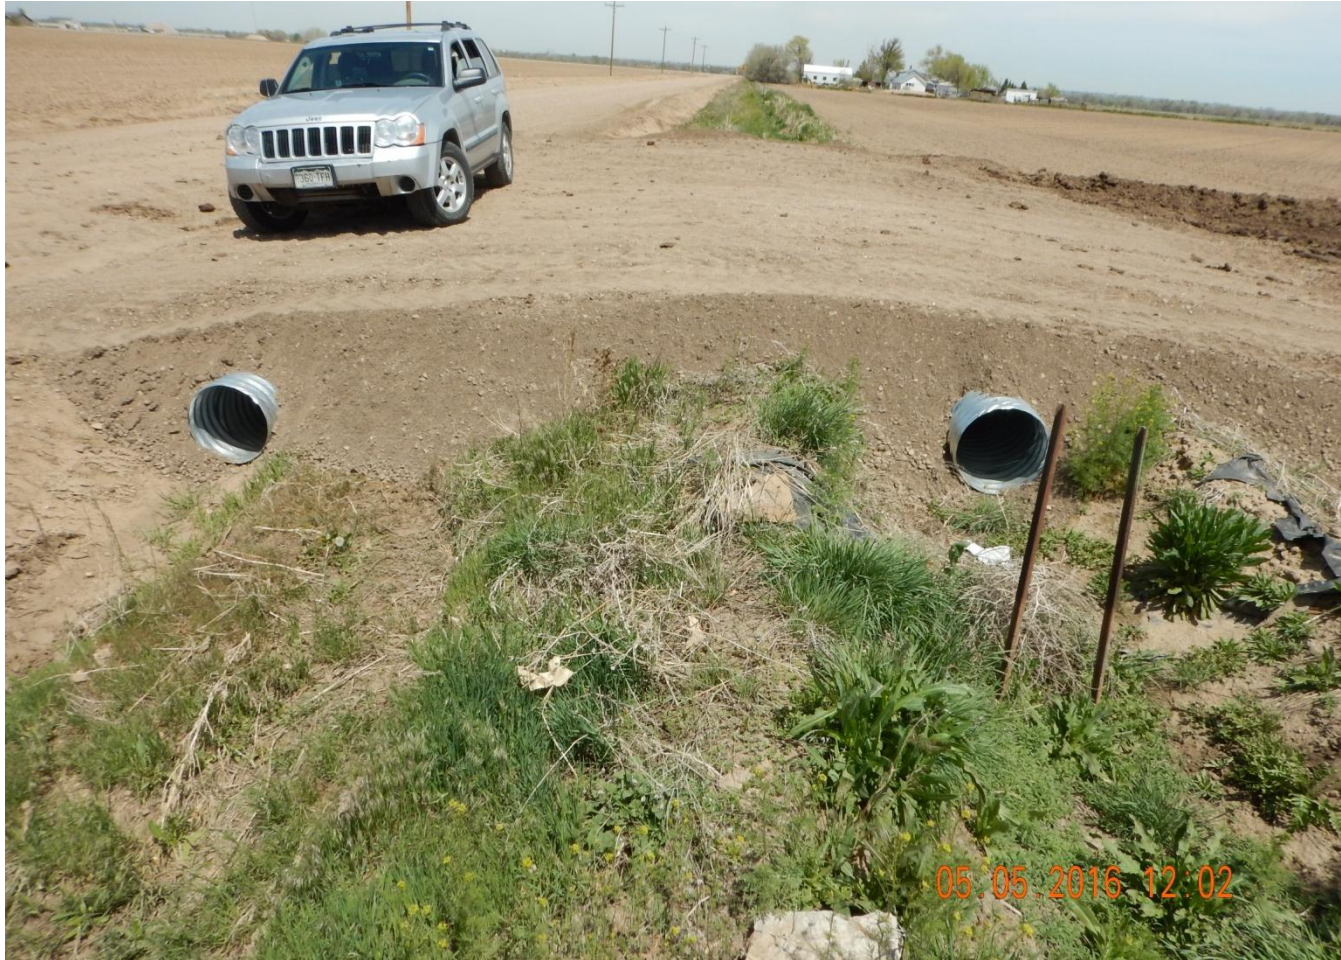
Photo 2. Photo taken from entrance of location, facing North. Culverts installed at entrance.

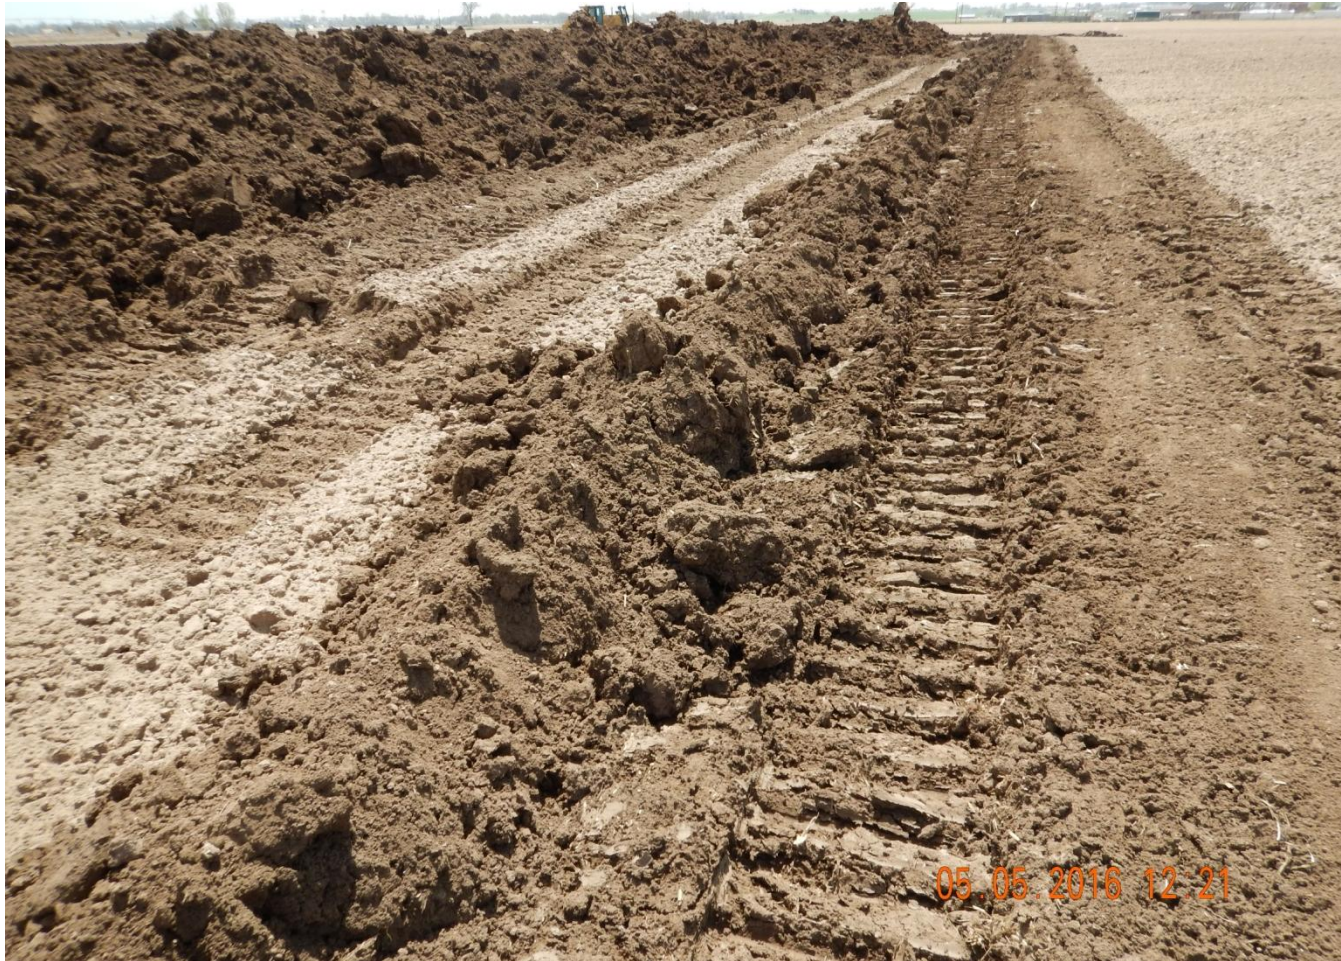
Photo 3. Photo taken from northwest location, facing South. Stormwater BMP installed in center of photo.

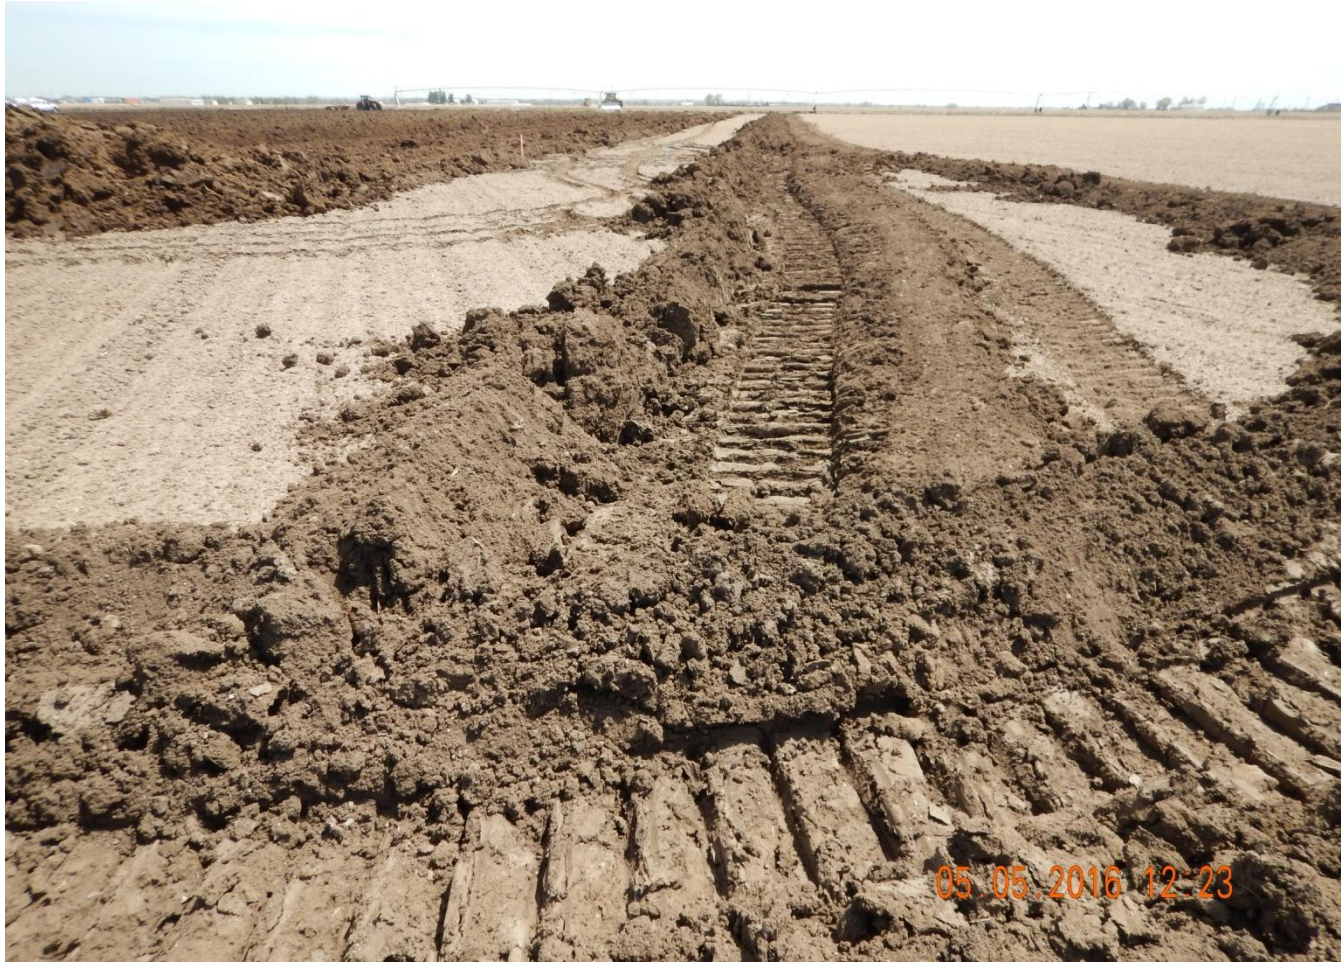
Photo 4. Photo taken from southwest location, facing East. Stormwater BMP installed in center of photo.

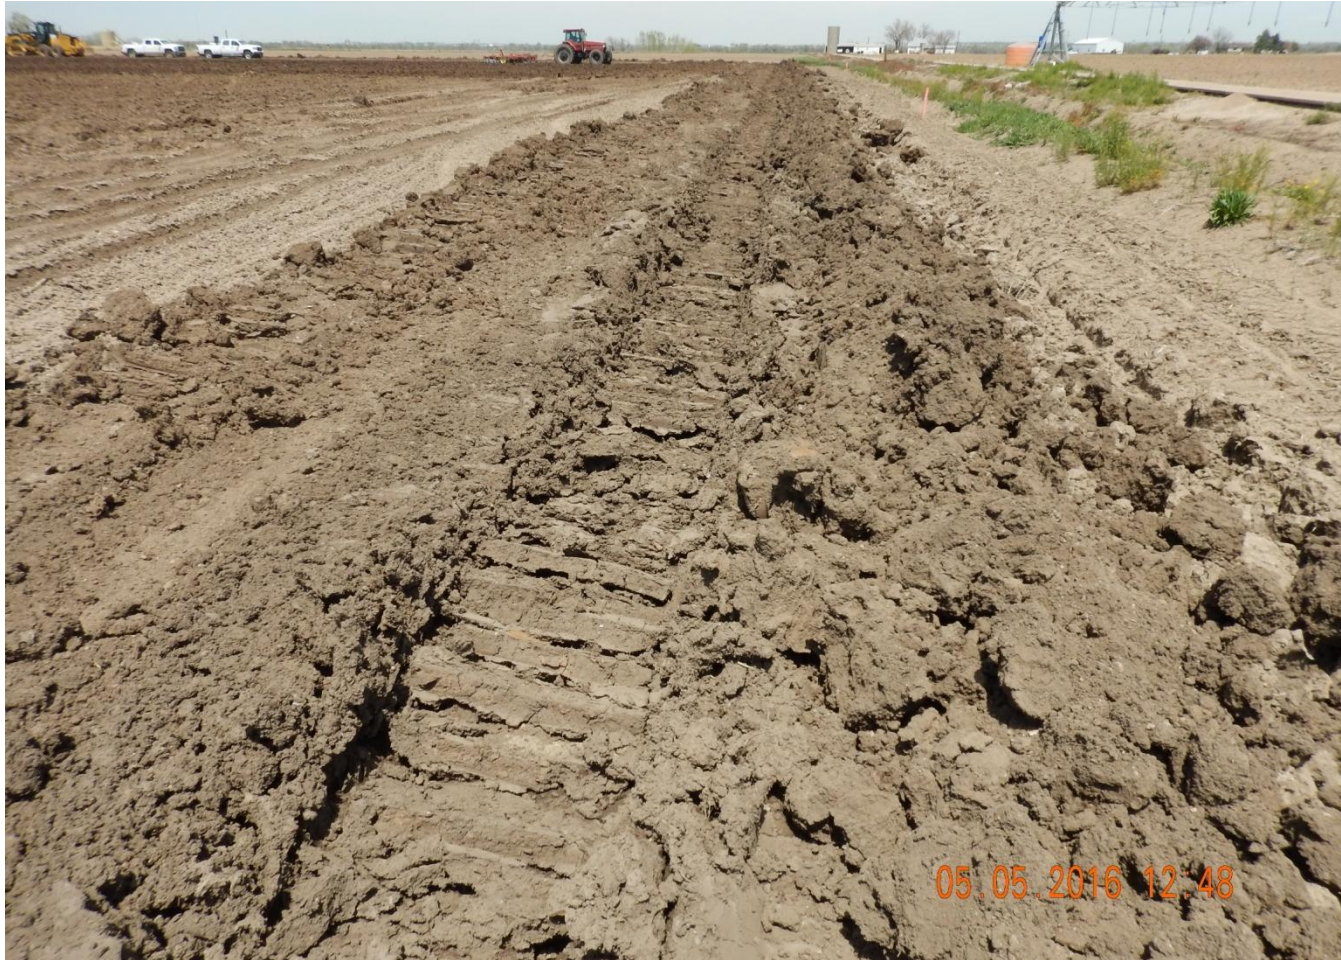
Photo 5. Photo taken from southeast location, facing North. Stormwater BMP installed in center of photo.

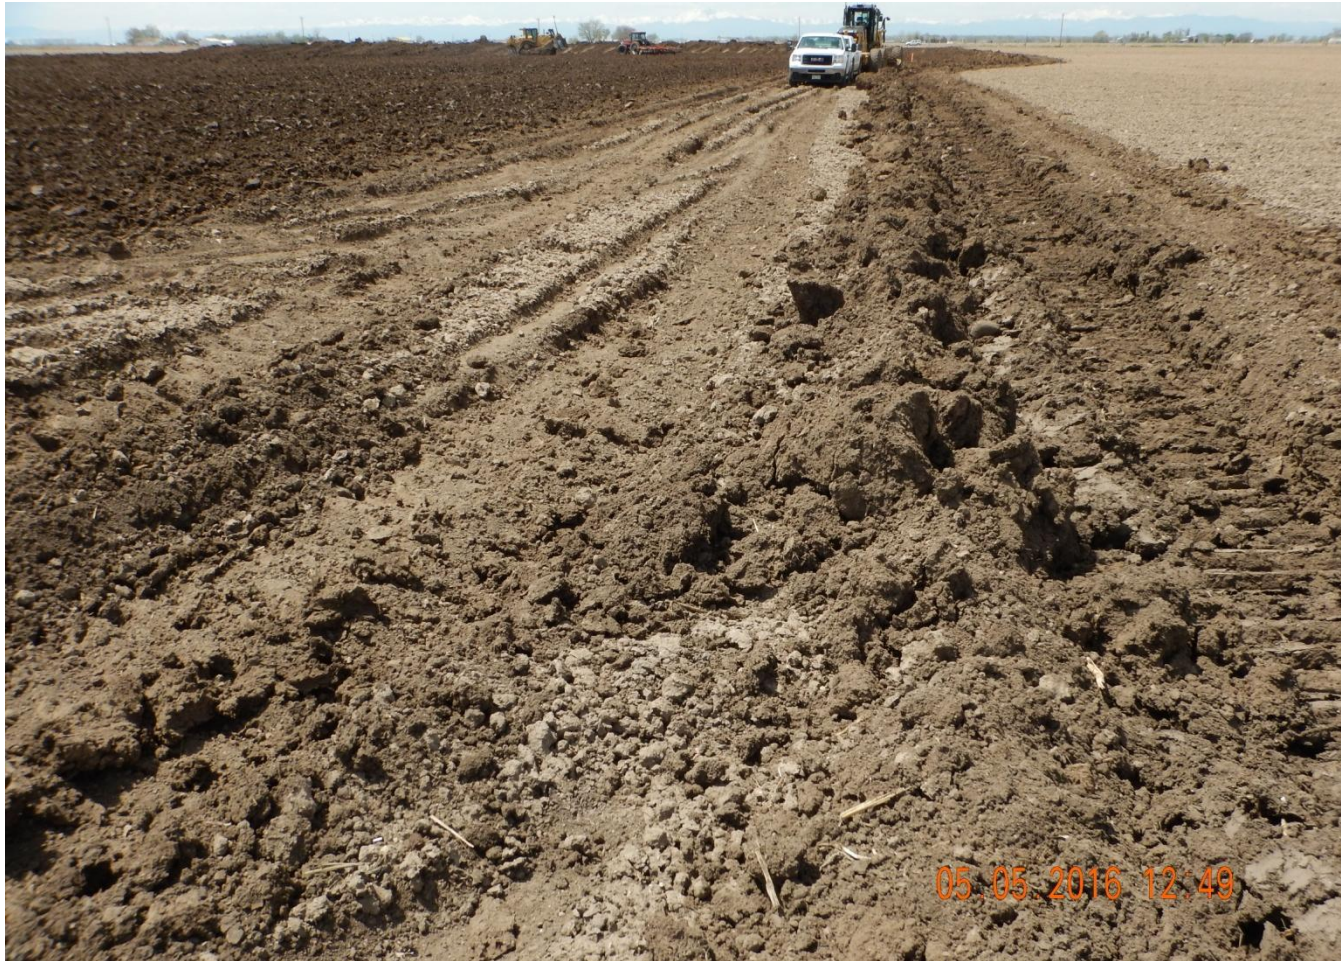
Photo 6. Photo taken from northeast location, facing West. Stormwater BMP installed in center of photo.

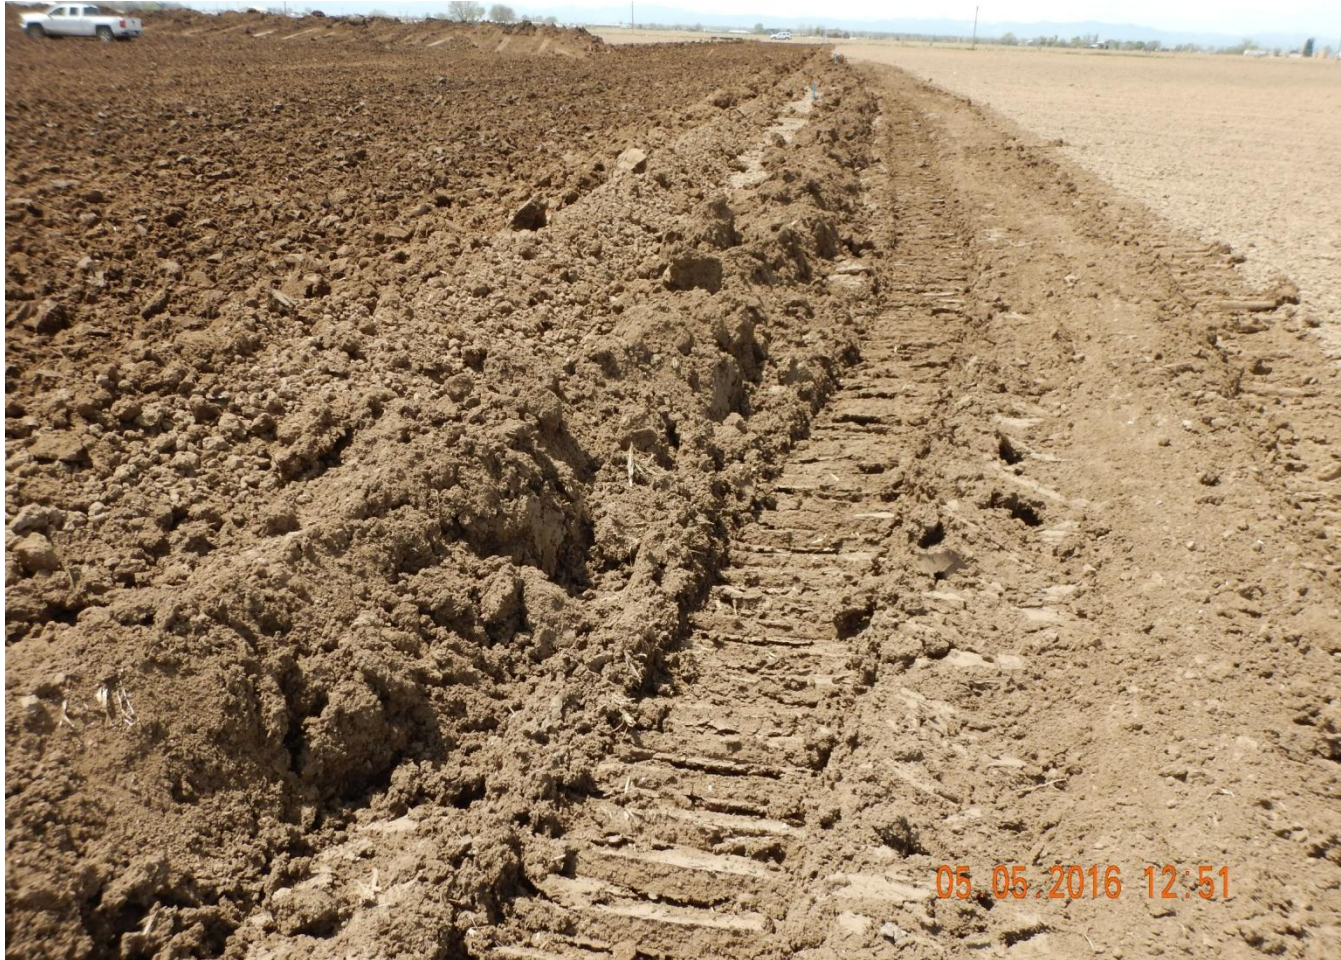
Photo 7. Photo taken from northern location, facing West. Stormwater BMP installed in center of photo.

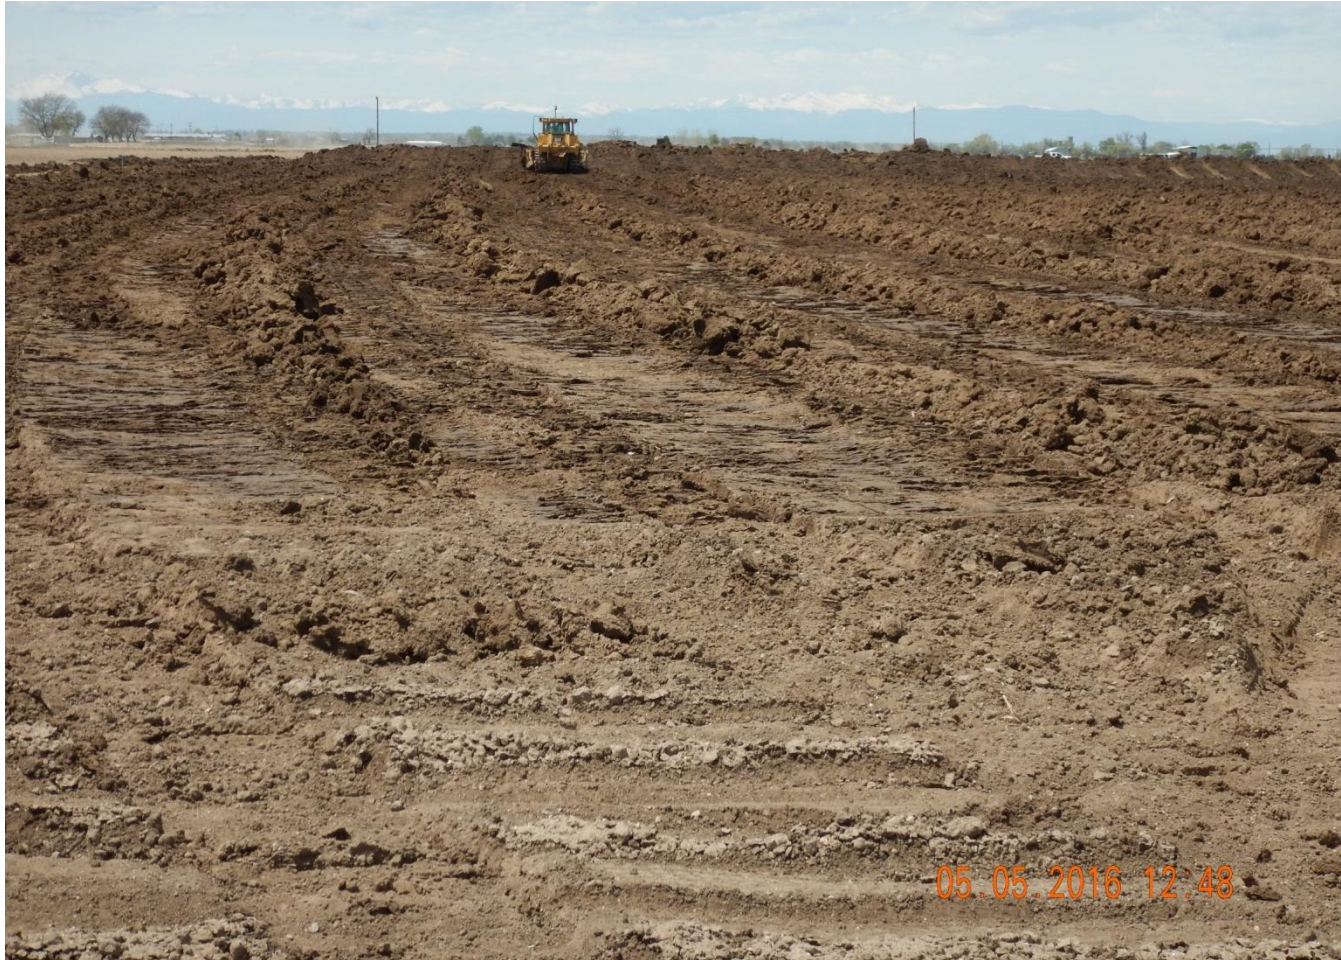
Photo 8. Photo taken from eastern location, facing West. Topsoil salvage in process.

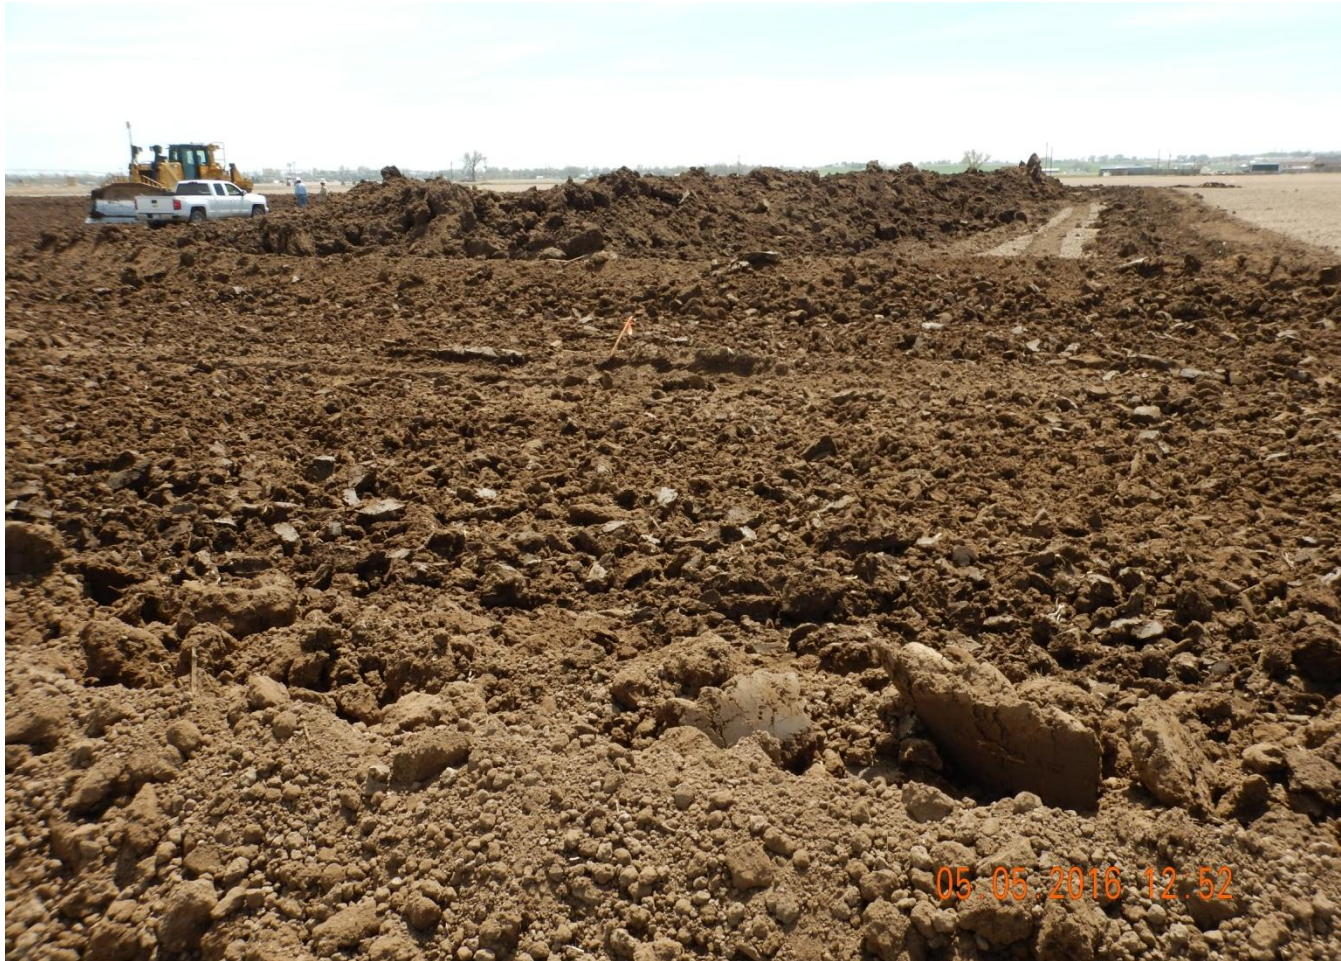
Photo 9. Photo taken from northwest location, facing South. Topsoil stockpile in center of photo. Topsoil stockpile needs to be stabilized upon completion of salvage process.
