## Final Reclamation Inspection

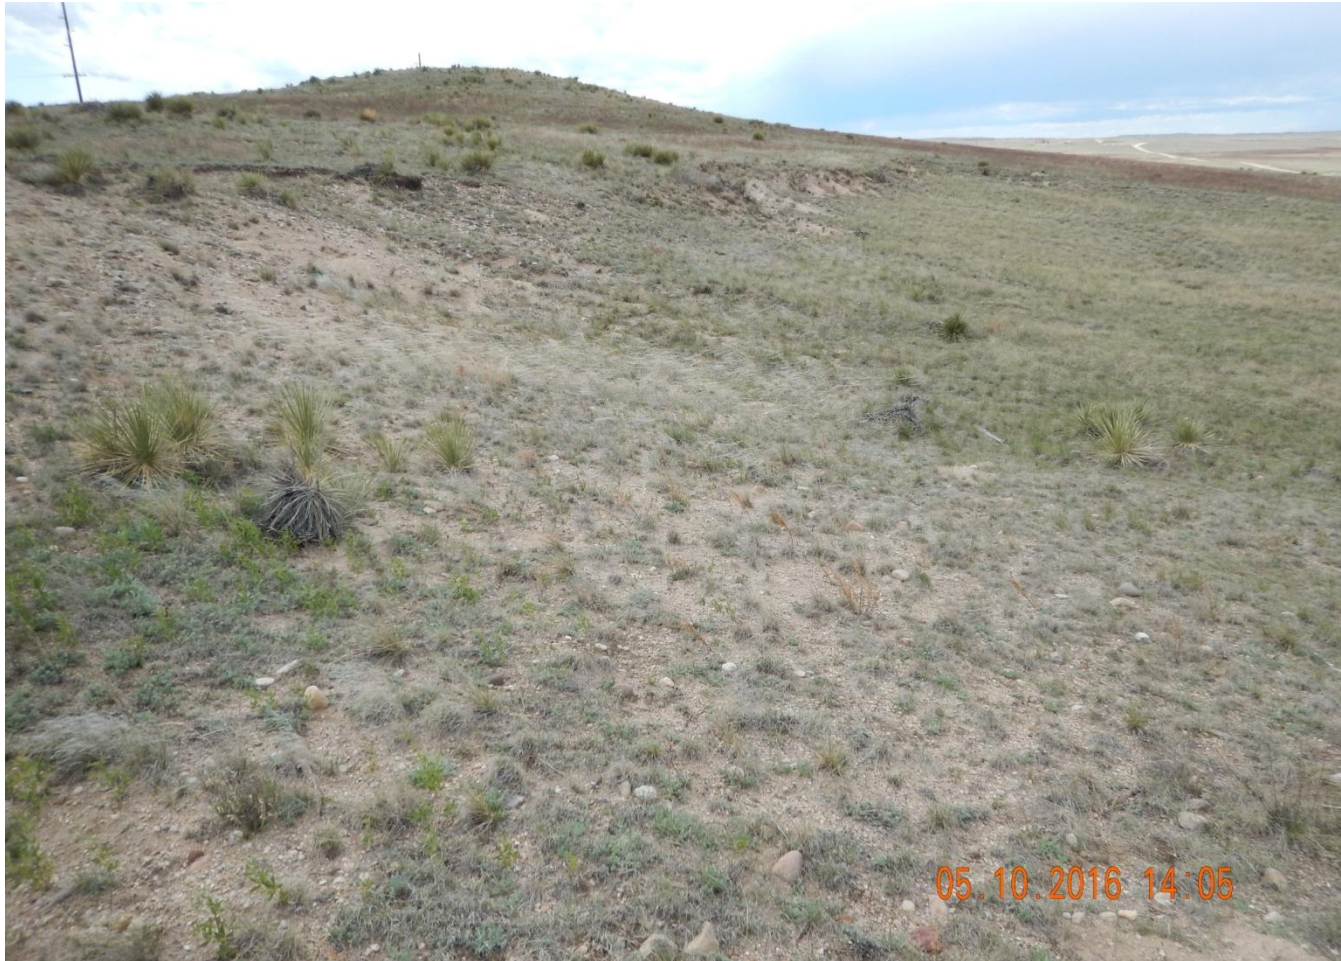
**Photo 1.** Photo taken from eastern location, facing West. Cut slopes still present that are stabilized with vegetation but rill erosion is occurring along portions of the cut slope.

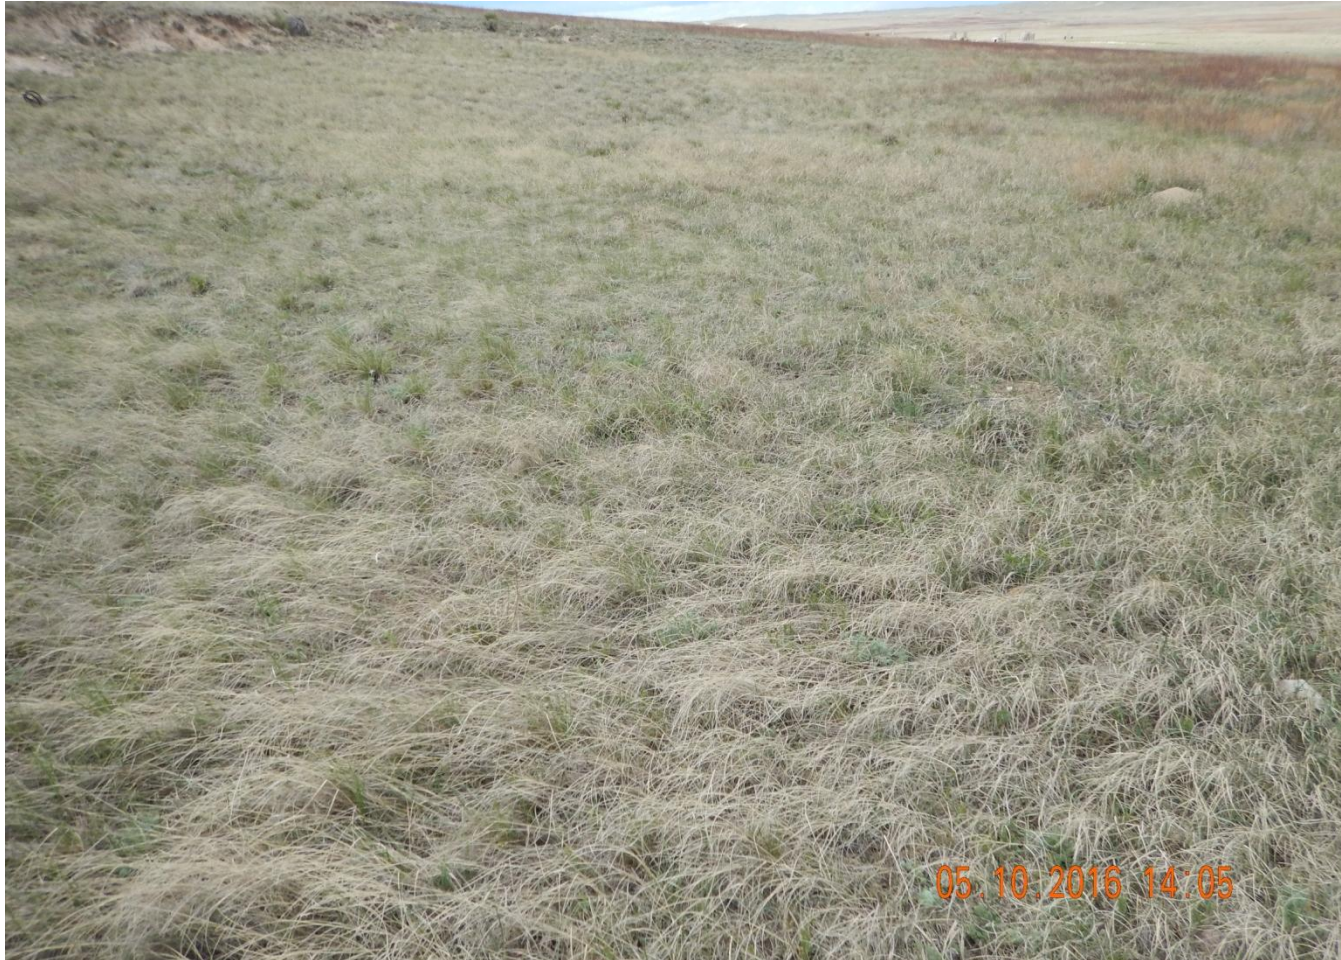
**Photo 2.** Photo taken from eastern location, facing West. Uniform native, perennial vegetation established throughout most of location.

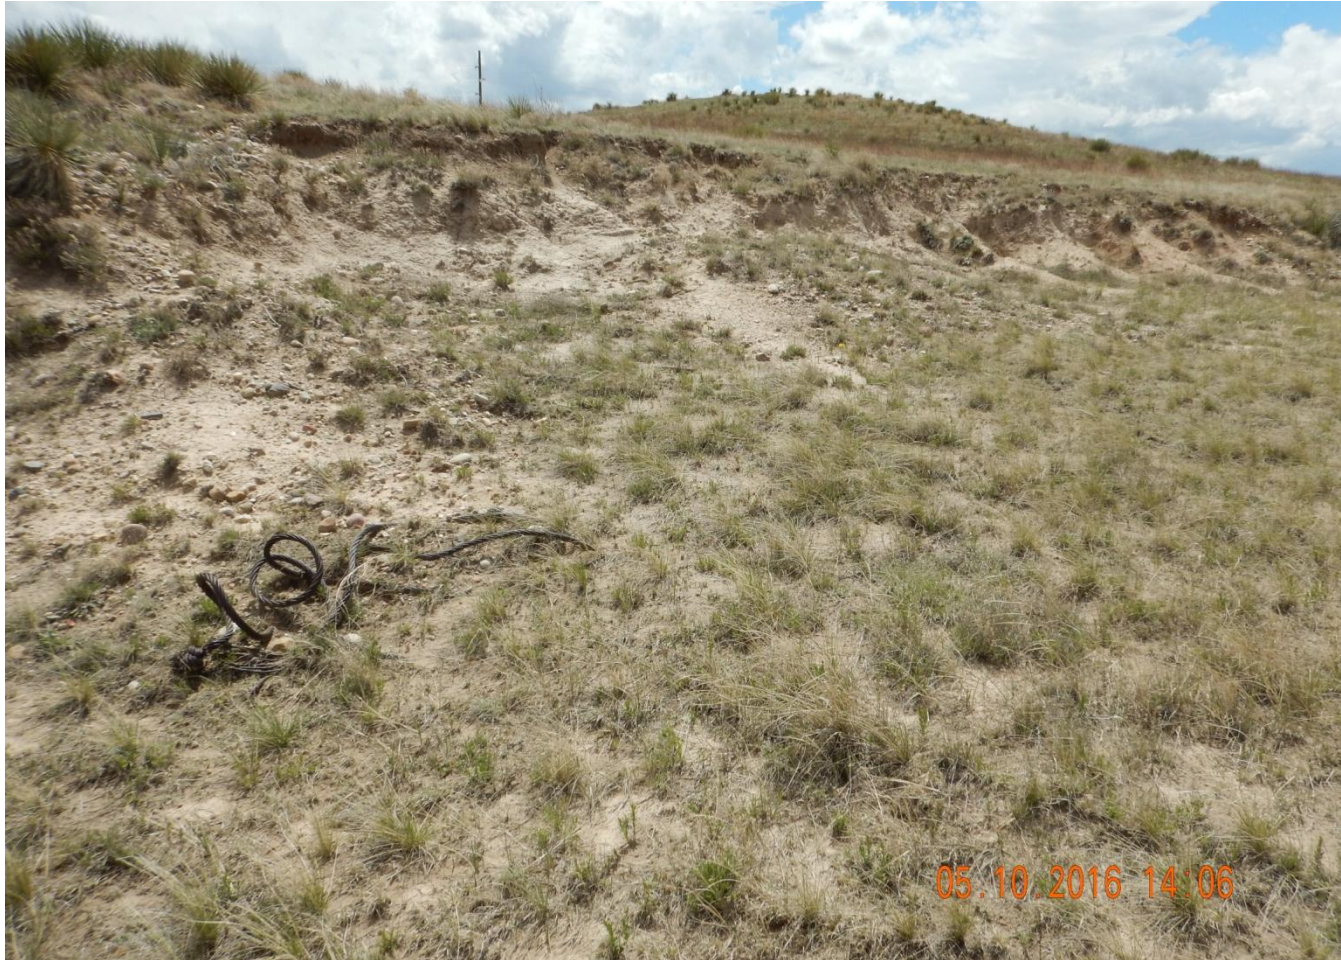
**Photo 3.** Photo taken from southeast location, facing South. Equipment at location and rill erosion occurring which is forming into gully erosion overtime.

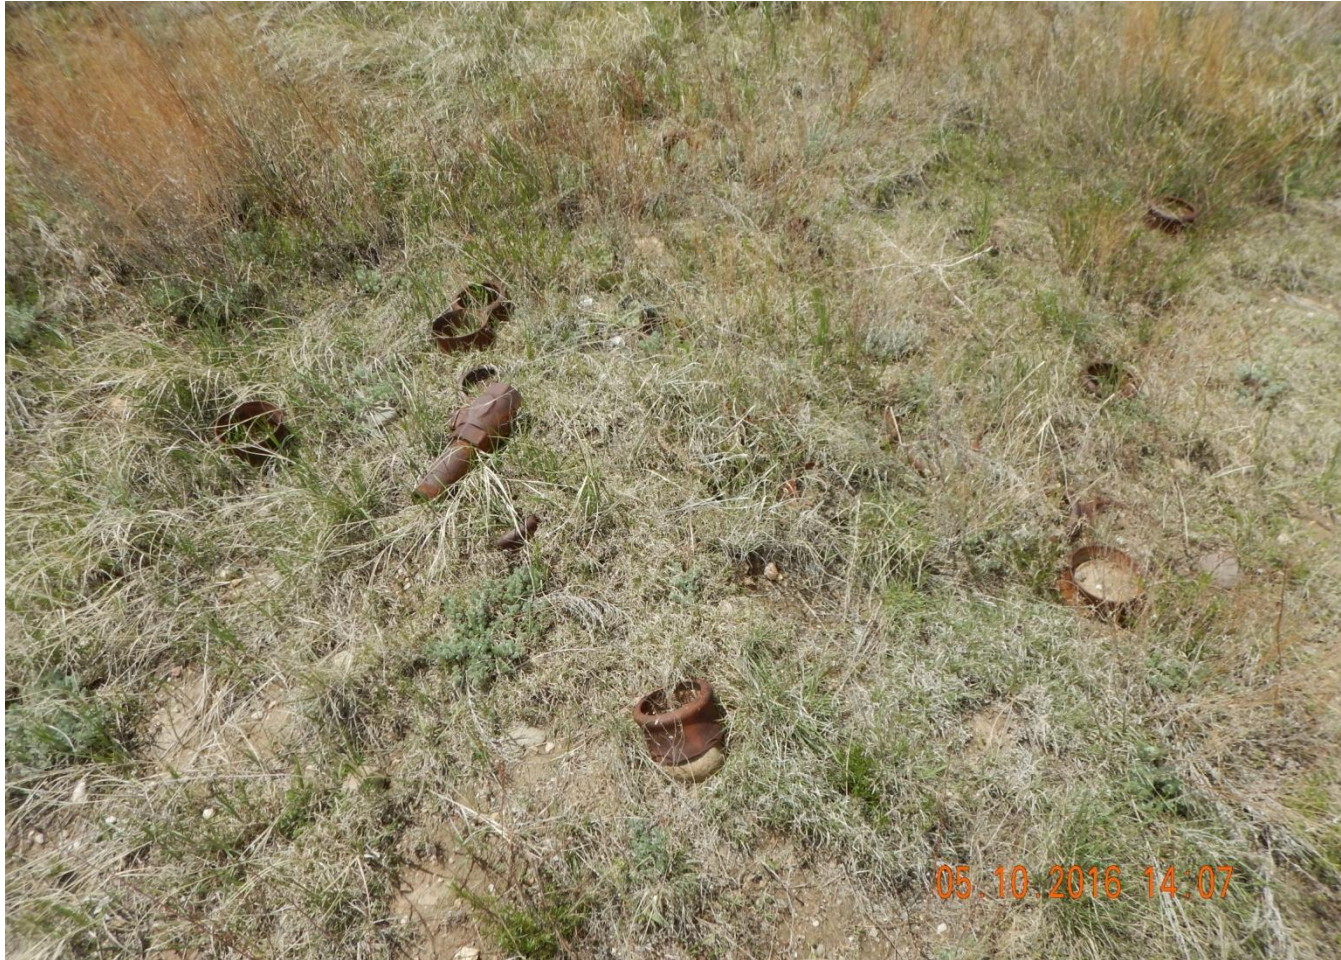
**Photo 4.** Photo taken from approximate northern location. Equipment left at location.

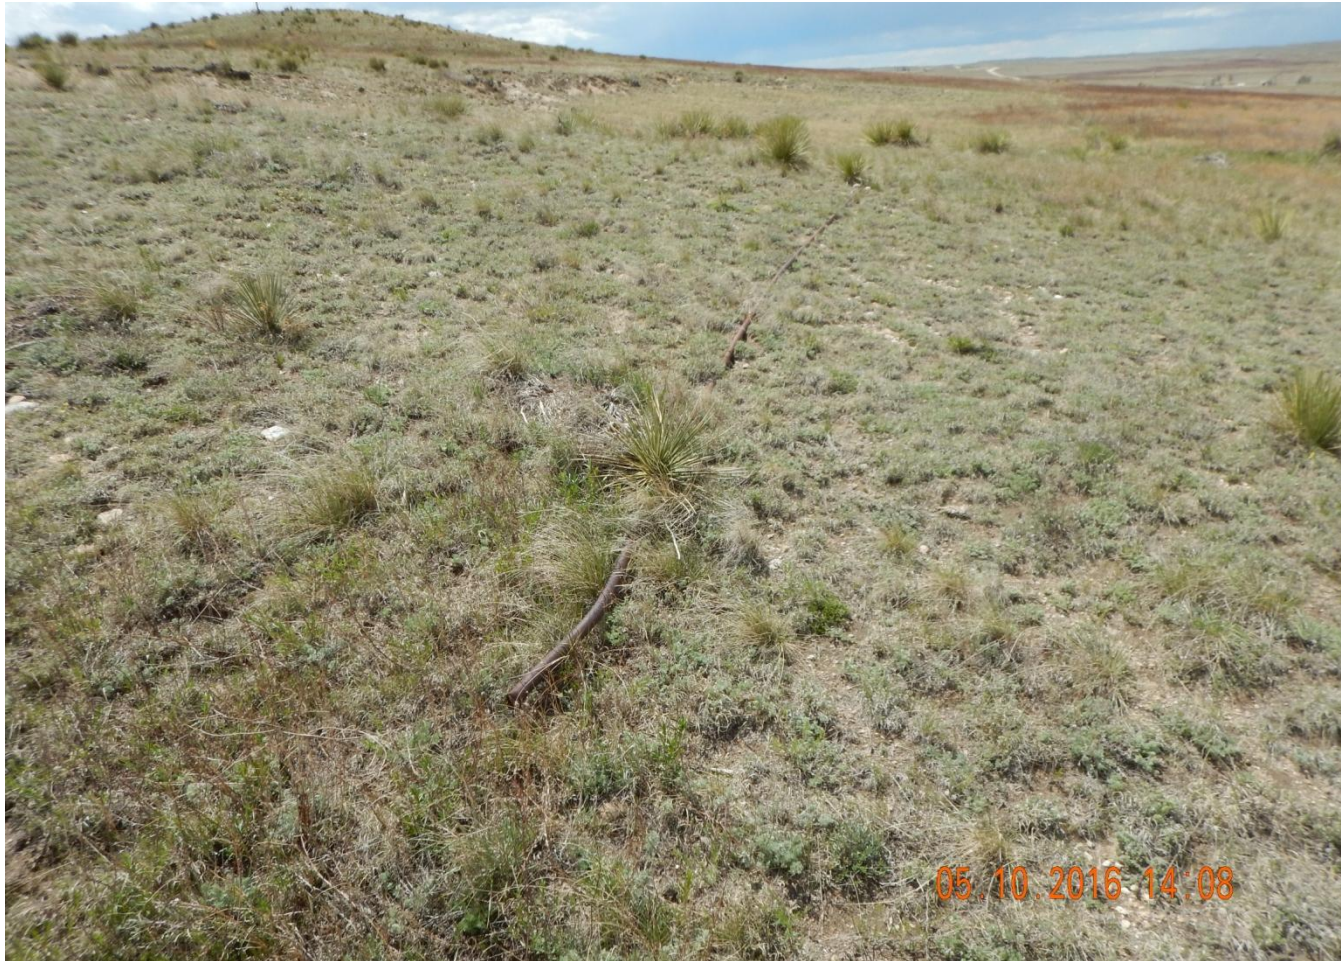
**Photo 5.** Photo taken from eastern location, facing West. Equipment left at location.
