June 18, 2016

Inspection Photos: Potter Loc#335172.

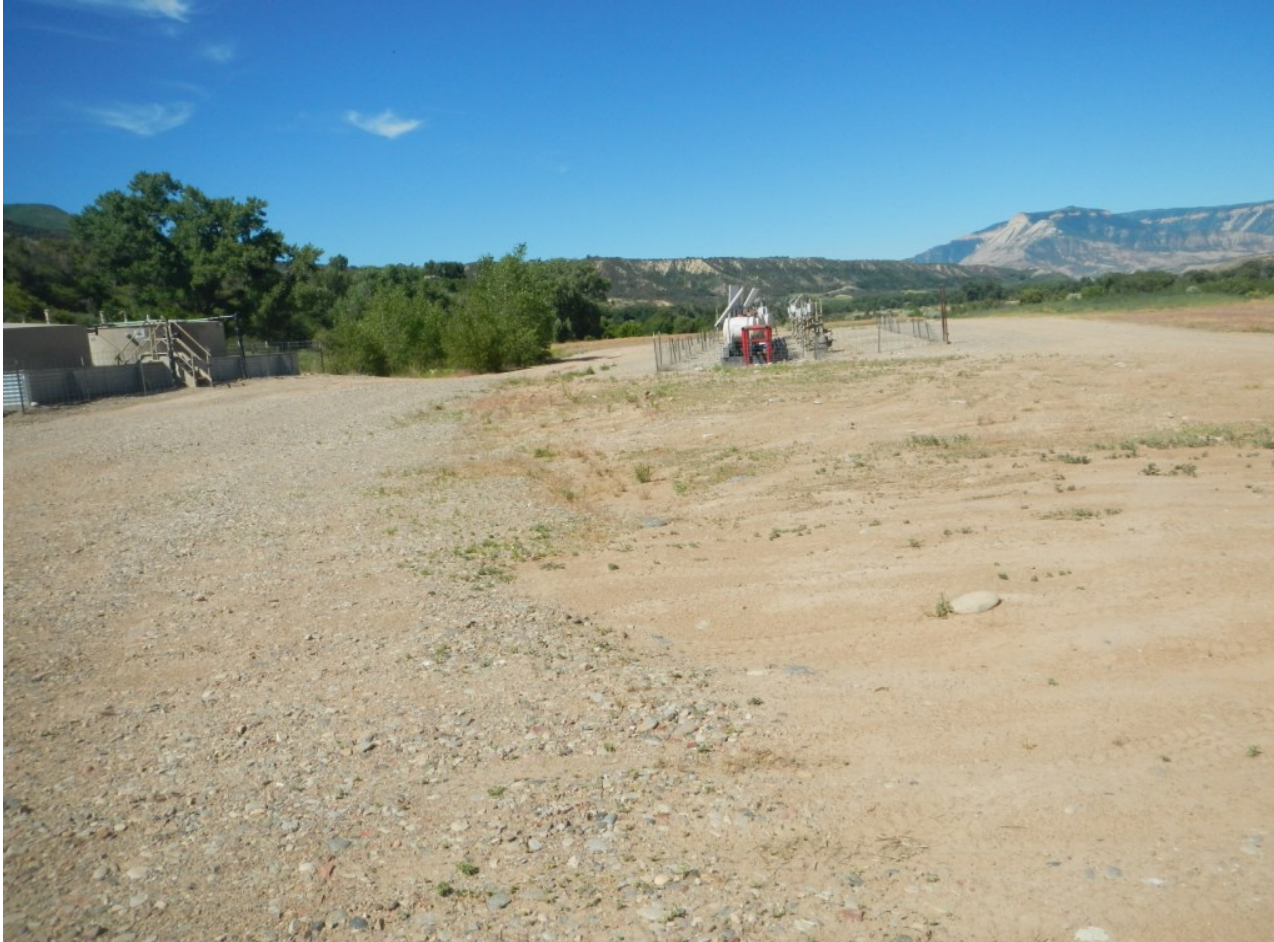
Photo#1: Overview of Location to SW.

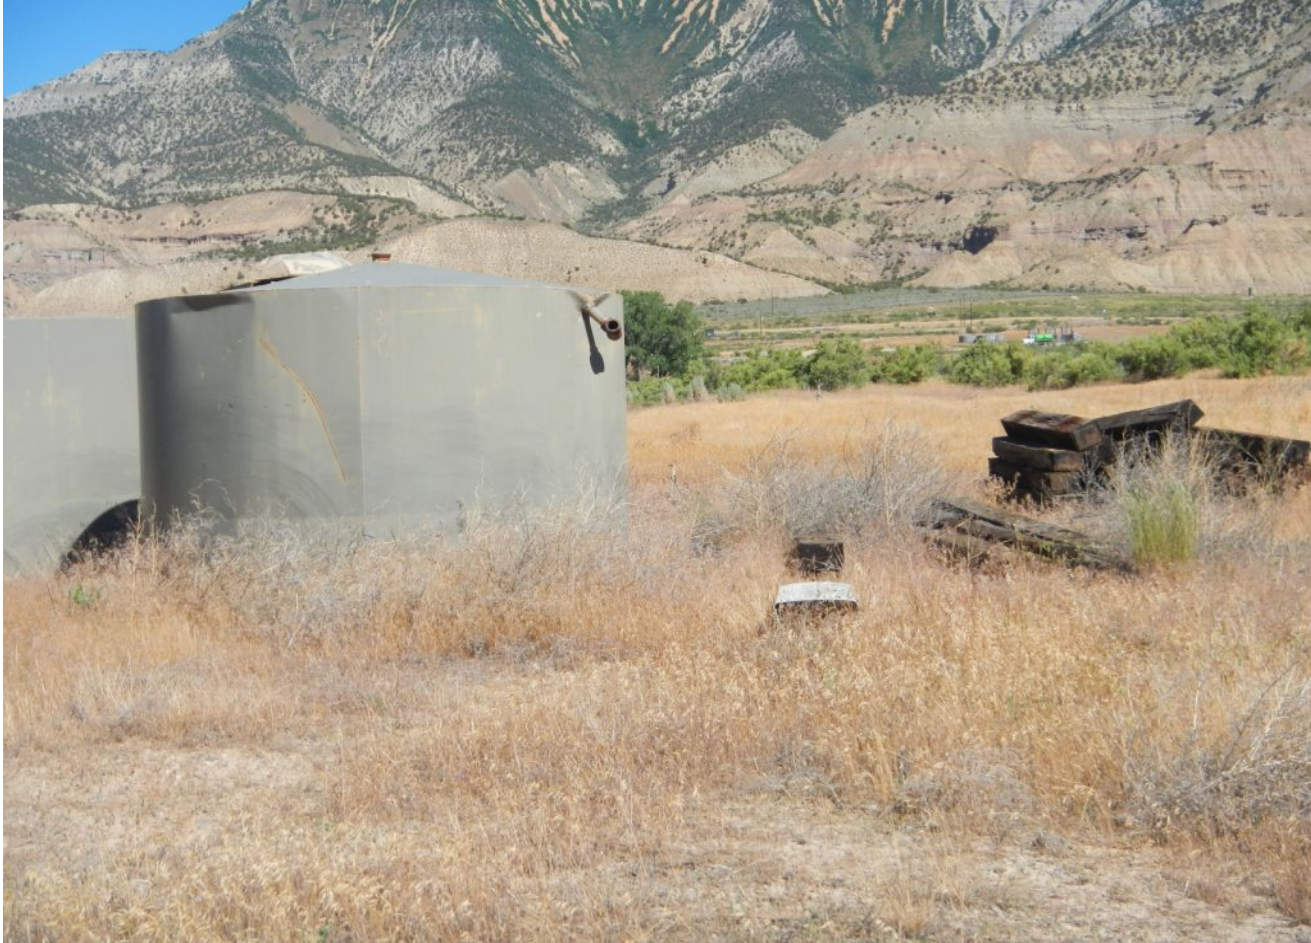
Photo#2: Equipment / Supplies stored on NE portion of Location. Kochia has senesced and become Debris.

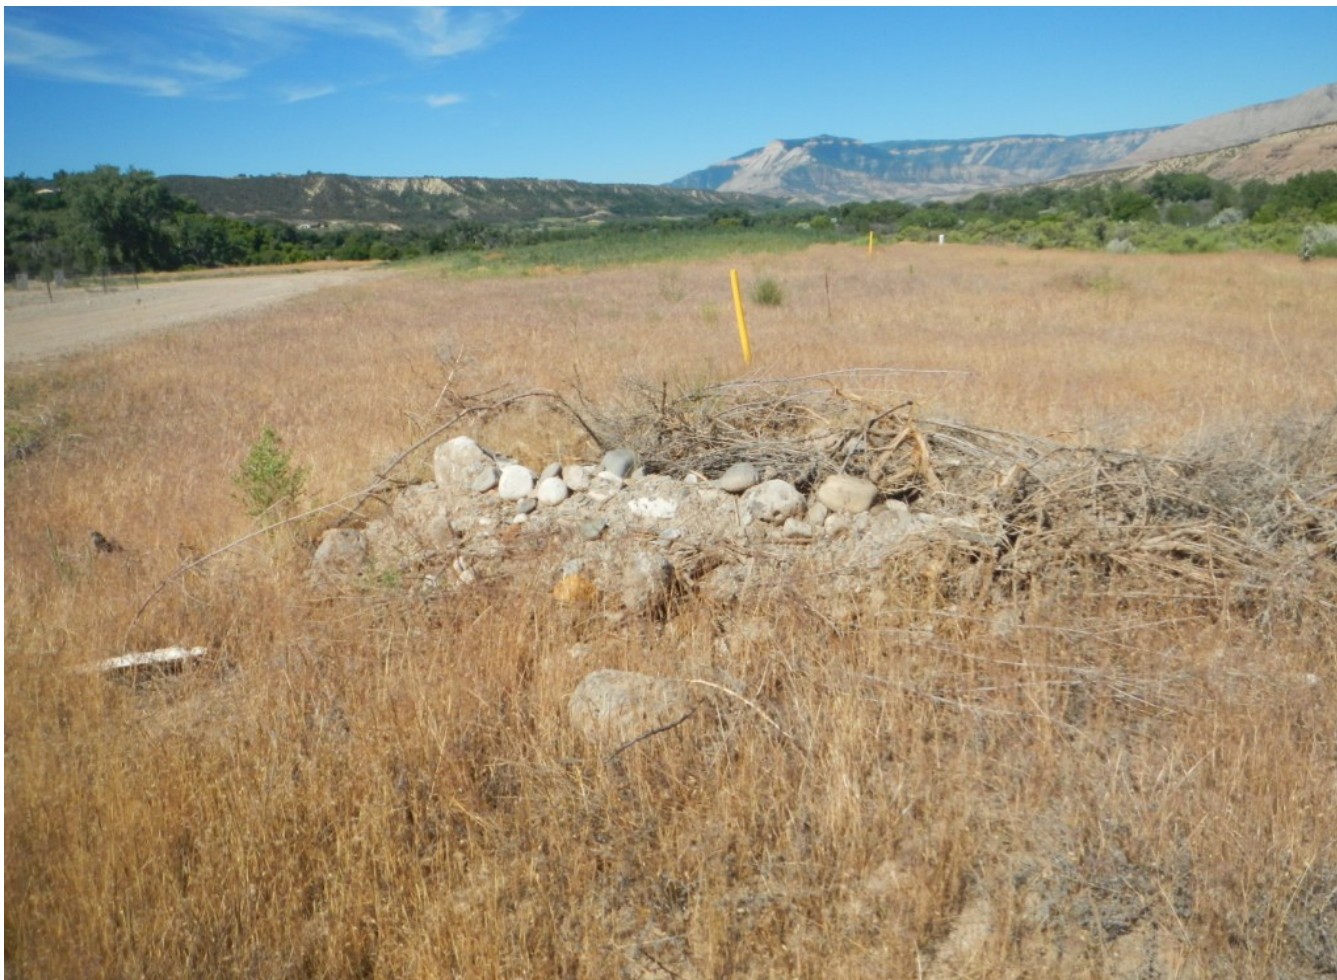
Photo#3: Slash/Debris pile in Interim Reclamation area along North side of Location

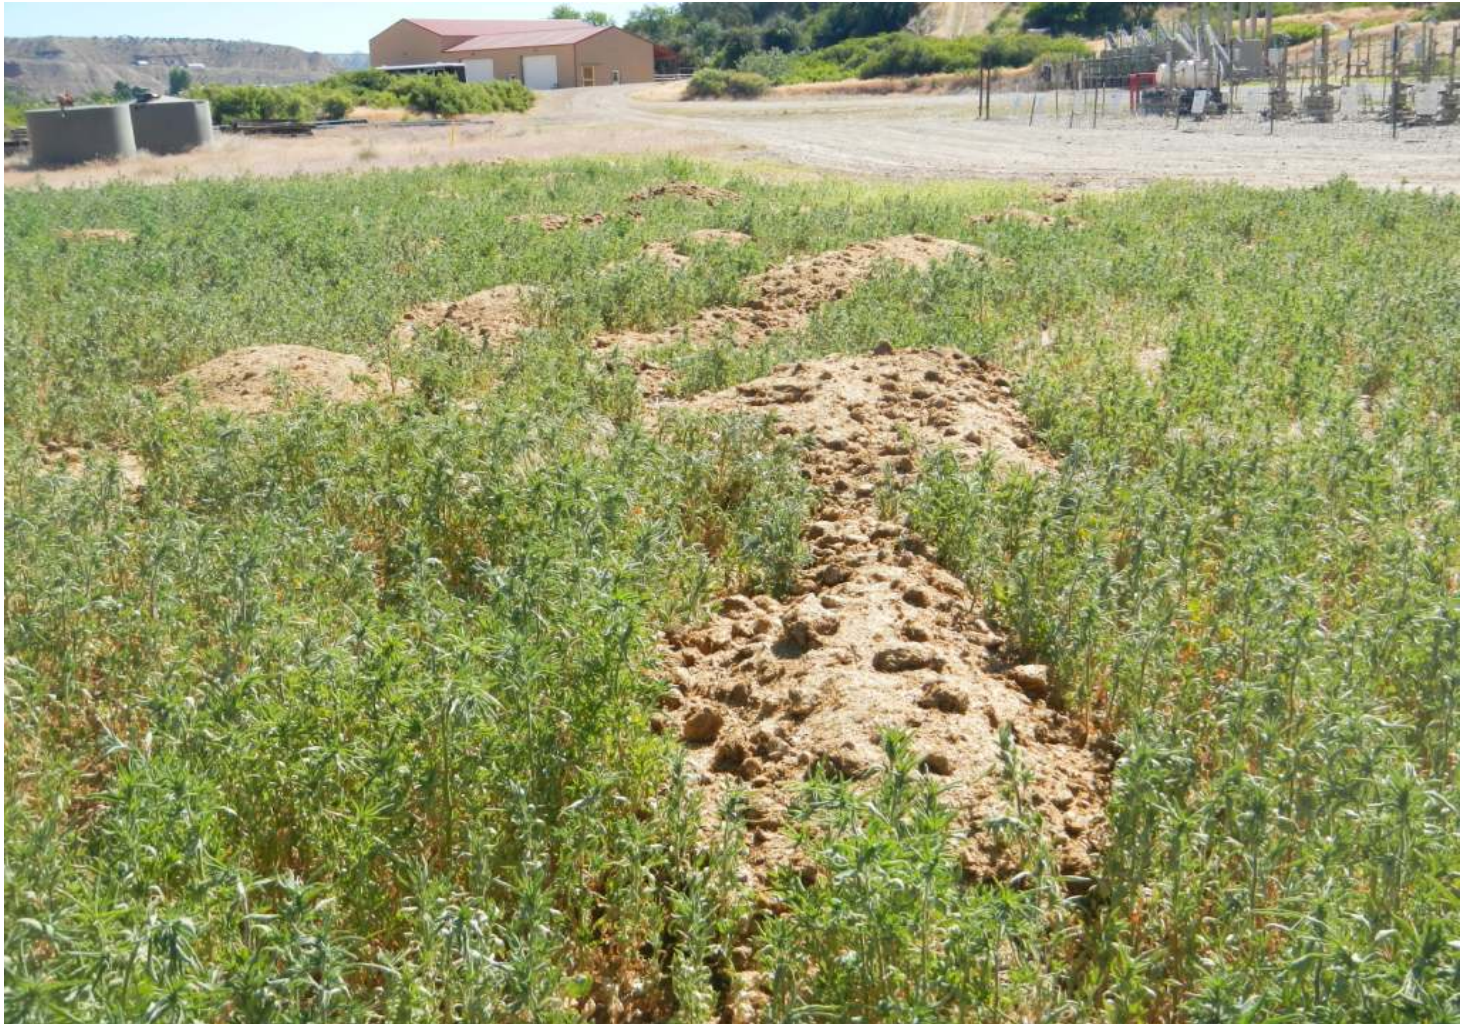
Photo#4: Interim Reclamation Area#1 has had more manure dumped since previous Inspection on what Operator said was seeded Interim Reclamation.

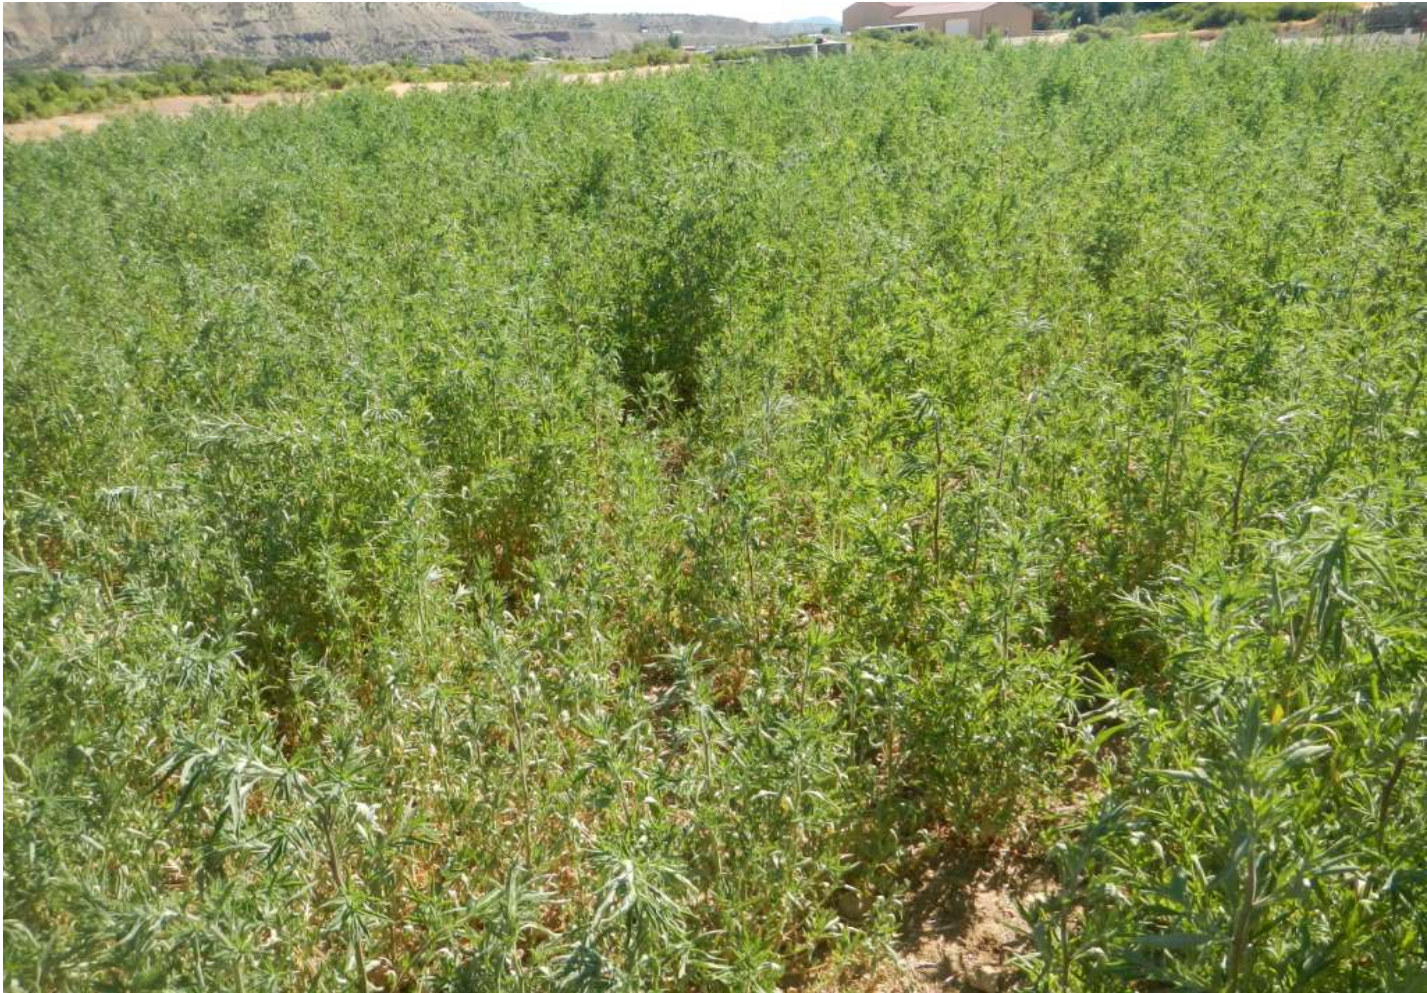
Photo#5: Kochia is only successful Vegetation in the heavily Manured area.

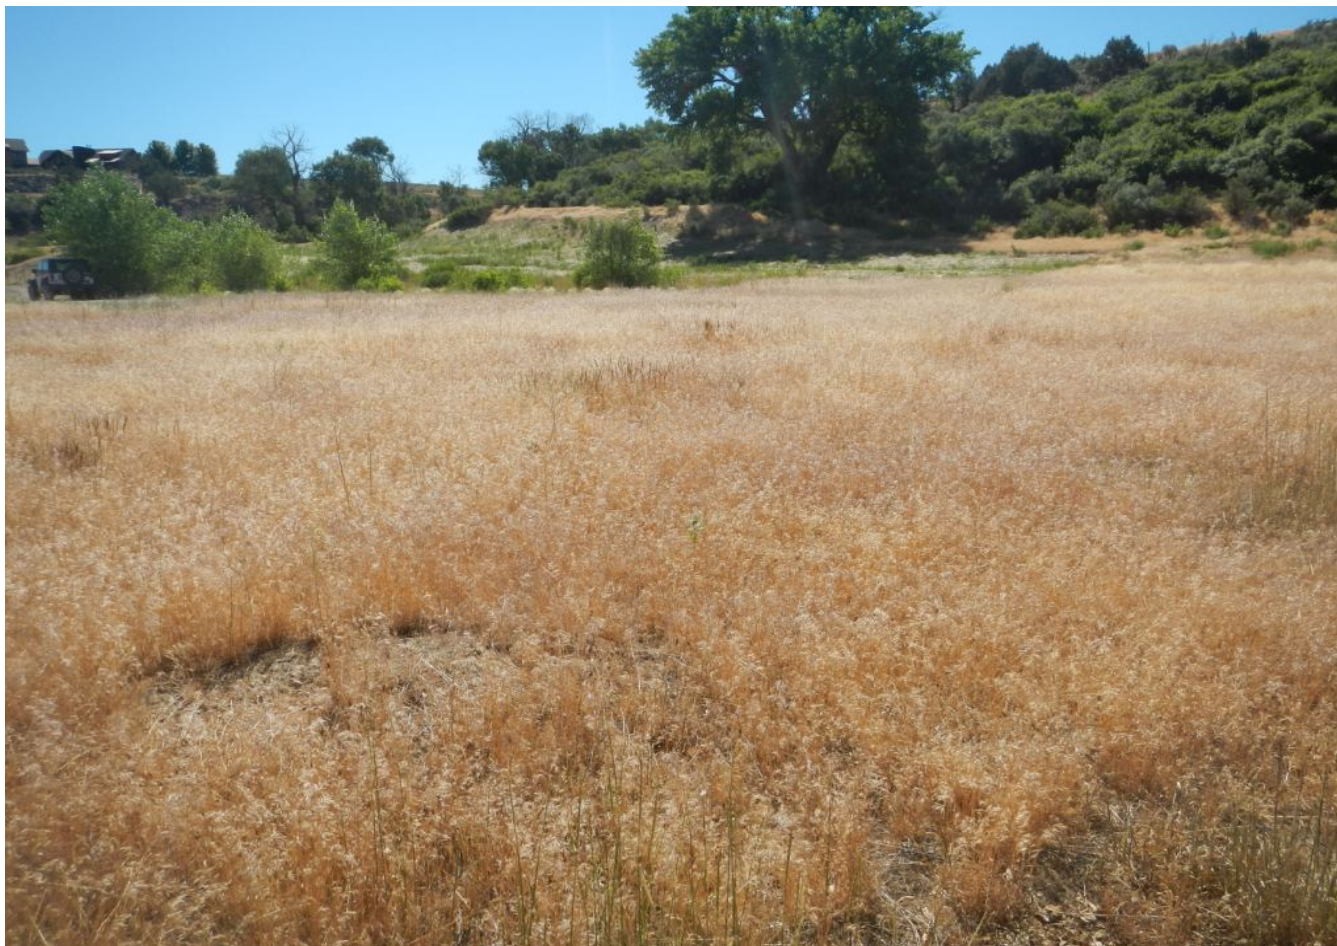
Photo#6: Interim Reclamation Area#2 at SW end of Location is predominately a Monoculture of Cheat grass.

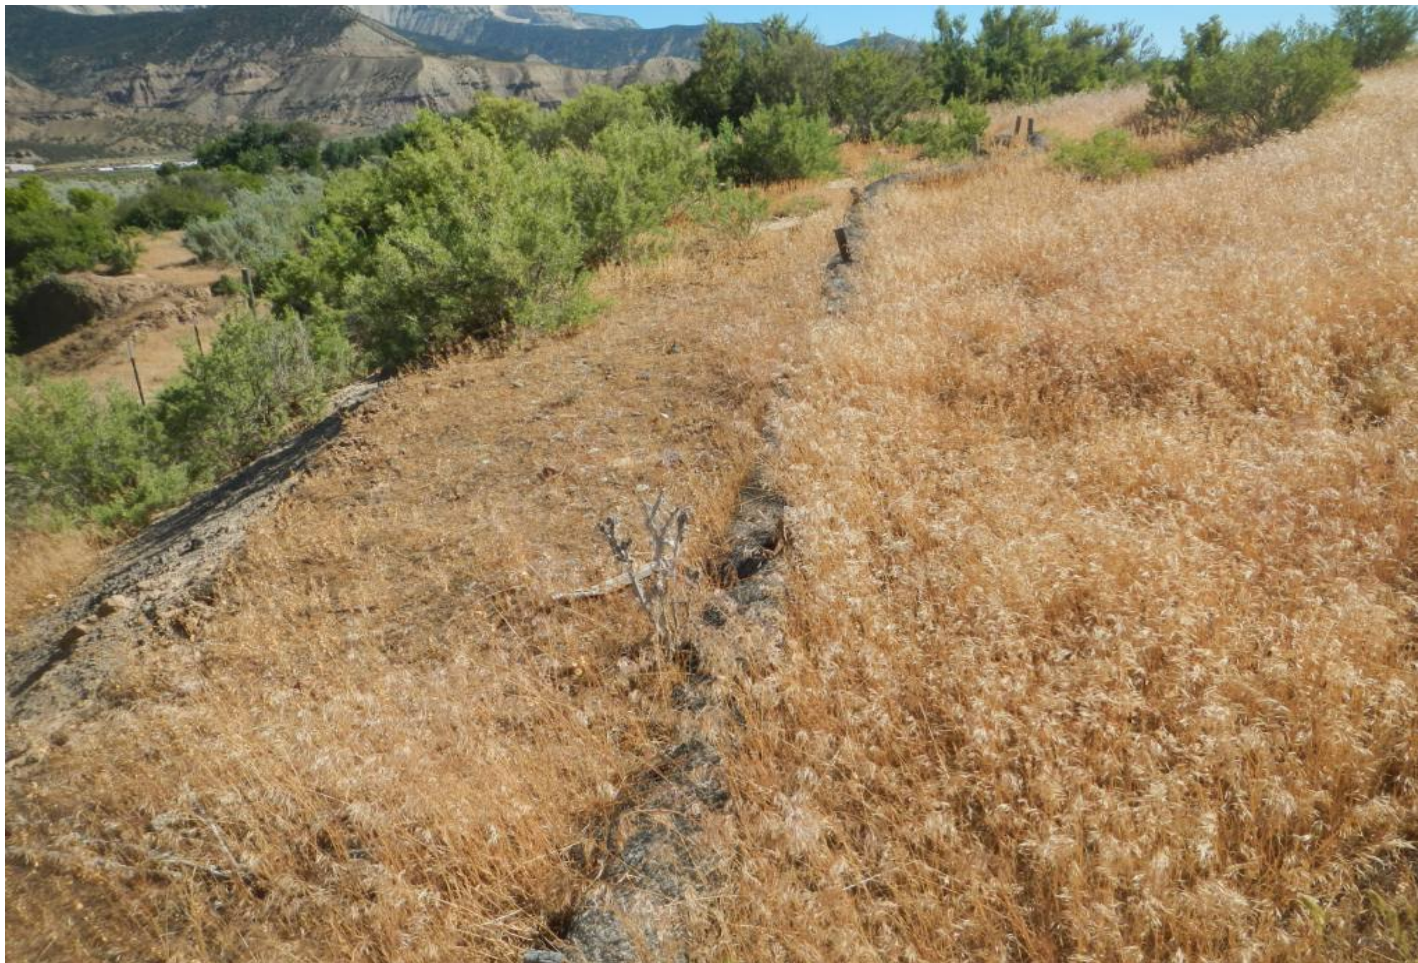
Photo#7: Wattles running East to West at NW perimeter of Location

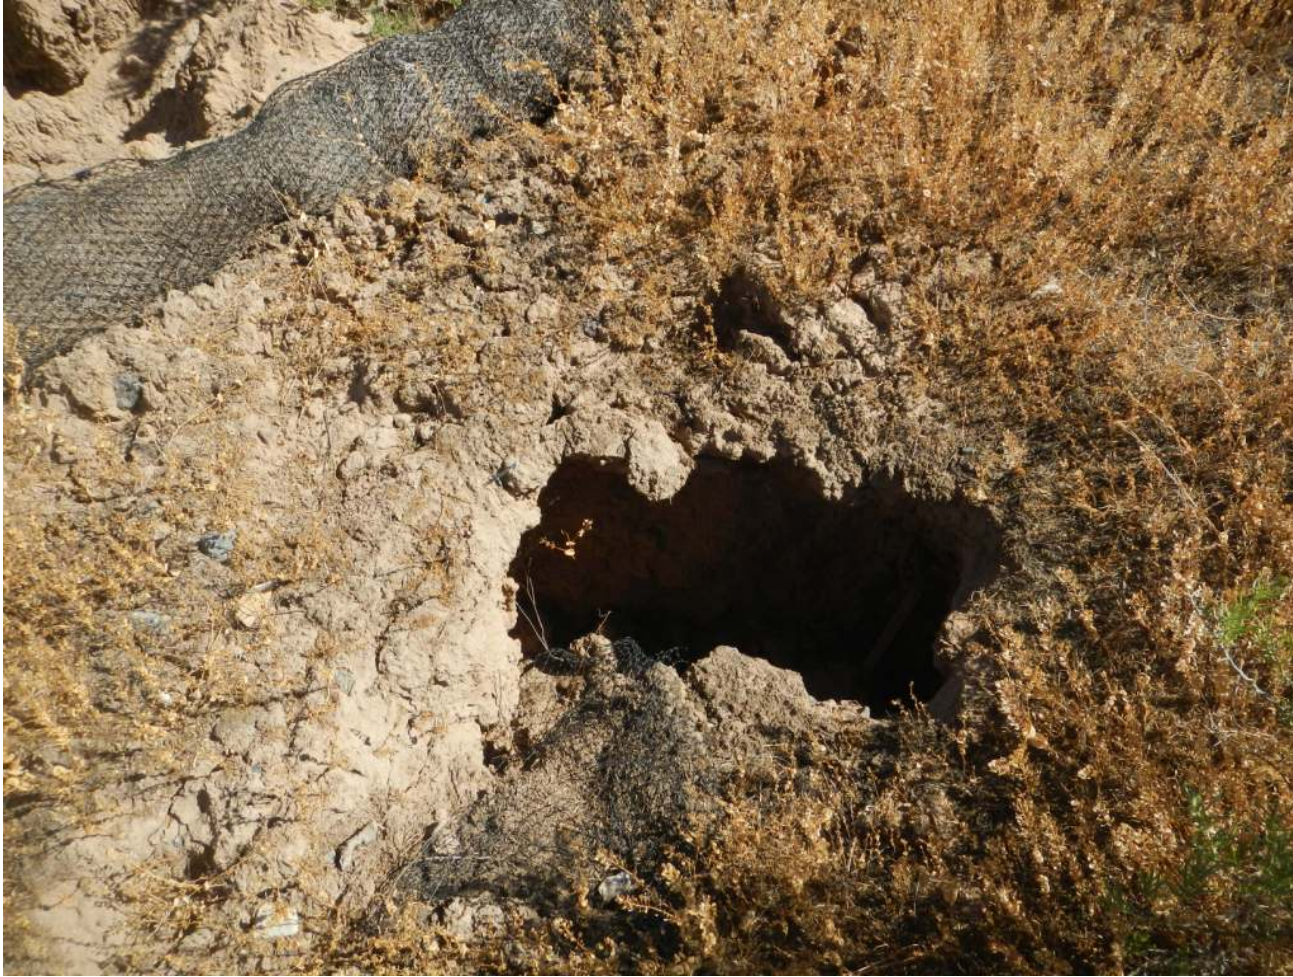
Photo#8: Water is undercutting wattles at multiple sites.

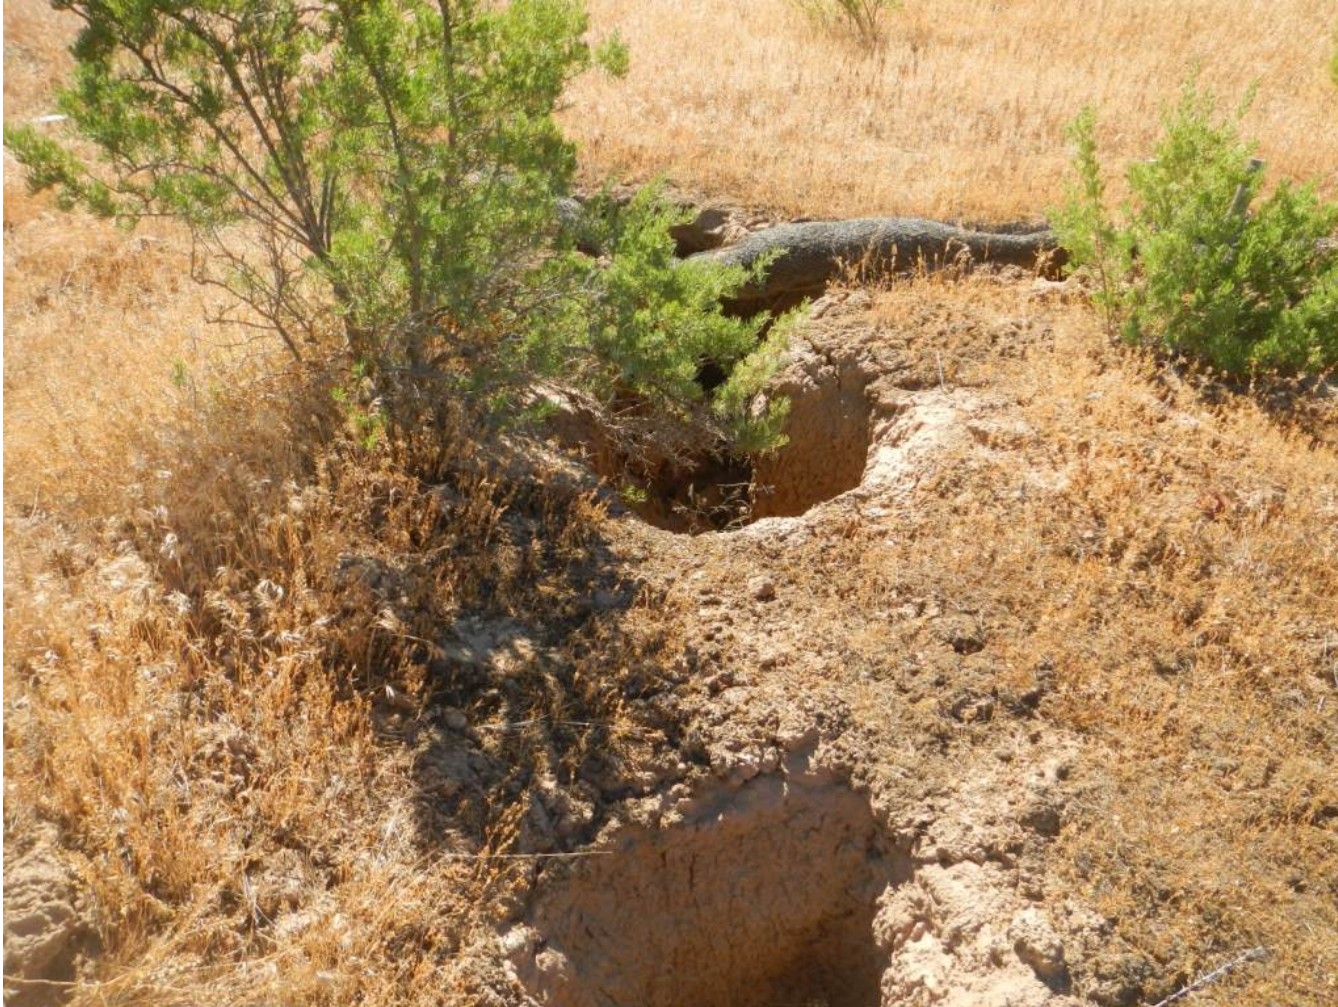
Photo#9: Water is undercutting wattles at multiple sites.

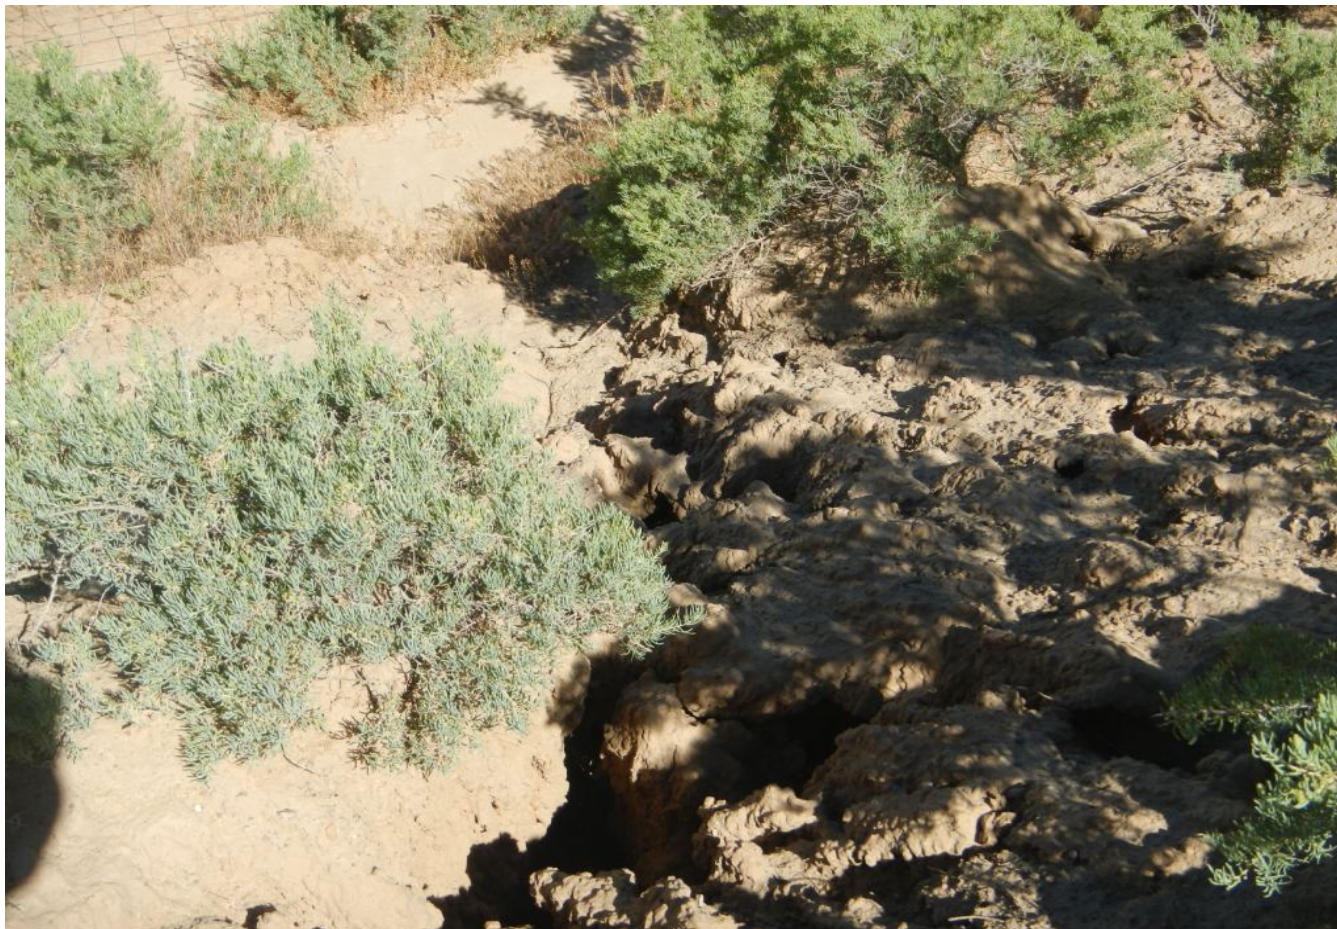
Photo#10: Further erosion and Channeling after undercutting of Wattles.

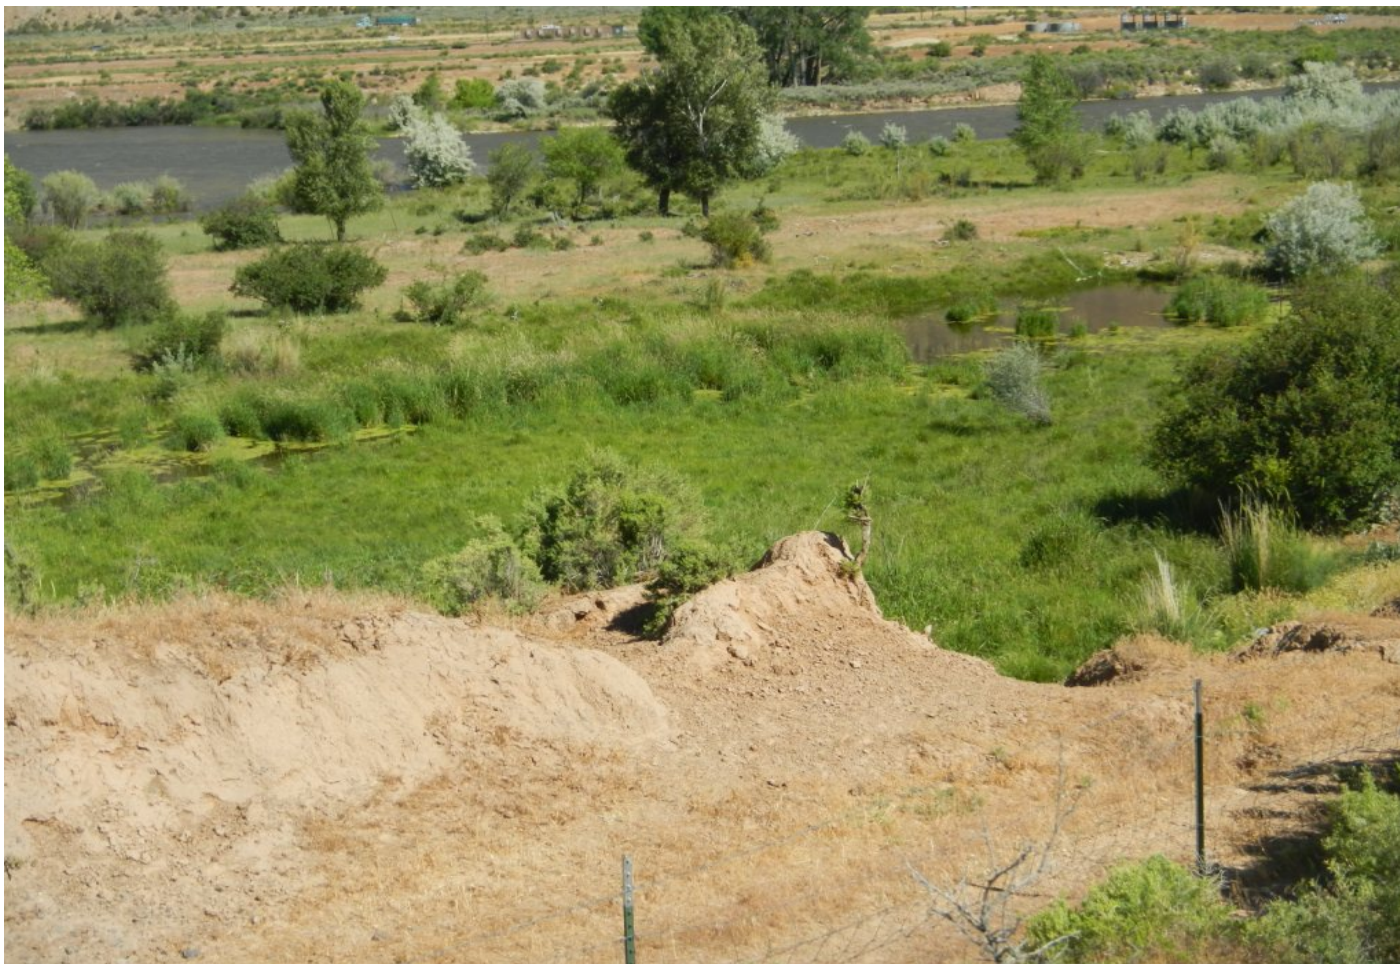
Photo#11: Run off is draining to water bodies immediately adjacent to River.

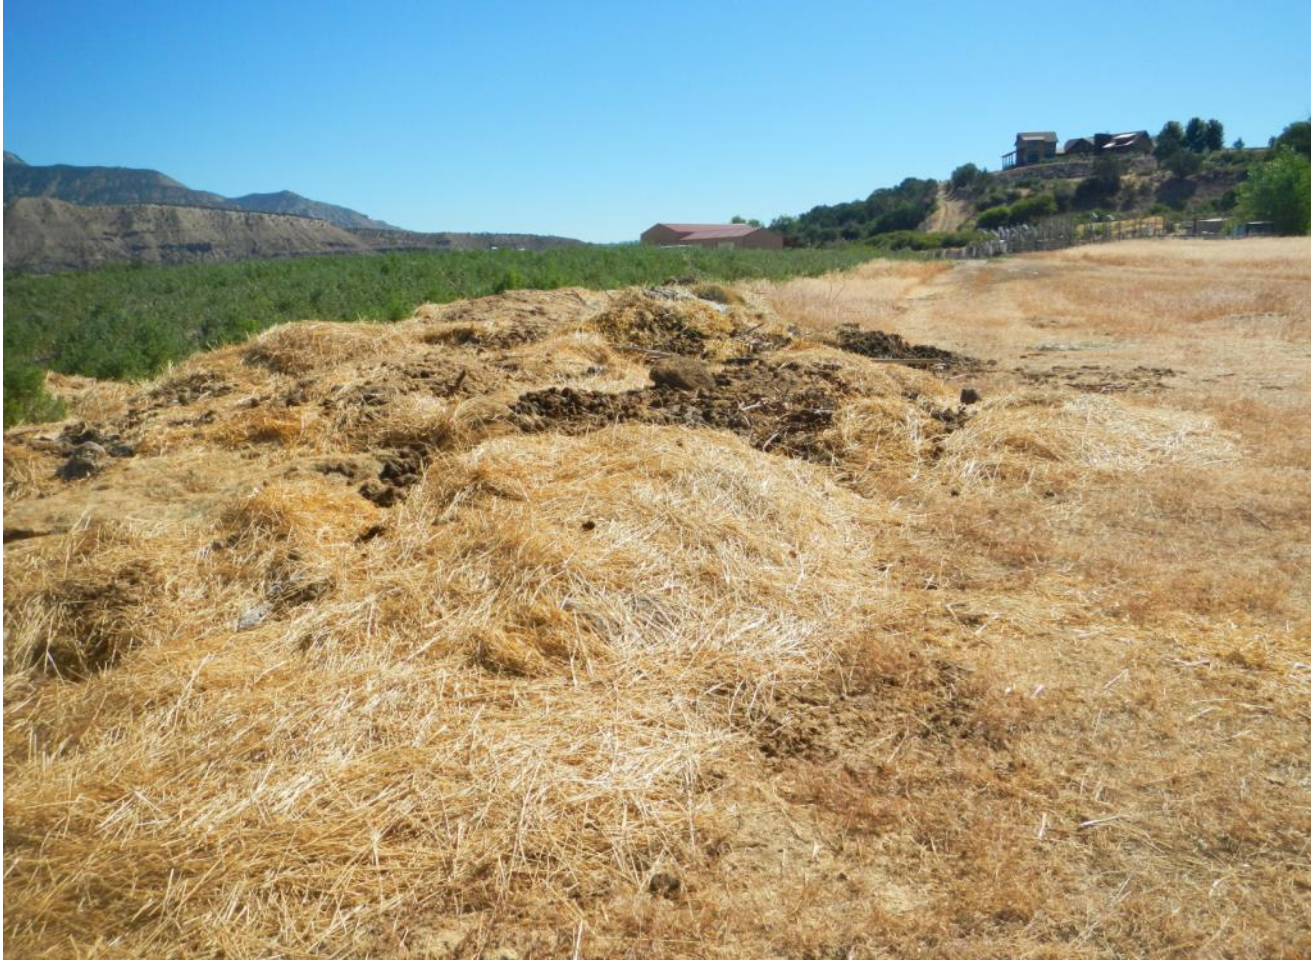
Photo#12: Manure / Bedding piled at NW corner of Location.

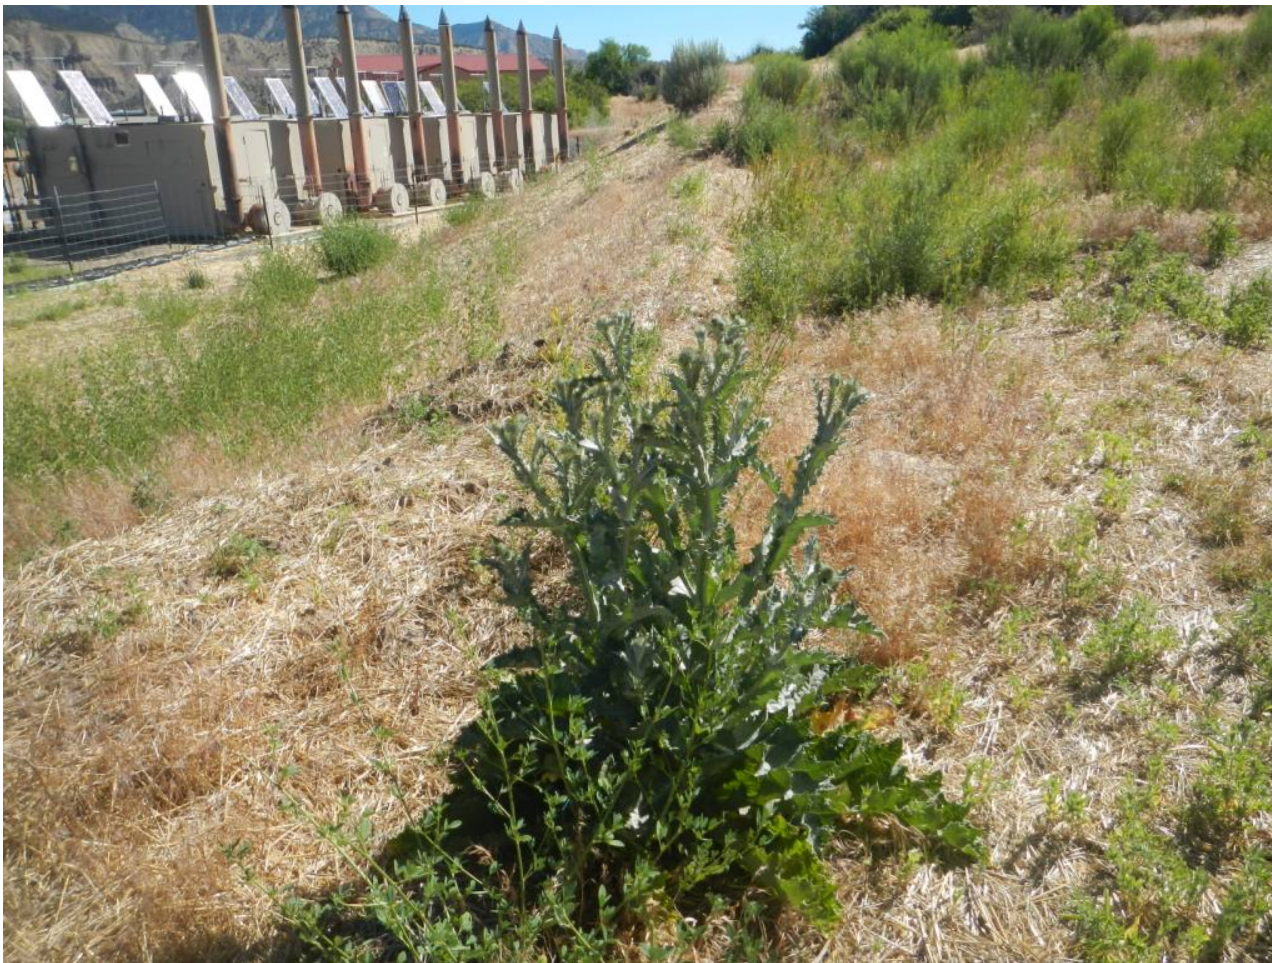
Photo#13: Scotch Thistle is establishing in scattered sites in perimeter areas of Location.

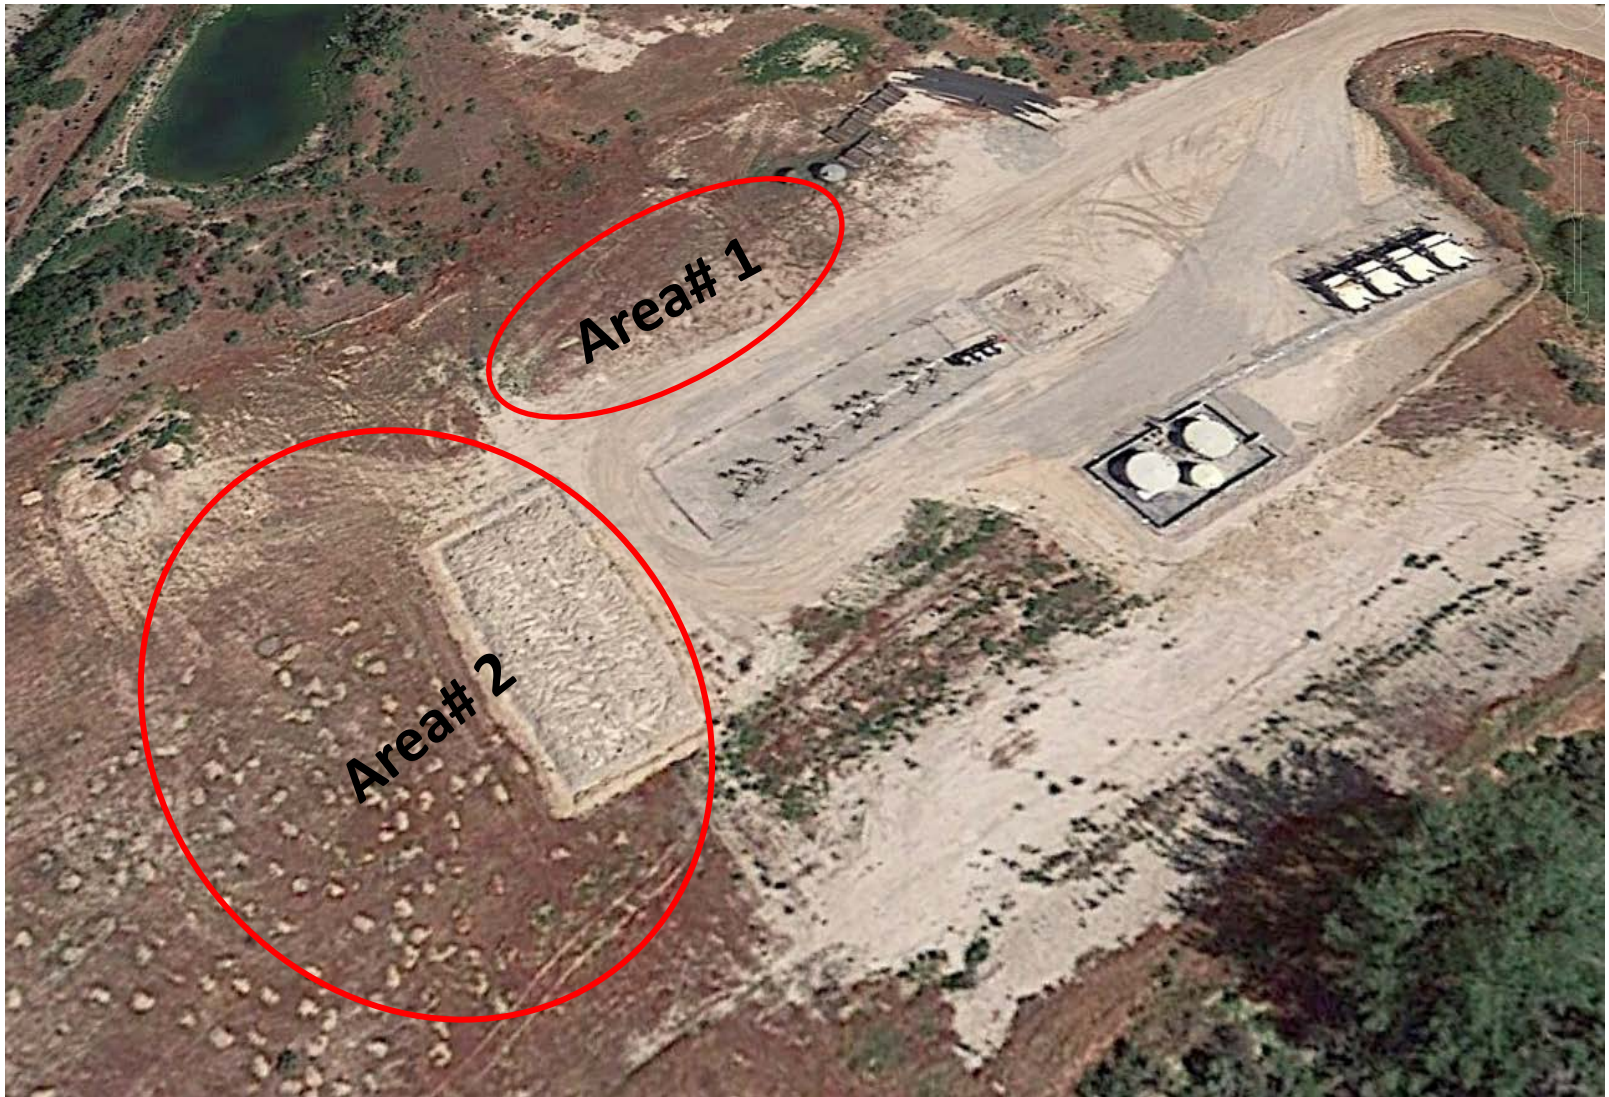
Photo#13: Interim Reclamation Areas identified in Inspection.
