Pictures were taken during field inspection of spill area on 8/11/2016.

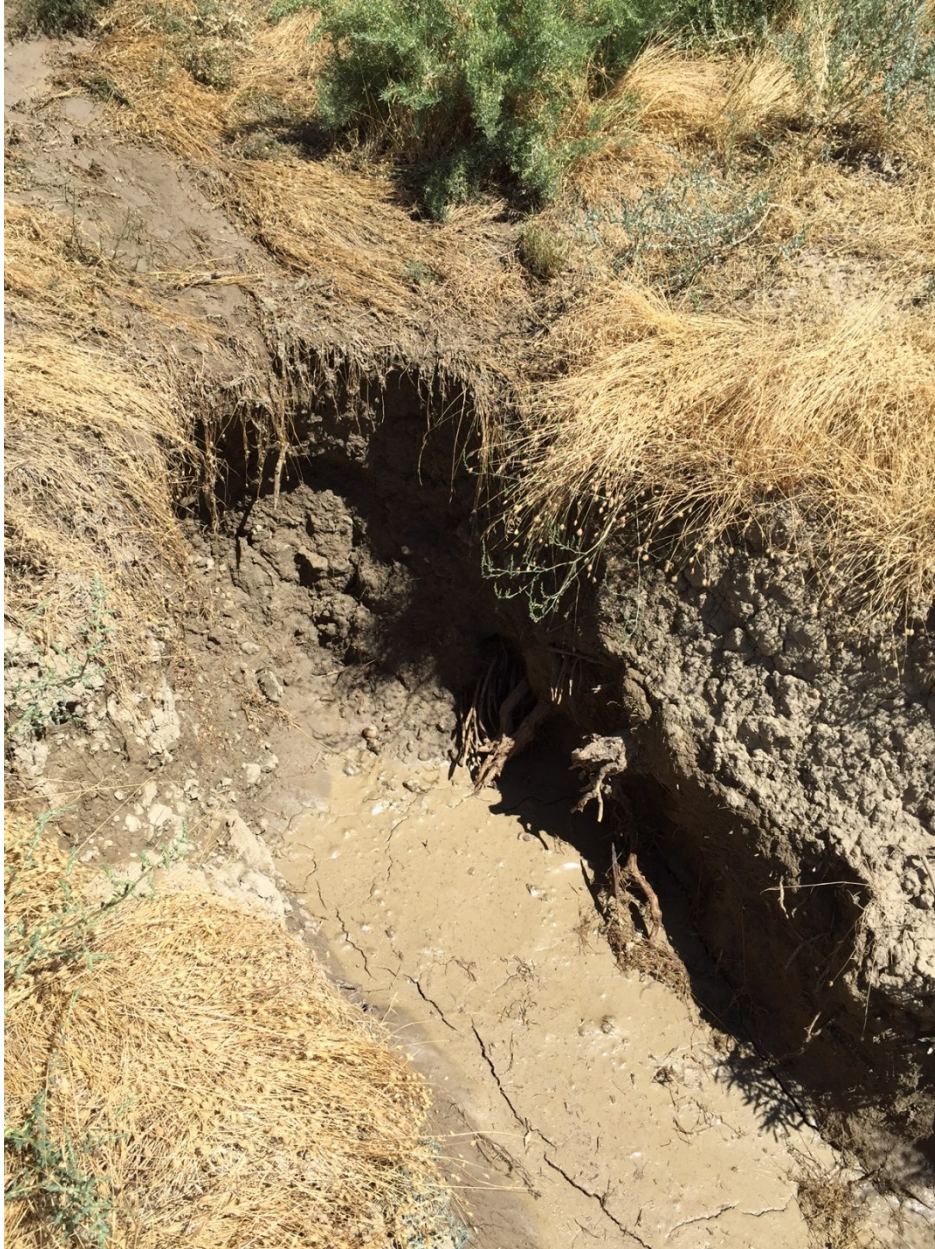
This erosion area was between the flowline and siphon 43 impoundment. No hydrocarbon was observable in this area.

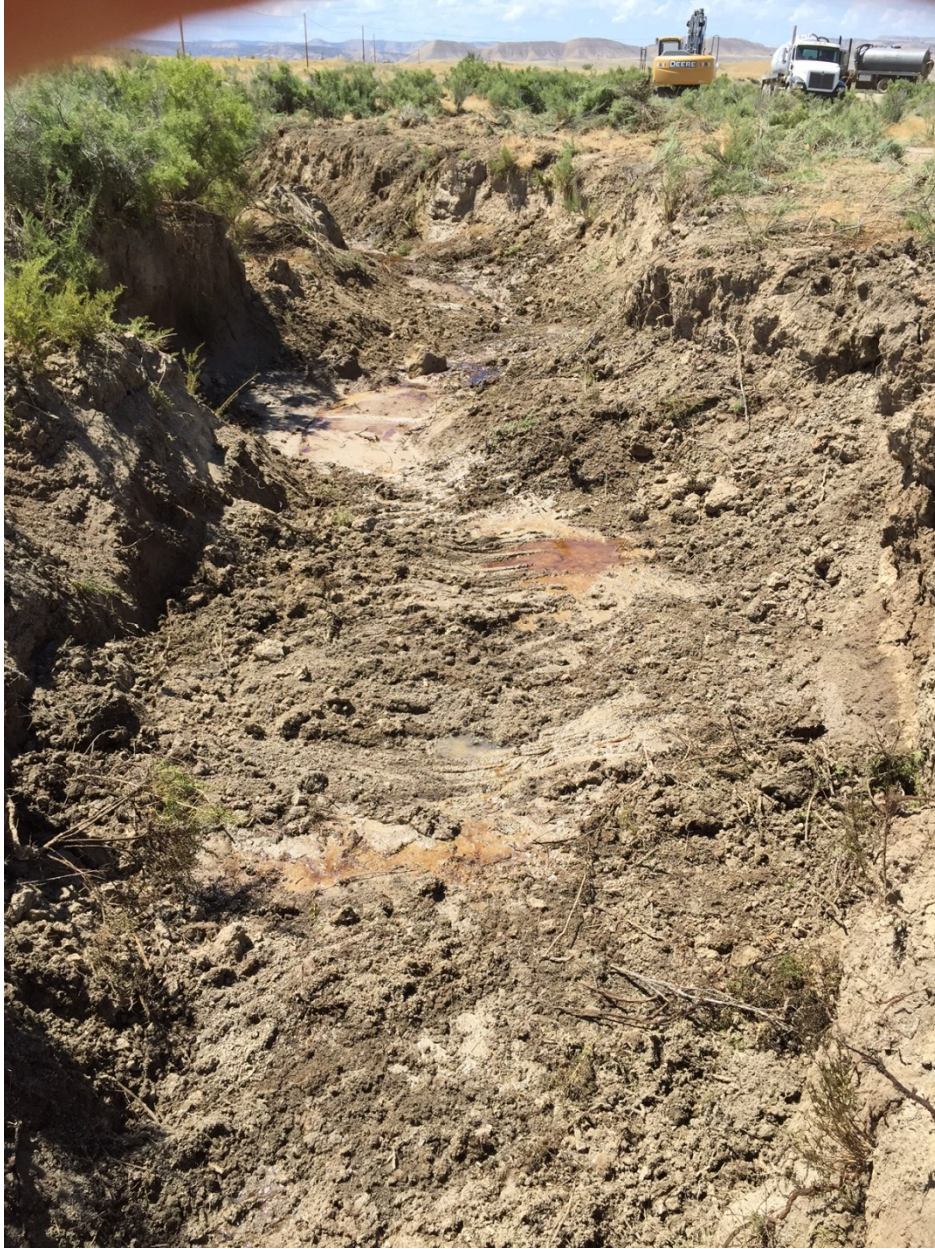
Photo taken at spill release point. Area with excavator is at siphon 43.

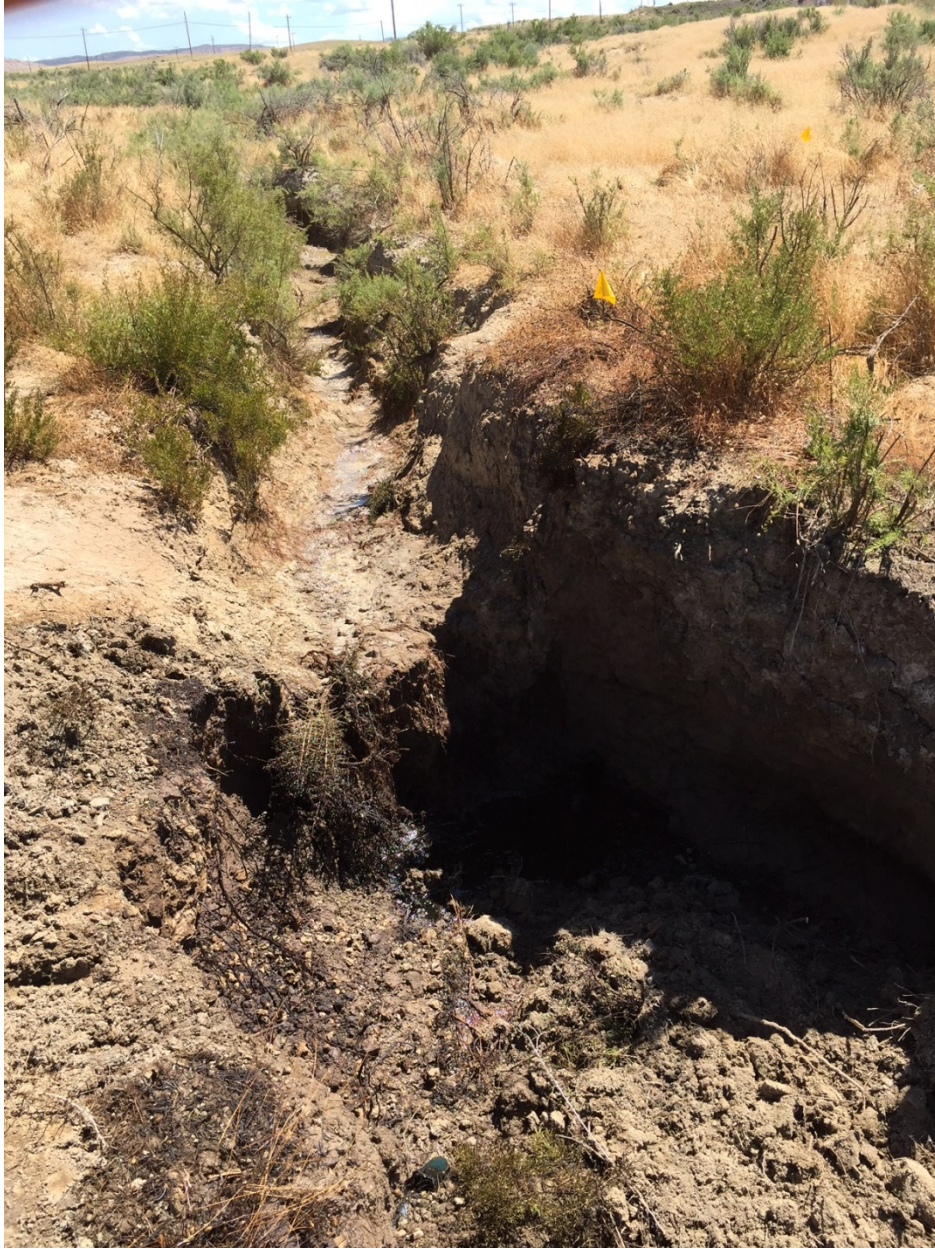
Yellow flag is marking the flowline. This was point of discharge.
