Stormwater Inspection

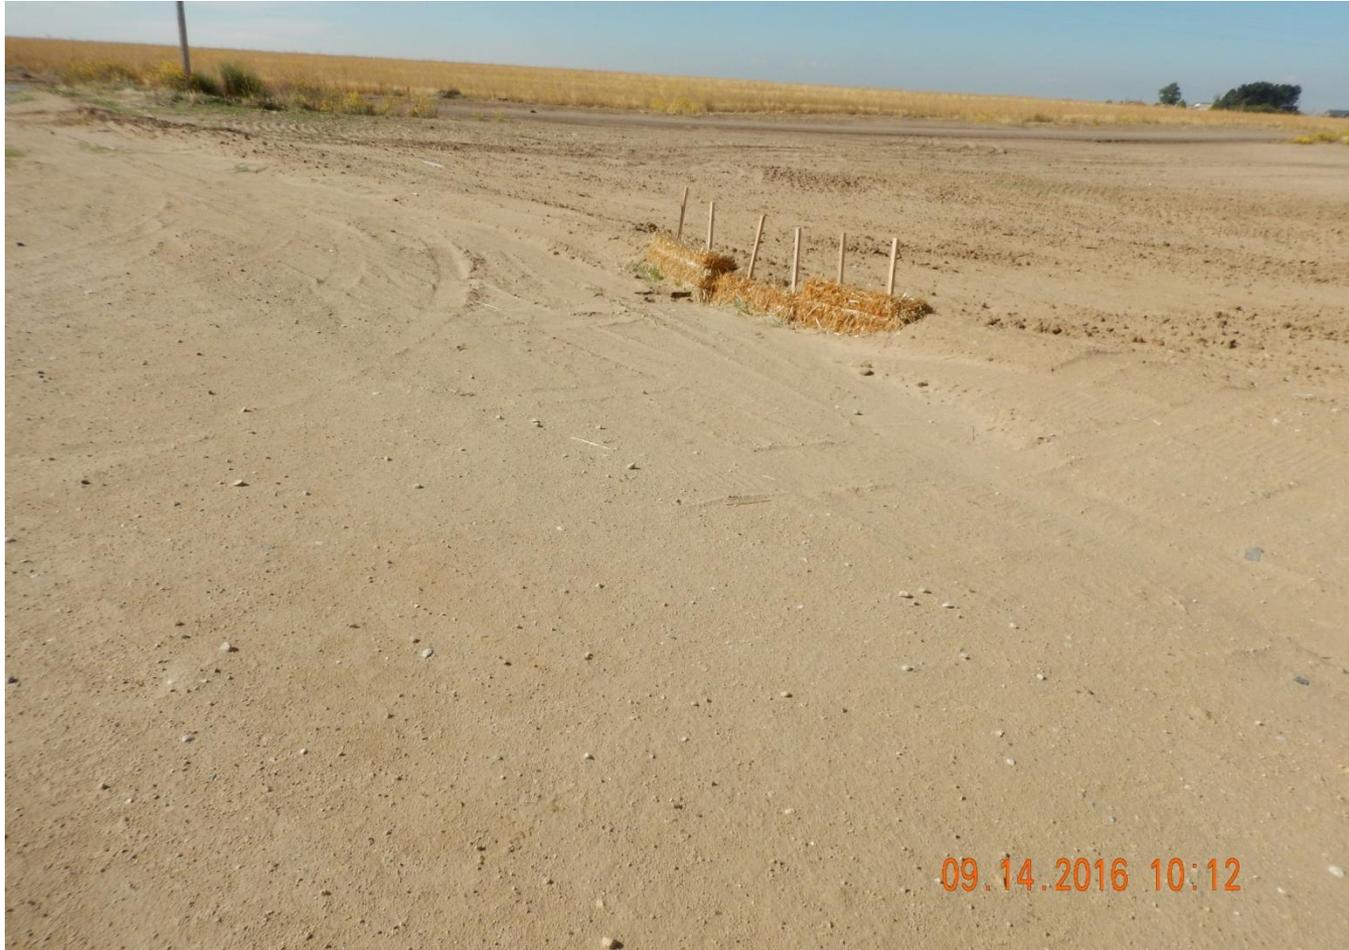
Photo 1. Photo taken from the western location, facing Southwest. Berm was constructed and straw bales installed to control sedimentation from leaving location.

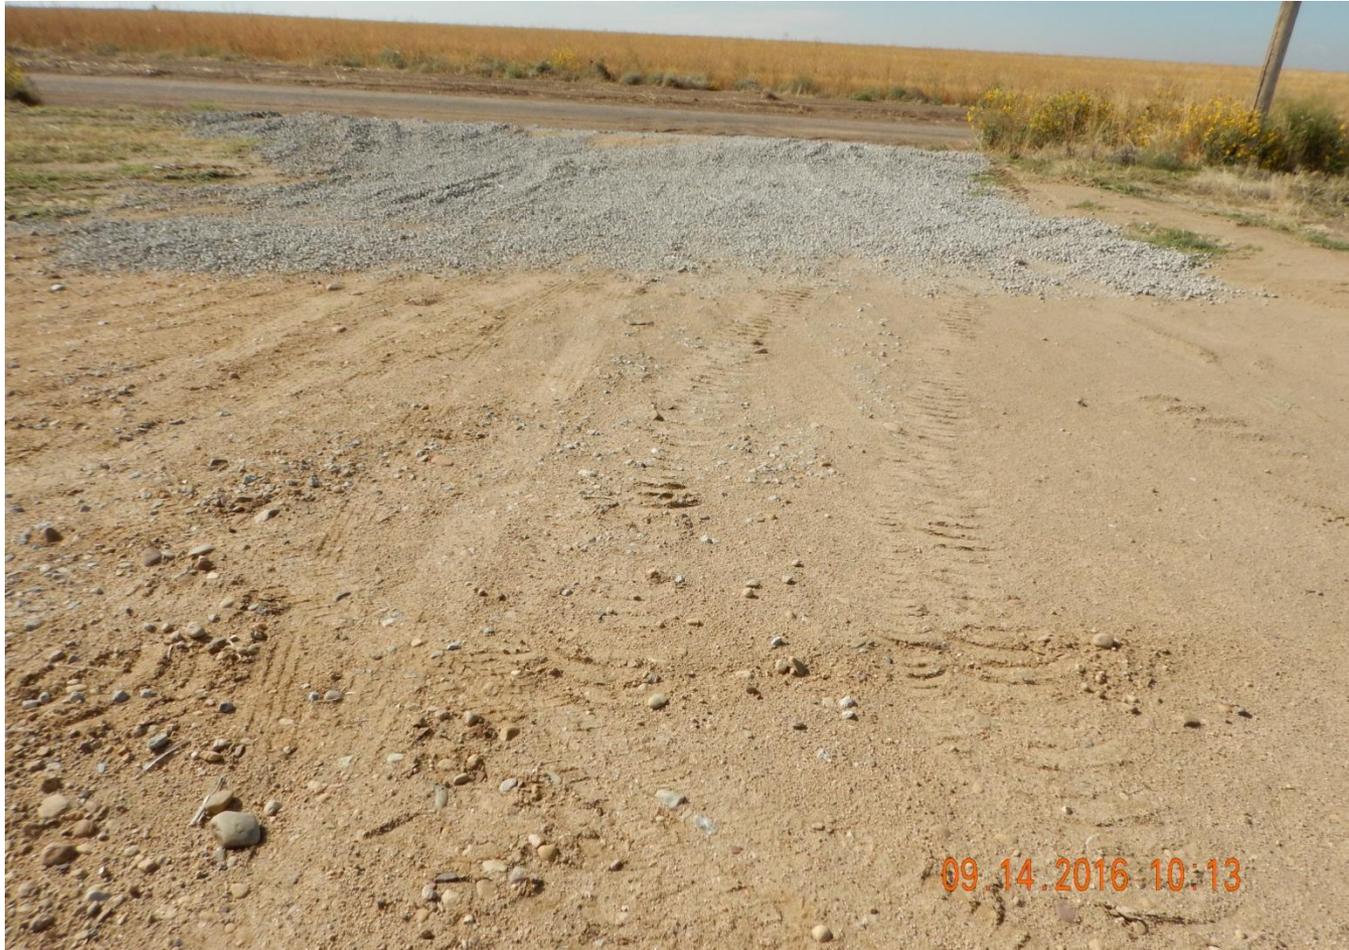
Photo 2. Photo taken from the western entrance, facing South. Gravel installed at location entrance.

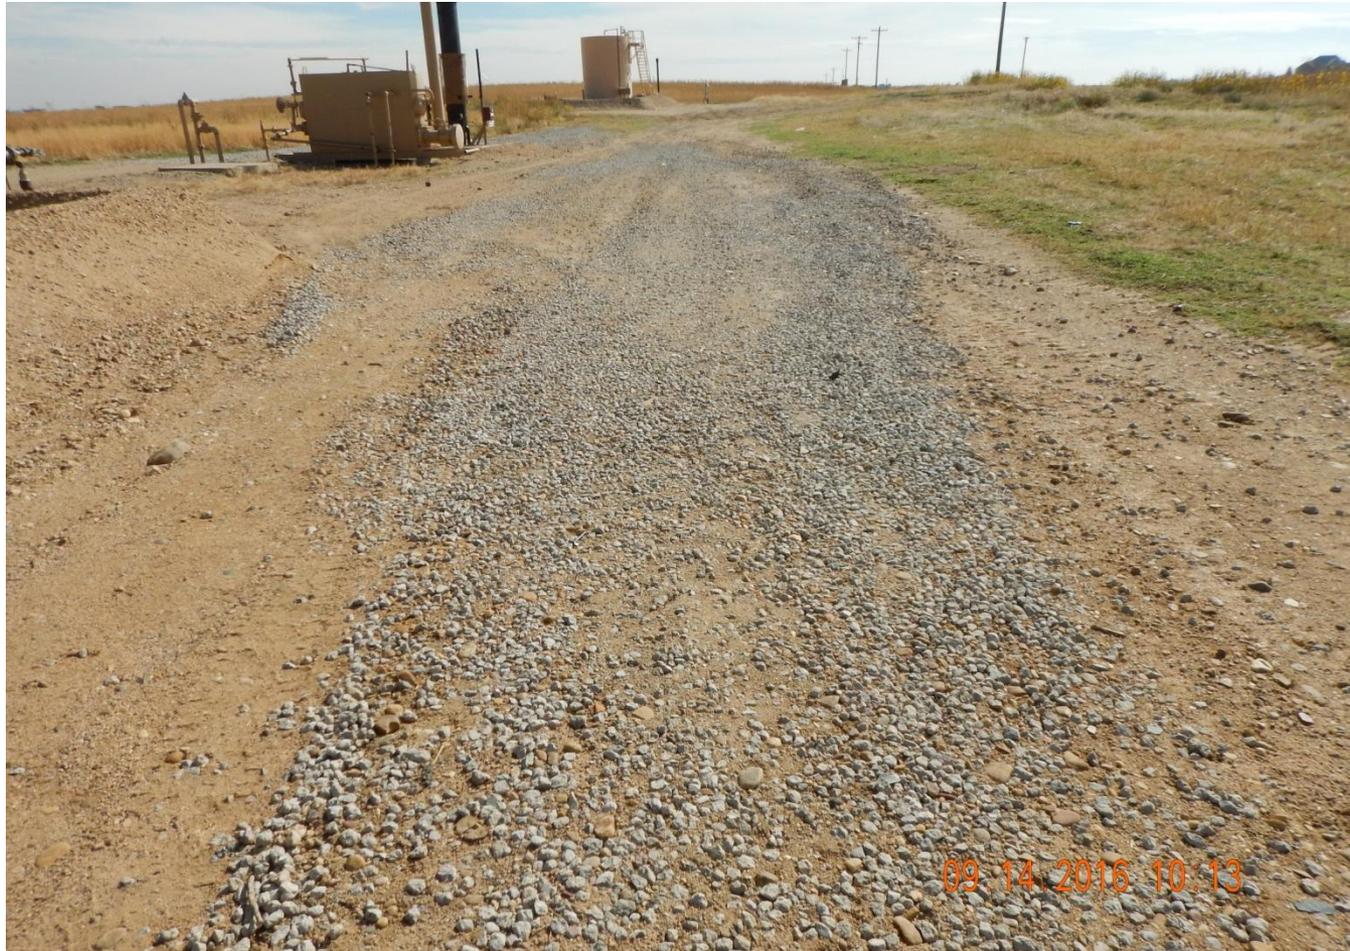
Photo 3. Photo taken from the western entrance, facing East. Gravel installed to stabilize location and prevent erosion.

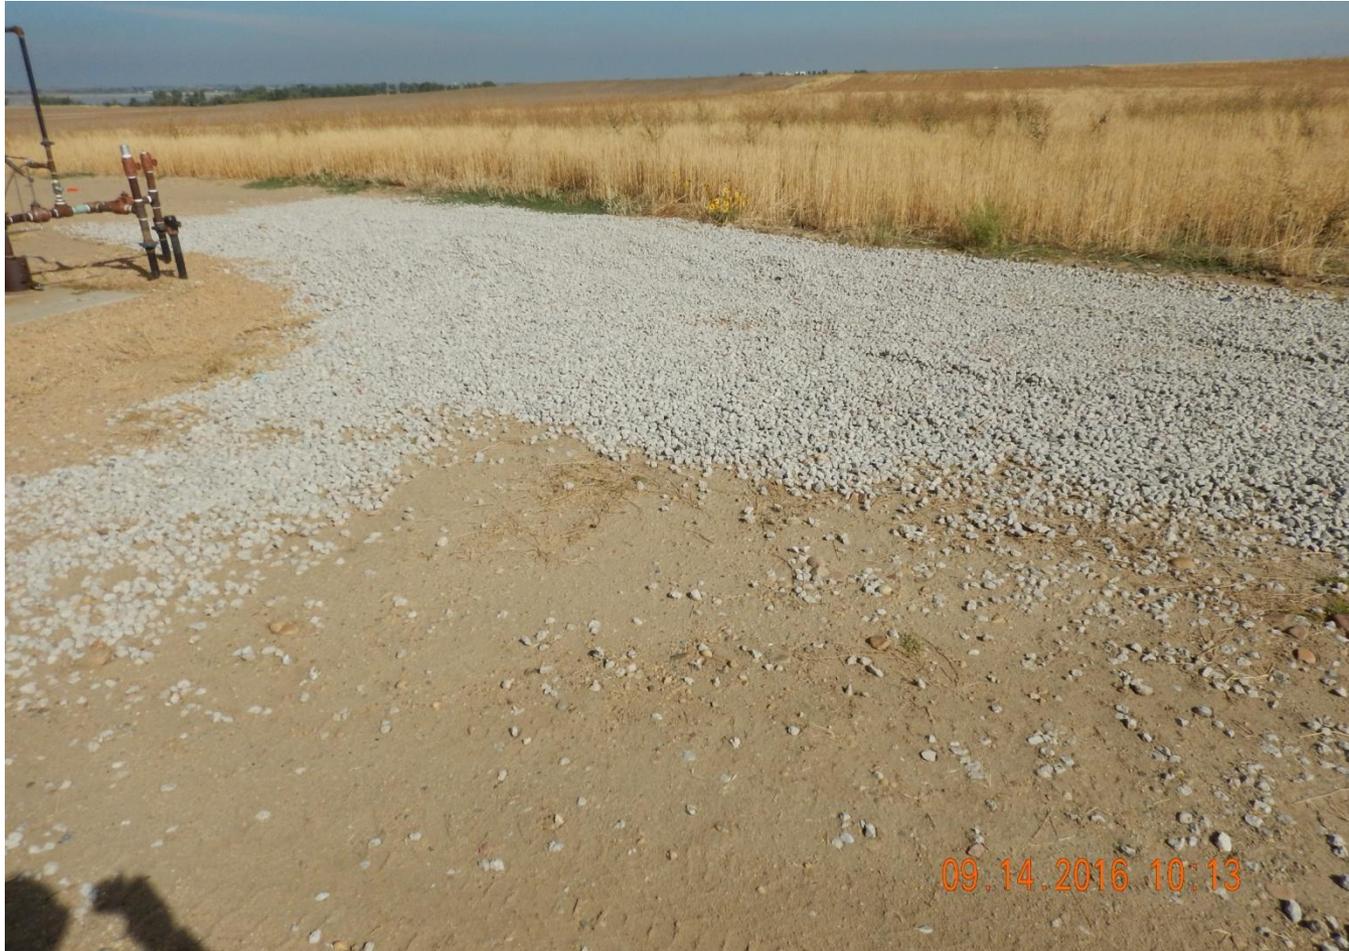
Photo 4. Photo taken from the northern location, facing Northwest. Gravel installed to stabilize location and prevent erosion.

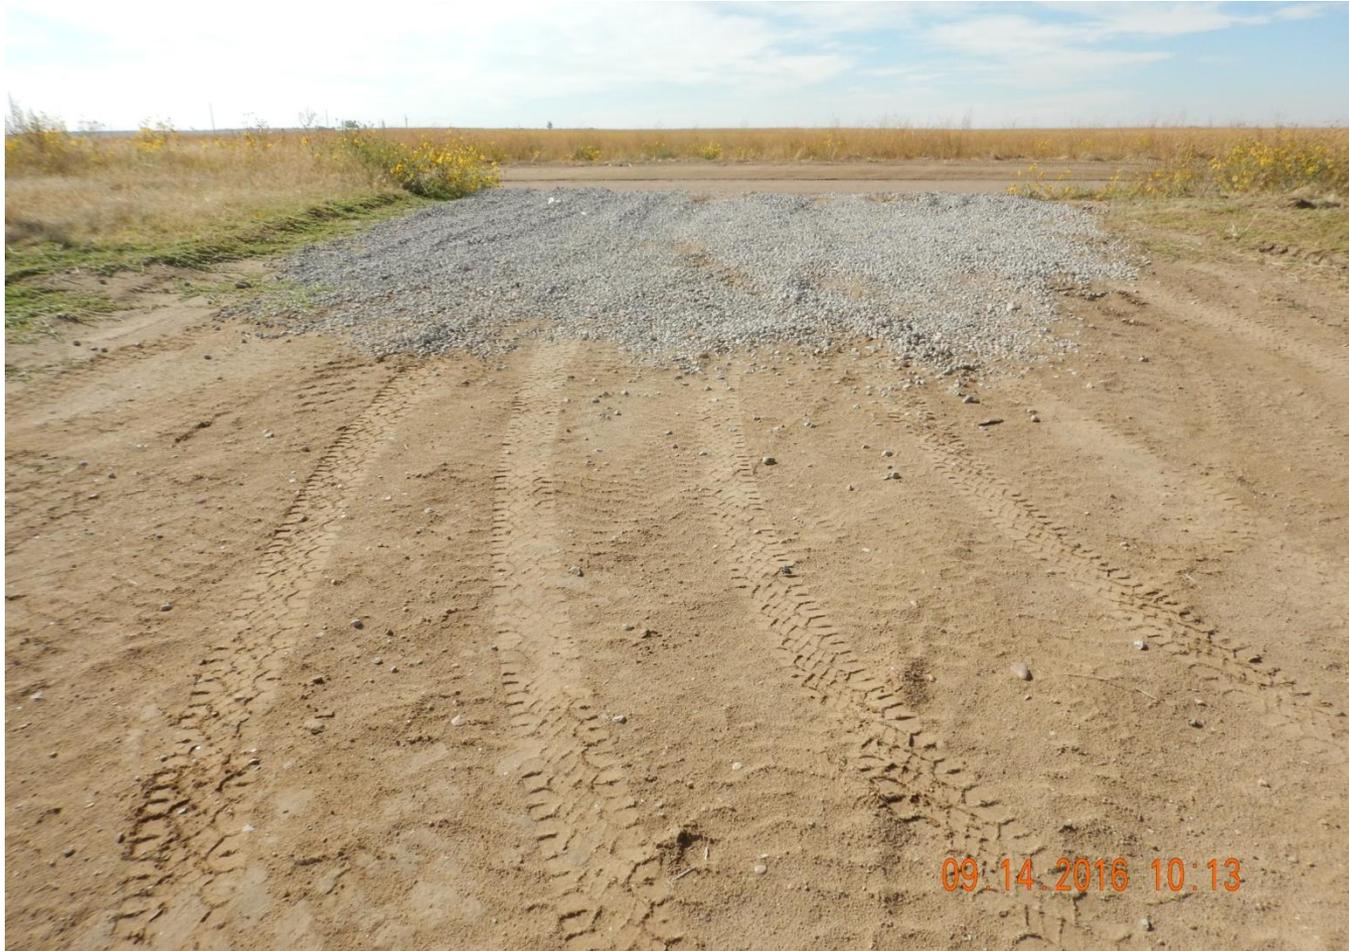
Photo 5. Photo taken from the eastern entrance, facing South. Gravel installed at location entrance.
