## Interim Reclamation Inspection- Overview

# Interim Reclamation Inspection

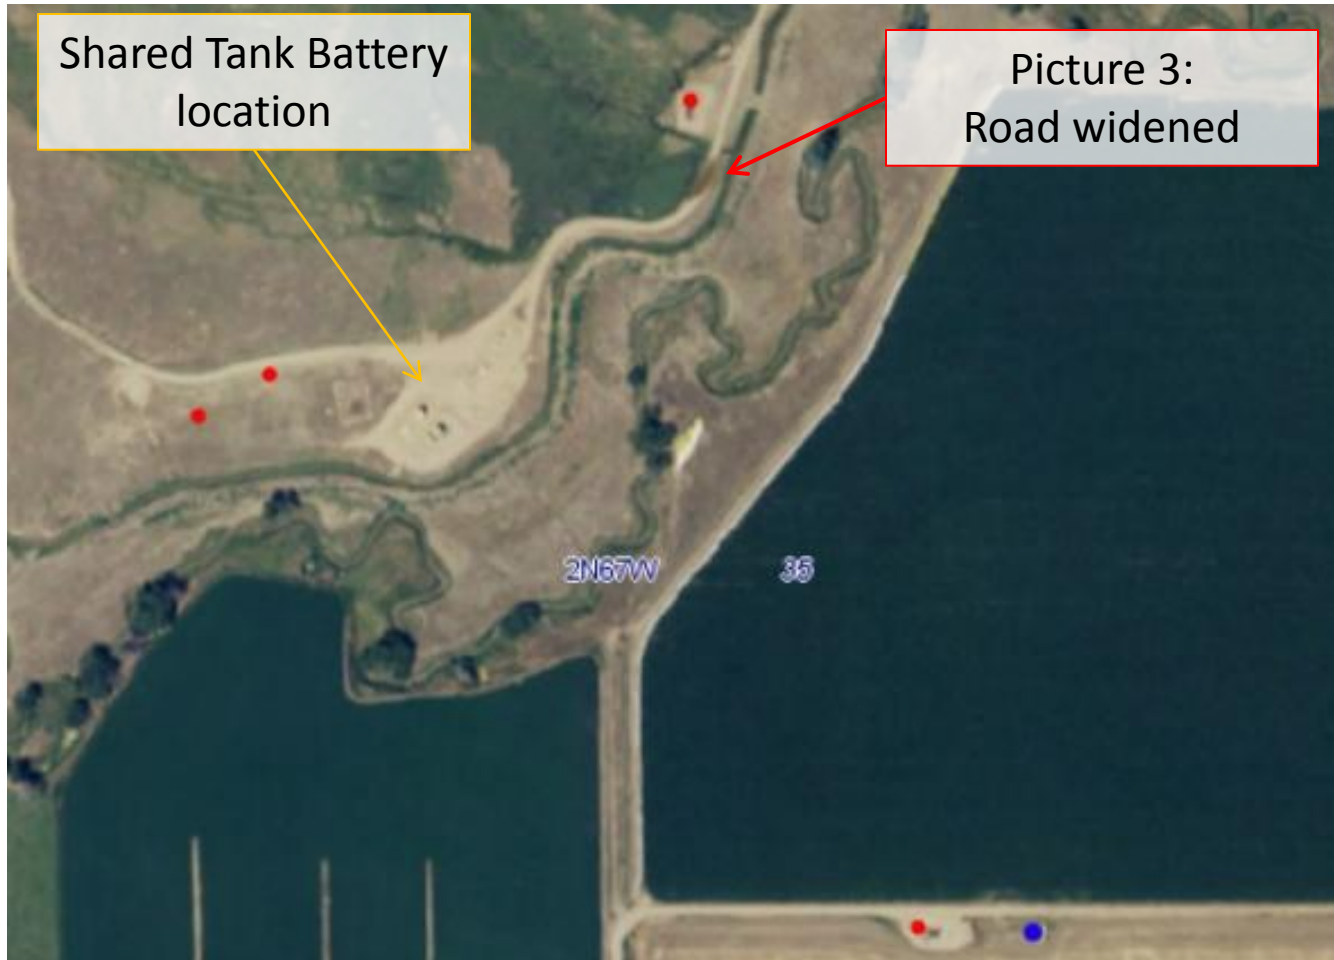
Aerial imagery taken September 2015 using COGCC GISOnline database, illustrating KPK and Kerr McGee shared tank battery location in relation to a corrective action to fix a portion of the access road that was widened by an operator.

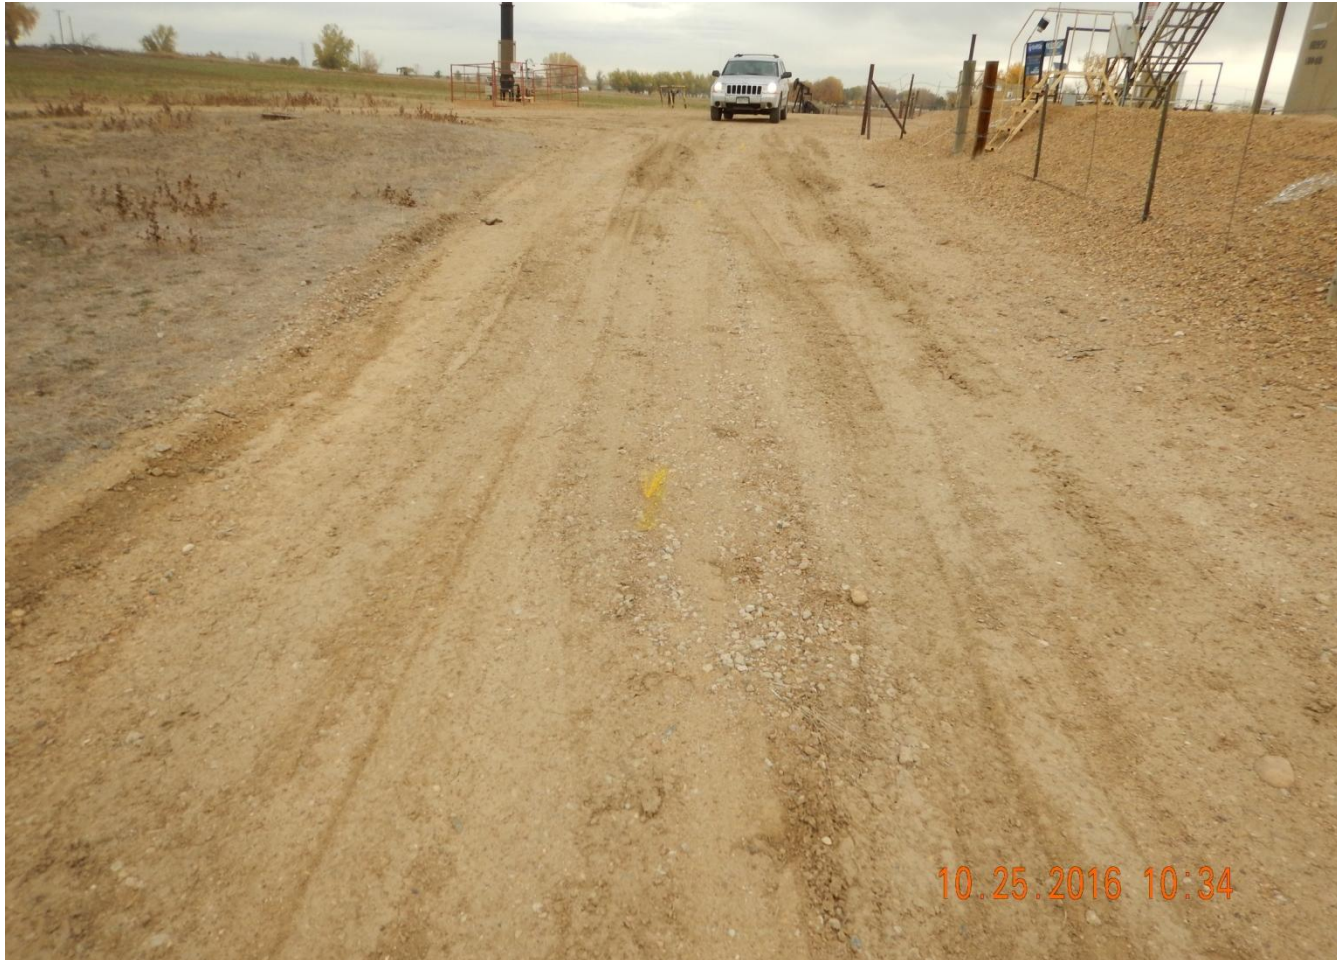
**Photo 1.** Photo taken west of the batteries, facing North. Corrective actions to repair ruts have been performed.

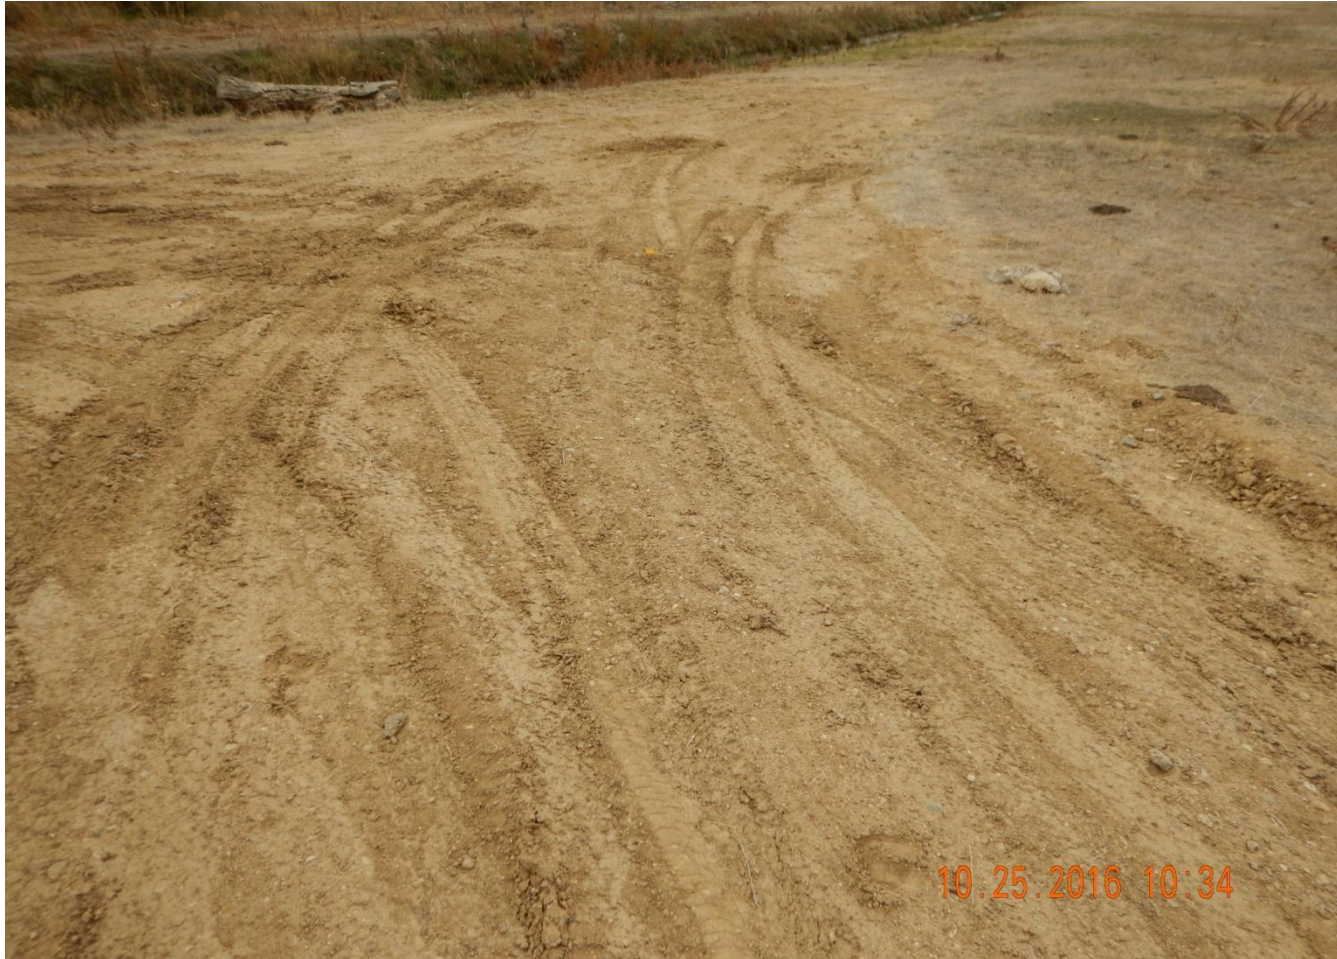
**Photo 2.** Photo taken west of the batteries, facing South. Corrective actions to repair ruts have been performed.

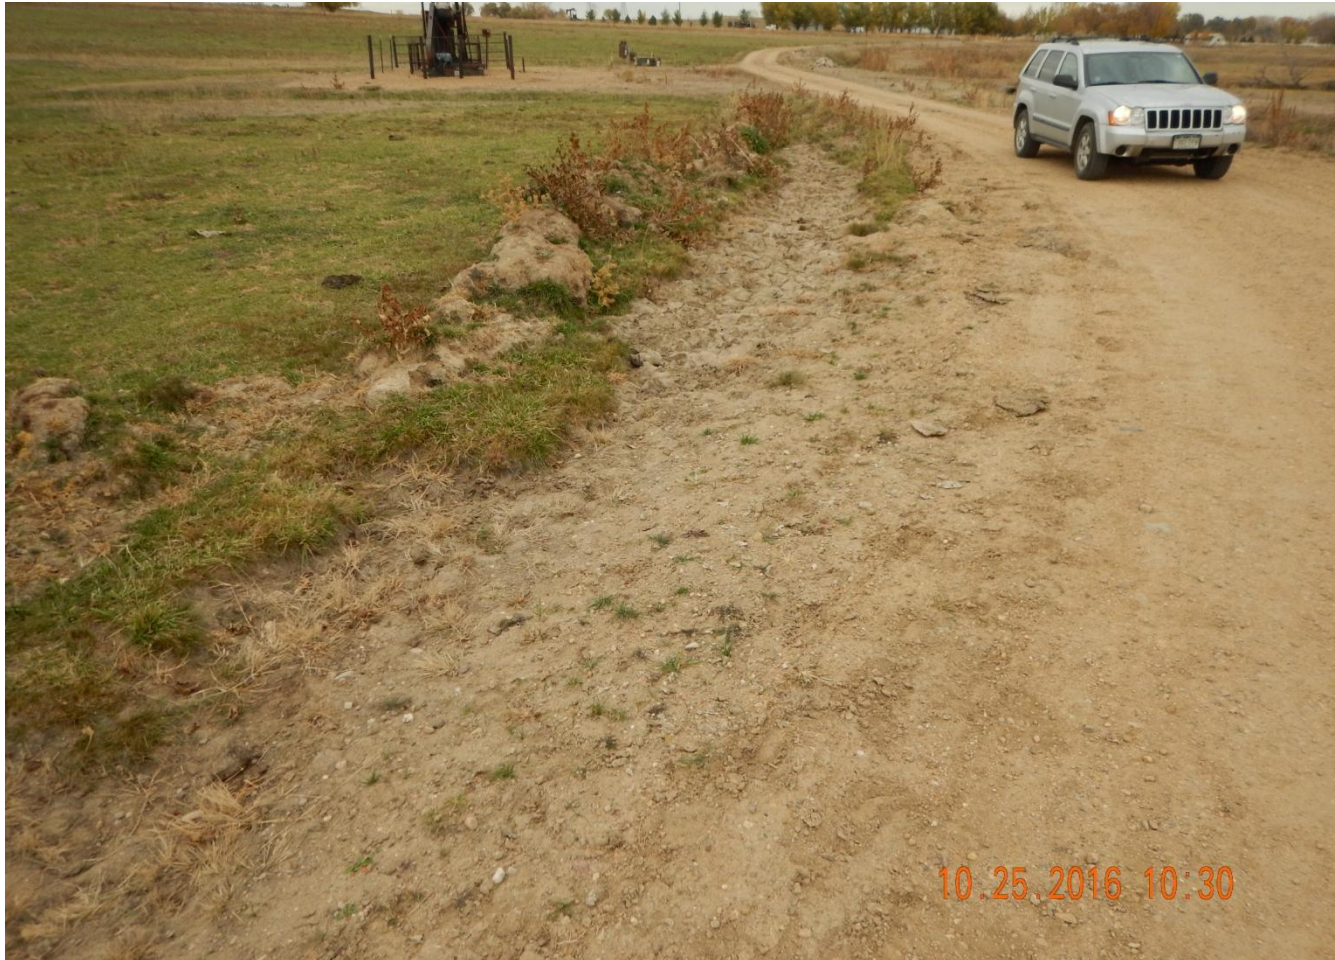
**Photo 3.** Photo taken north of the shared tank battery location, facing North along the access road. Need to repair access road that was widened by an operator and re-seed any portions that are disturbed during this process.
