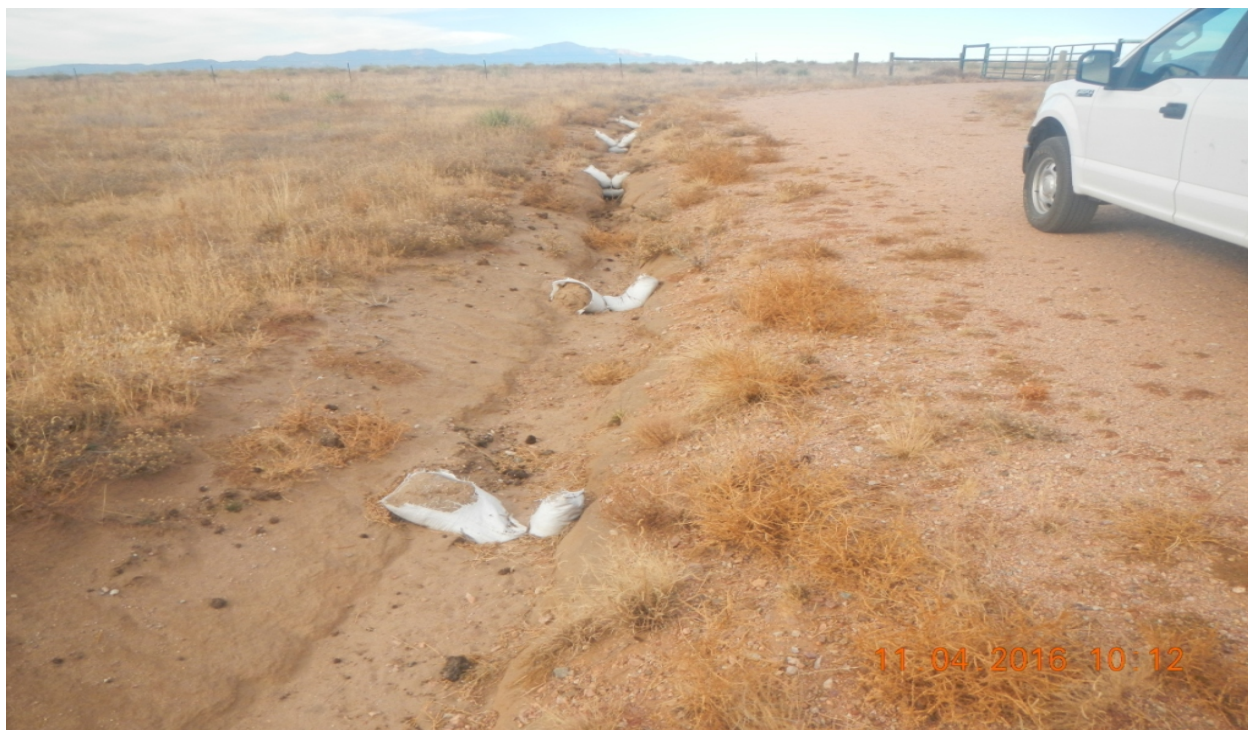
**photo 1:** Facing west along the access road. This erosion channel was documented in the previous inspection.

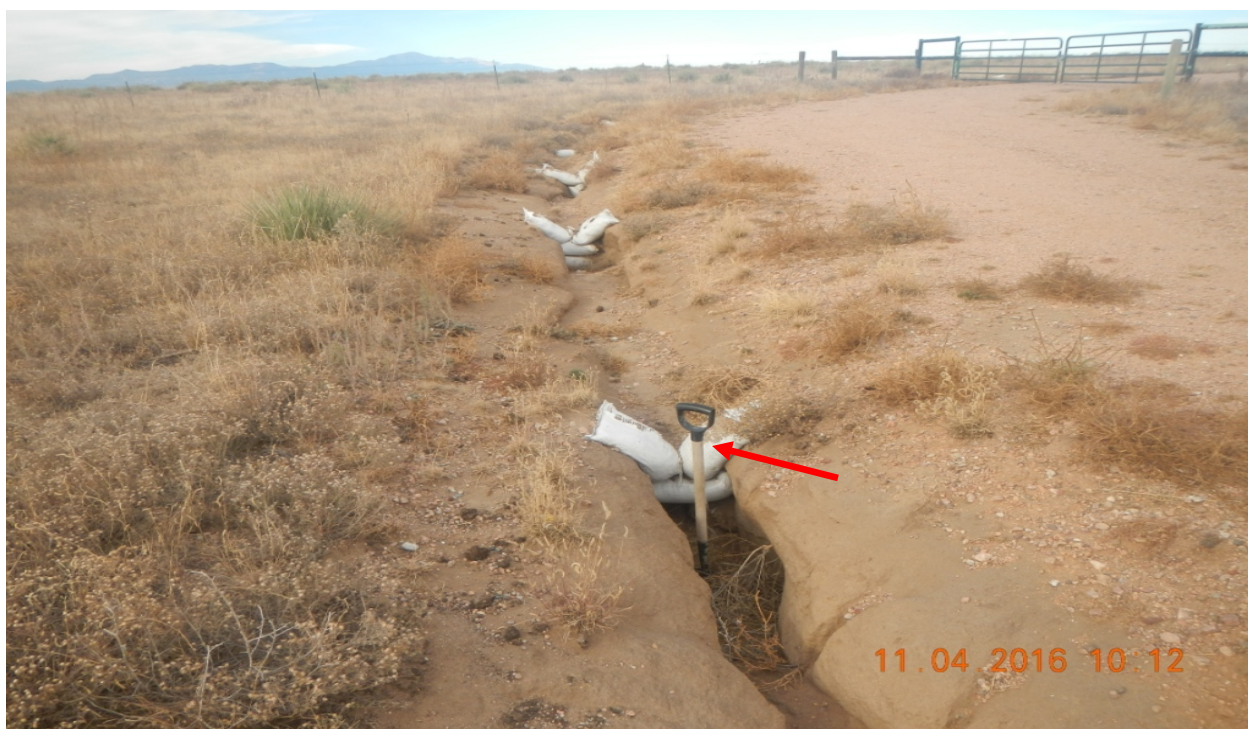
**photo 2:** A 3 ft. shovel indicates depth of channel.

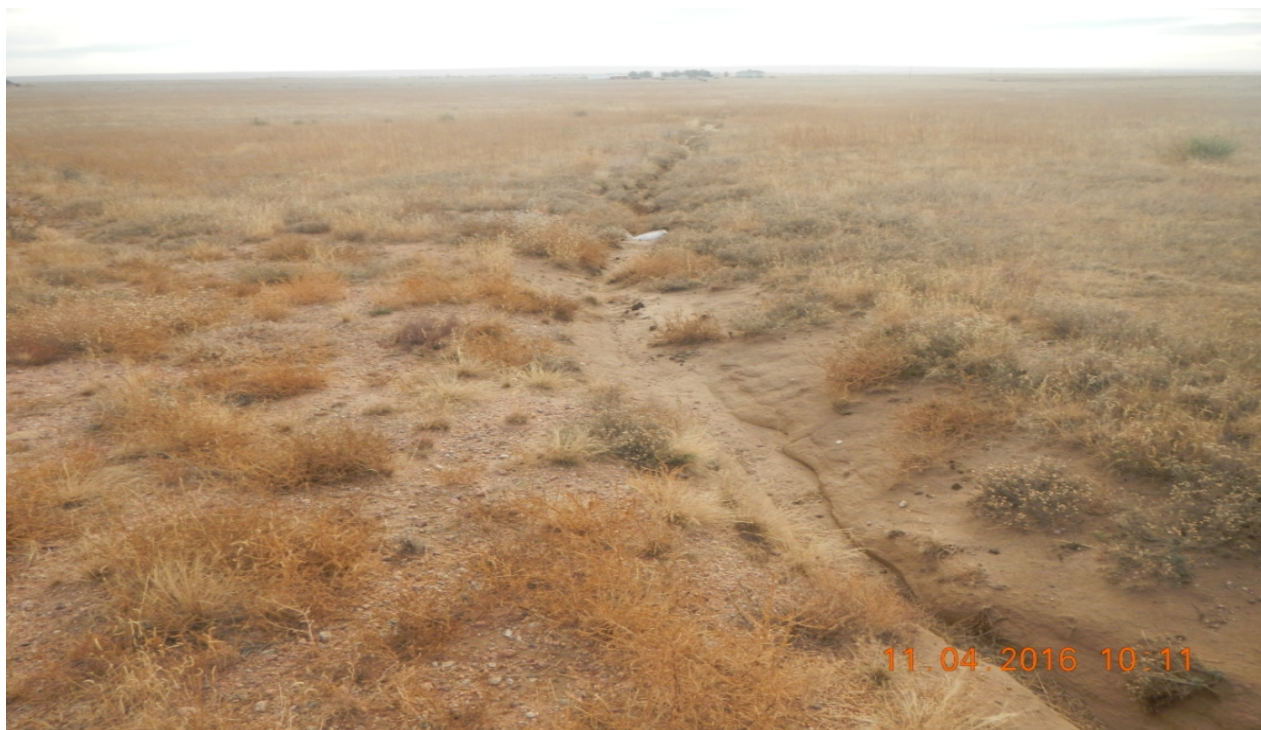
**photo 3:** The erosion channel is directed out into the pasture which is causing additional disturbance.

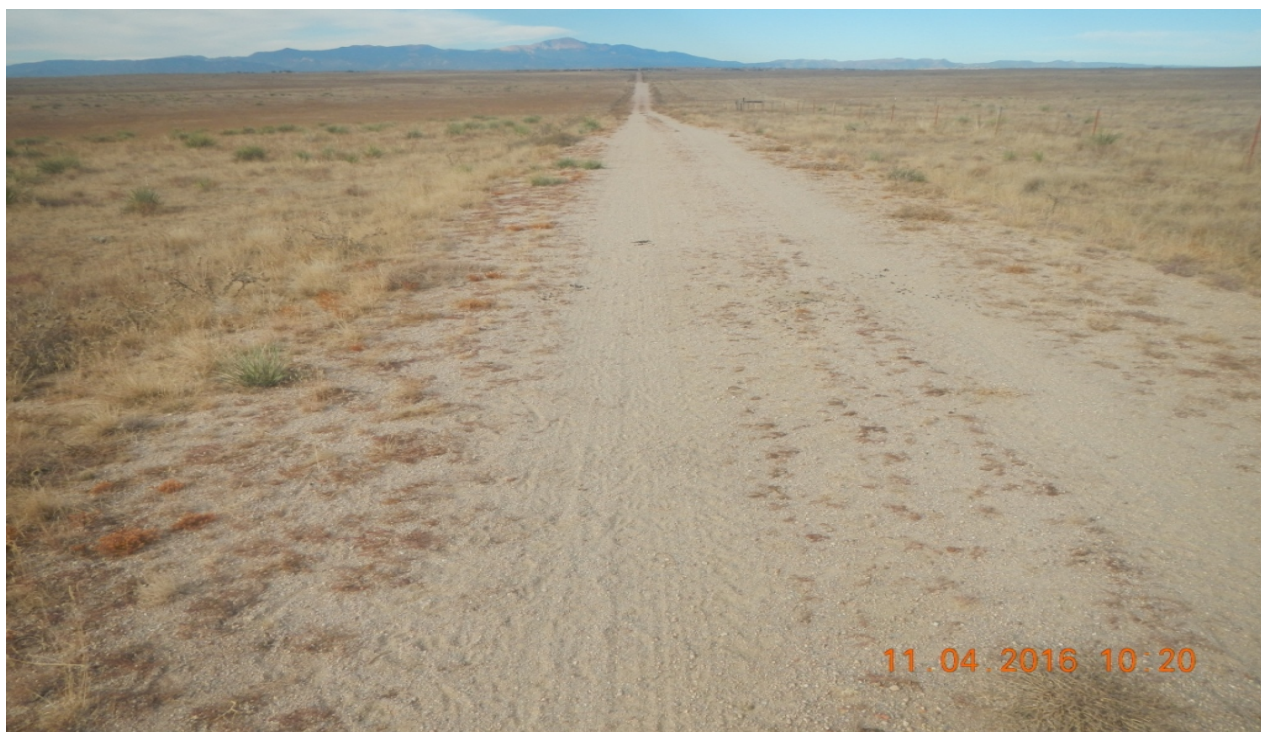
**photo 4:** Facing west along the access road.

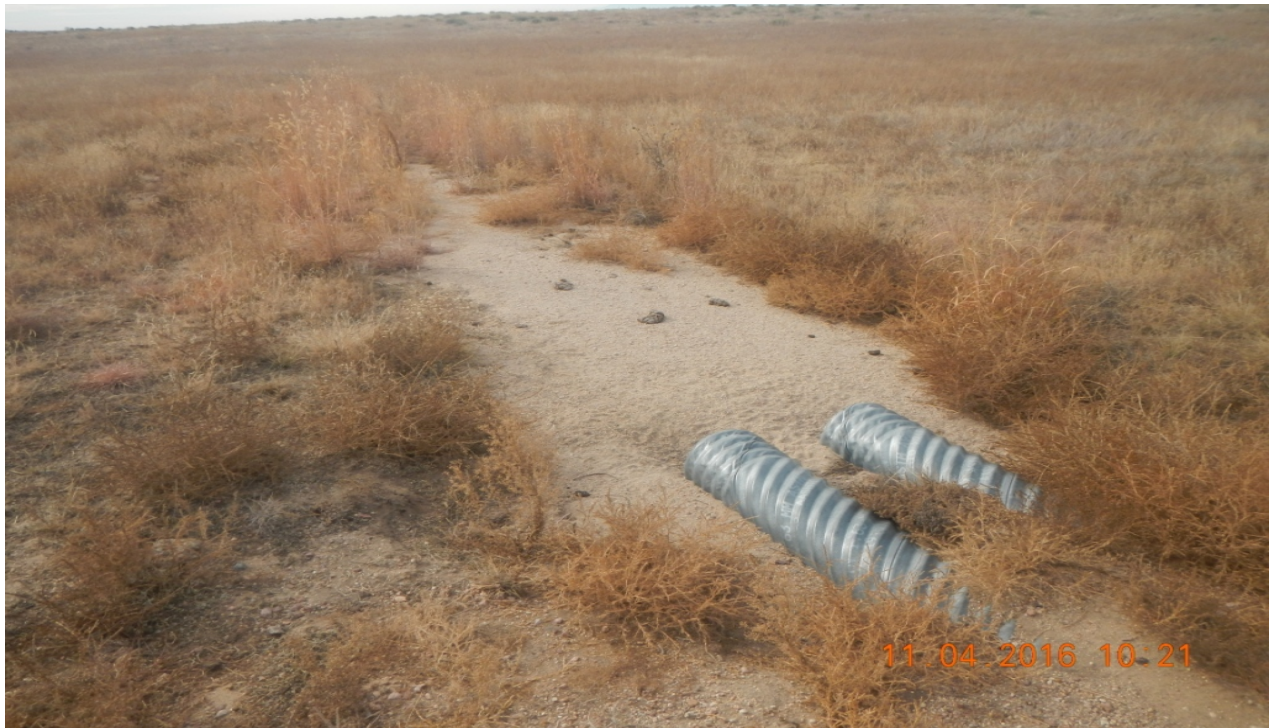
**photo 5:** Sediment is being directed out into the pasture and is beginning to fill in the culverts.

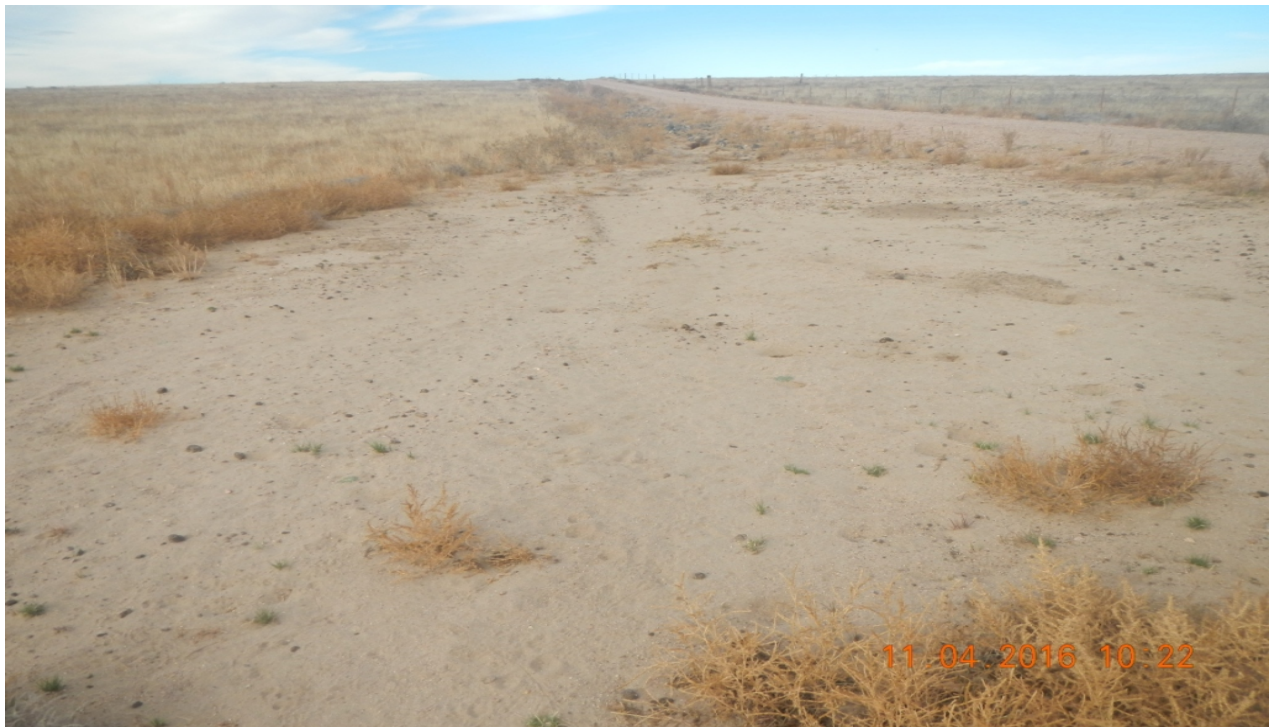
**photo 6:** Facing west at the south side of the access road. Sediment appears to have deposited from erosion off the access road.

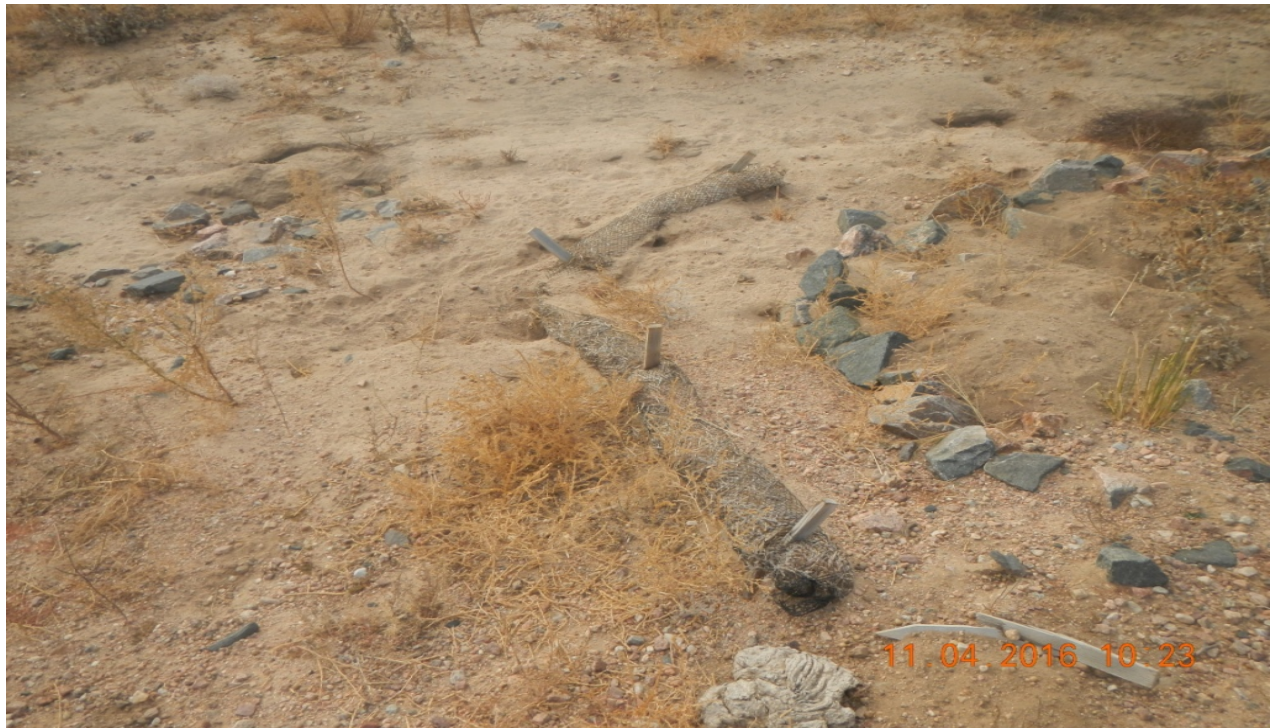
**photo 7:** Wattle placed at the end of the rip/rap along the access road is filled in with sediment.

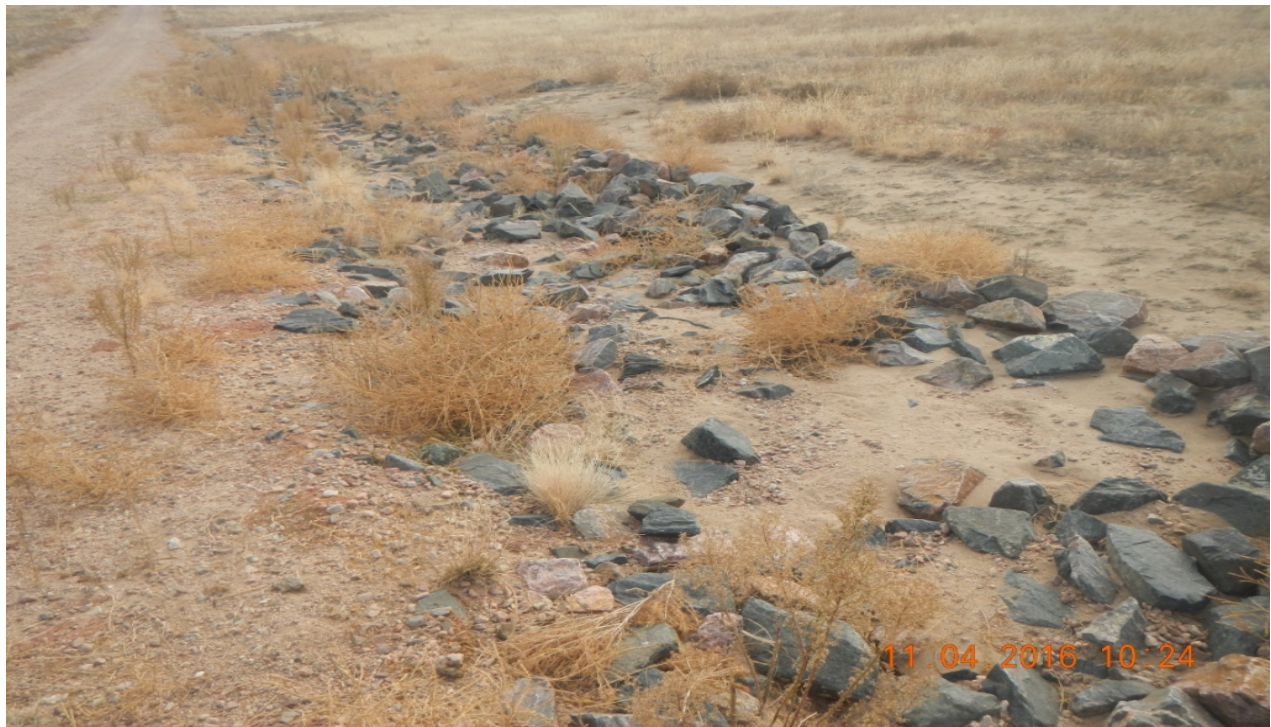
**photo 8:** Facing back towards the east along the access road where rip/rap rock has been placed.

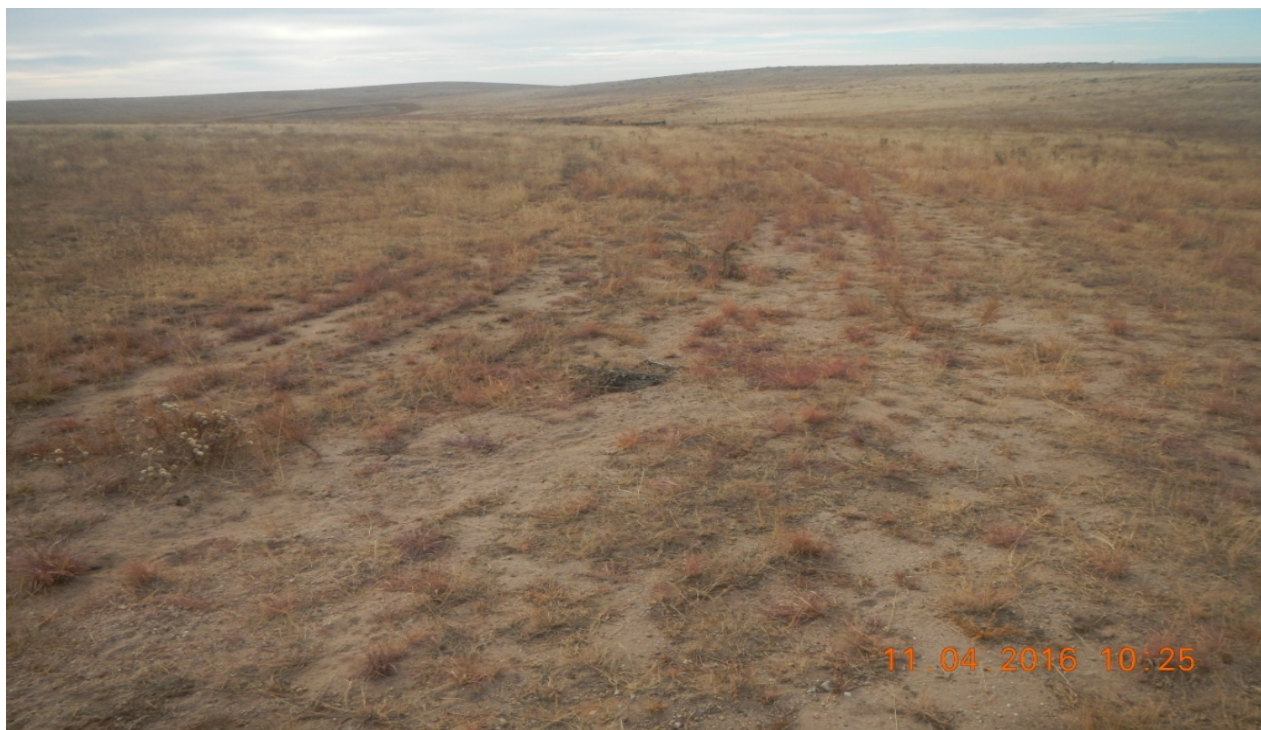
**photo 9:** Facing south toward the location.

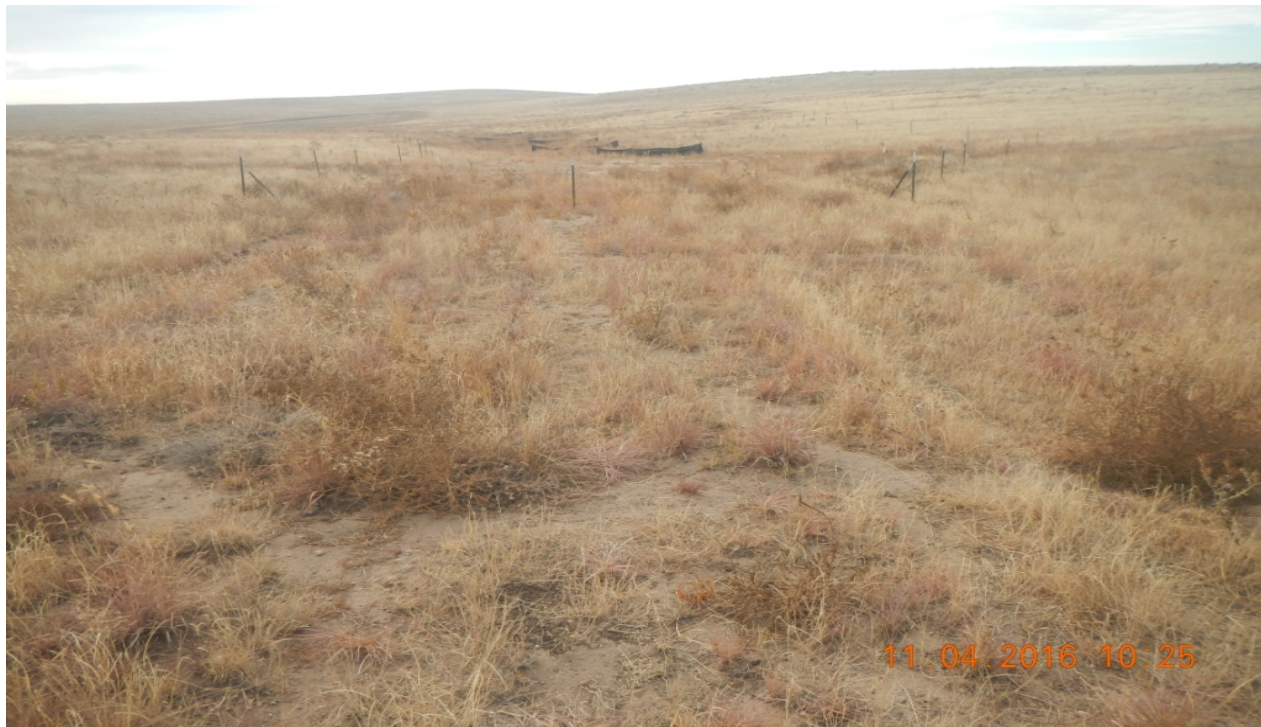
**photo 10:** Facing south toward the location.

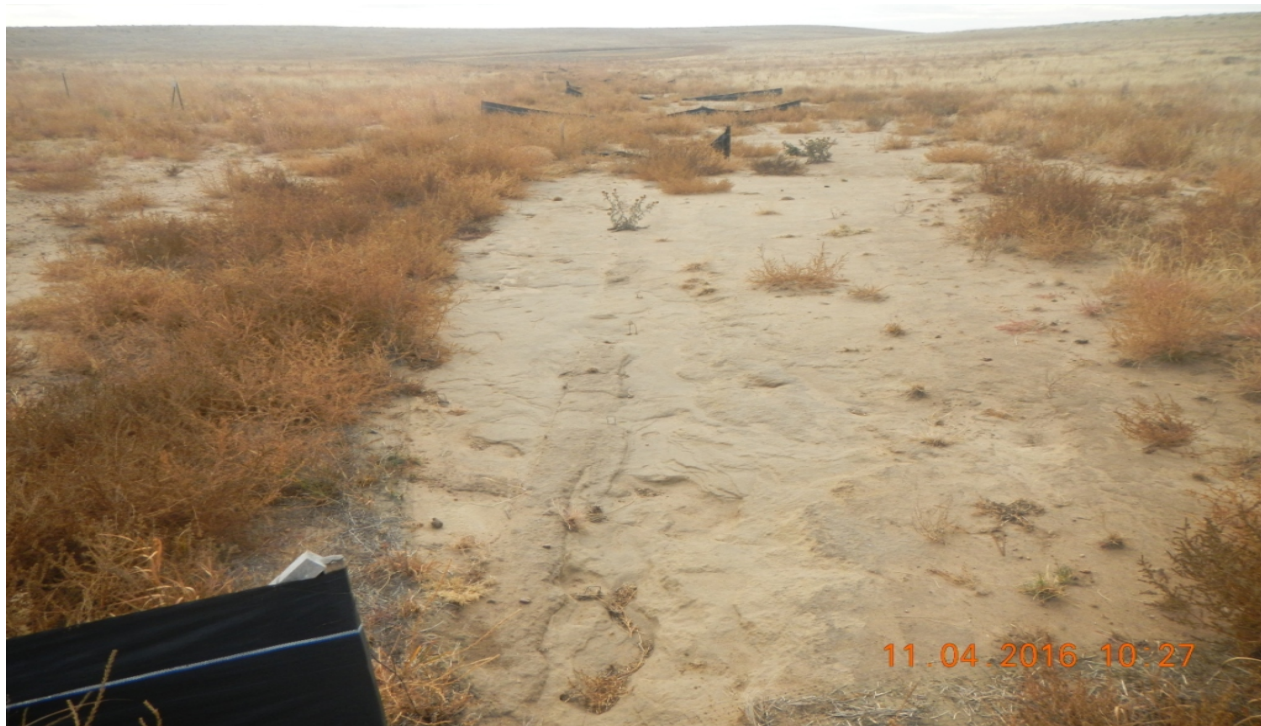
**photo 11:** Vegetation in areas near the silt fence sections has not established. There are signs of erosion occurring in this area.

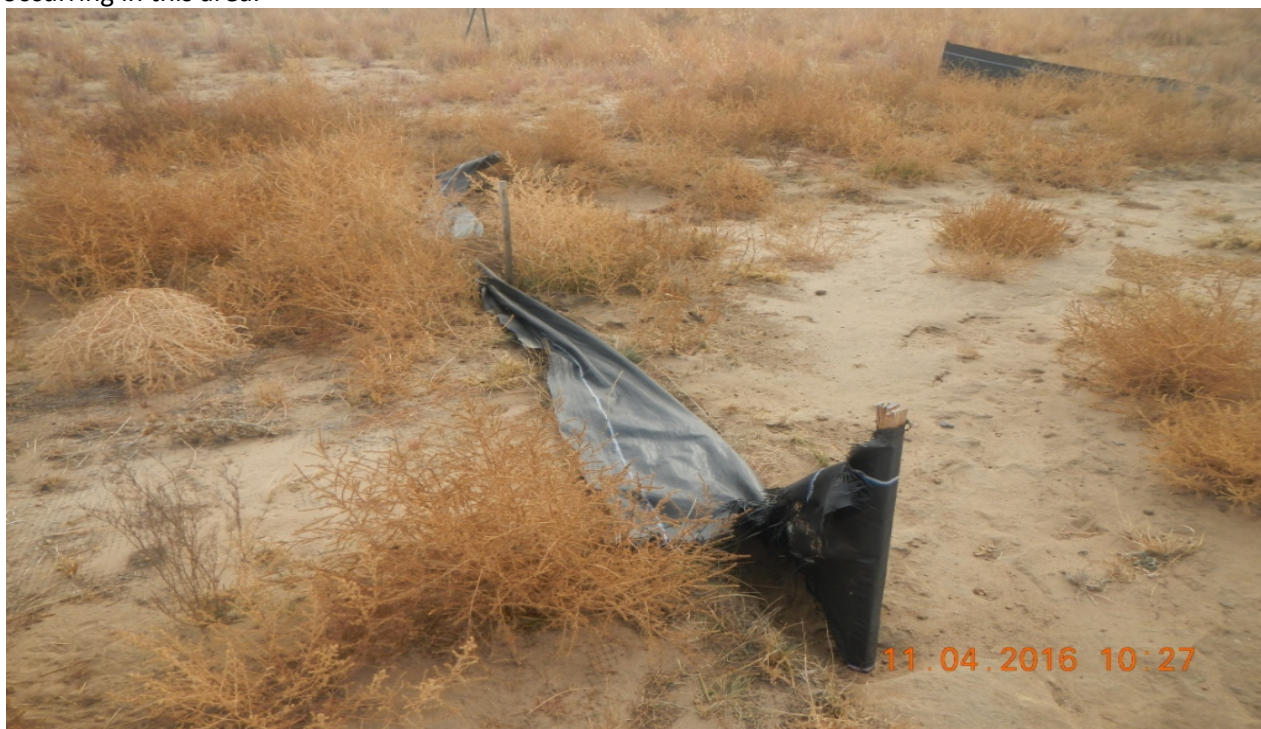
**photo 12:** The sections of silt fence are in disrepair.

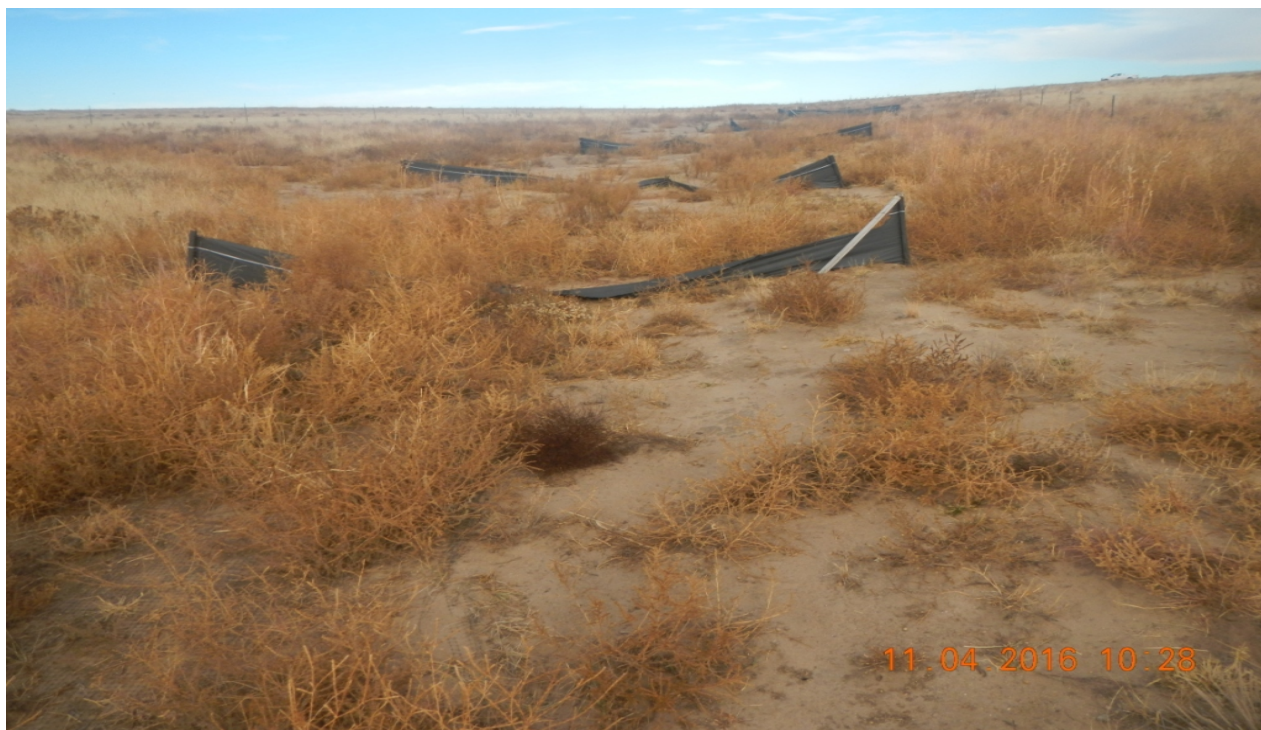
**photo 13:** Facing north at the location. There is undesirable weed growth throughout this area.

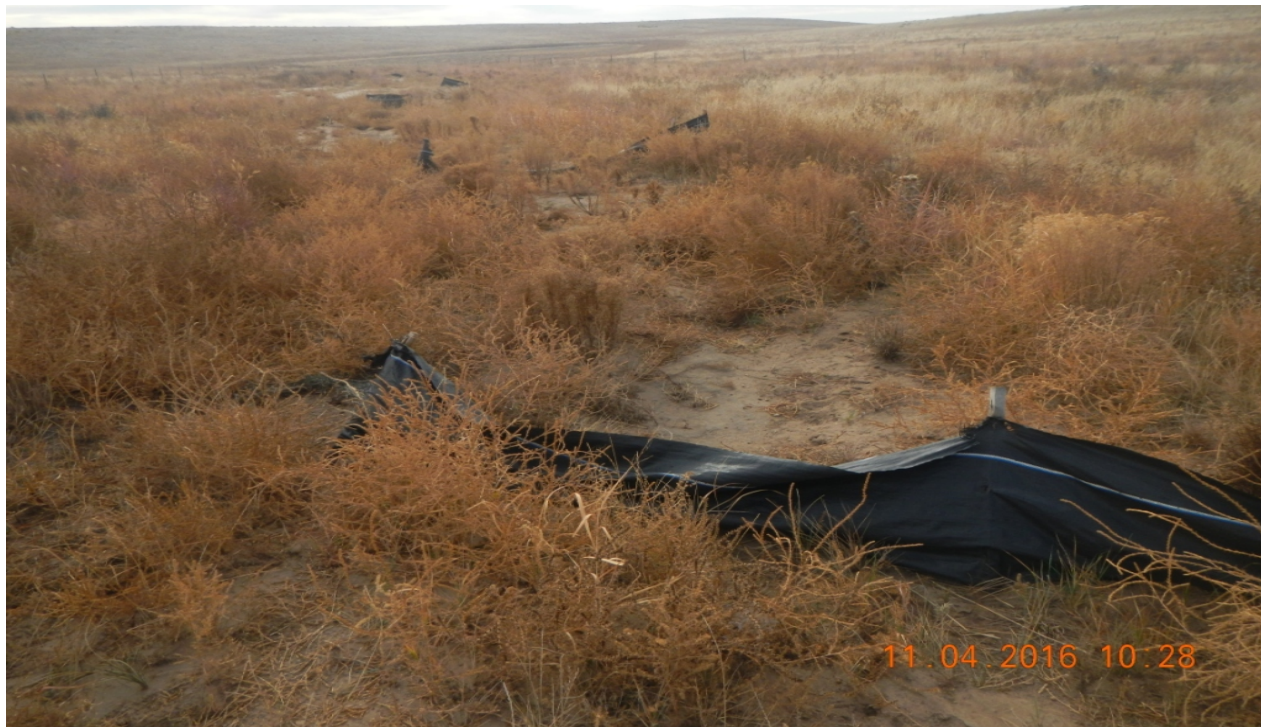
**photo 14:** Facing south at the location. There is undesirable weed growth throughout this area.

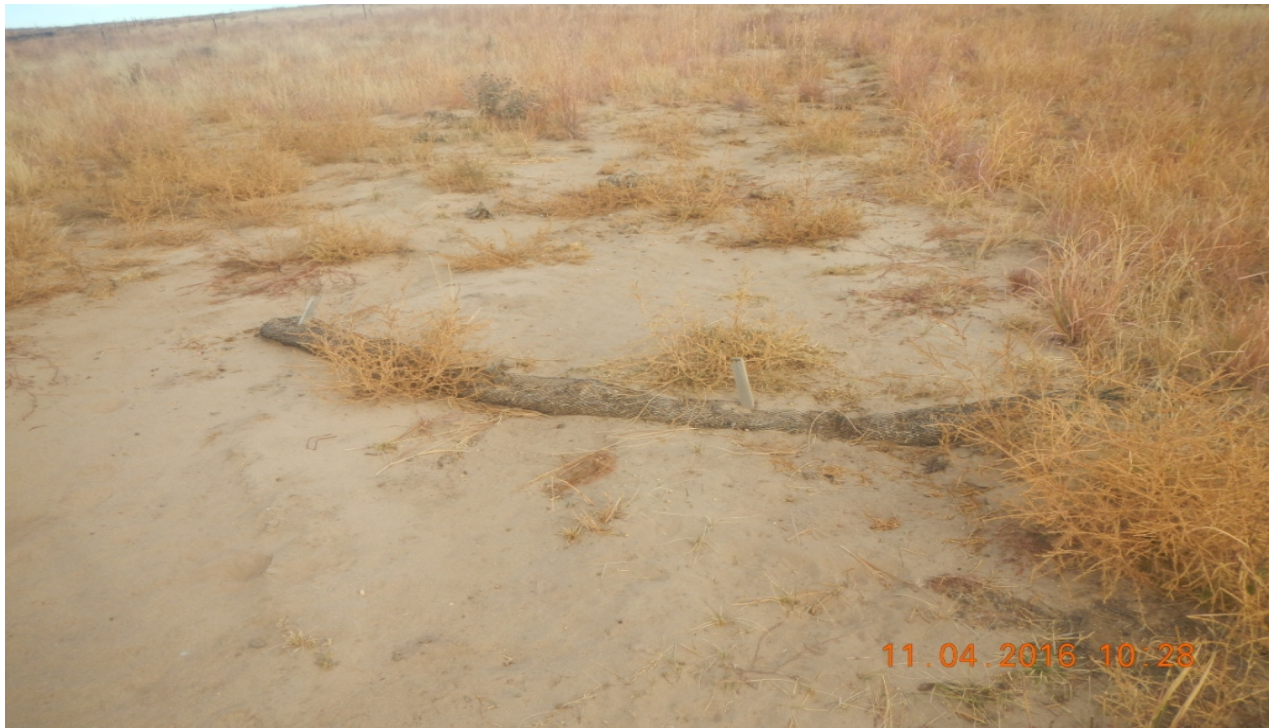
**photo 15:** There are wattles which are filled in with sediment.

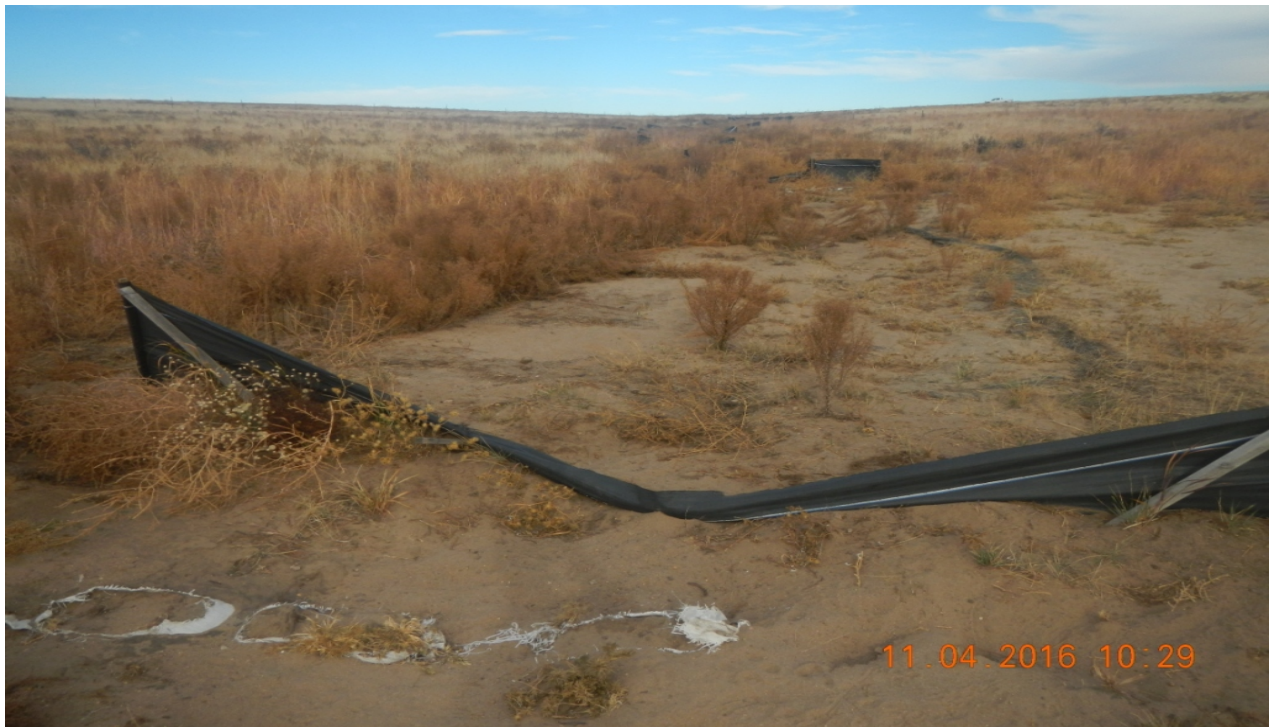
**photo 16:** Facing north at the location. The white sandbags are filled in with sediment and the sections of silt fence are in disrepair.

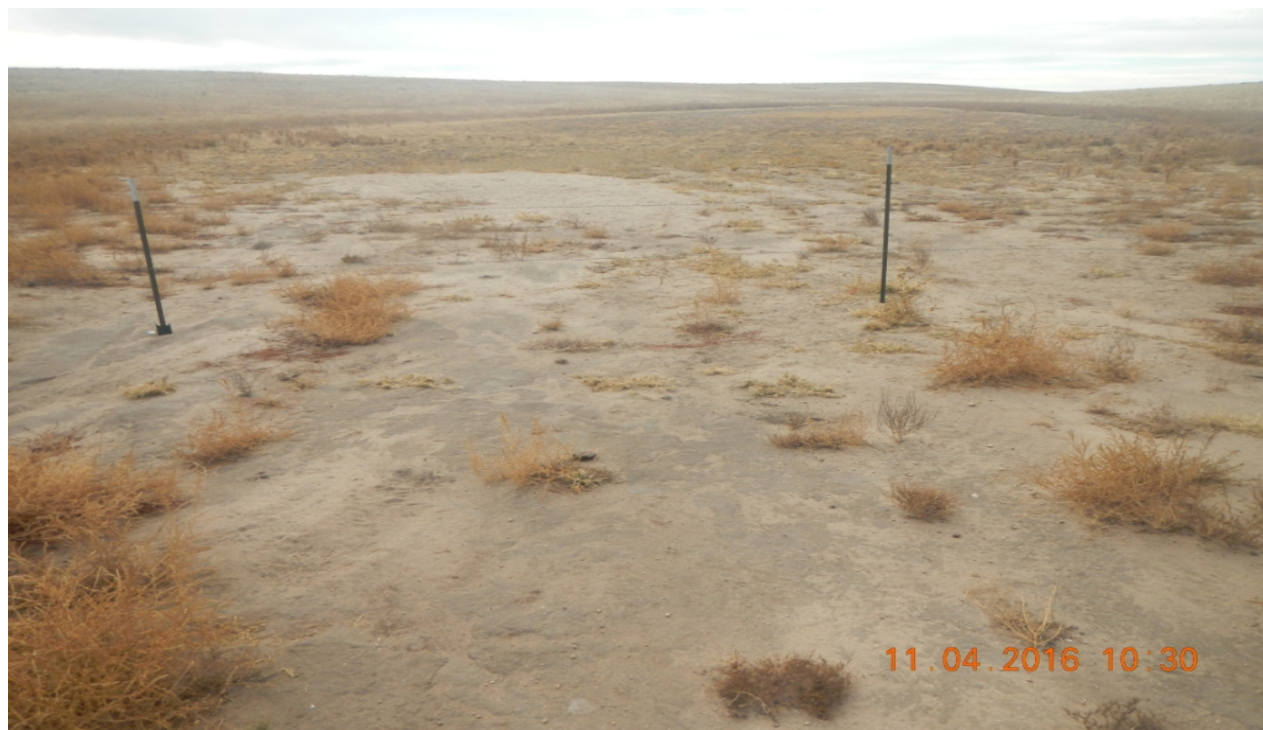
**photo 17:** Facing toward the south side of the location.

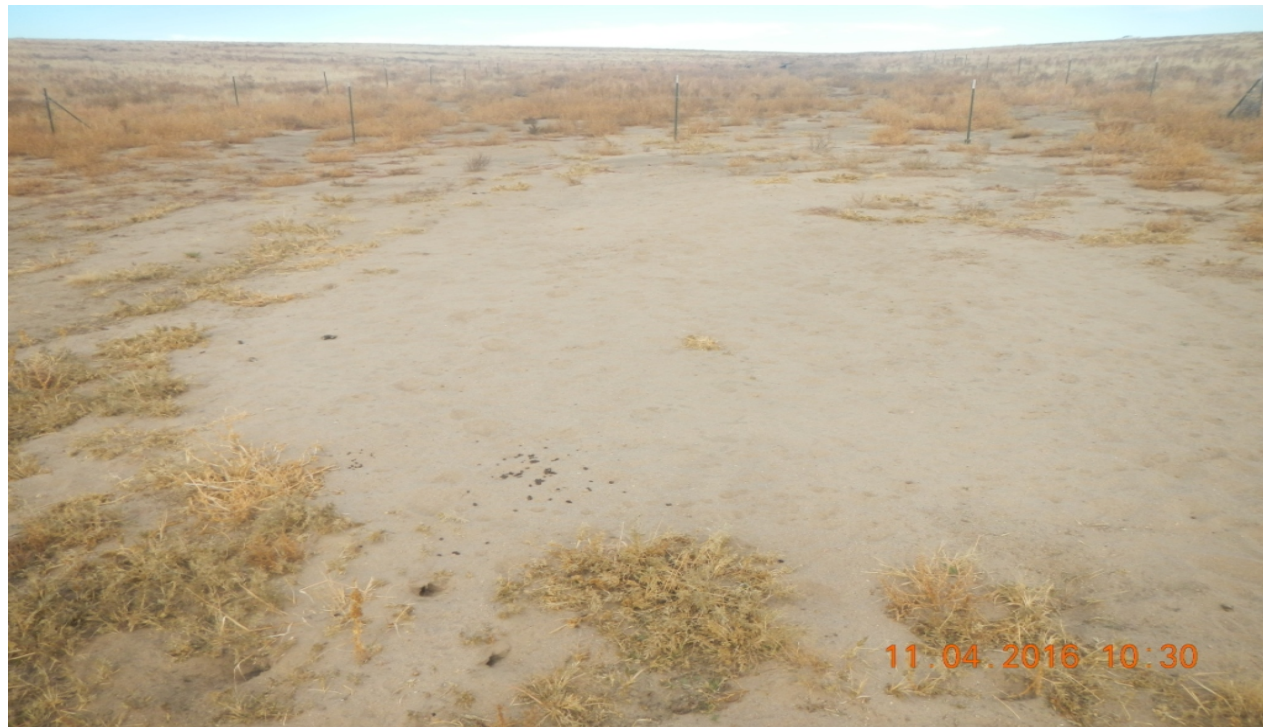
**photo 18:** South side of the location facing northwest. Vegetation has not established in this area.

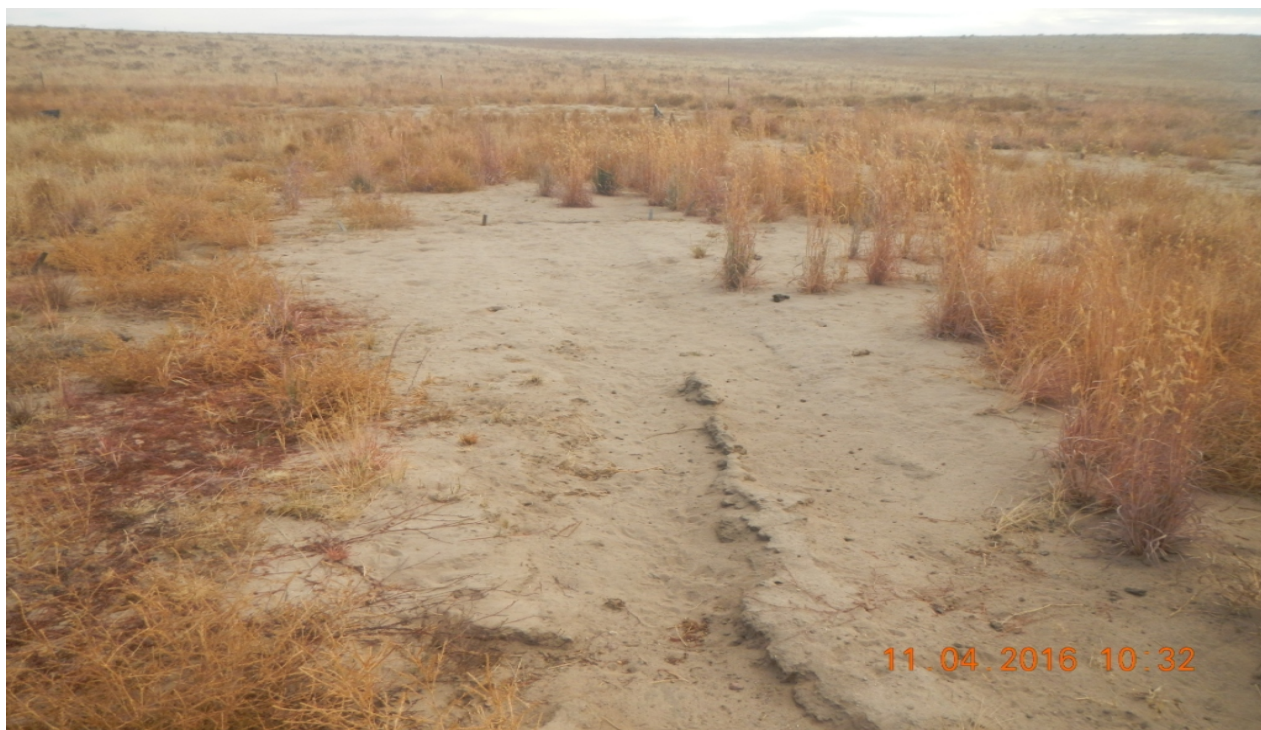
**photo 19:** Facing east along the west side of the location.

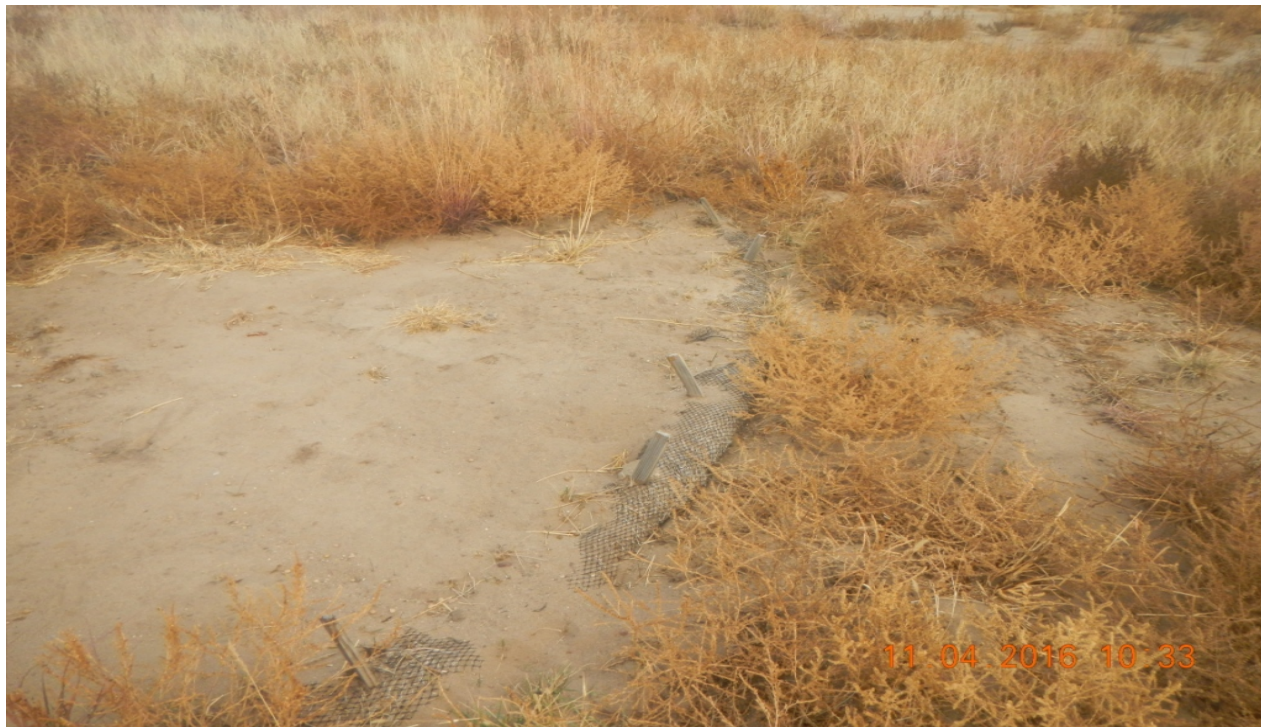
**photo 20:** The wattle is filled in with sediment.

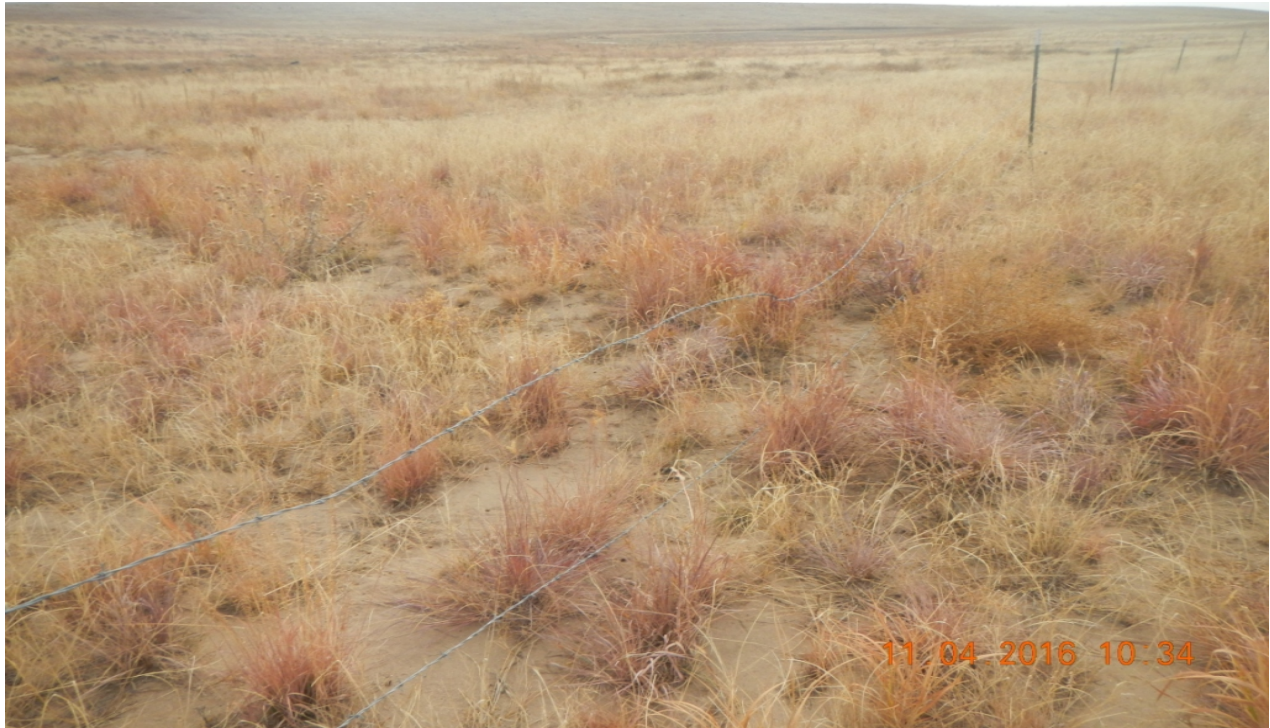
**photo 21:** Fence at the west side of the location which was documented in the previous inspection has not been repaired.

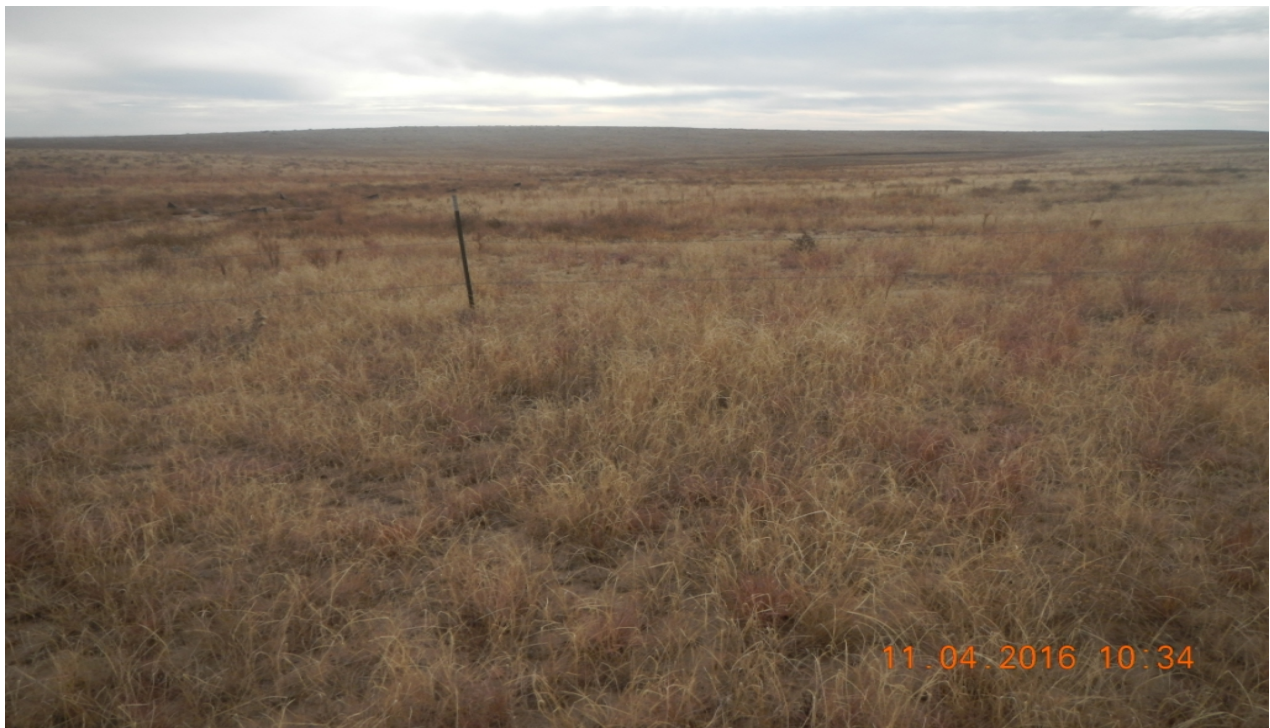
**photo 22:** Northwest side of the location facing southeast.
