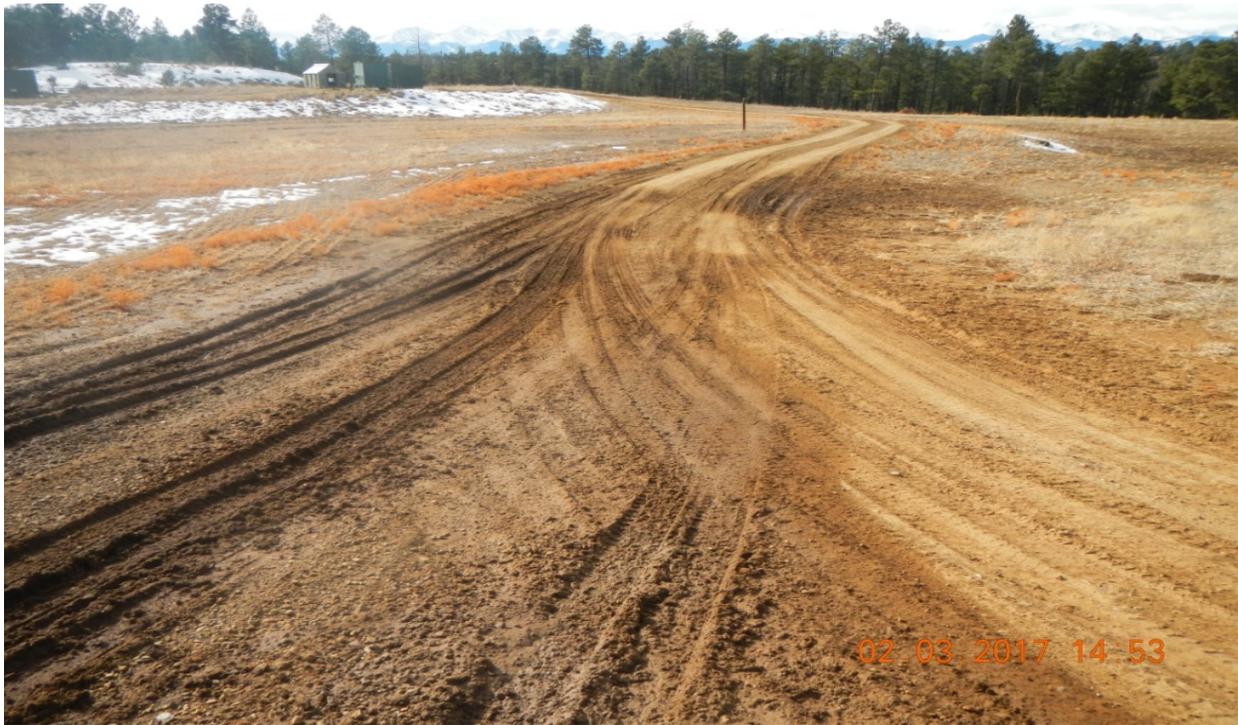
photo 1: Facing west toward the location along the access road.

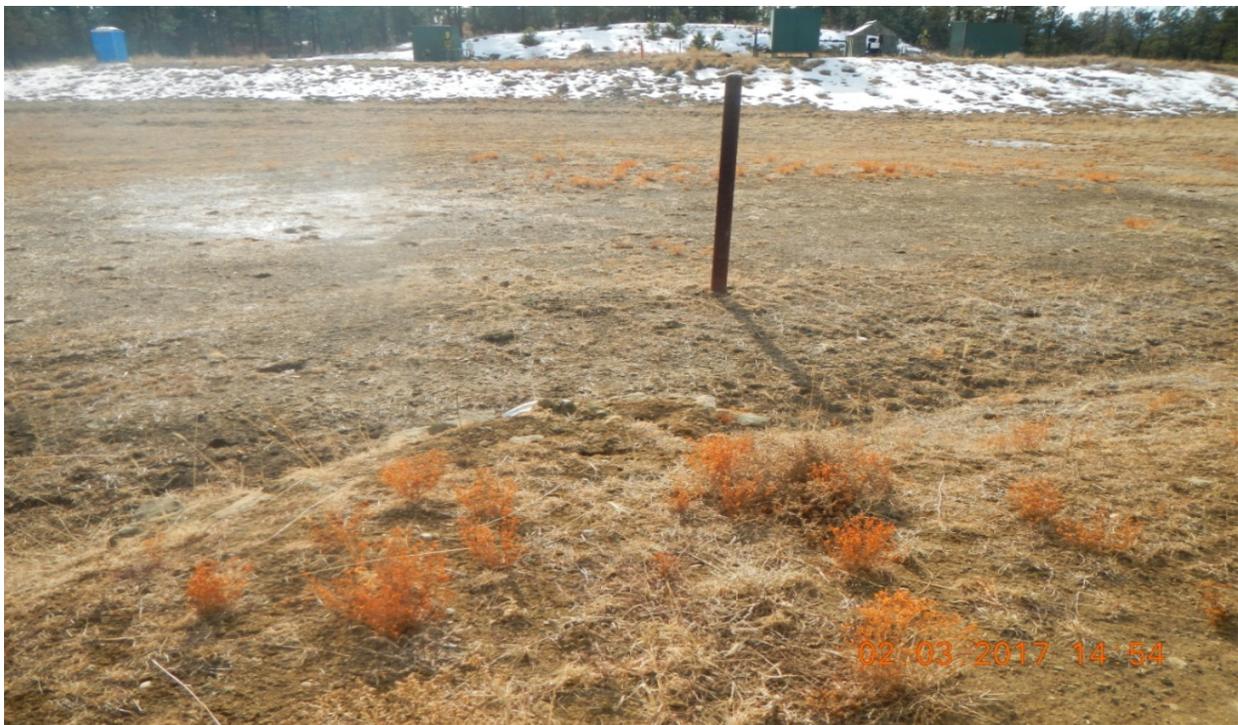
photo 2: Well marker at the center of the location.

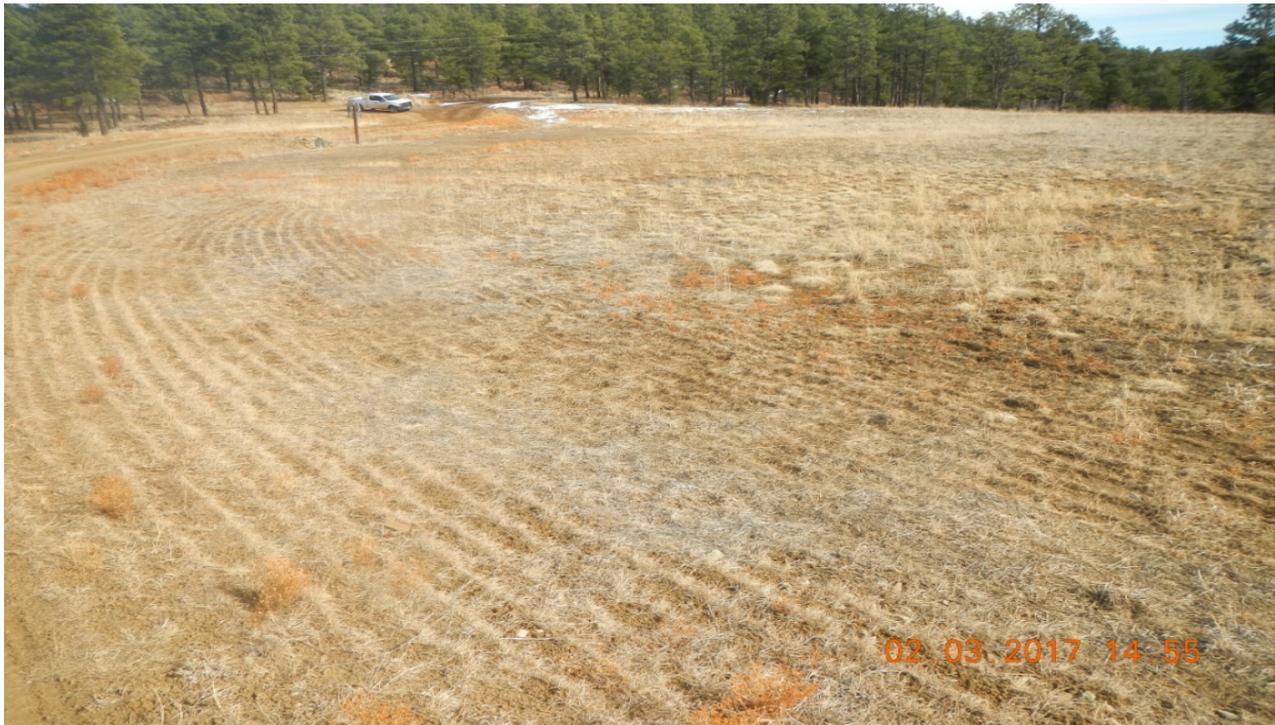
photo 3: West side of the location facing east.

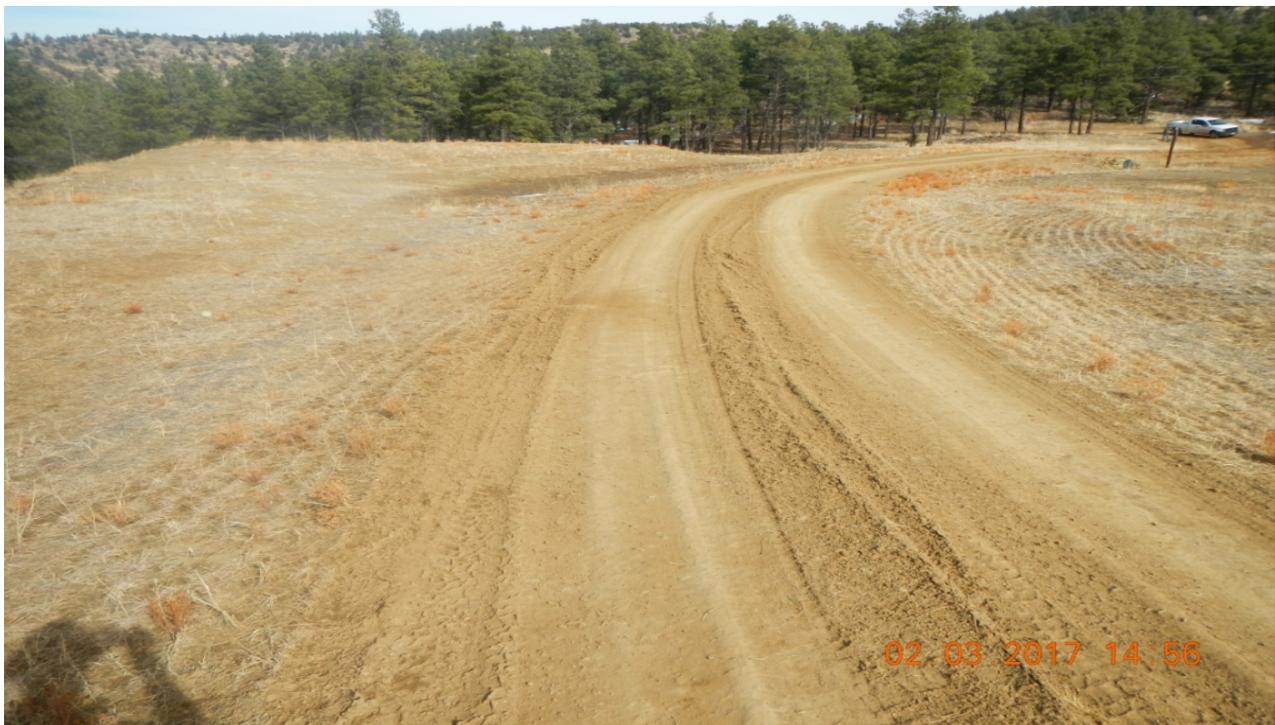
photo 4: Facing northeast toward the location.

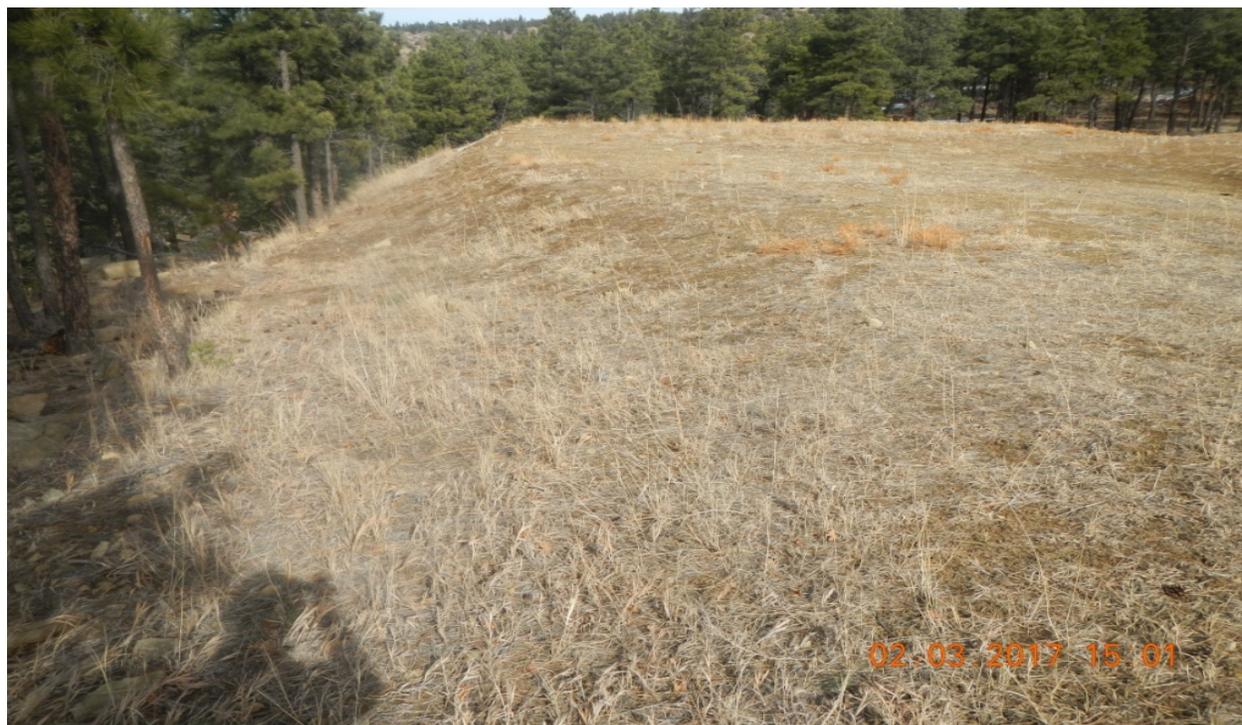
photo 5: Facing along the northeast side of the location.

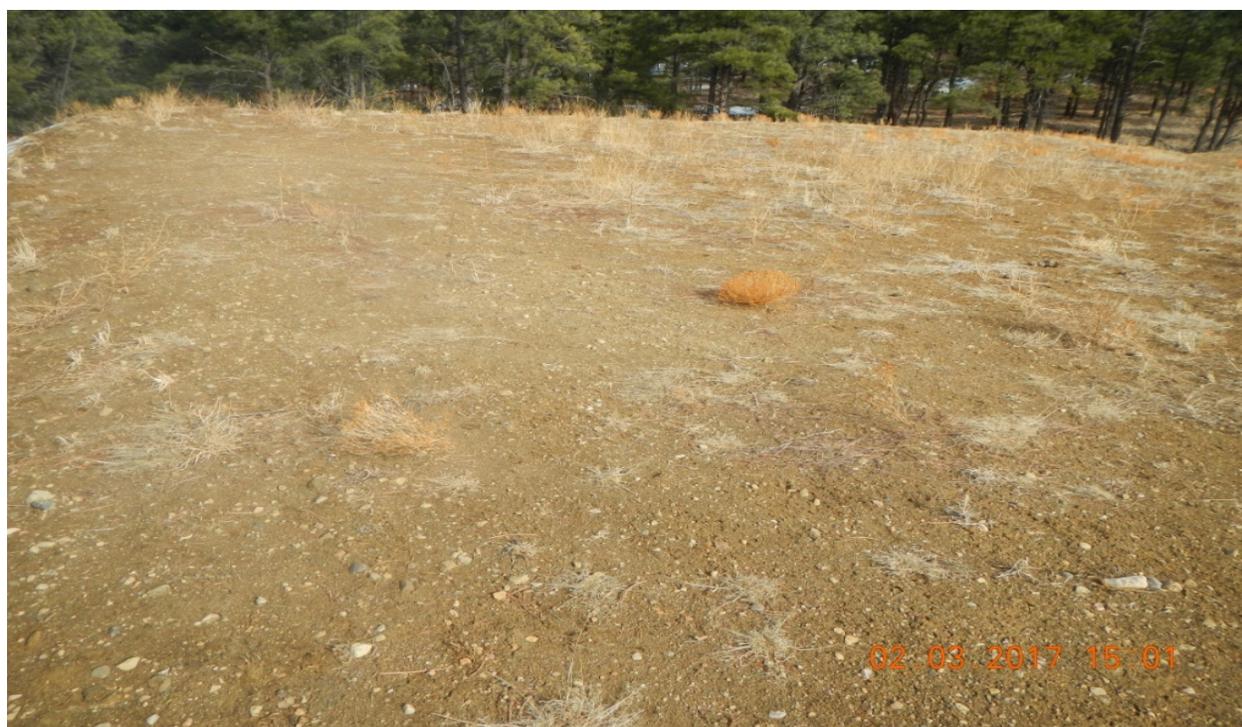
photo 6: The vegetation has not adequately established at the northeast side of the location.

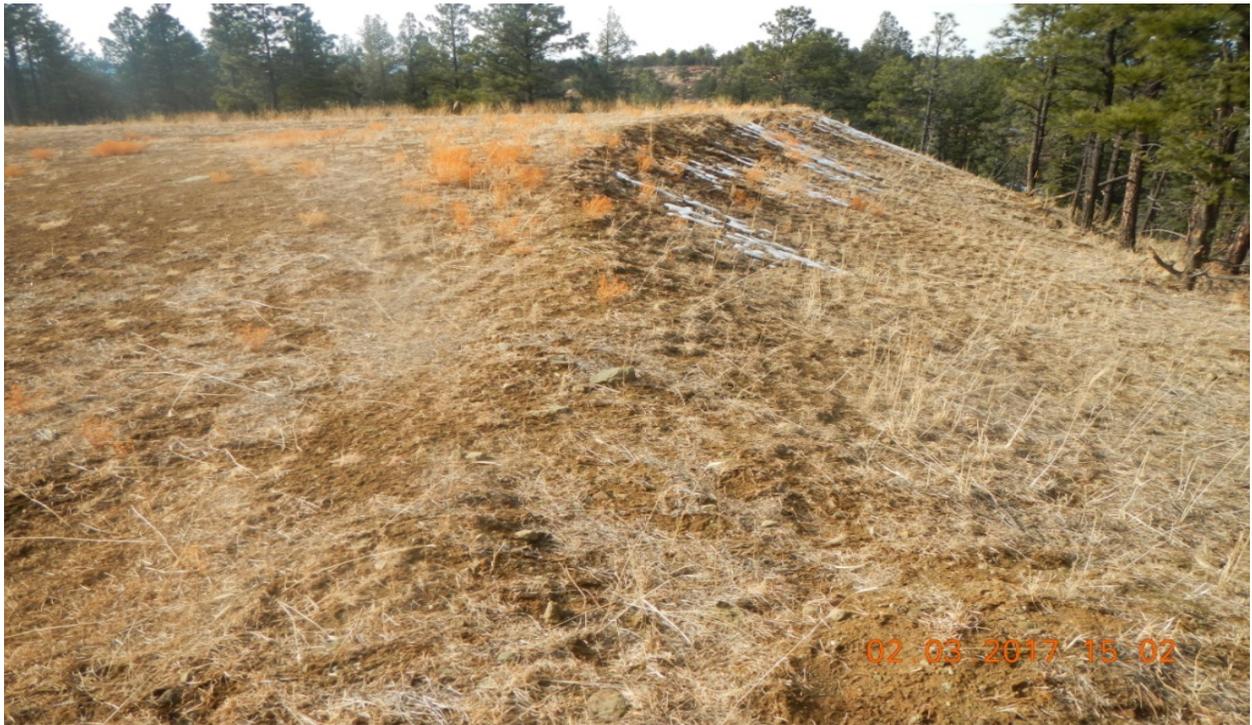
photo 7: East side of the location facing north.

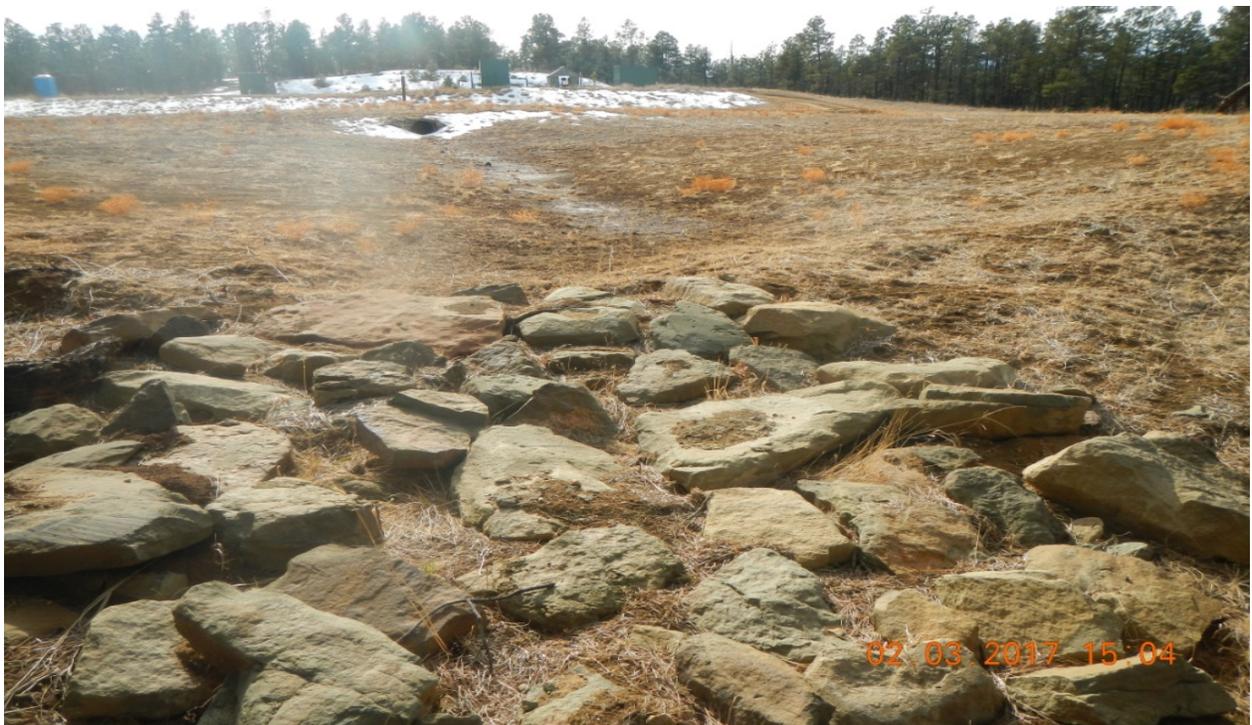
photo 8: East side of the location facing southwest. Rock rip/rap is placed at the drainage.

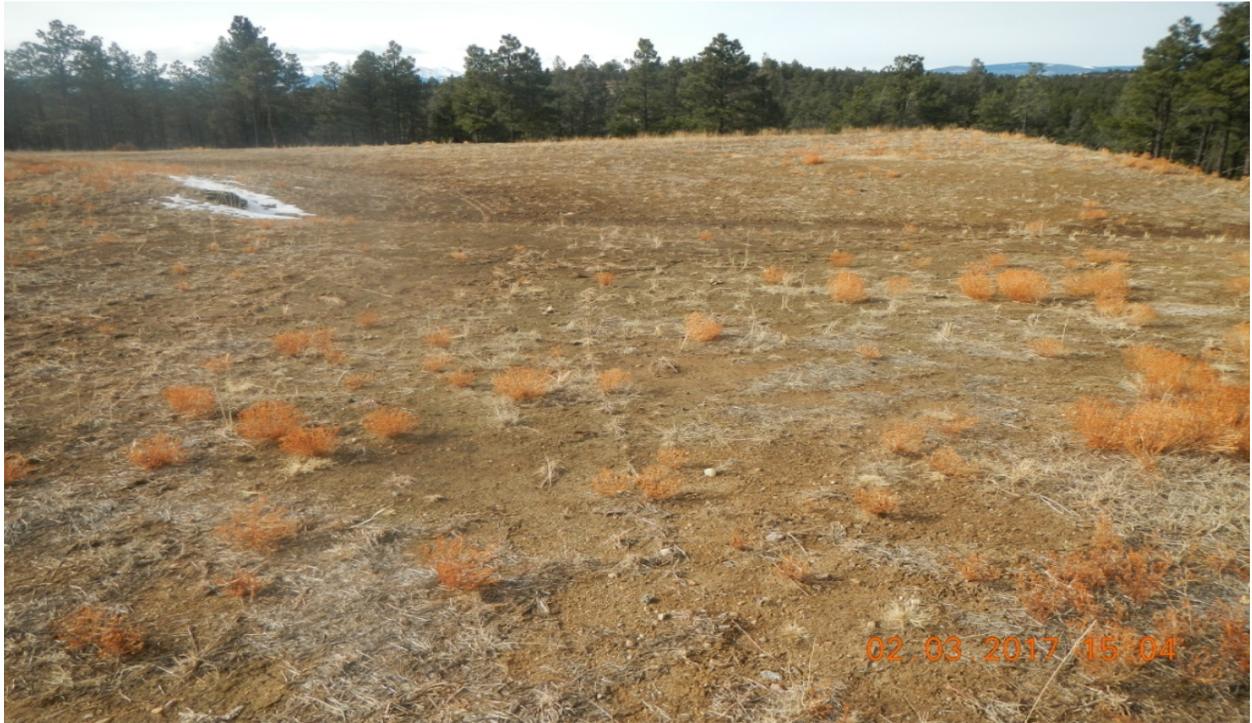
photo 9: East side of the location facing northwest.

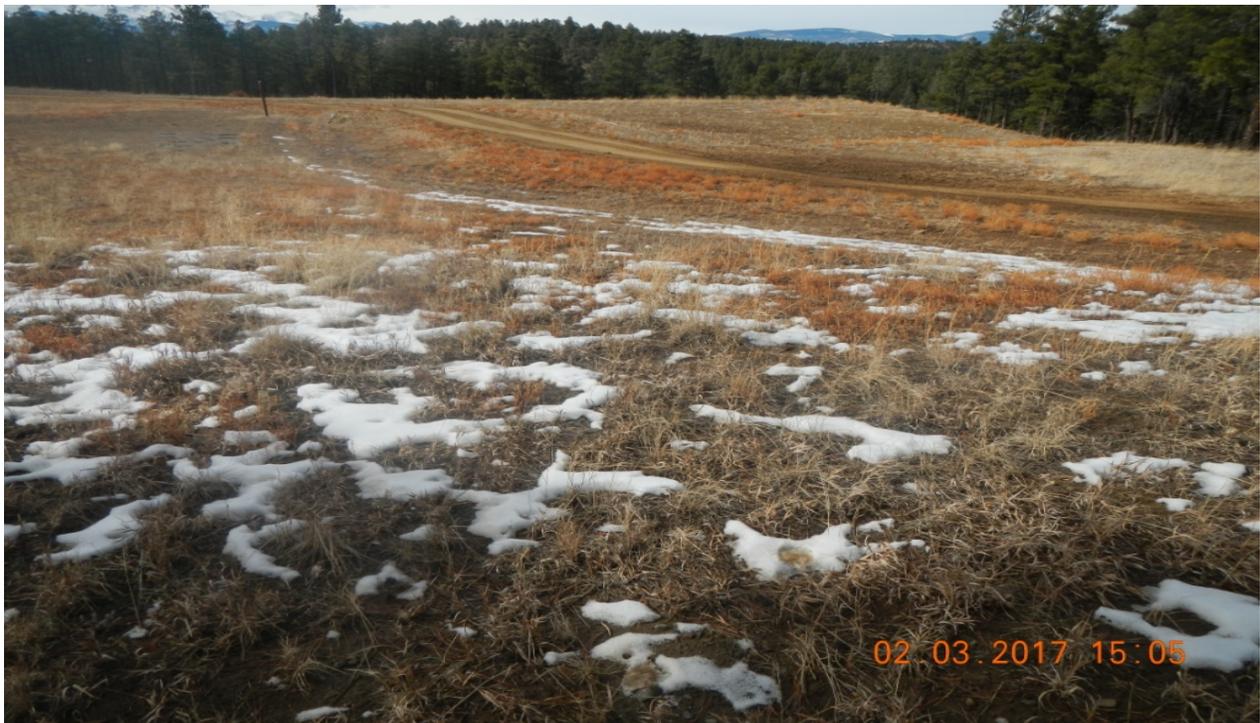
photo 10: Southeast side of the location facing northwest.
