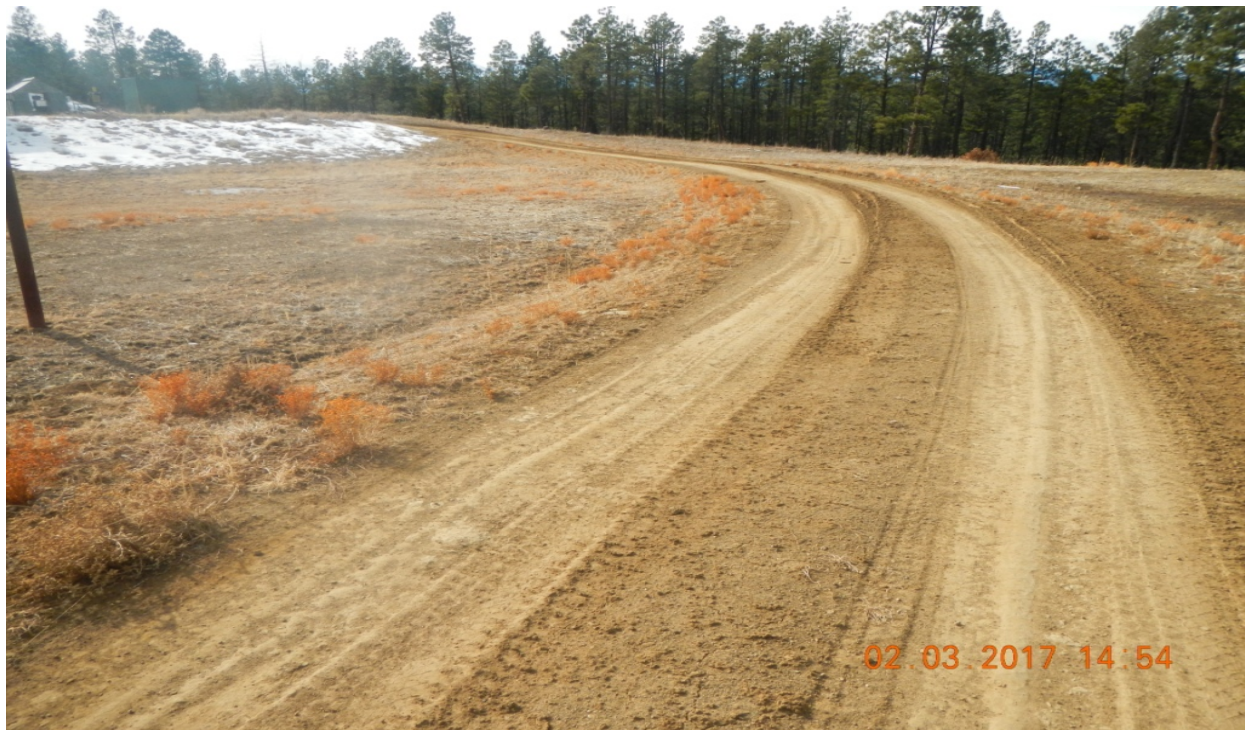
photo 1: Facing west along the access road.

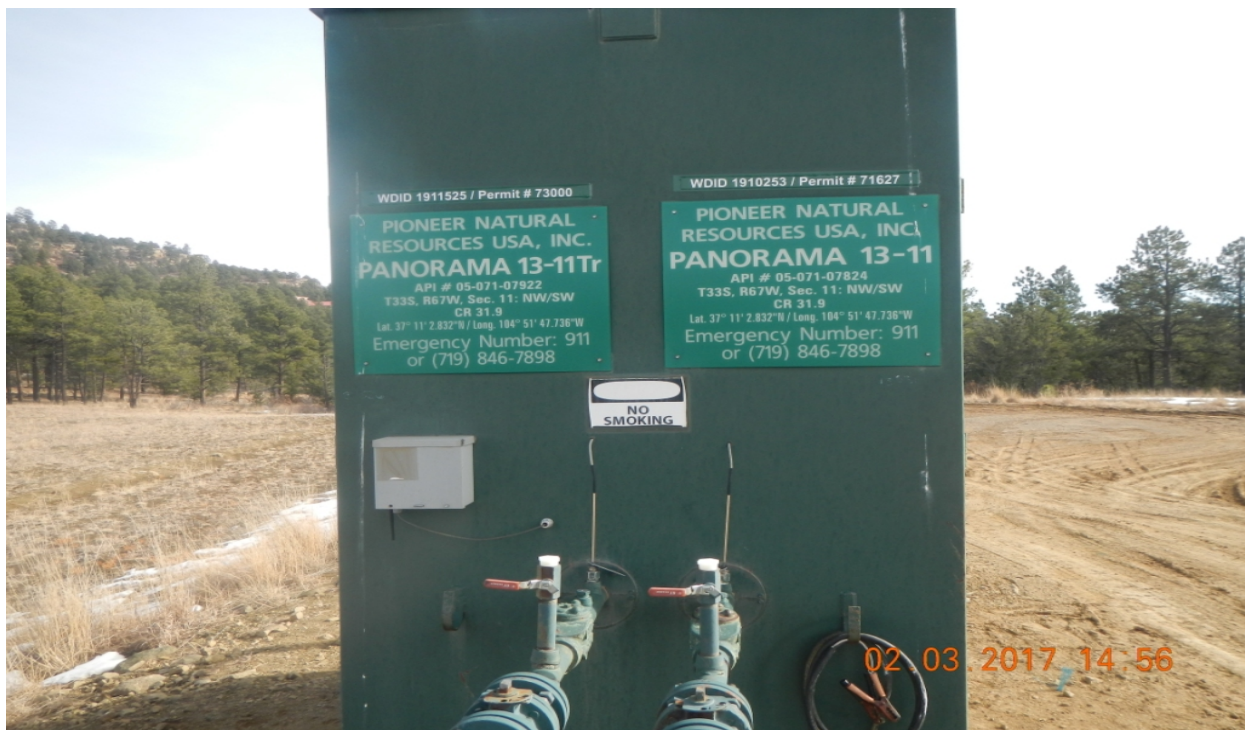
photo 2: Well signs at the location.

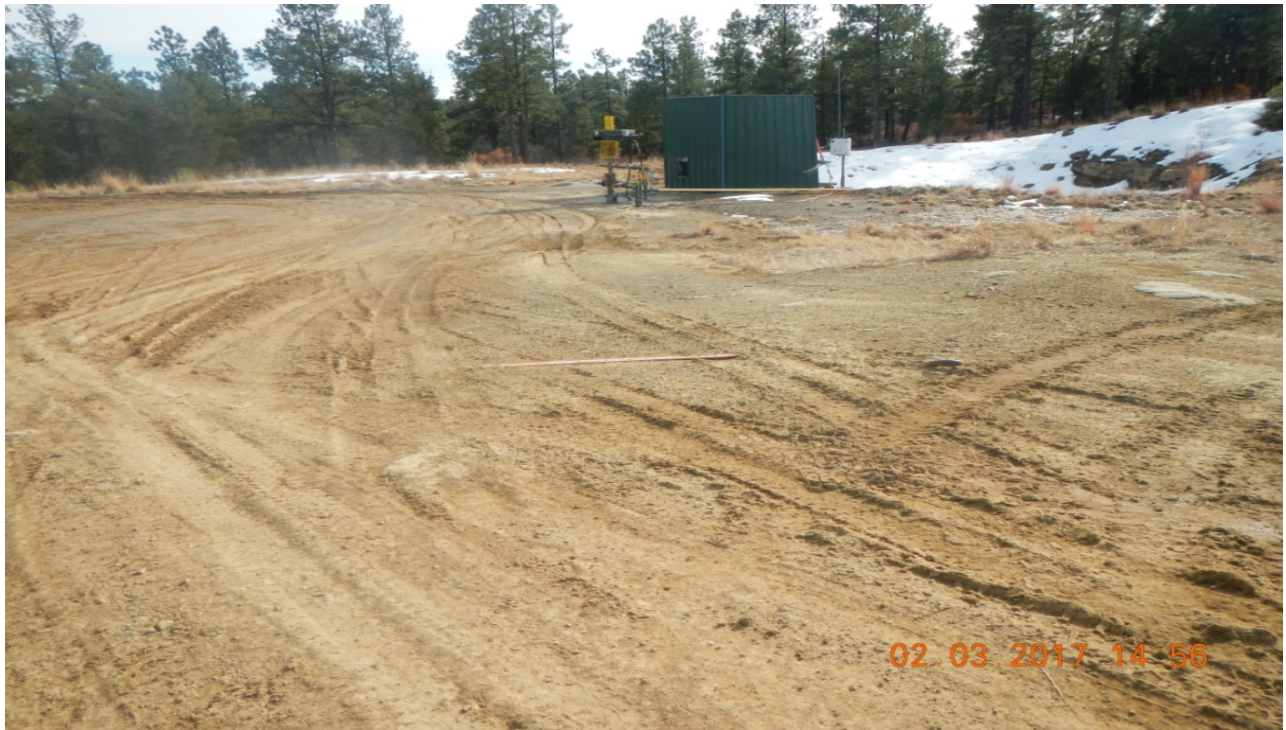
photo 3: Facing southeast toward the location.

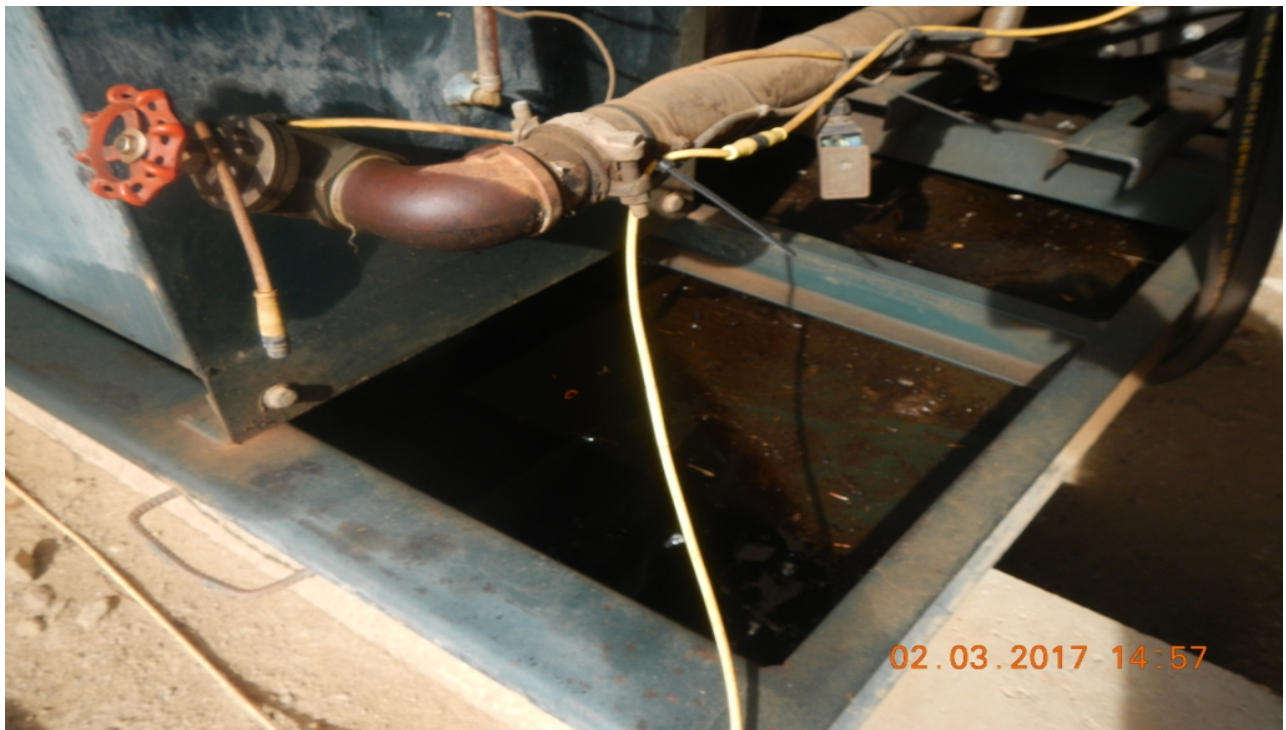
photo 4: There was oil noticed on the engine skid.

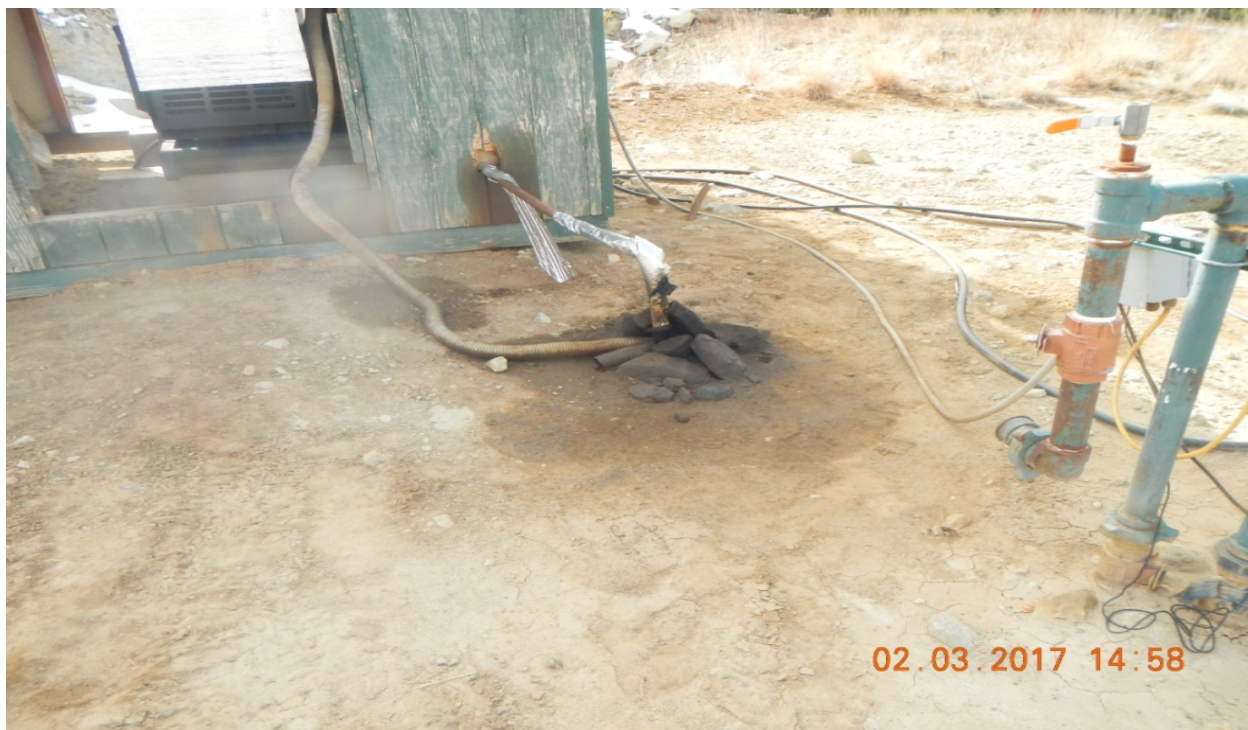
photo 5: There is stained soil around the exhaust from the engine.
