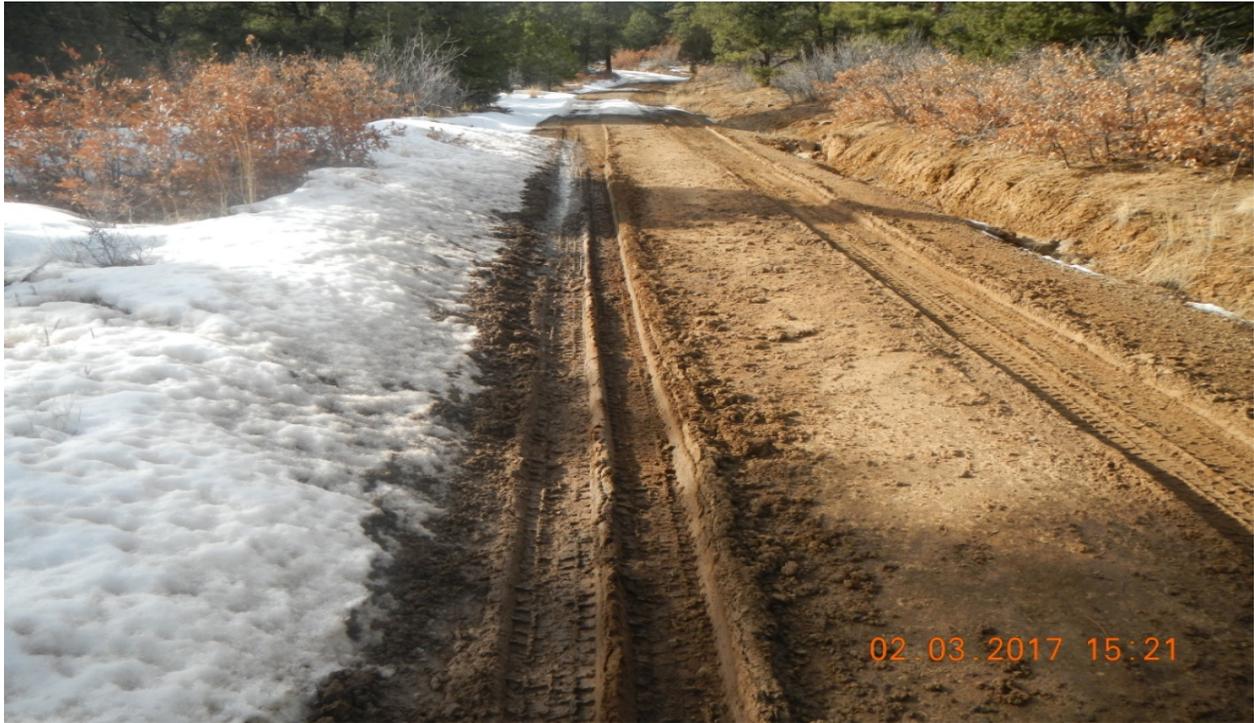
photo 1: Facing west along the access road. Vehicle rutting is developing along the road.

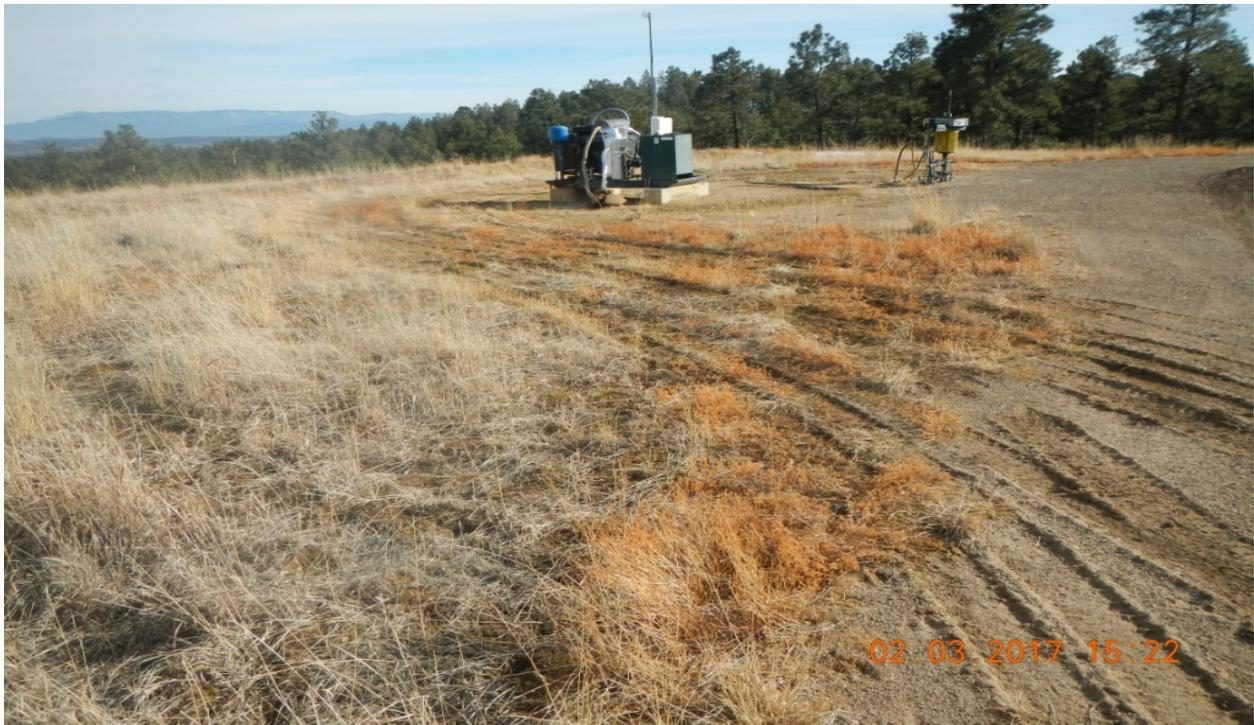
photo 2: Facing southeast toward the location.

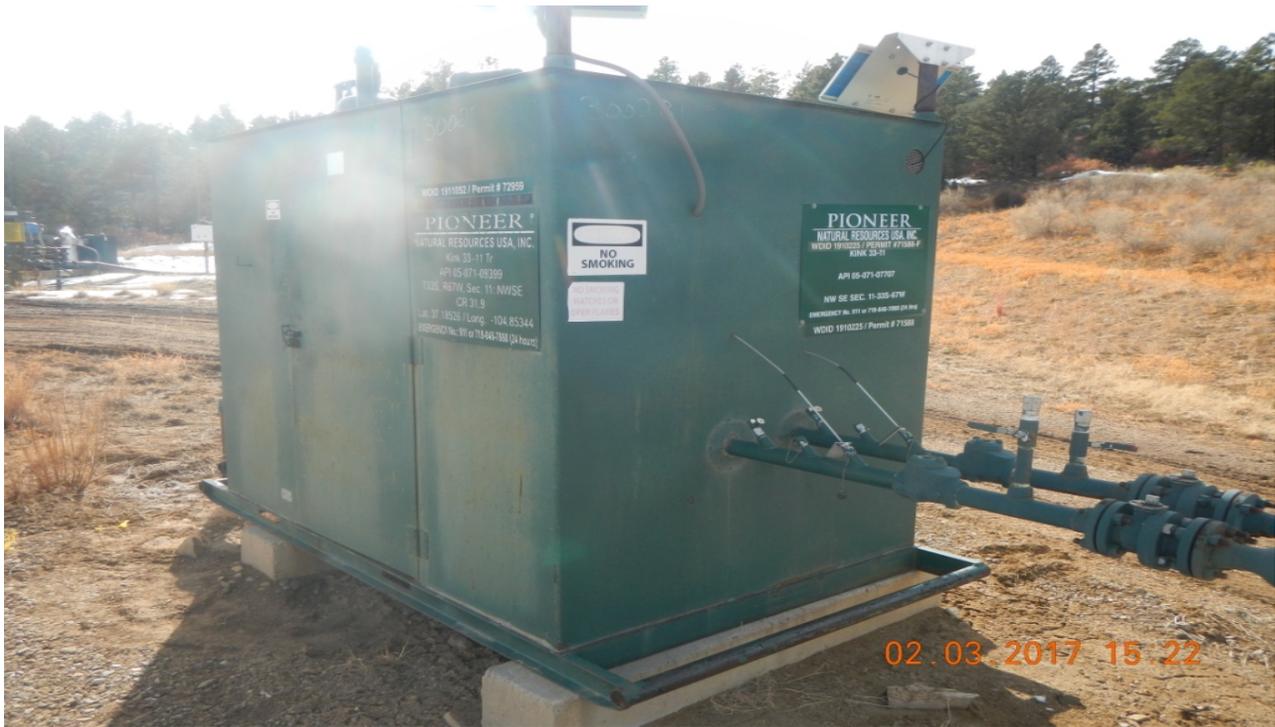
photo 3: Well signs at the location.

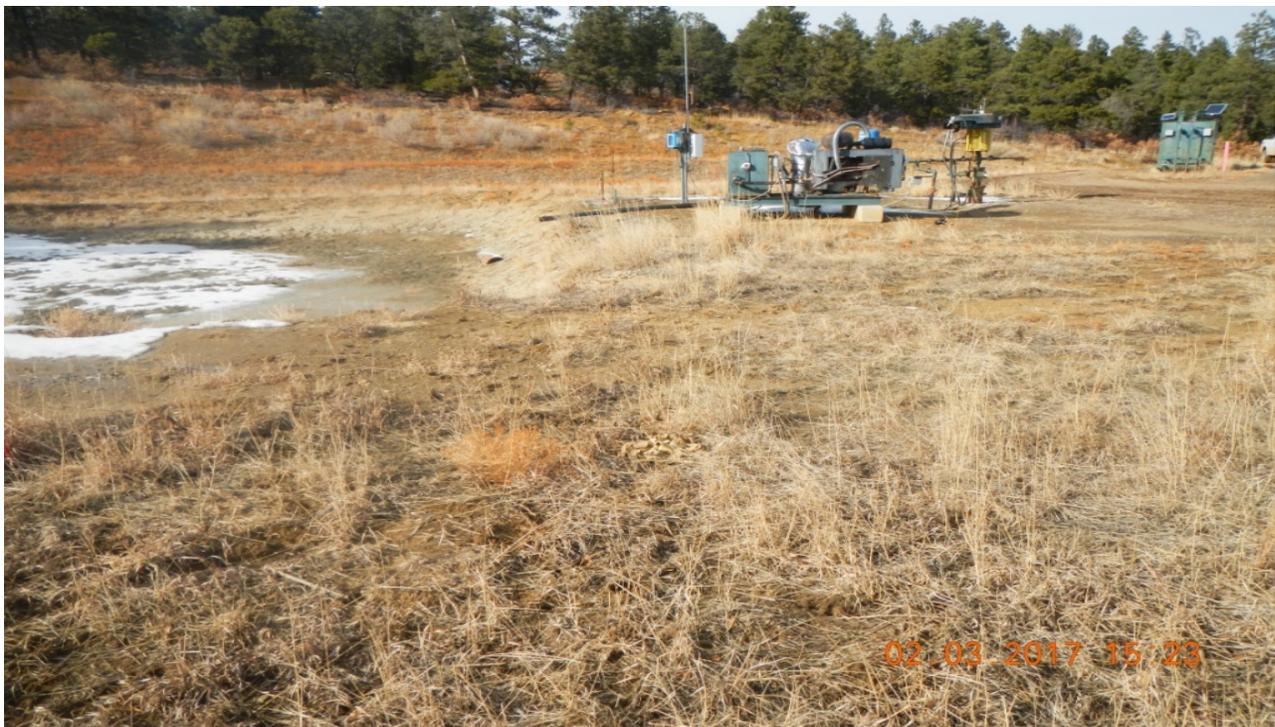
photo 4: South side of the location facing north. The pit is at the left side of photo.
