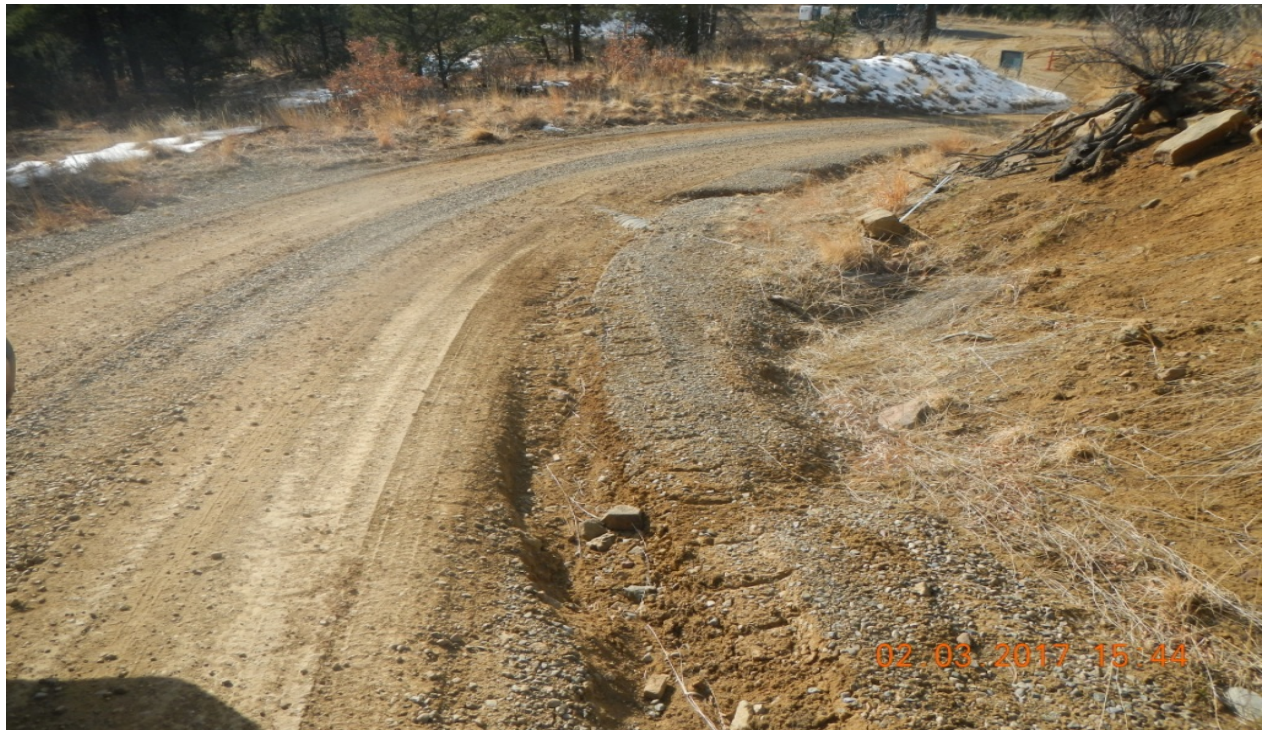
photo 1: There are signs of erosion along the access road near the location. Stormwater is not being directed toward the culvert.

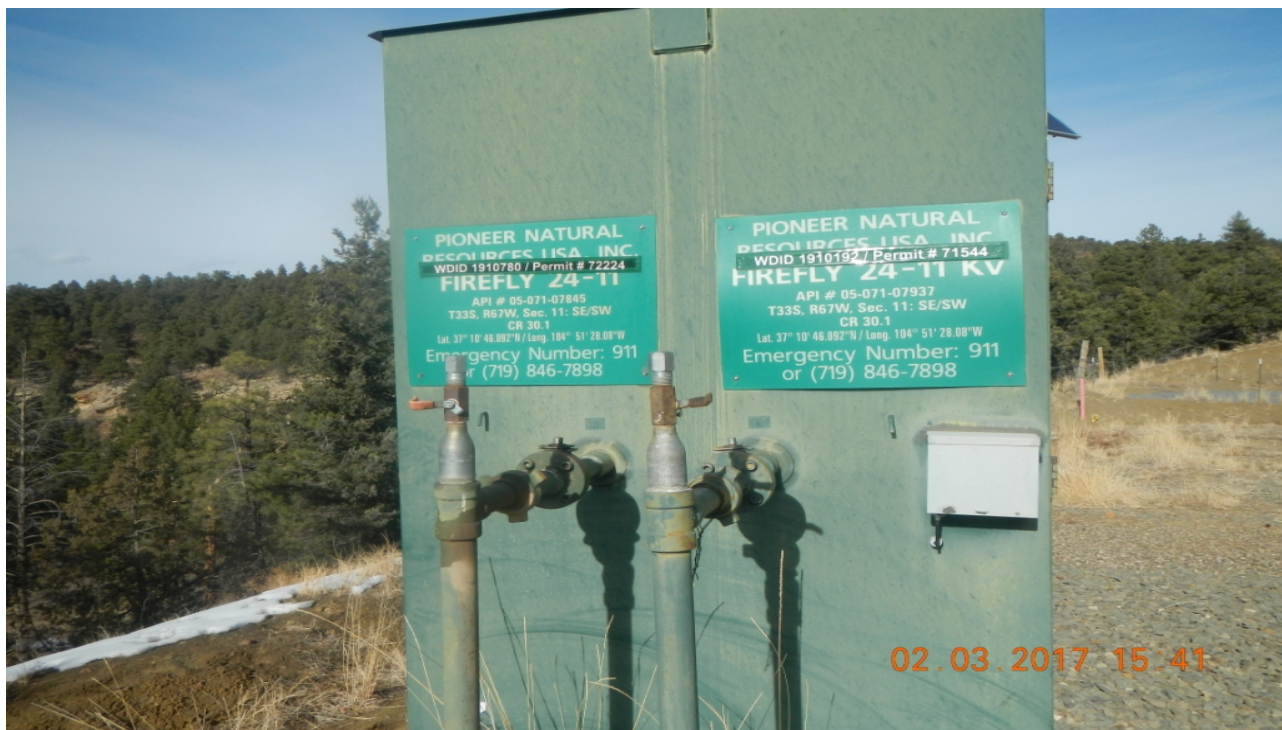
photo 4: Well signs at the location.

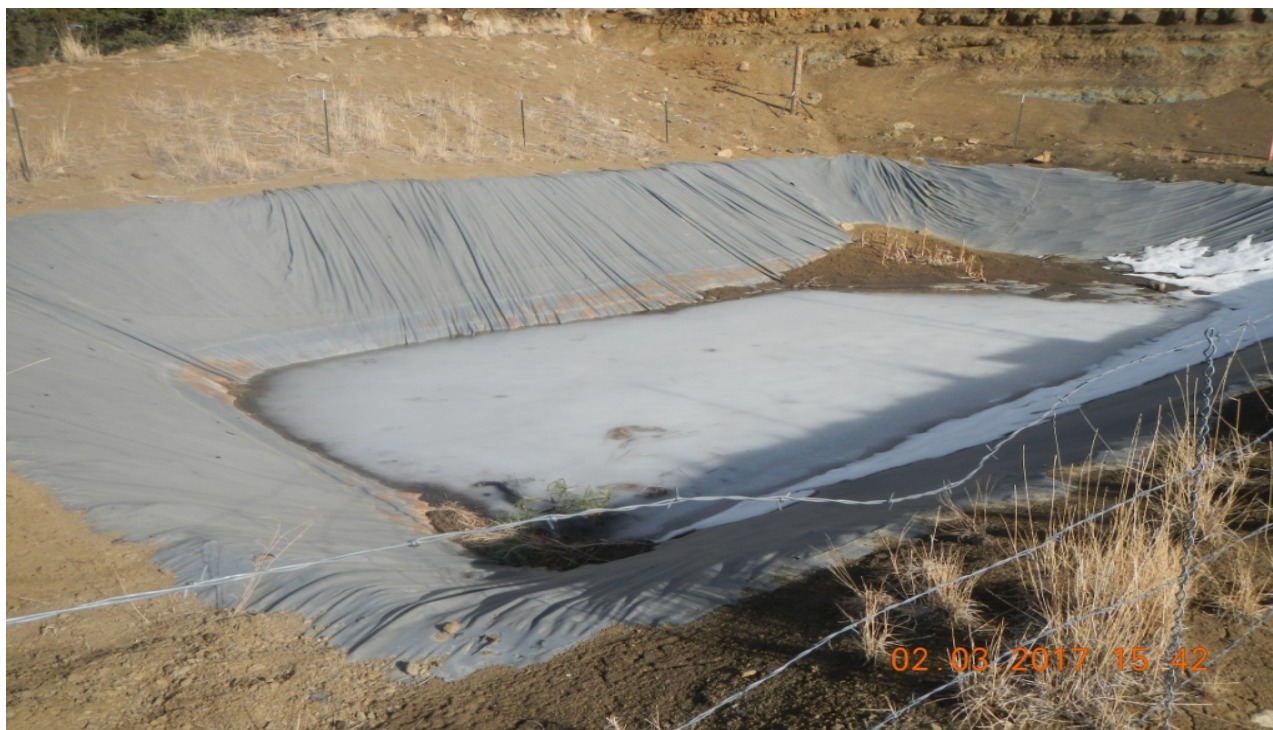
photo 5: Lined pit at the northeast side of the location.

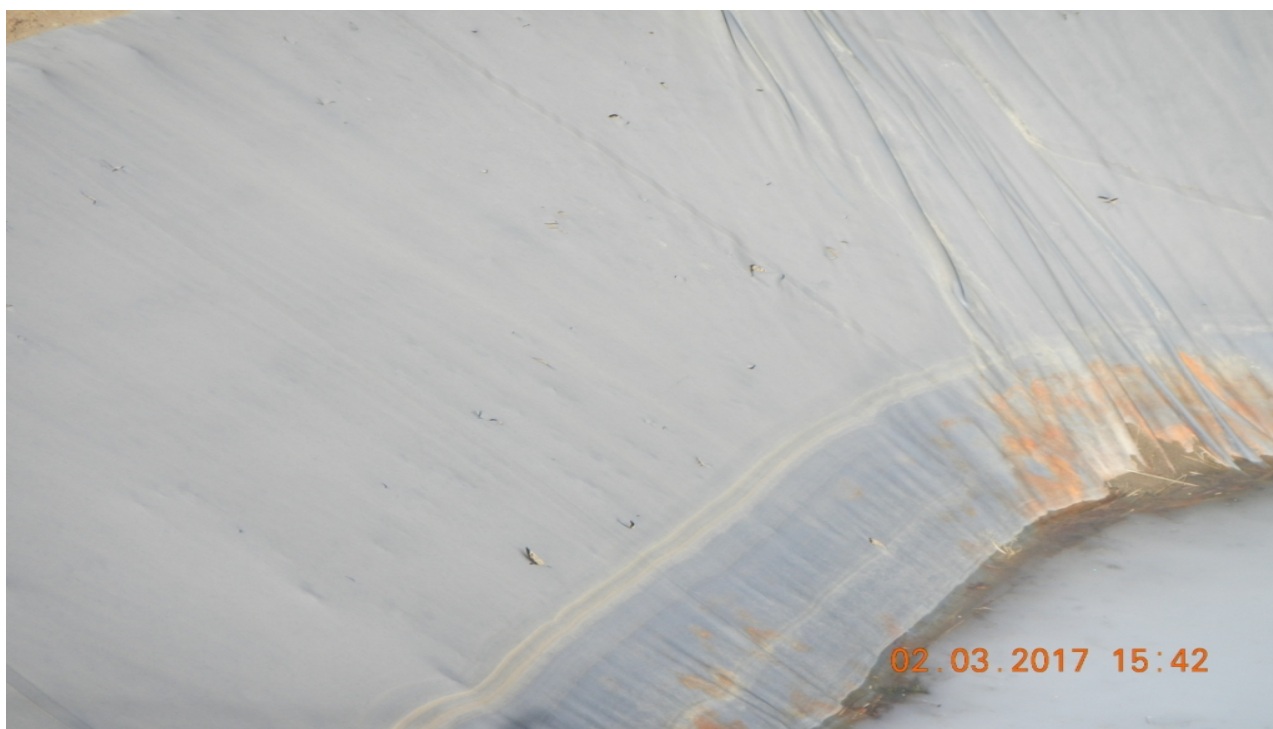
photo 6: There appears to be tears in the pit liner.

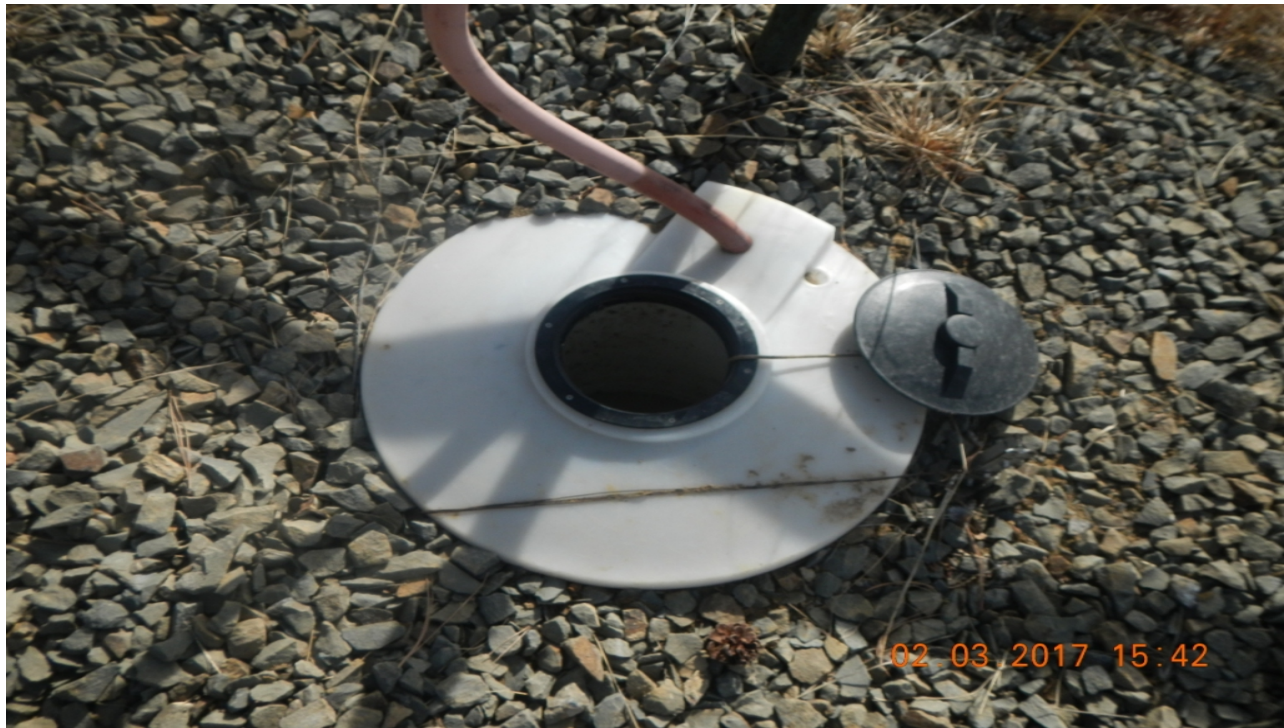
photo 7: The lid was left off the buried container at the east side of the location.

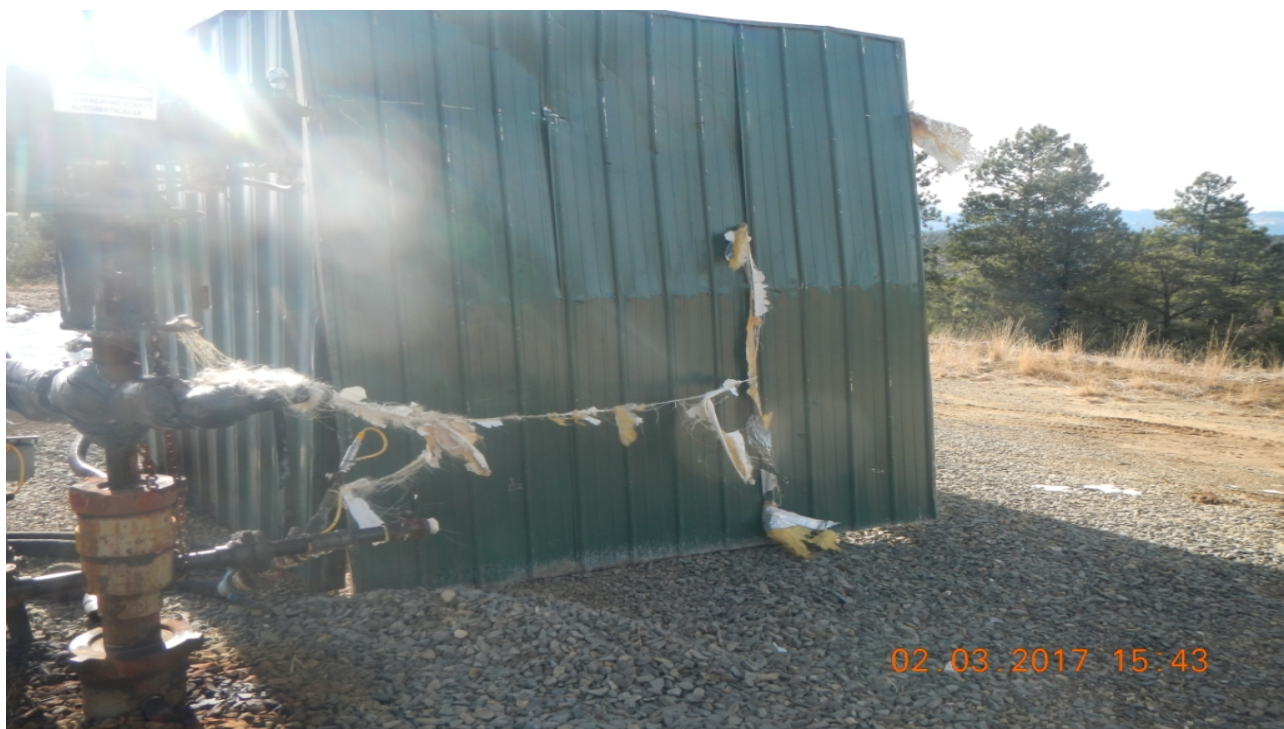
photo 8: The insulation is outside of the sound wall near the well head.
