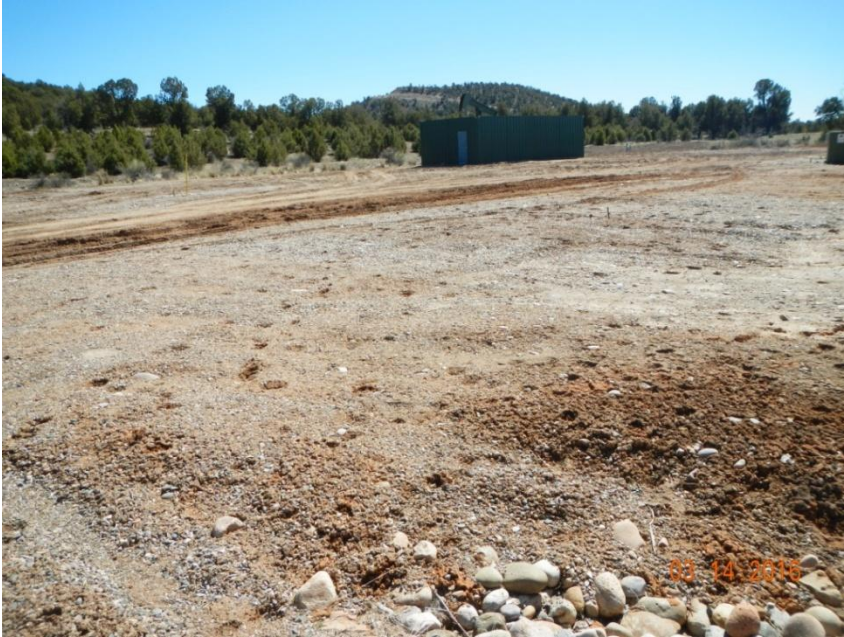
Photo 1: View of the project area from the northwestern corner facing center.

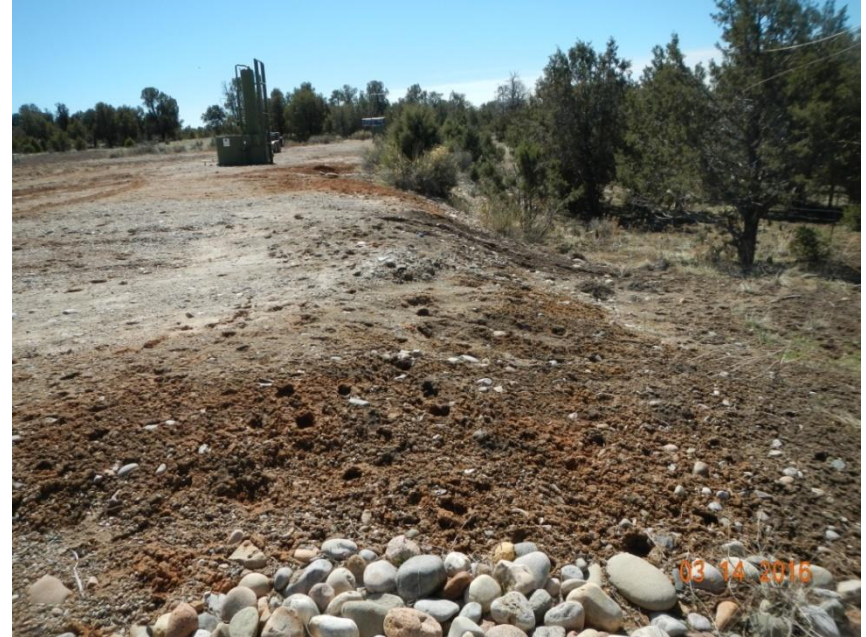
Photo 2: View of the western portion of the project area from the northwestern corner facing southward. Revegetation is largely comprised of grasses such as crested wheatgrass (*Agropyron cristatum*) and Intermediate wheatgrass (*Thinopyron intermedium*), and dropseed (*Sporobolus* sp.)

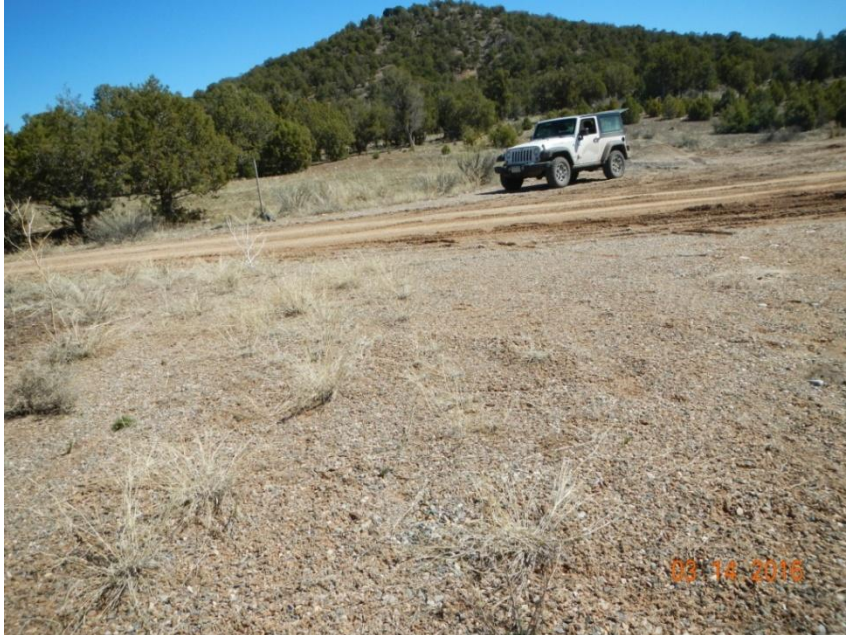
Photo 3: View of the northern portion of the project area from the southwestern corner facing eastward.

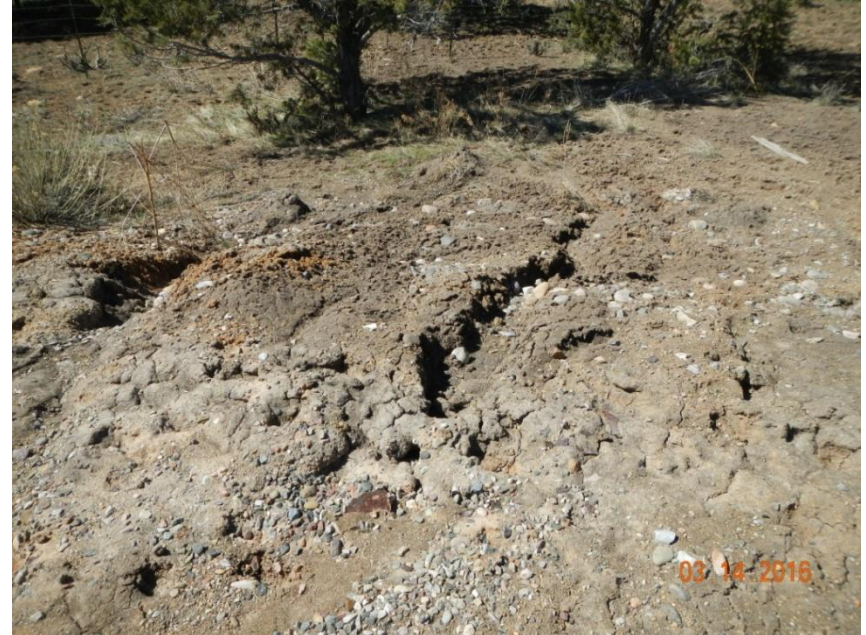
Photo 4: View of stormwater erosion occurring within the western portion of the project area.

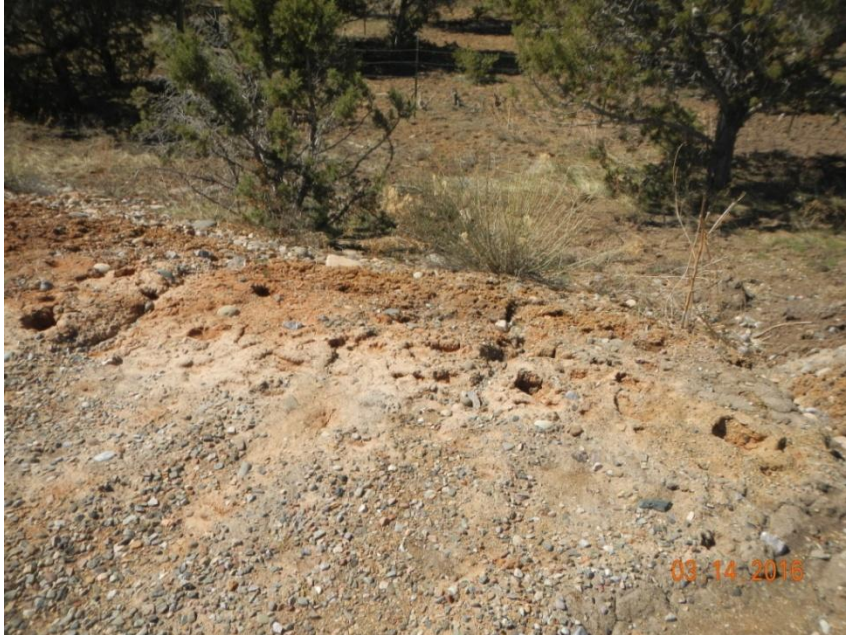
Photo 5: Another view of stormwater erosion within the western portion of the project area.

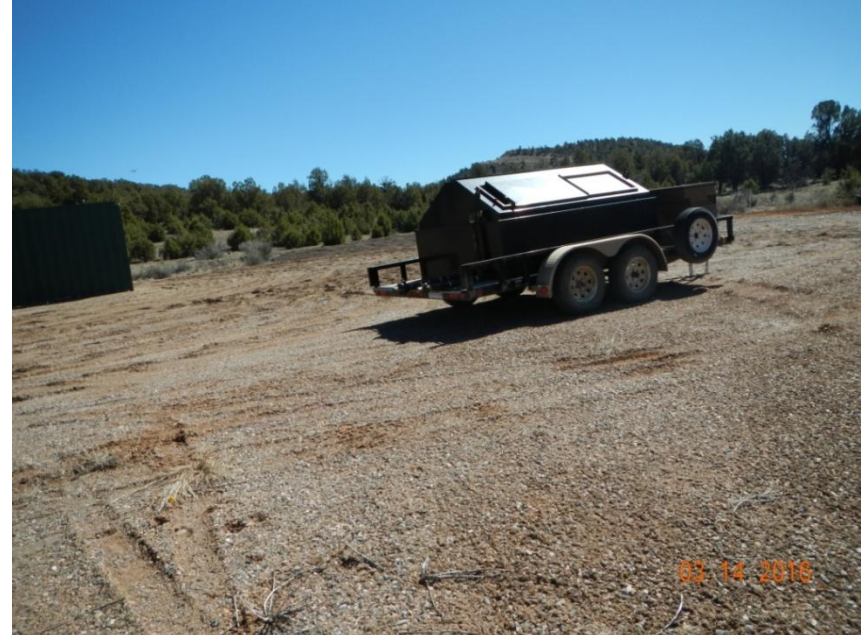
Photo 6: View of trailer in the southern portion of the project area that needs to be removed.

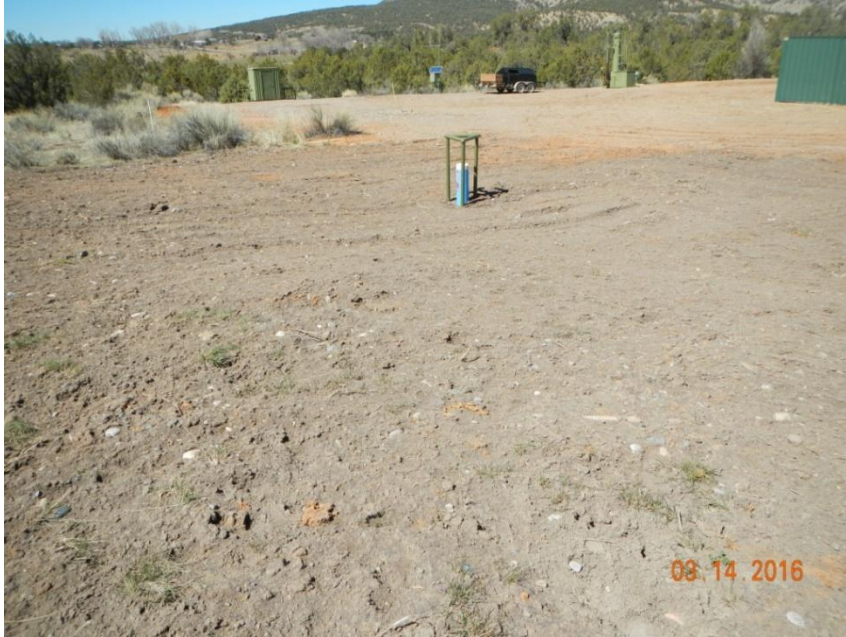
Photo 7: View of area that is approximately 75 feet long and wide that has recently been disturbed and needs to be seeded.

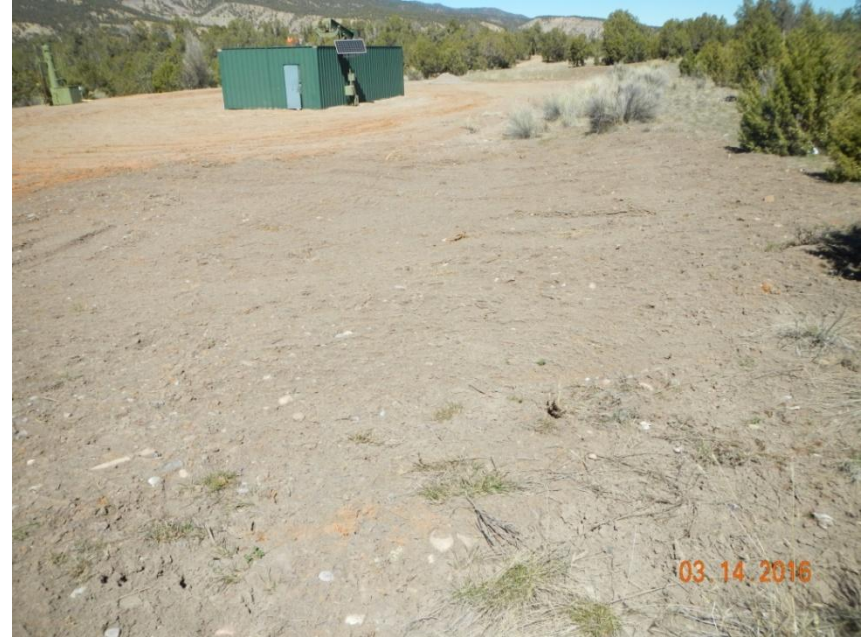
Photo 8: View of the eastern portion of the project area from the southeastern corner facing northward.

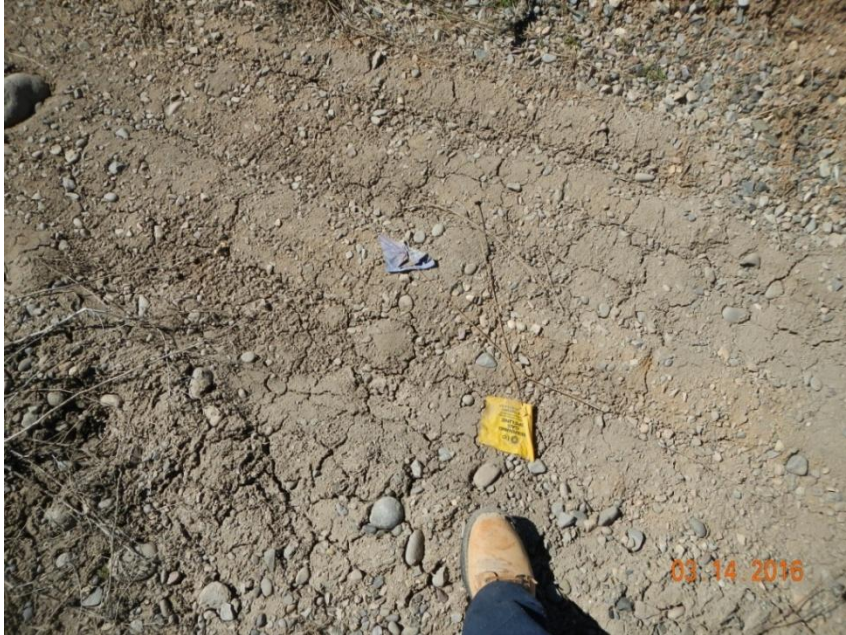
Photo 9: View of some pin flags that are scattered around the well pad.

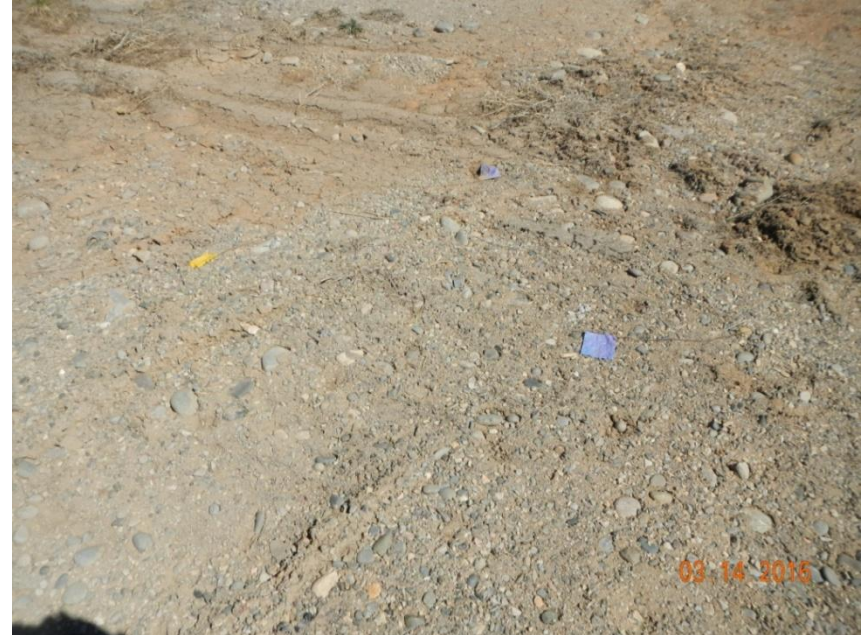
Photo 10: View of more pin flags that are scattered around the well pad. Several more were observed and need to be properly disposed of.
