COGCC Environmental Field Inspection Report Photo Attachment

Inspection Date: July 18, 2017

COLORADO
Oil & Gas Conservation
Commission

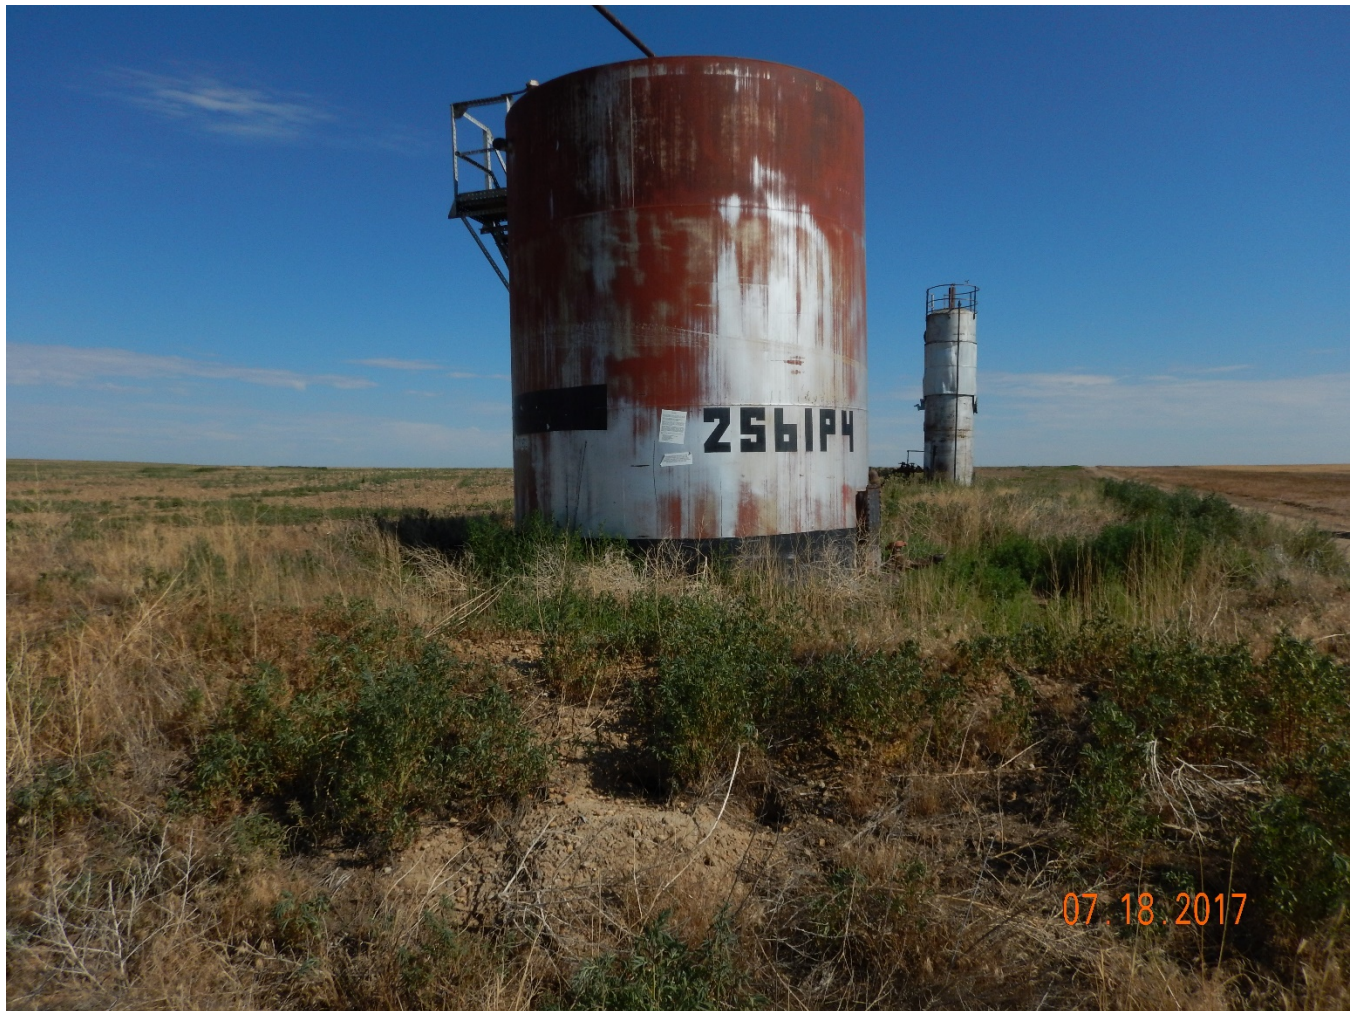
Photo 1 - Schmidt 1-B Tank battery. Note: tank lacking required labels/placard and earthen berms are overgrown with weeds.

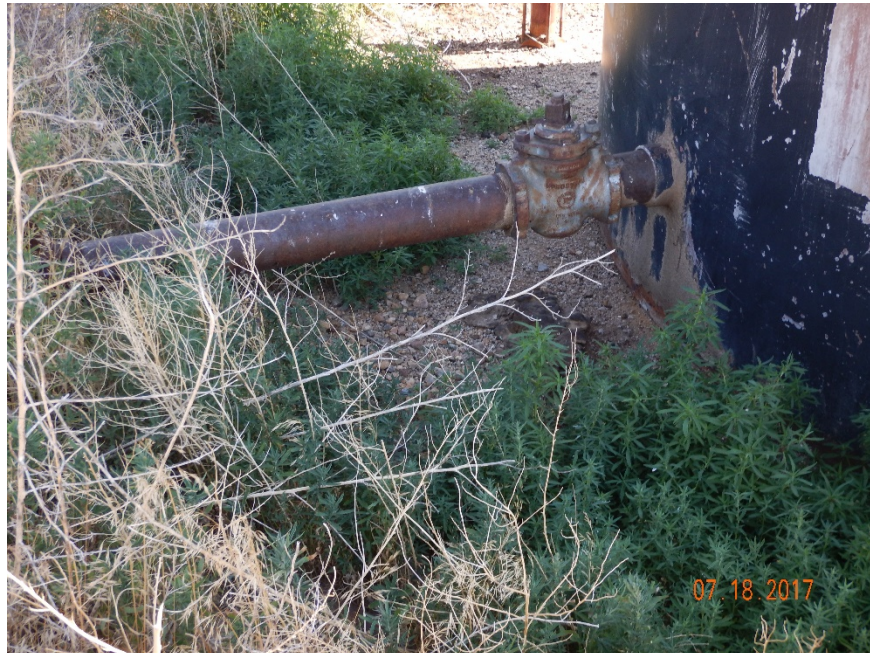
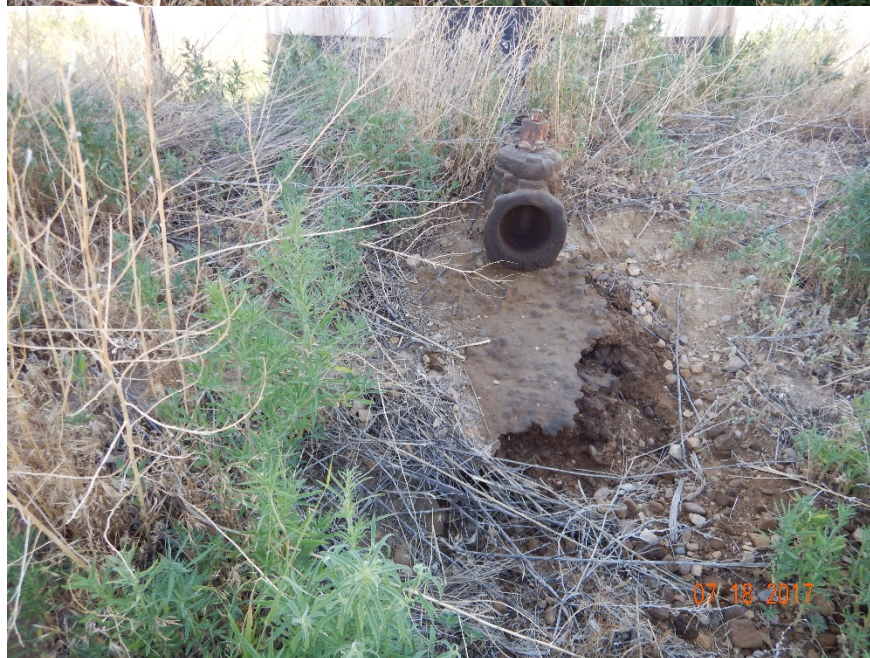
Photos 2 & 3 - Historical accumulations of oily waste at crude oil valves (top) and loadout (bottom). Note: loadout is outside of berm and lacks secondary containment device.

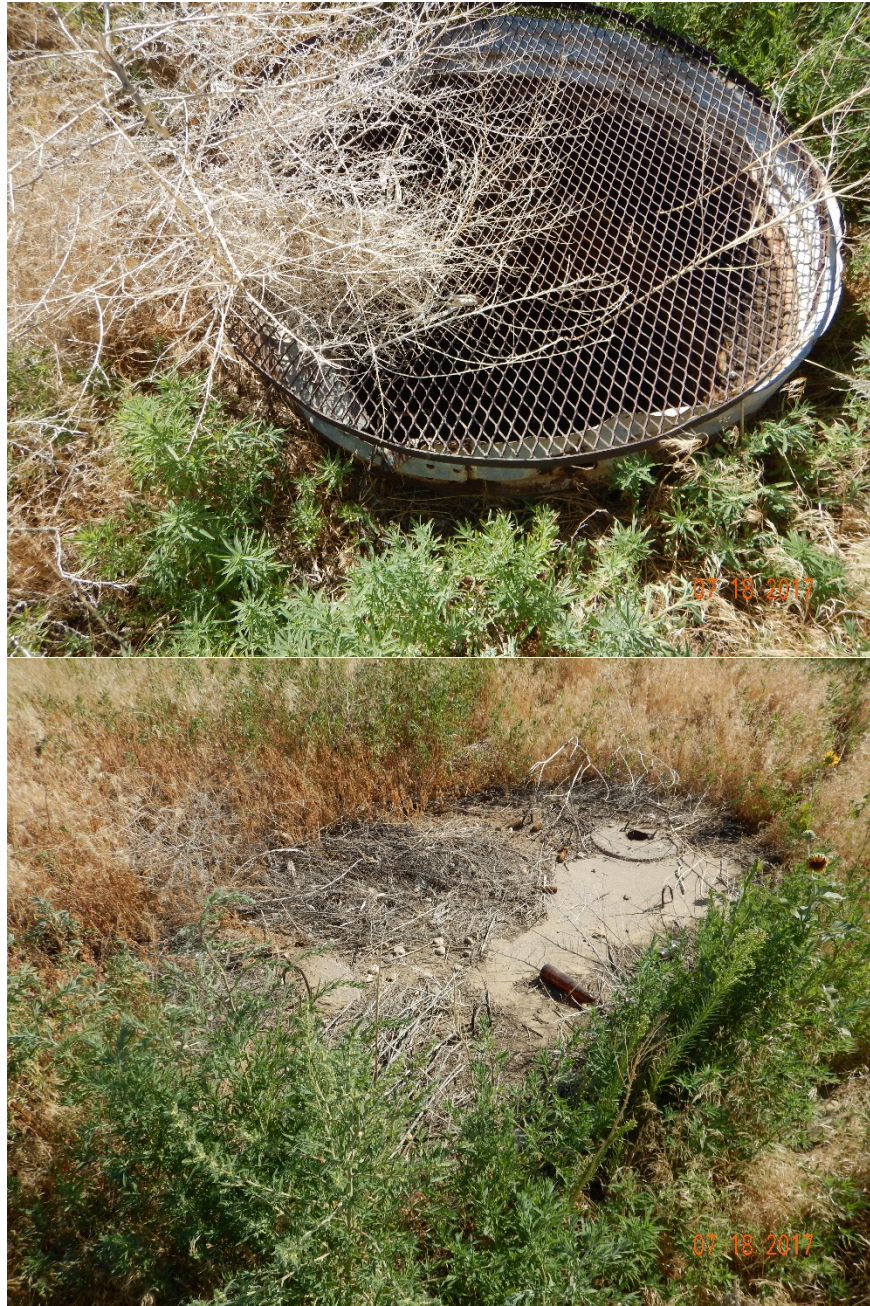
Photos 4 & 5 - Mesh-covered culvert (top) and buried cement vault (bottom) located north of crude oil AST. Note: culvert contains water and cement vault is overgrown. Facility ID #114389 was created for culvert in COGCC database.

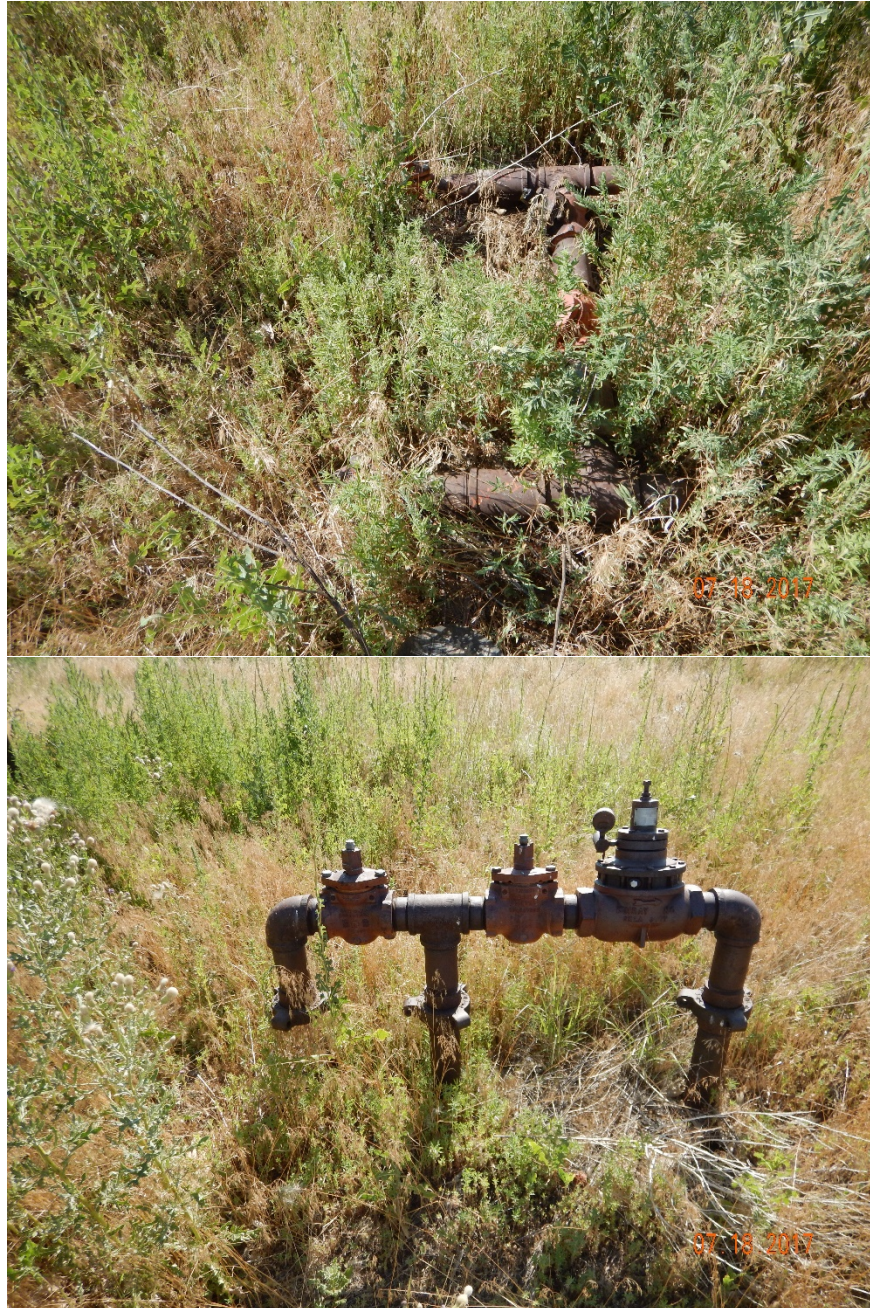
Photos 6 & 7 - Flowline risers/manifolds with valves located between tank battery and separator. Note: uncontrolled weeds.

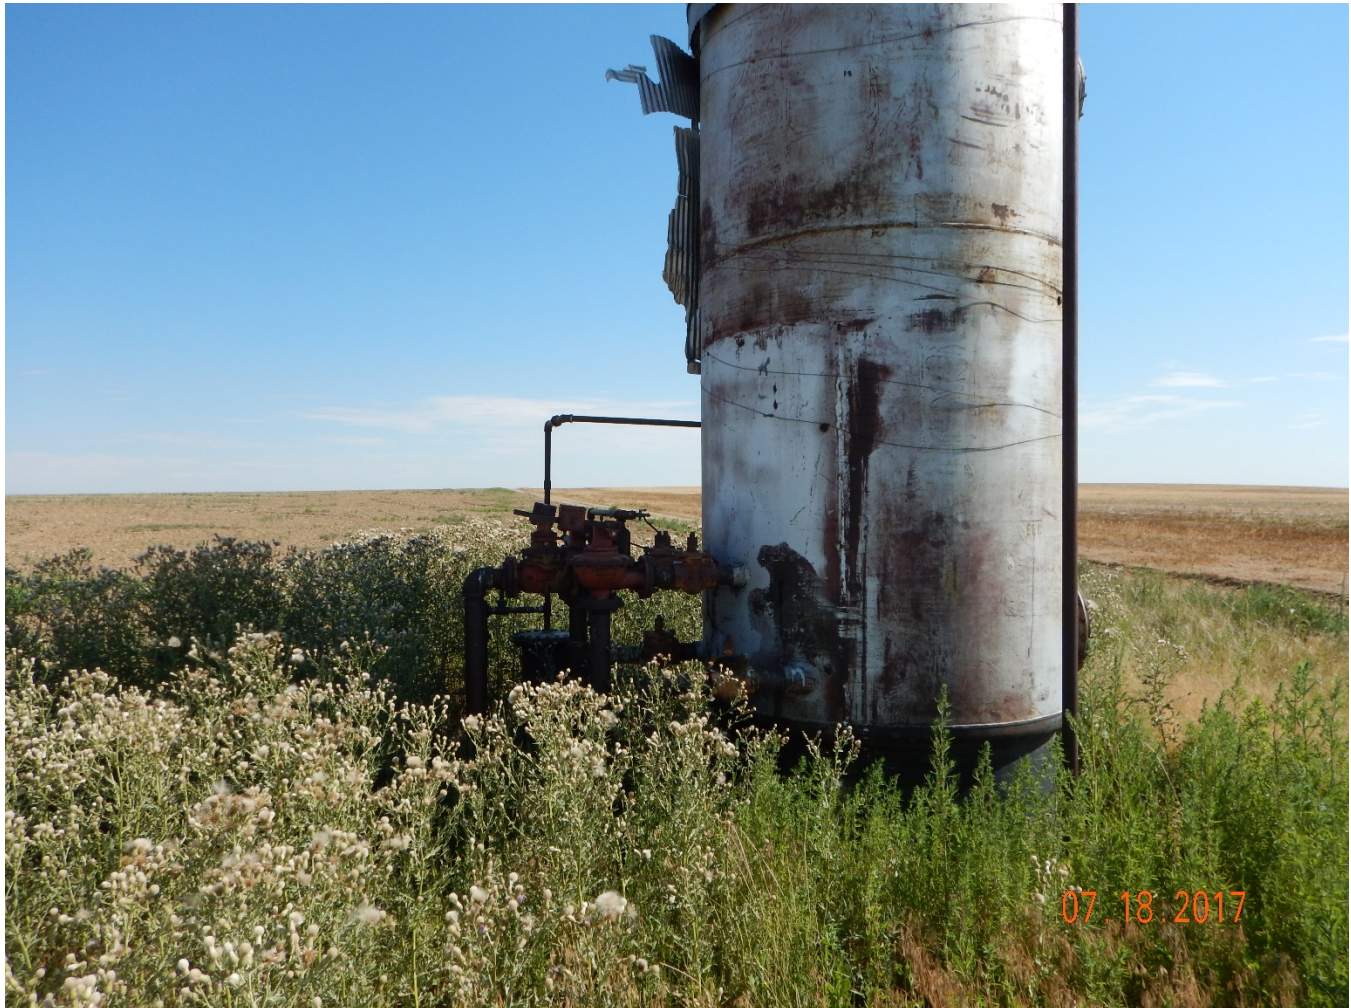
Photo 8 - Flowline riser assembly at vertical heater treater. Note abundance of weeds encroaching upon equipment.

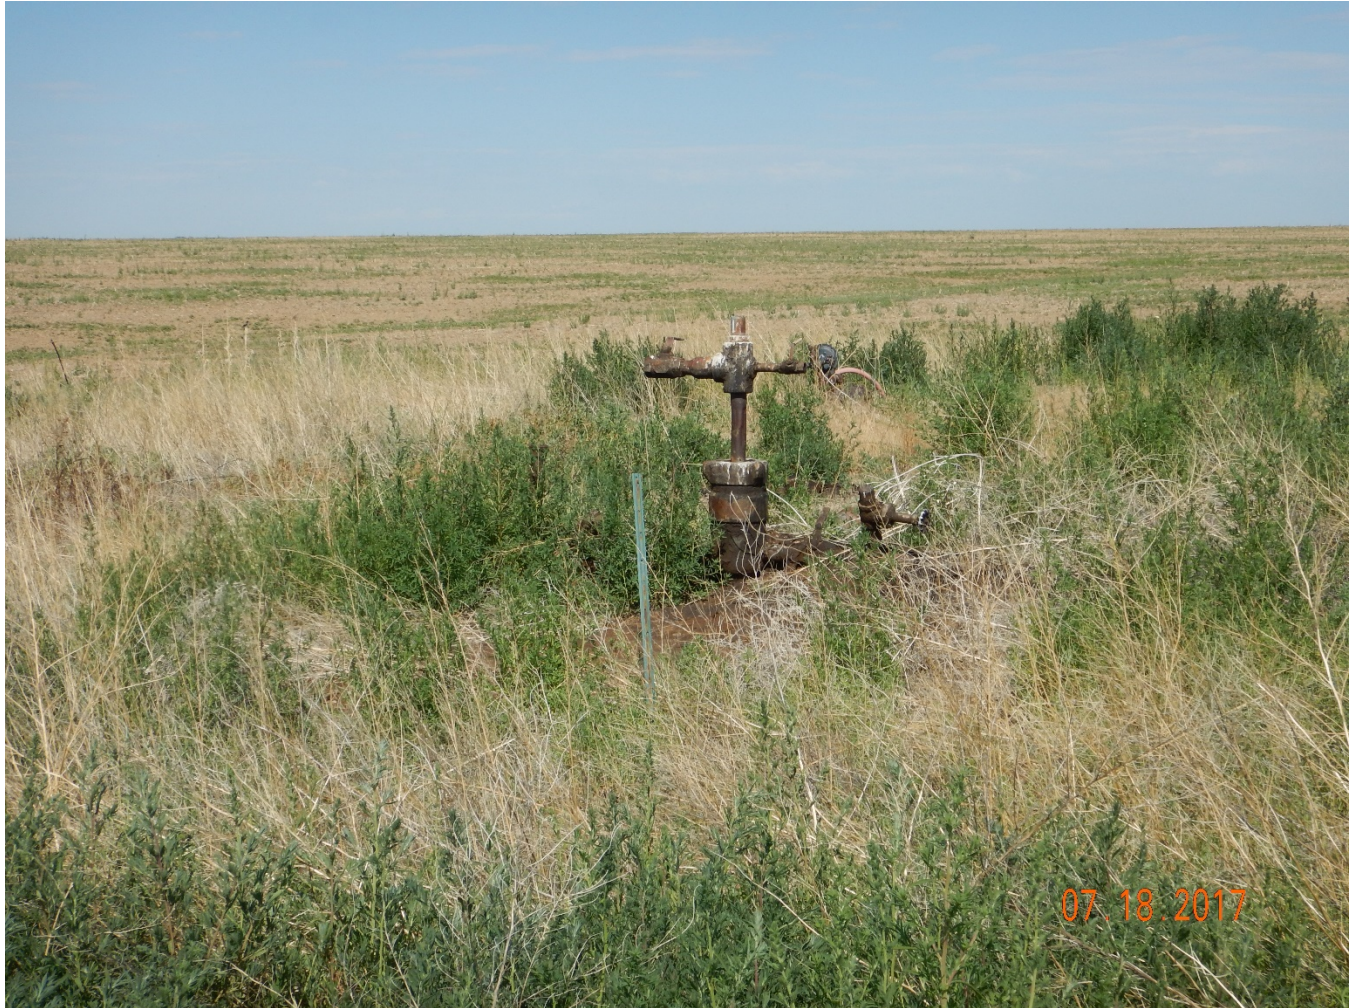
Photo 9 - Significant accumulation of oily waste localized at wellhead. Note absence of wellhead sign.

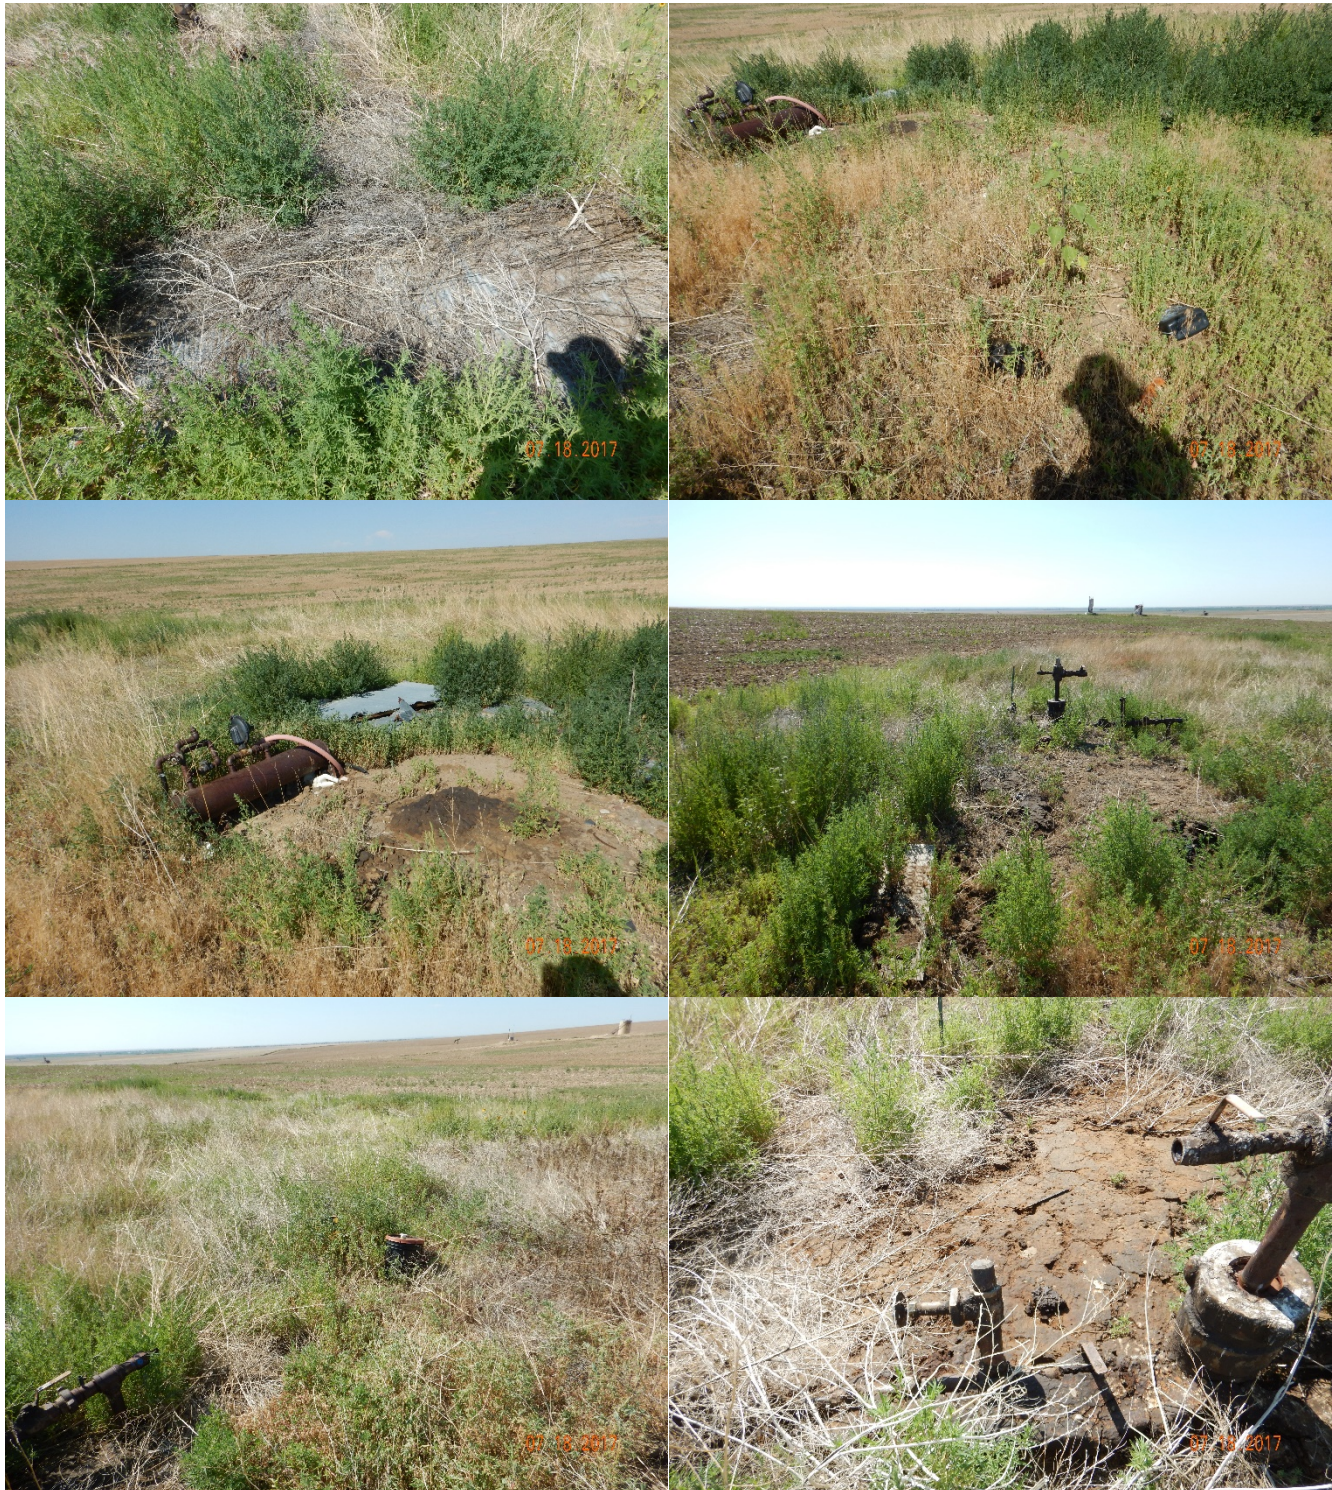
Photos 10-15 - Assorted oily waste, debris, unused equipment, weeds, and trash/junk scattered around wellhead.
