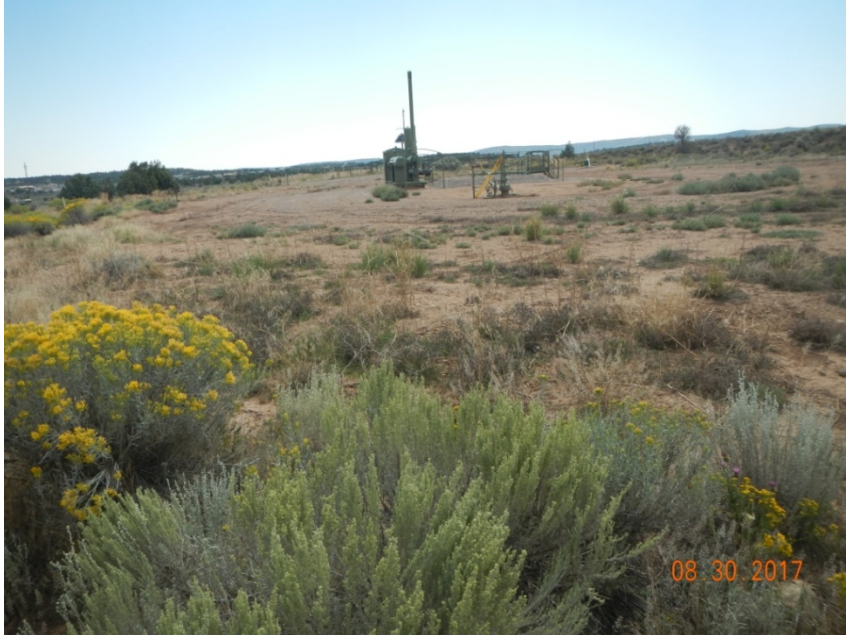
Photo 1: View of the project area from the northern edge facing center.

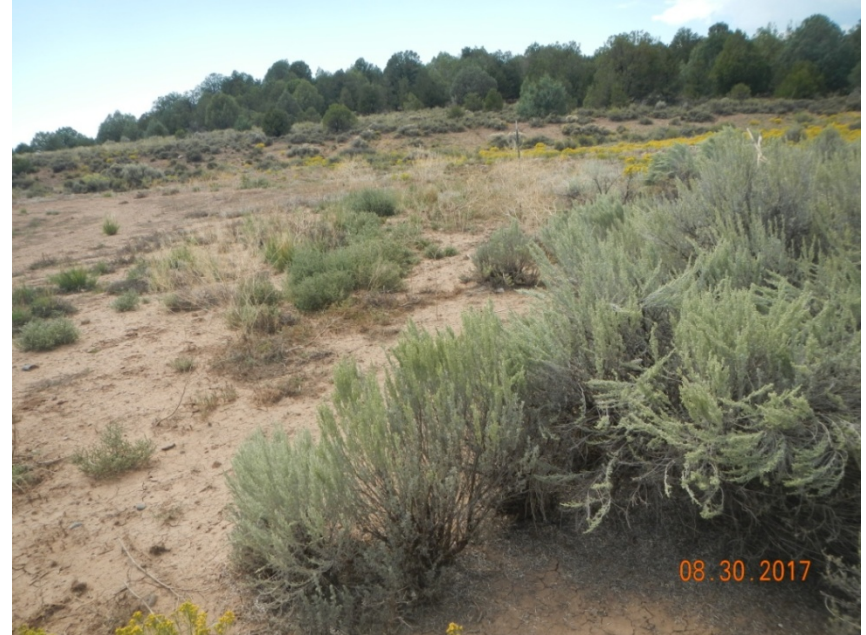
Photo 2: View of the northern portion of the project area from the northern edge facing westward. Revegetation is progressing, but weedy in portions. Common species such as sagebrush (*Artemisia tridentata*), rubber rabbitbrush (*Chrysothamnus nauseosus*), western wheatgrass (*Pascopyrum smithii*), yellow mustard (*Systembrium altissimum*), and cheatgrass (*Bromus tectorum*).

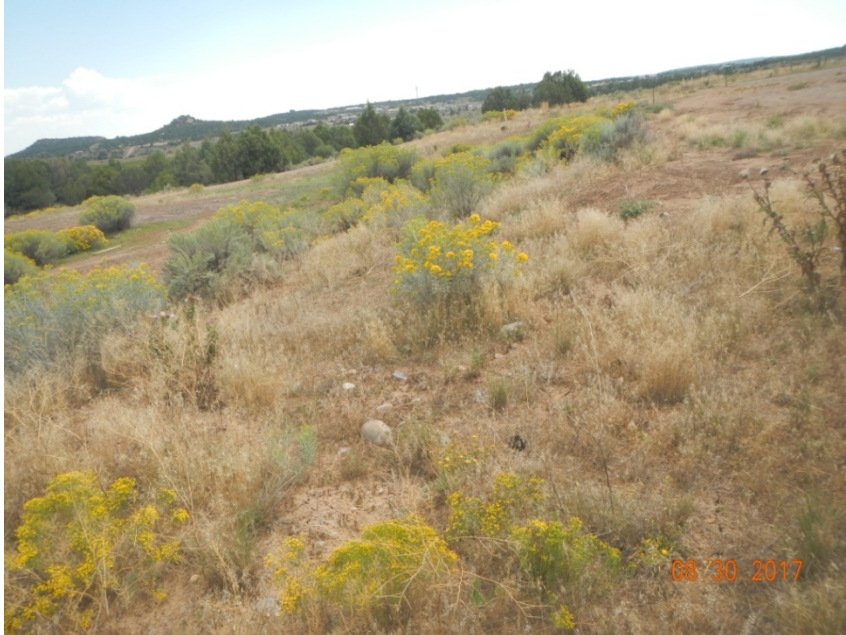
Photo 3: View of fill slope in the eastern portion of the project area from the northern edge facing westward.

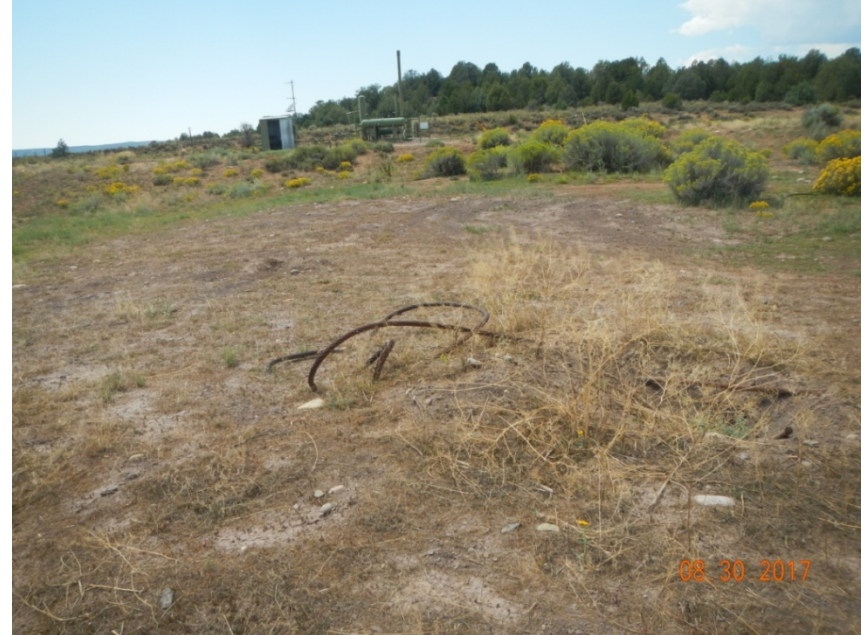
Photo 4: View rig anchor cable in the northeastern portion of the project area facing westward.

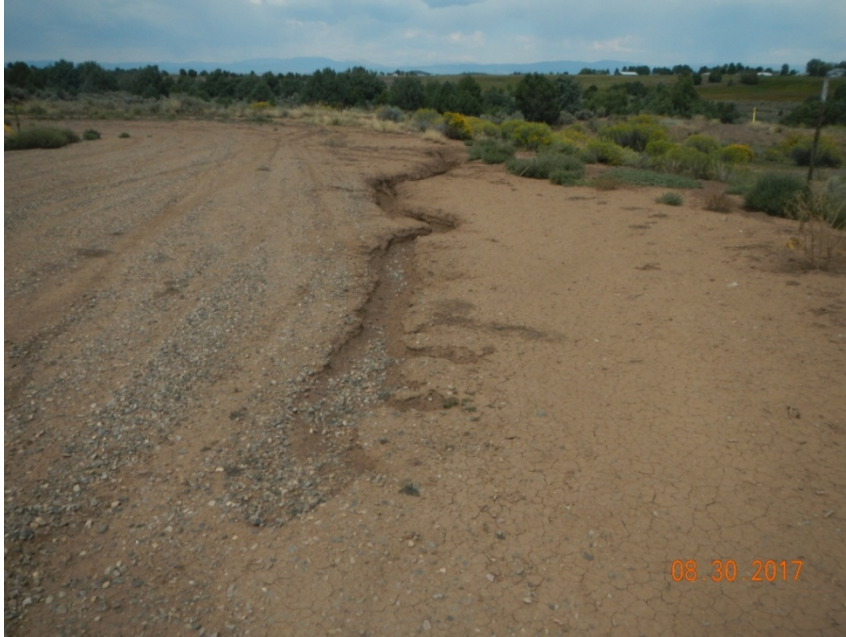
Photo 5: View of erosional channel approximately 2.5 feet wide and deep on the eastern edge of the working area.

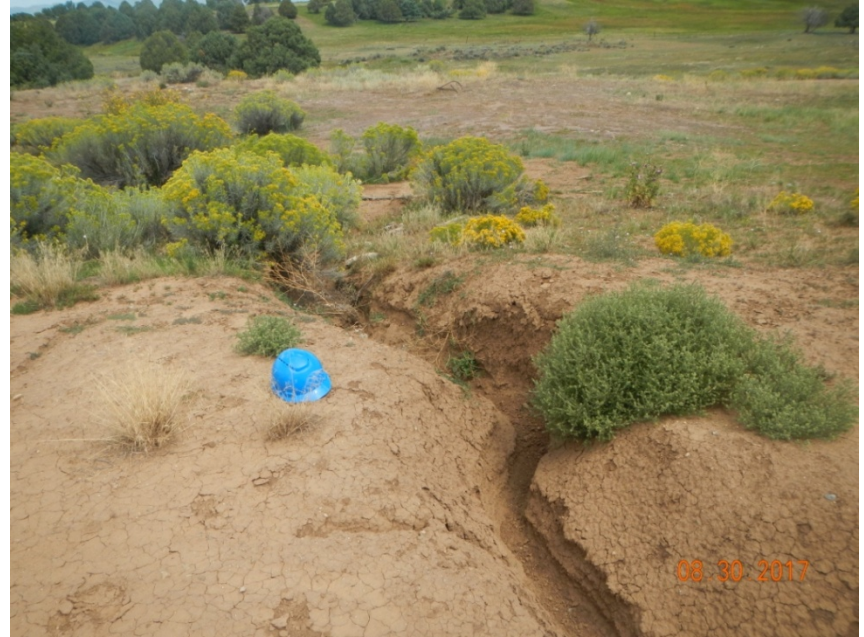
Photo 6: View of erosional channel downstream of Photo 5, in fill slope.
