Inspection Photos
Location Name: Federal Plover #28-5 X
API: 05-123-20126

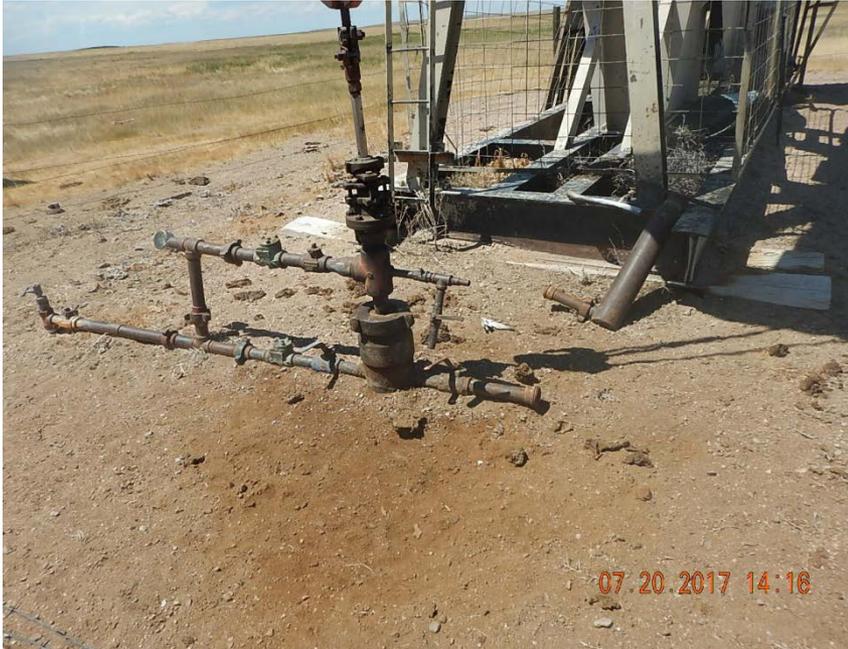
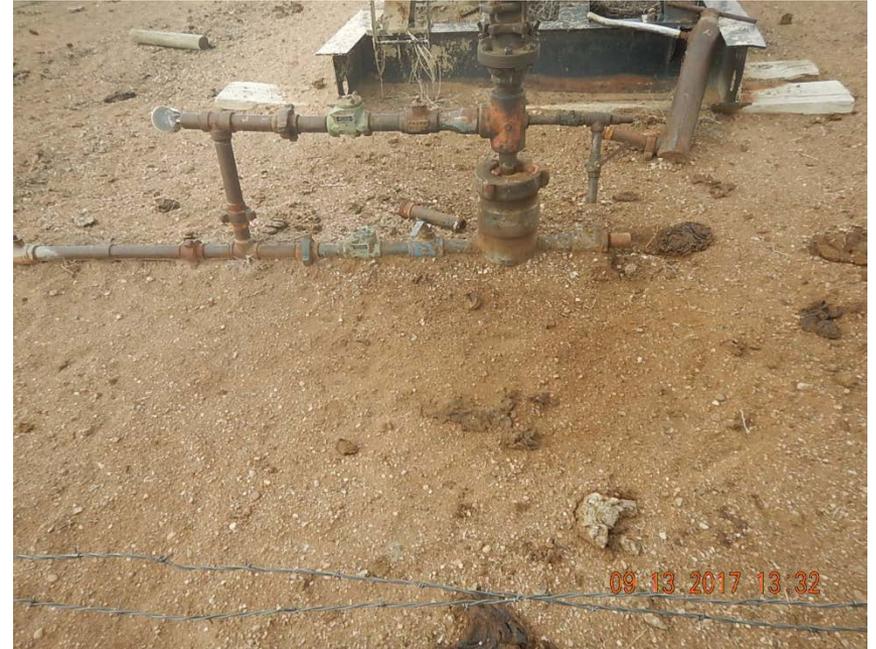
Photo from prior inspection for comparison

Photo 1: Bradenhead not plumbed to surface.

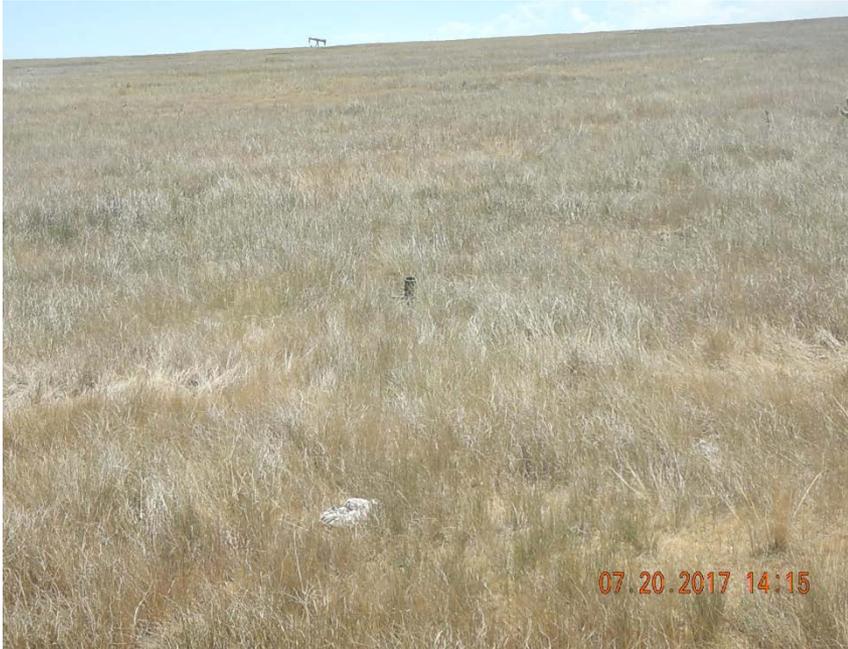
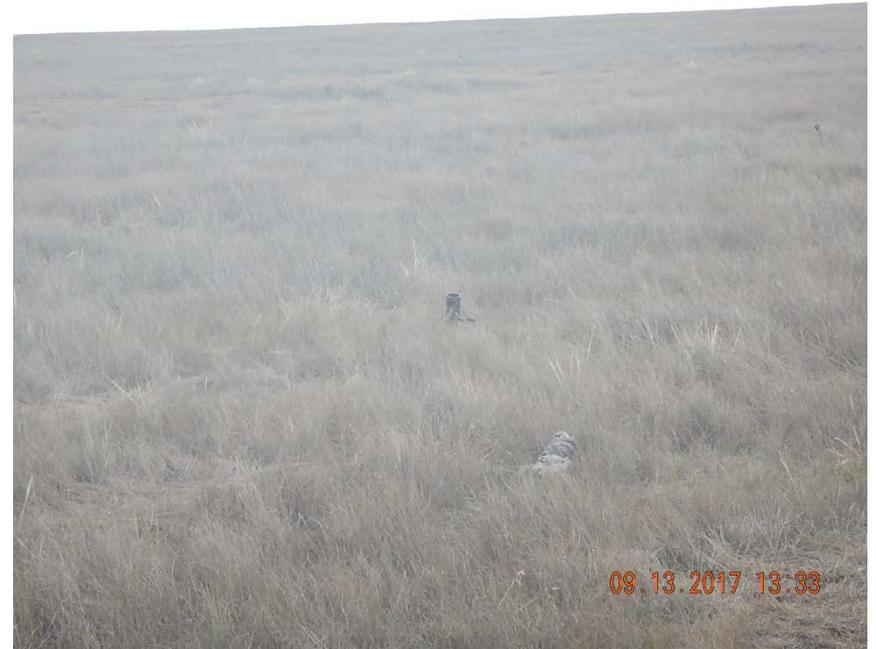
Photo from prior inspection for comparison

Photo 2: Deadman unmarked

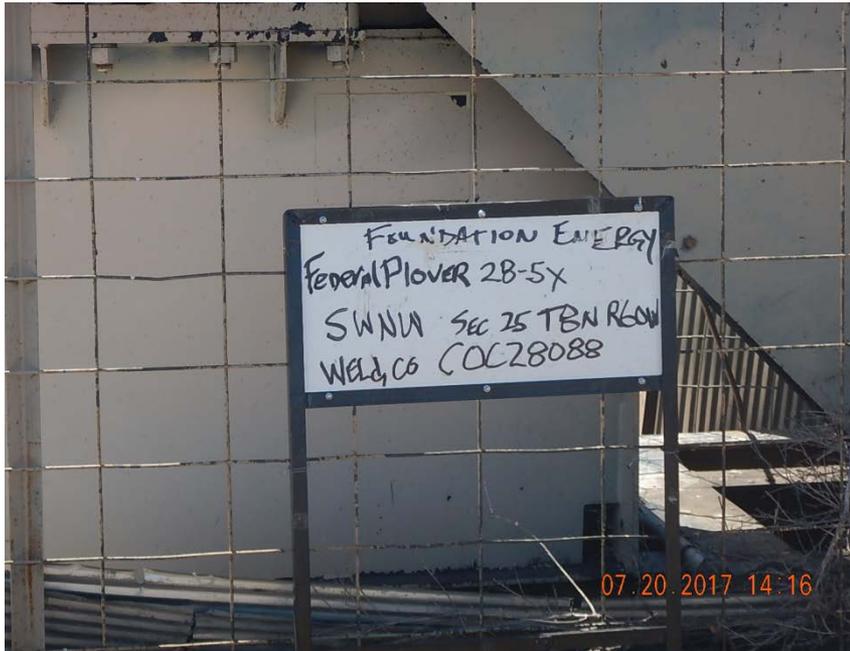
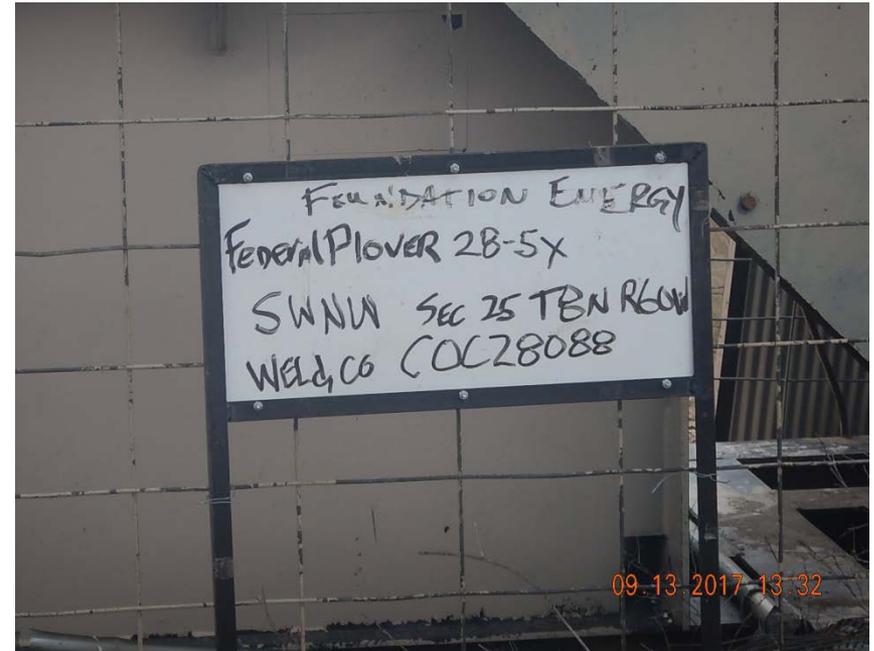
Photo from prior inspection for comparison

Photo 3: No emergency contact number at wellhead

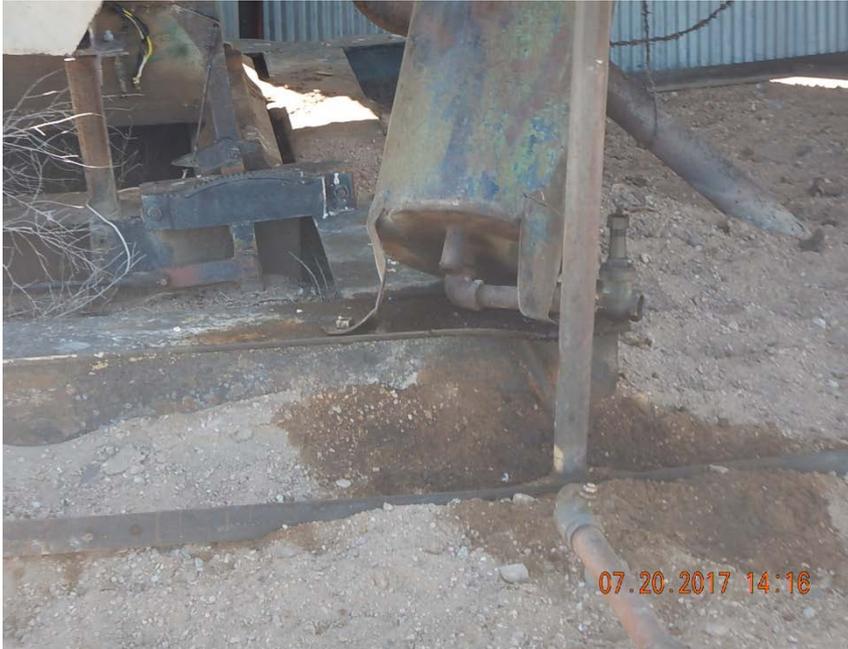
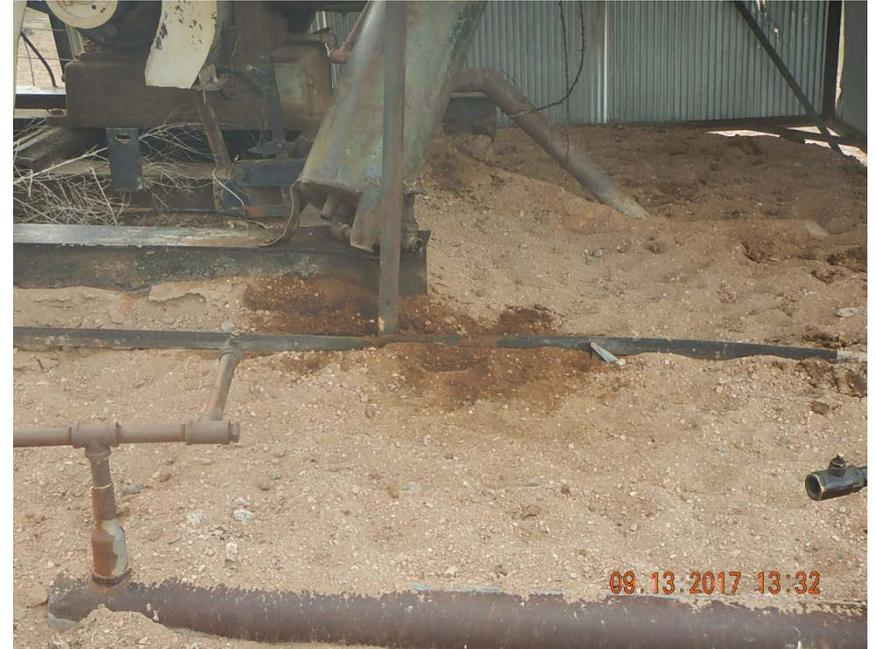
Photo from prior inspection for comparison

Photo 4: Stained soil at engine
