Inspection Photos

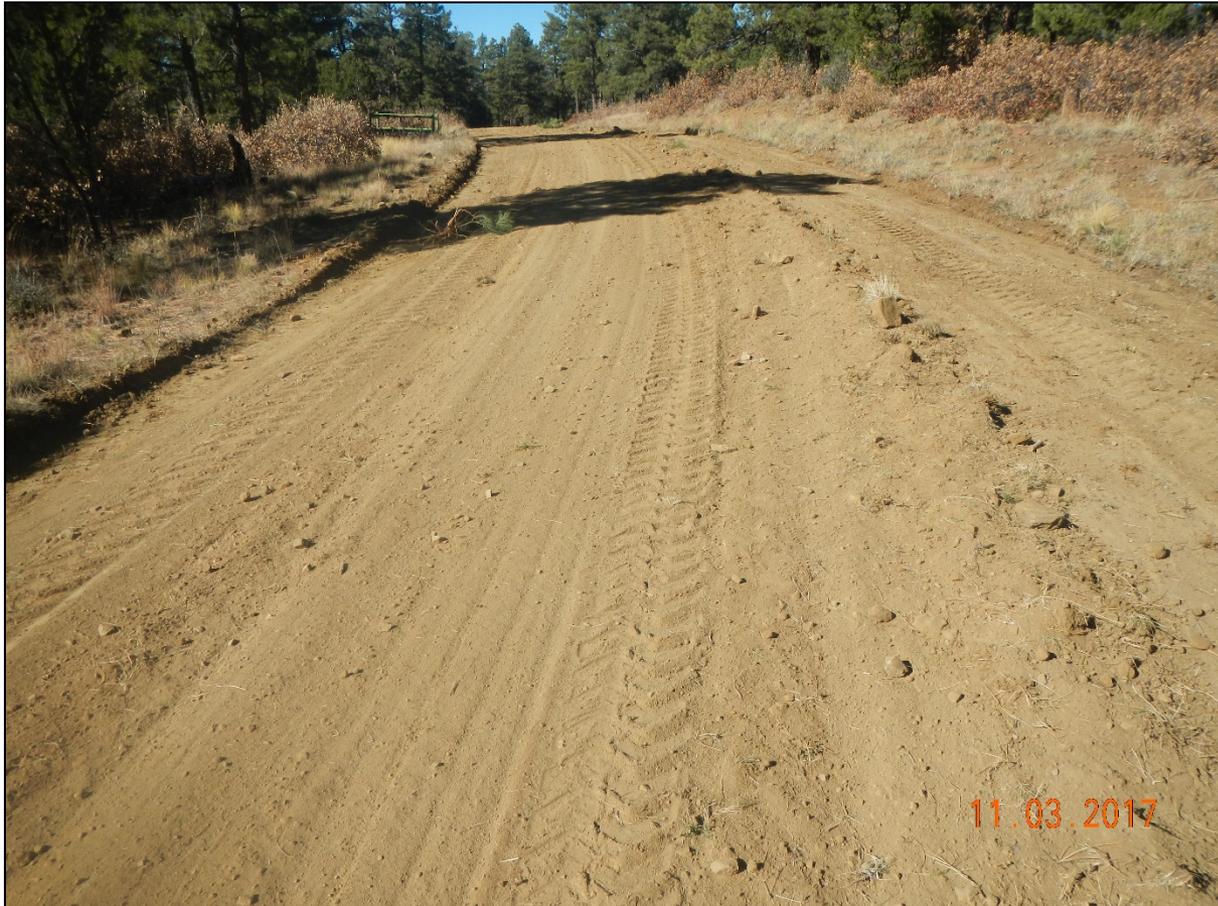
Photo 1. Facing northwest along the access road. The road was in the process of being graded and soil was being pushed onto the road.

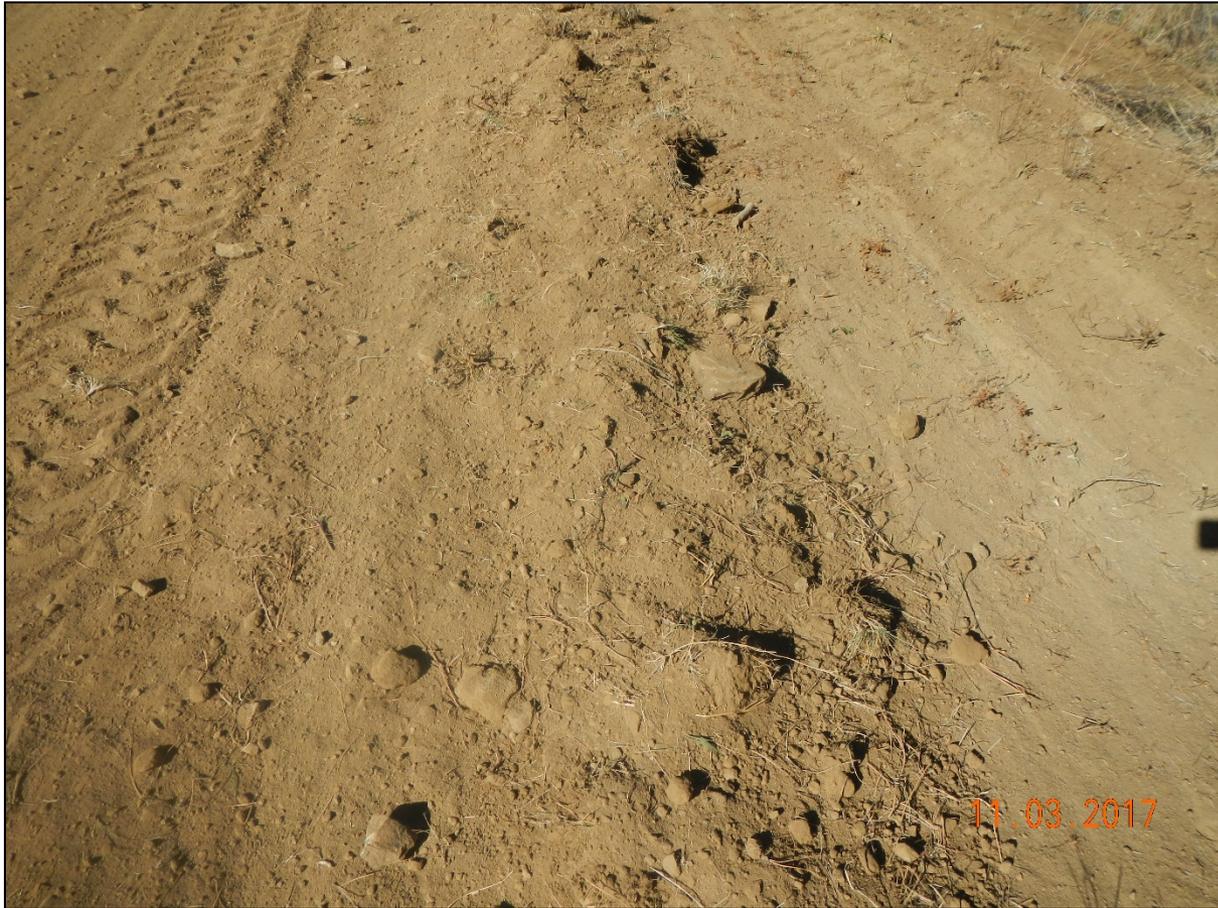
Photo 2. Soil was being pushed onto the road from the road side. The soil is loose and susceptible to erosion.

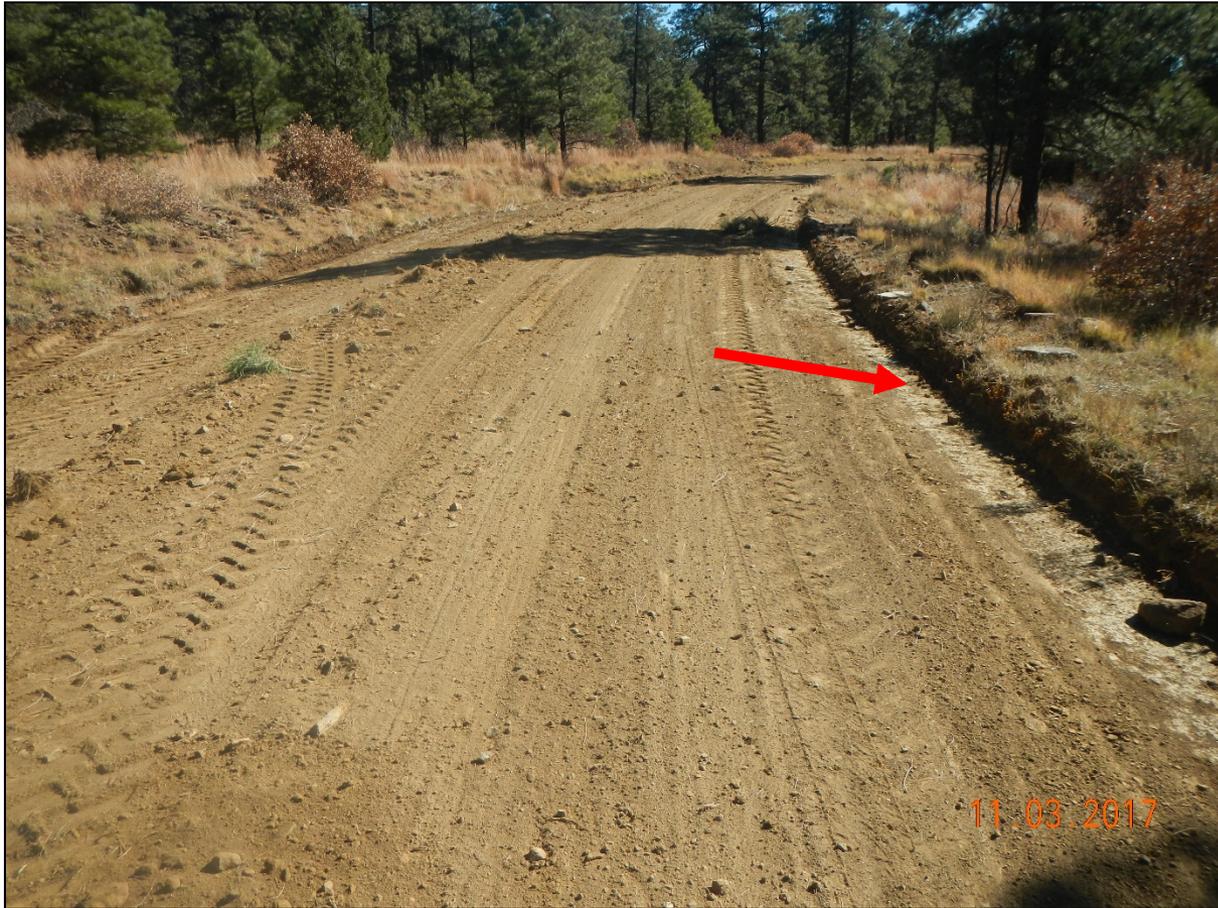
Photo 3. The arrow points to the side of the road where soil is being pushed onto the road which is also causing the road to become widened.

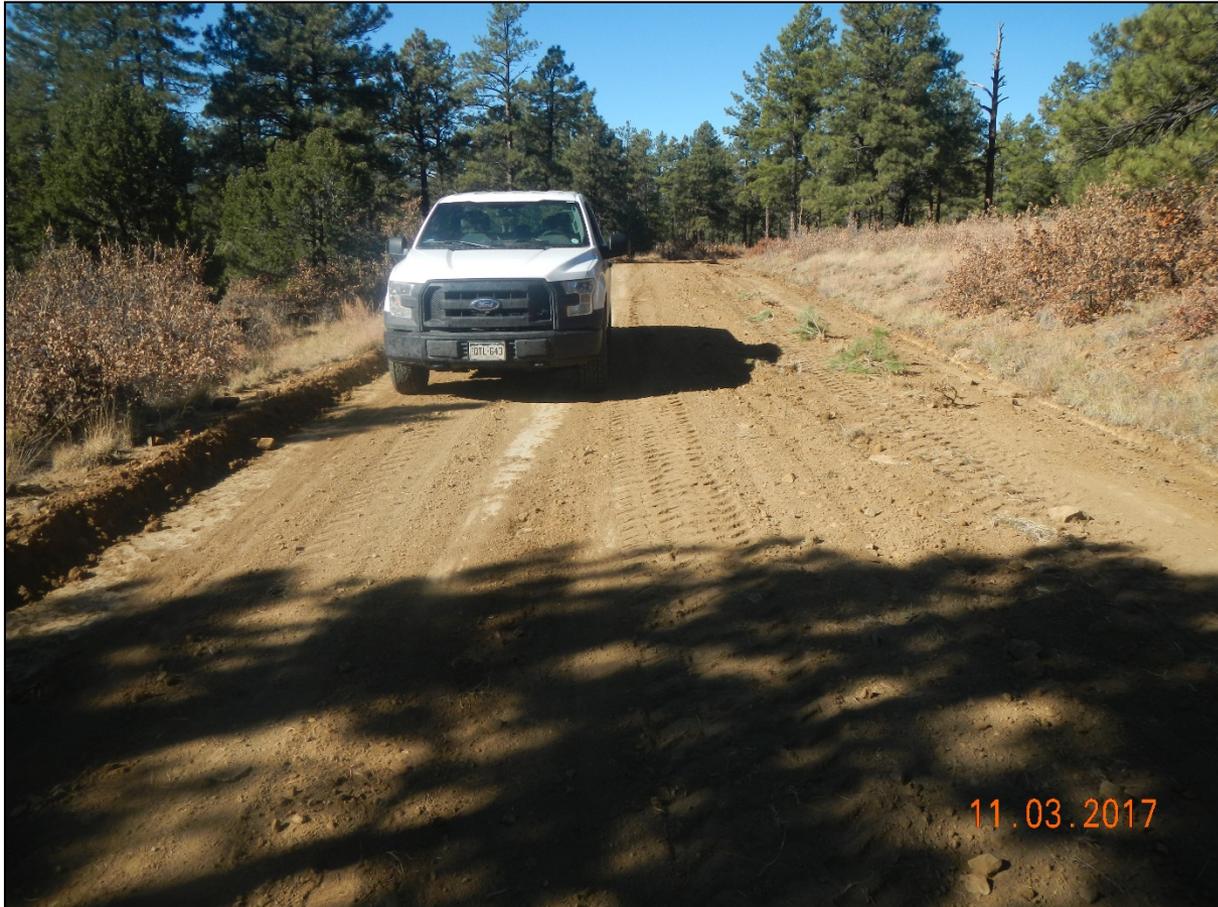
Photo 4. The vehicle shows the size of the access road. The road needs to be maintained to prevent widening of the road.

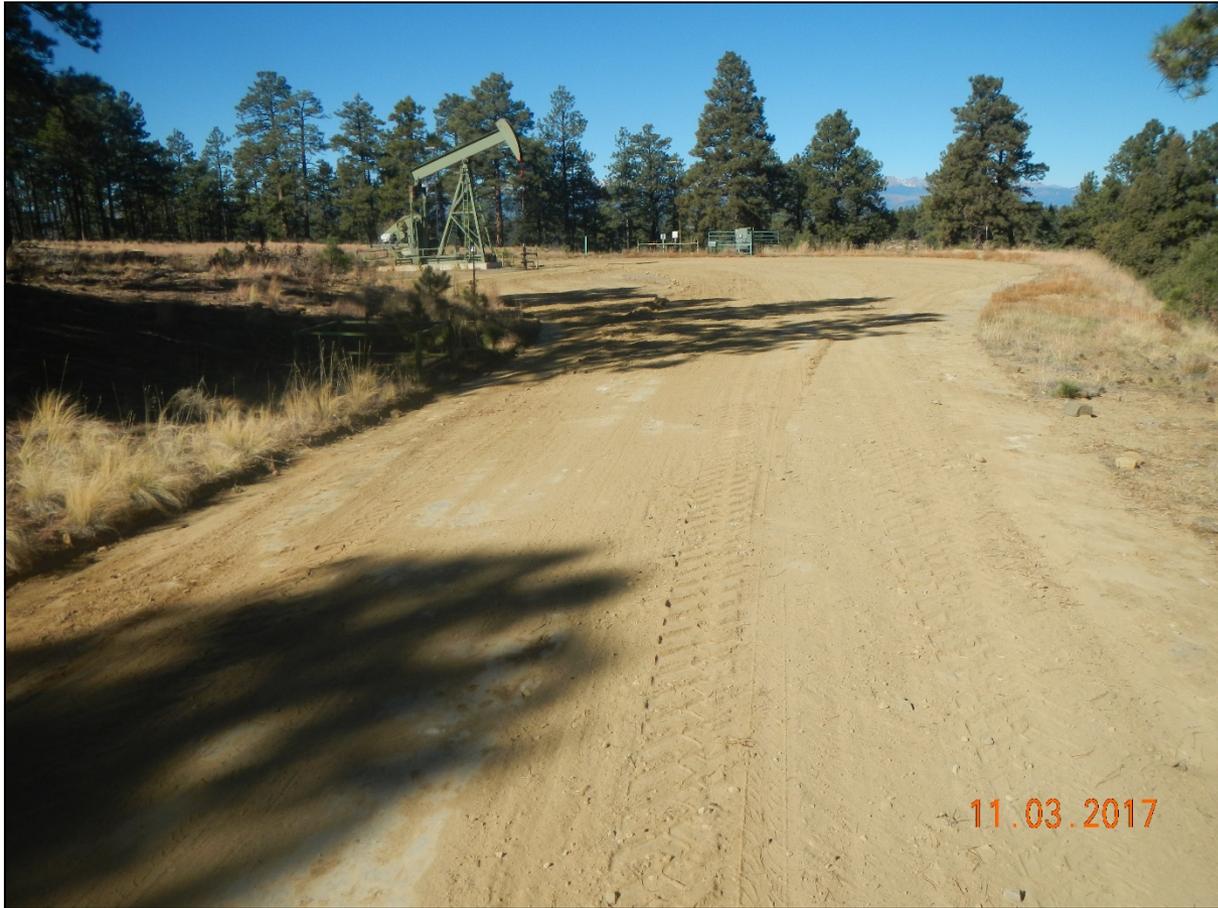
Photo 5. Facing northwest toward the location.

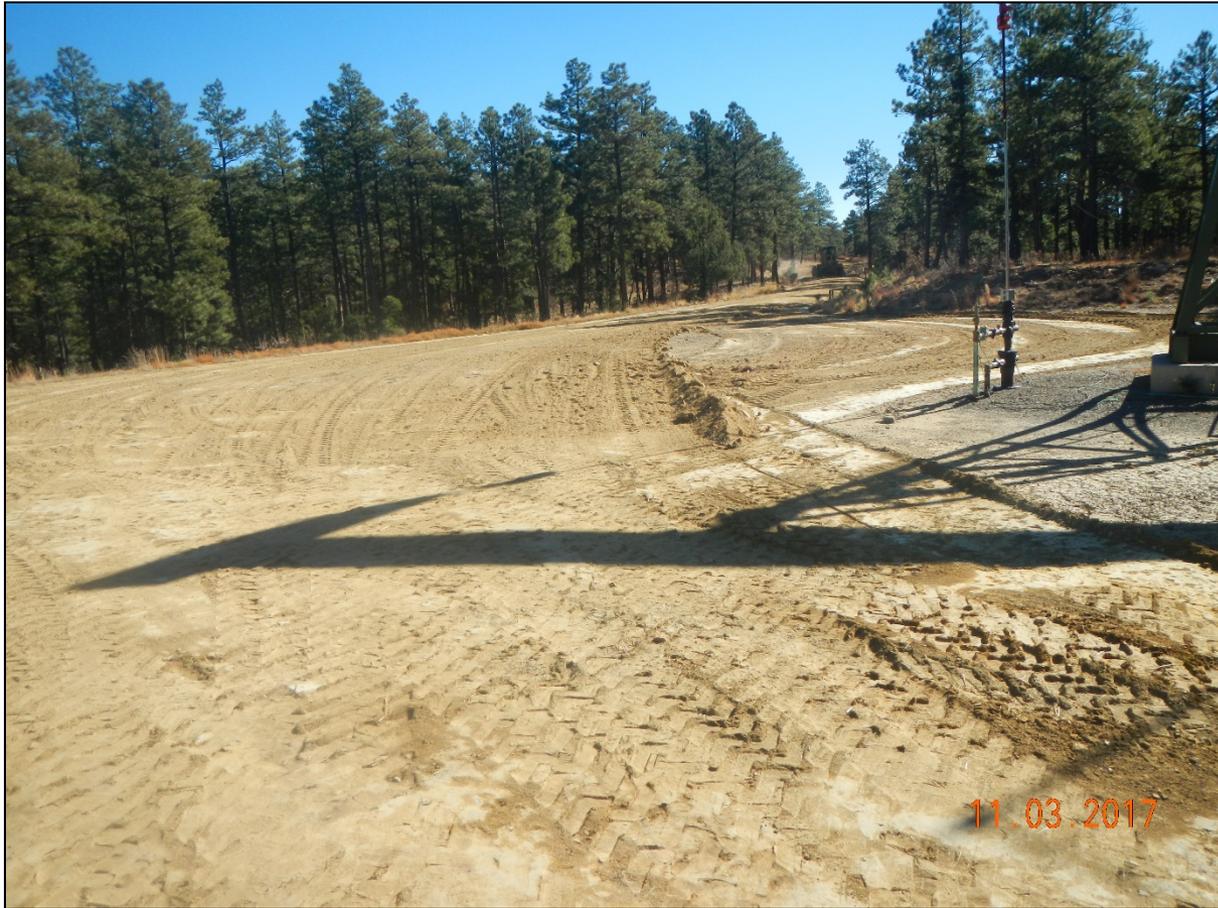
Photo 6. West side of the location facing southeast. The location was recently graded.

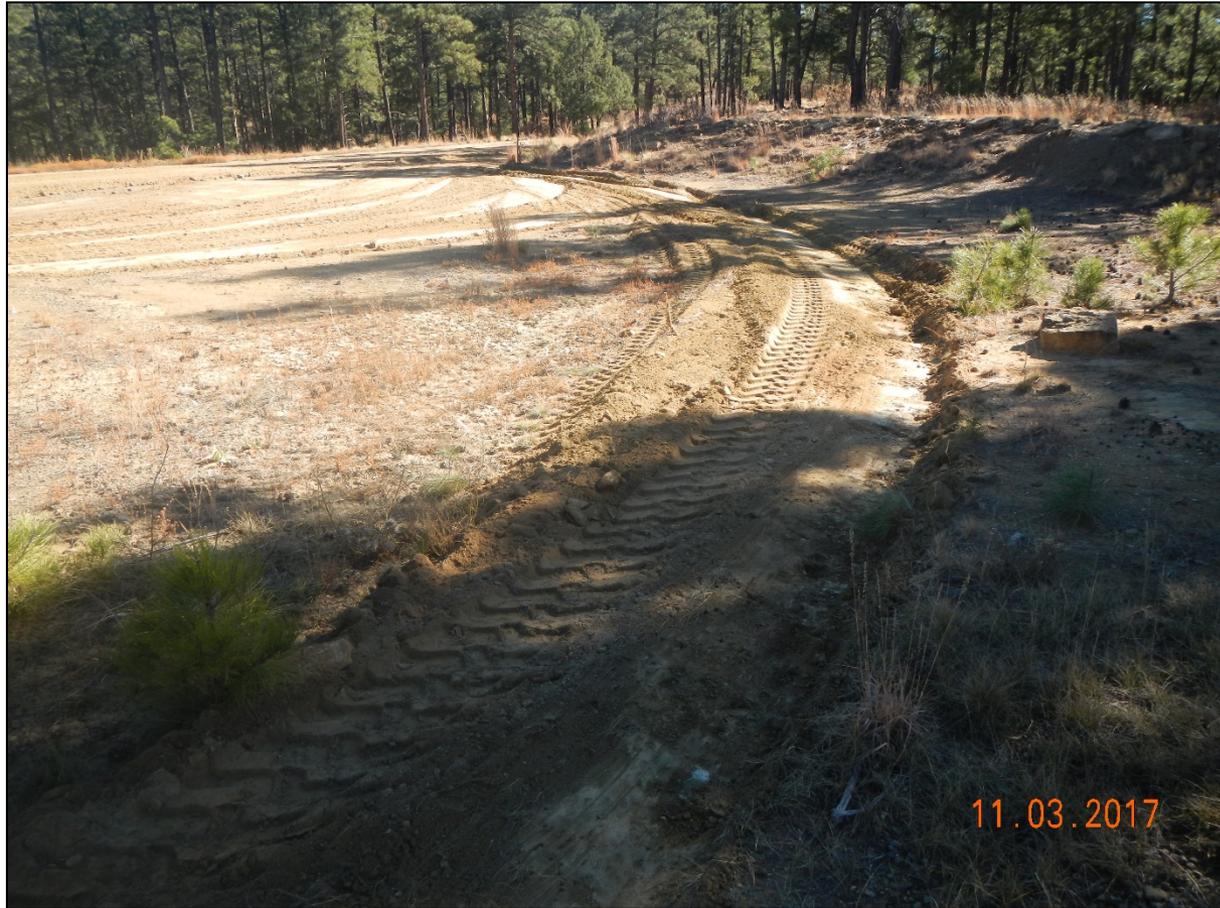
Photo 7. The diversion ditch was installed along the south side of the location.

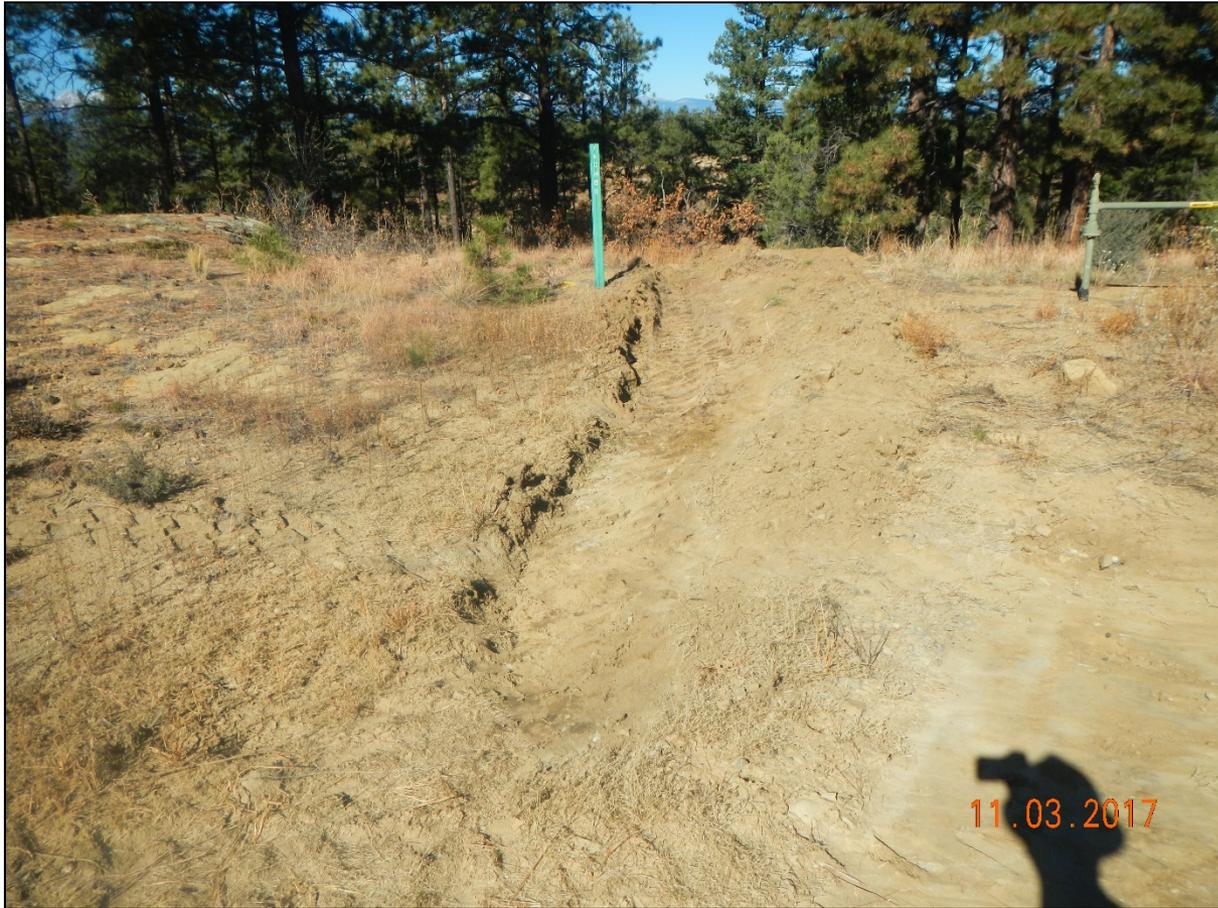
Photo 8. A diversion ditch was created for stormwater diversion. This disturbance is susceptible to erosion and no other BMP's are installed.
