Inspection Photos

Location Name: 17L-794 Pad

Spill Point ID #453078

Well Rulison 23c-17

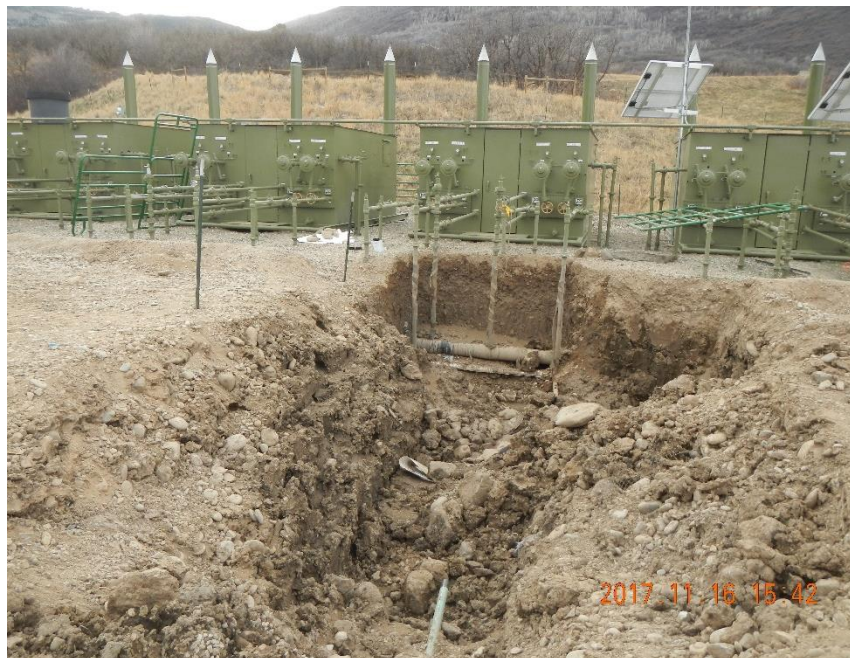
Looking west. Excavated area where the flowline from wellhead Rulison 23c-17 (API 045-18765) to the separator leaked.

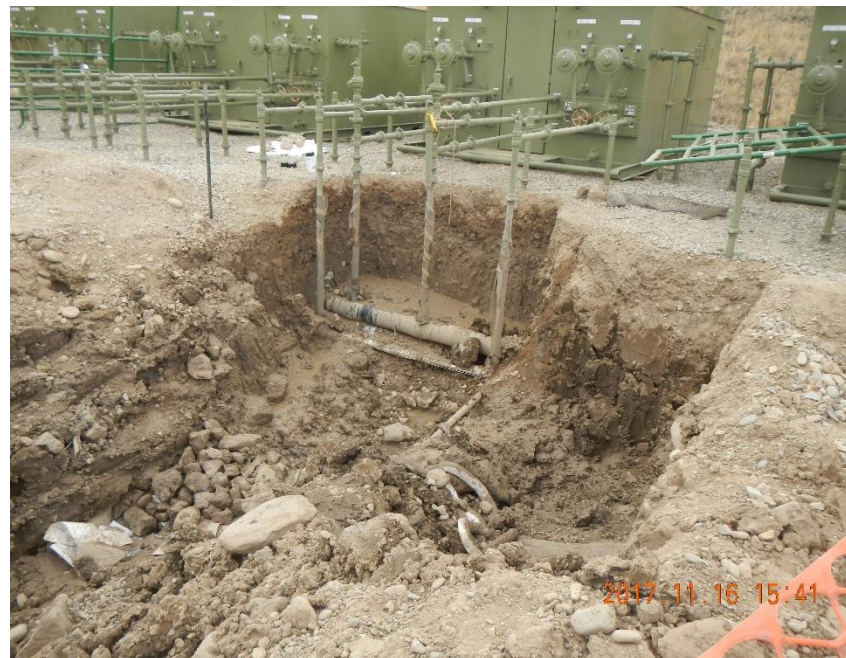
Excavation reached water table. A French drain crosses the excavation from left to right (south to north).

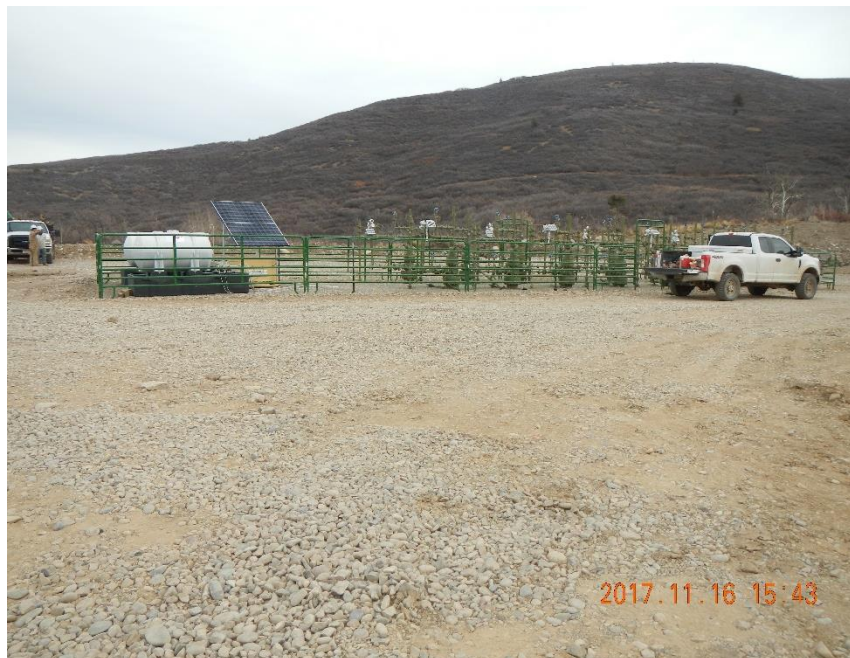
Looking east. Wellheads. Fenced.

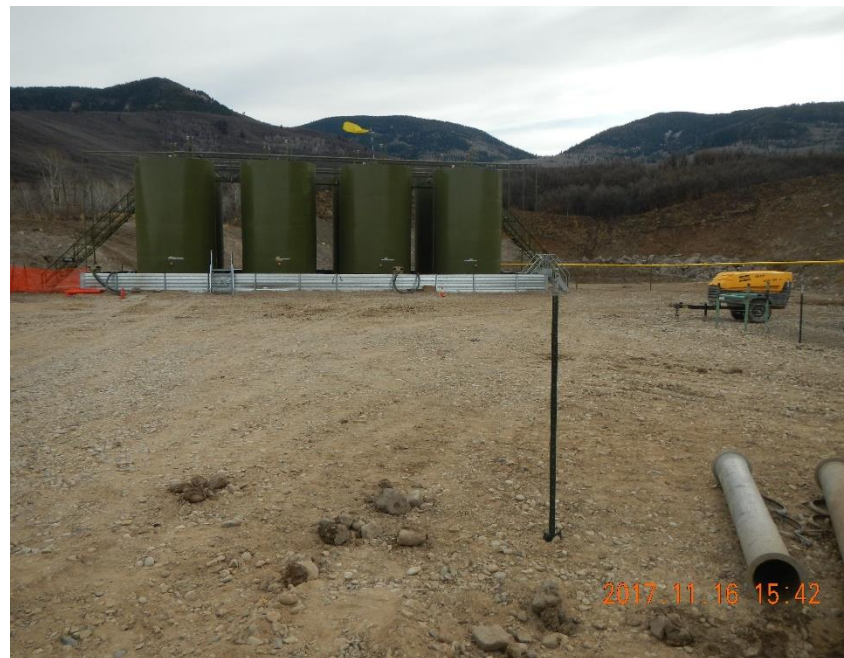
Looking south. Tank Battery, lined and bermed.

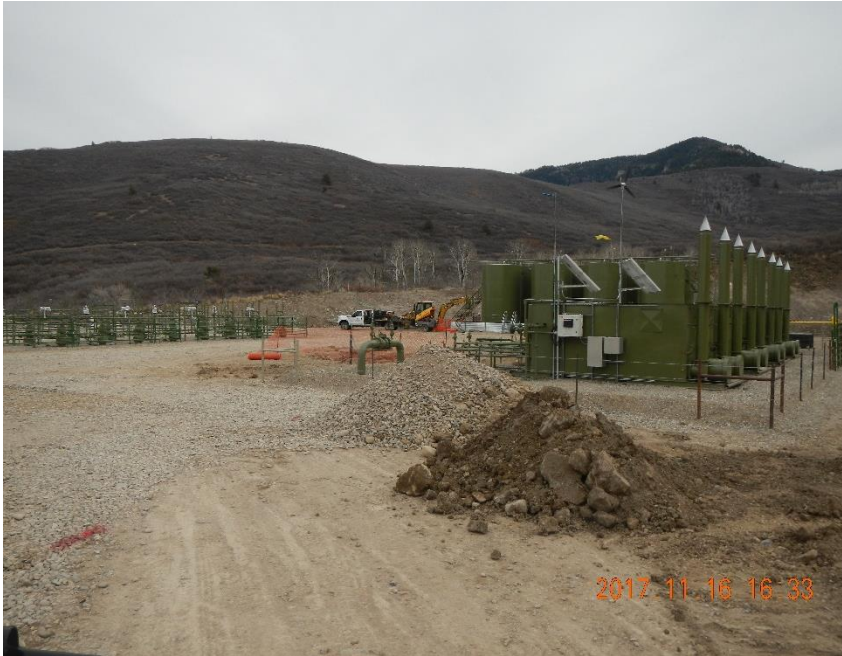
Looking south-southeast. Separators to the right, wellheads to the left and tank battery near the cut slope on the back.

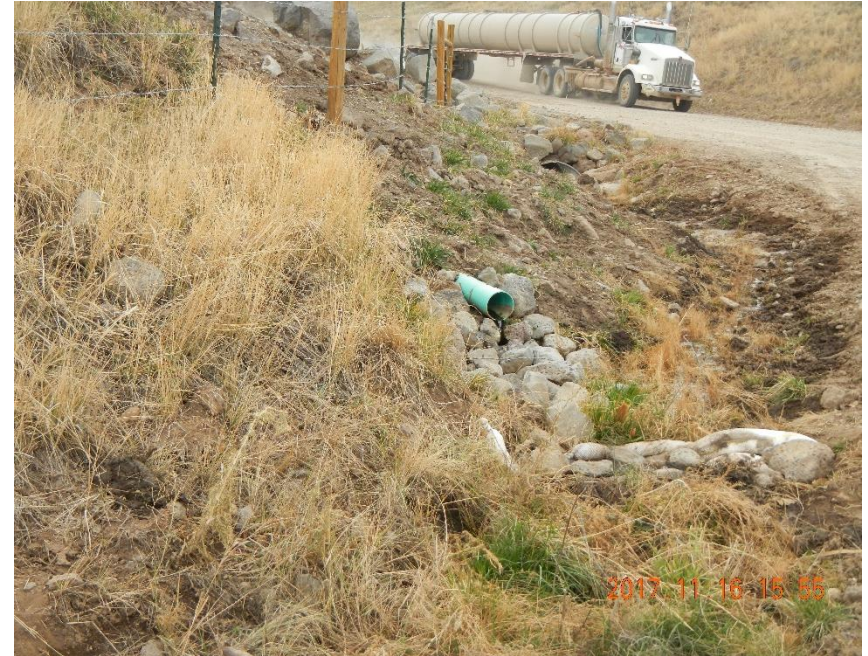
French drain (green pipe) discharging into the storm water drainage. Observe culvert further up. Water flows down to a retention pond (storm water BMP)

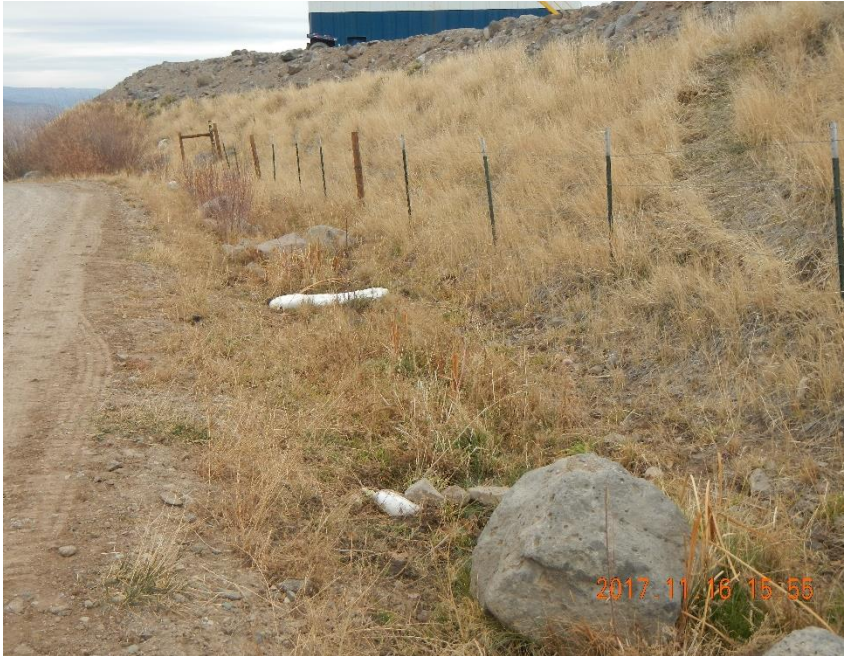
Storm water drainage with spill booms. Minimum if any staining was observed on booms.

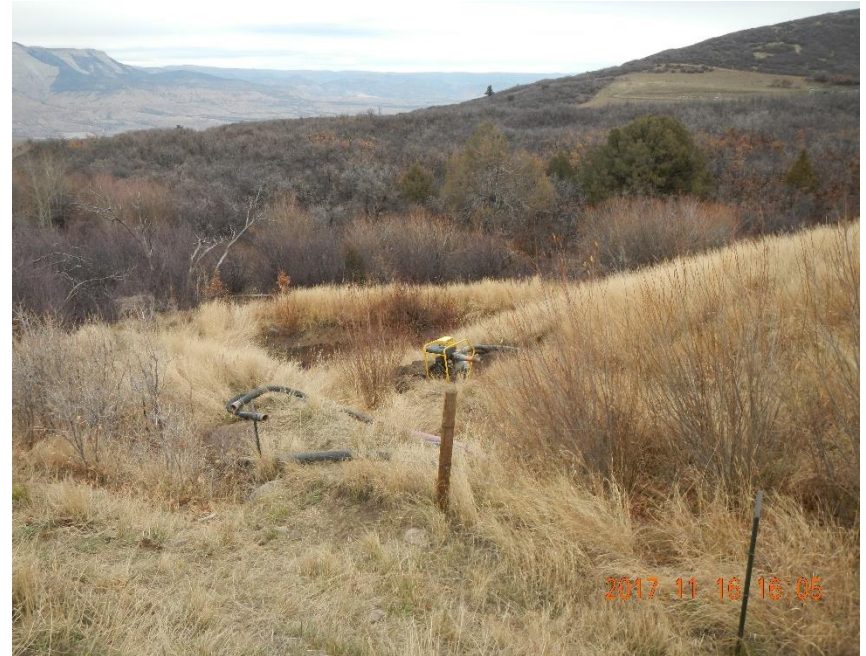
Retention pond. Caerus environmental consultant took samples of water in the pond and at the discharge of French drain and culvert.

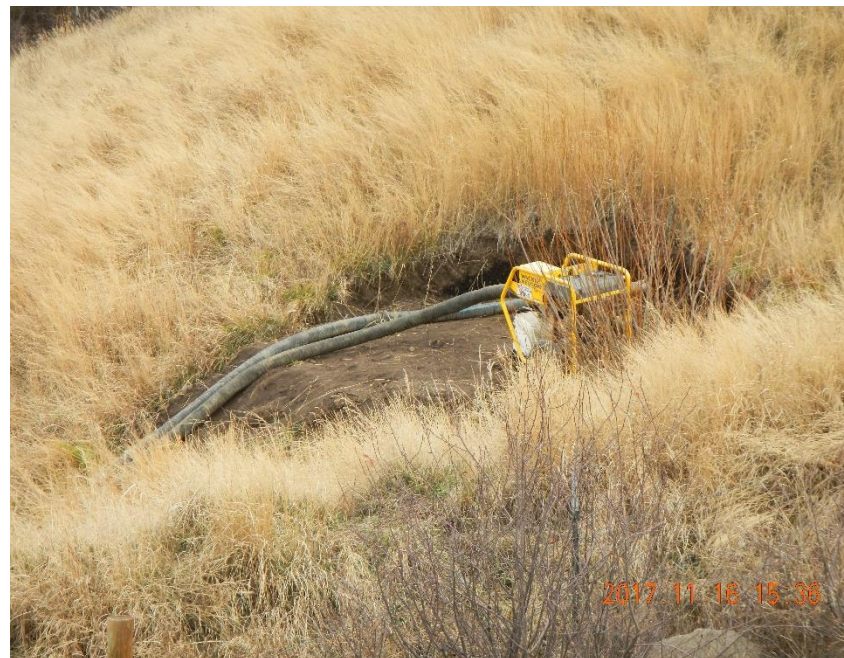
Pump to move water from retention pond back to the pad if necessary.
