Final Reclamation Inspection

December 4, 2017

Operator: KERR MCGEE OIL & GAS ONSHORE LP - # 47120

Location Name: CHAMPLIN 86 AMOCO Q #1

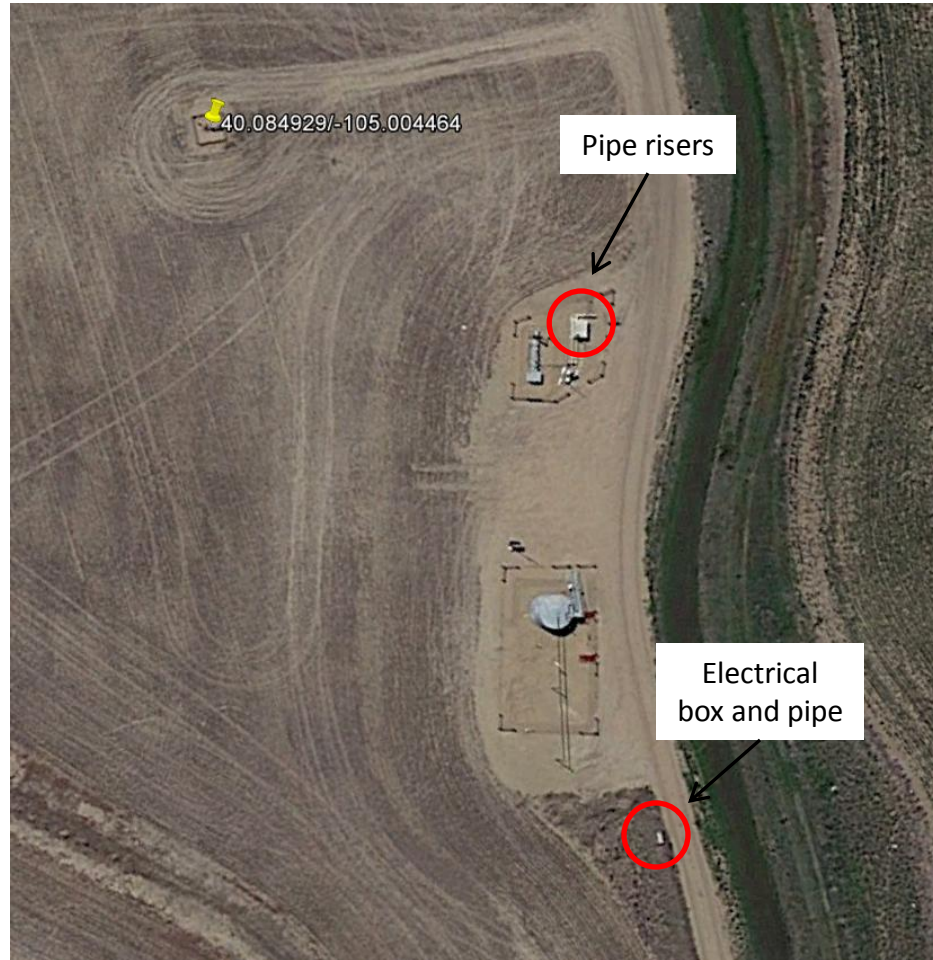
Photo 1. Google Earth aerial imagery taken on June 2, 2014 during active operations. Appears equipment and pipe risers have been left after plugging operations. Well was plugged October 27, 2014.

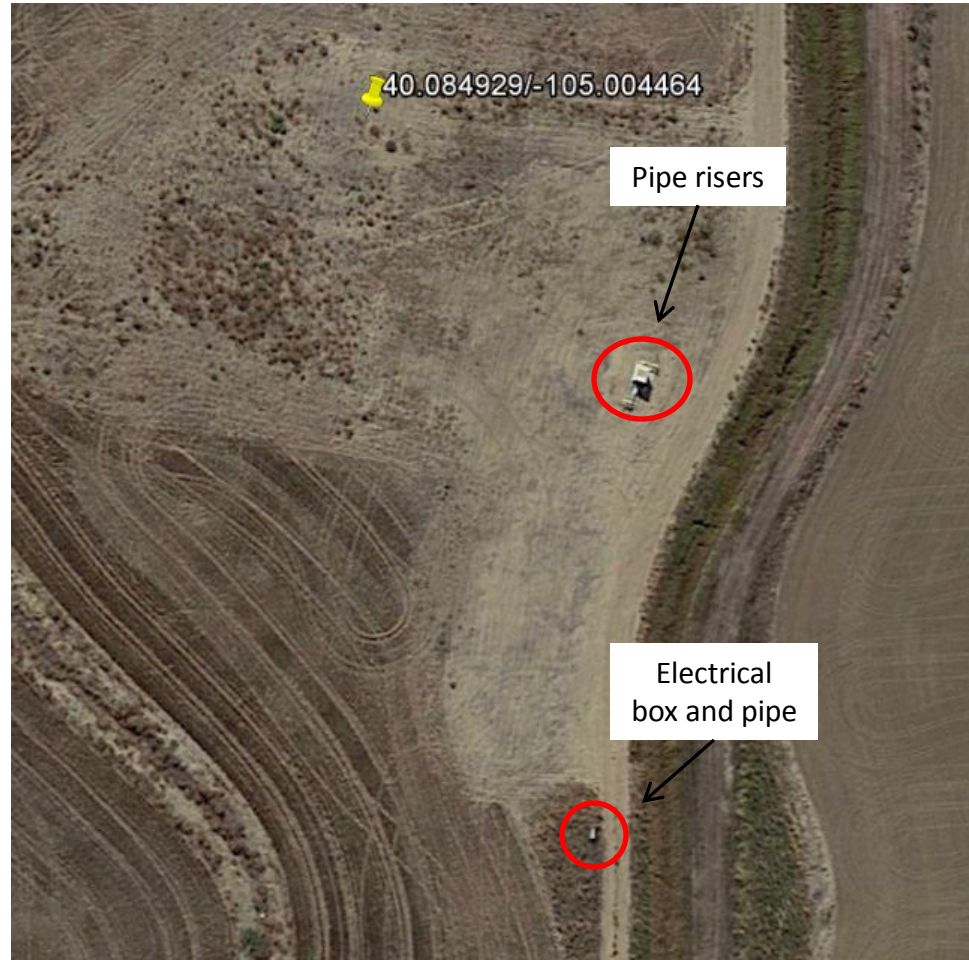
Photo 2. Google Earth aerial imagery taken on October 9, 2015 after plugging operations. Appears equipment and pipe risers have been left after plugging operations. Well was plugged October 27, 2014.

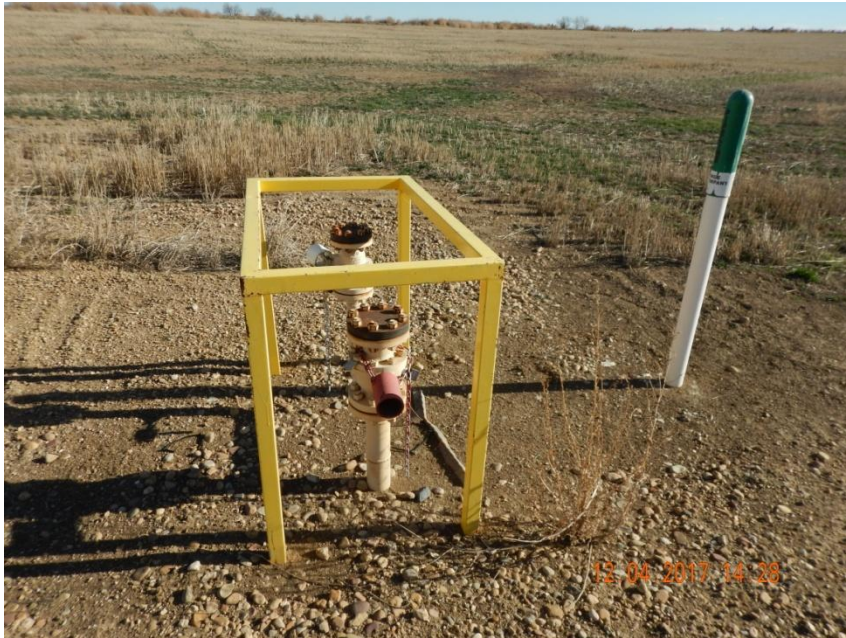
Photo 3. Photo taken from the southern battery location, facing East. Pipe risers remain at location. Operator needs to remove pipe risers per Rule 1004.a.

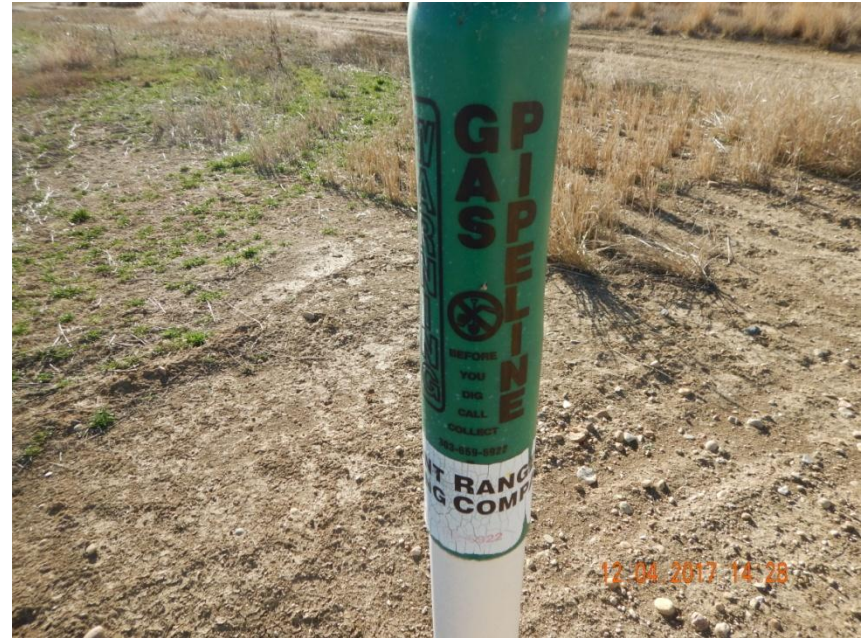
Photo 4. Close up photo taken from the post next to the pipe risers.

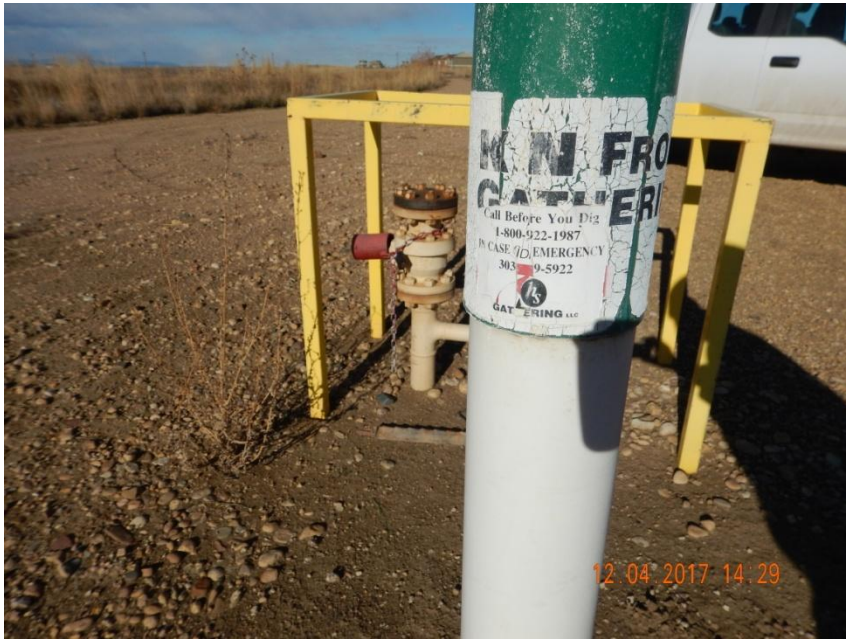
Photo 5. Close up photo taken from the post next to the pipe risers.

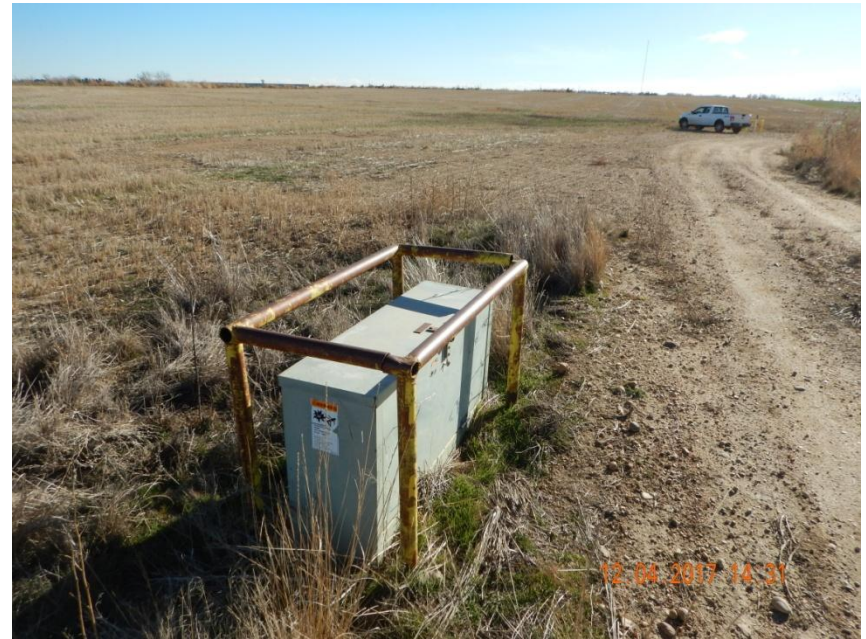
Photo 6. Photo taken from the northern battery location, facing South. Operator needs to remove equipment per Rule 1004.a.

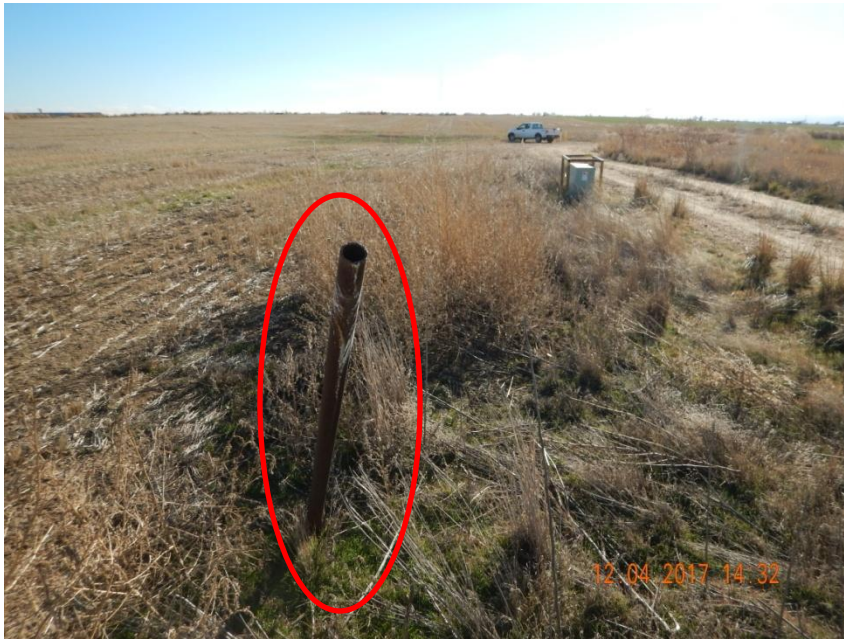
Photo 7. Photo taken from the northern battery location, facing South. See comments under Photo 6.

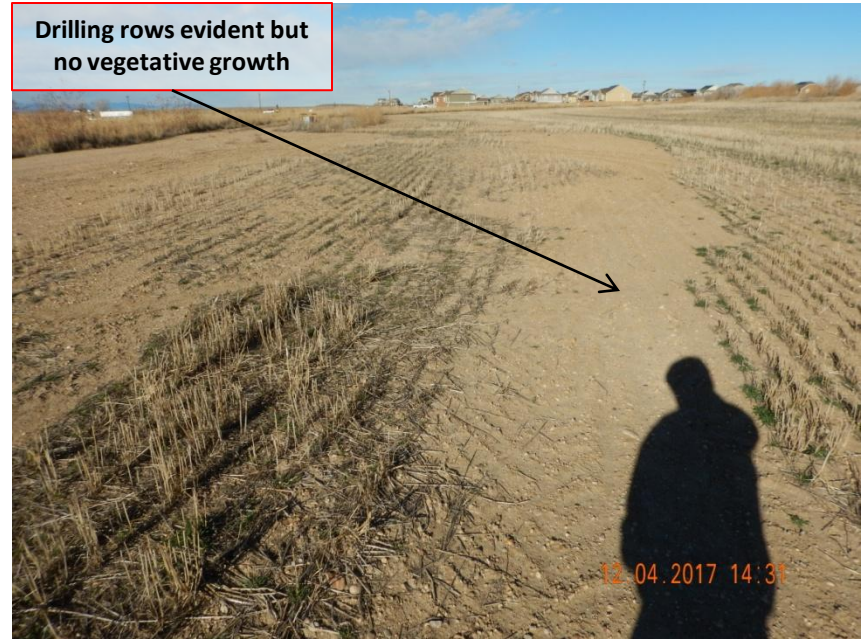
Photo 8. Photo taken from the southern battery location, facing North. Does not appear the Operator has removed gravel from the battery location; therefore, Operator has not performed compaction alleviation due to the lack of growth which is not reflective of reference vegetative levels.

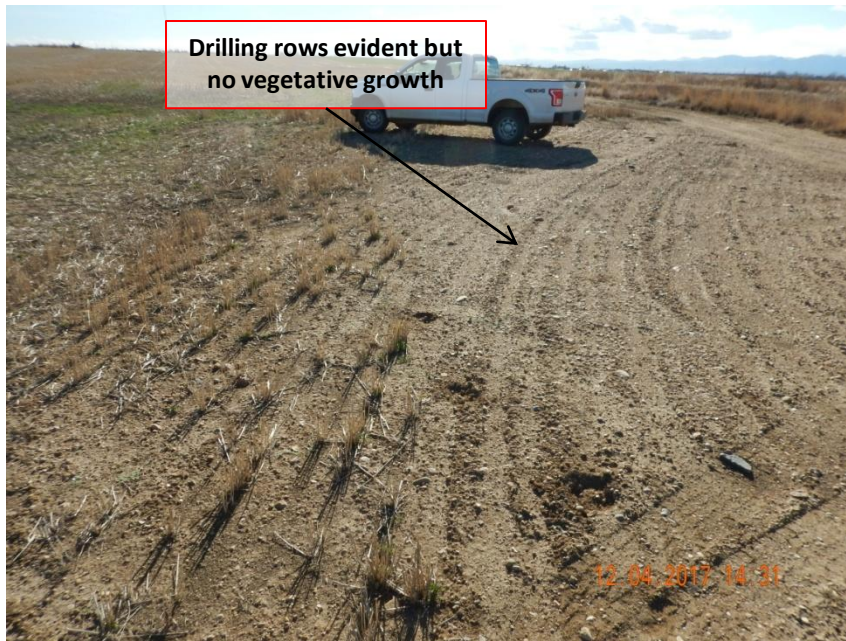
Photo 9. Photo taken from the southern battery location, facing South. See comments under Photo 8.

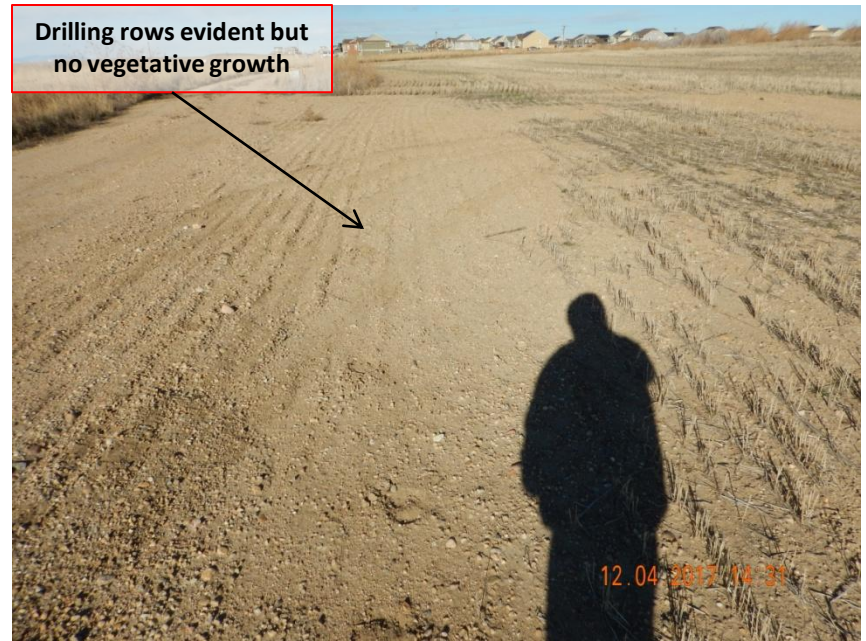
Photo 10. Photo taken from the central battery location, facing North. See comments under Photo 8.

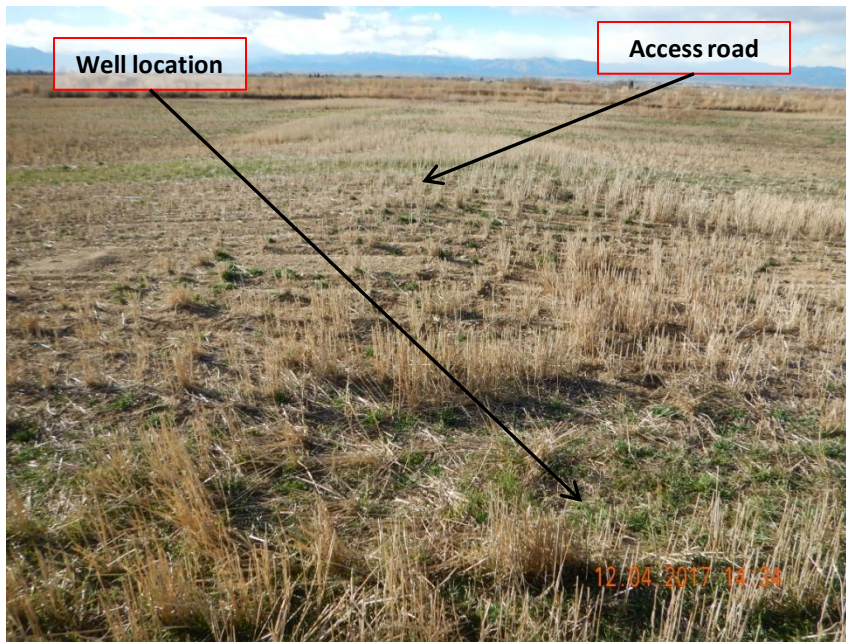
Photo 11. Photo taken from the well location, facing West. Appears subsidence is evident at the well location. Does not appear the Operator has contoured the access road used for the well location.

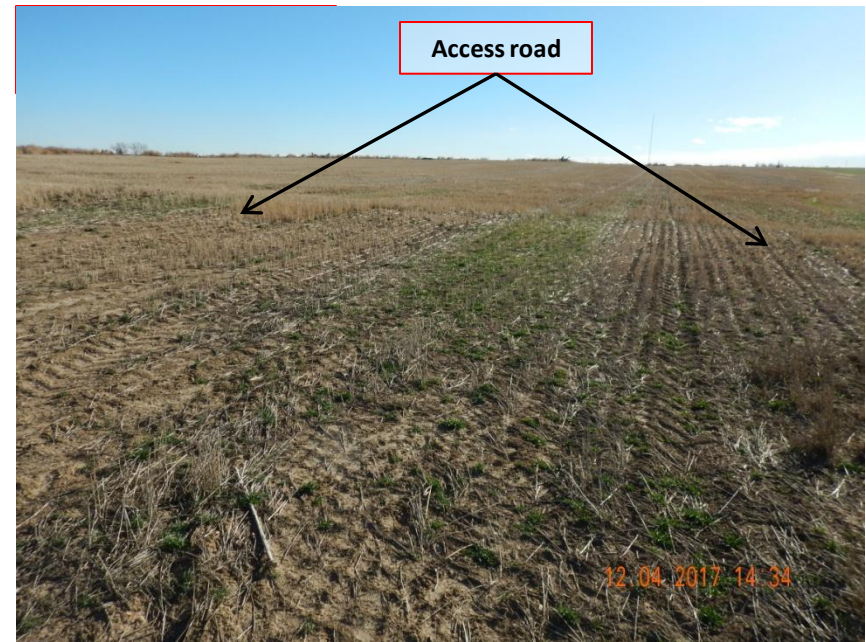
Photo 12. Photo taken north of the well location, facing South. Does not appear the Operator has contoured the access road used for the well location.
