Inspection Photos
Location Name: Pauline #5
API: 05-123-12903

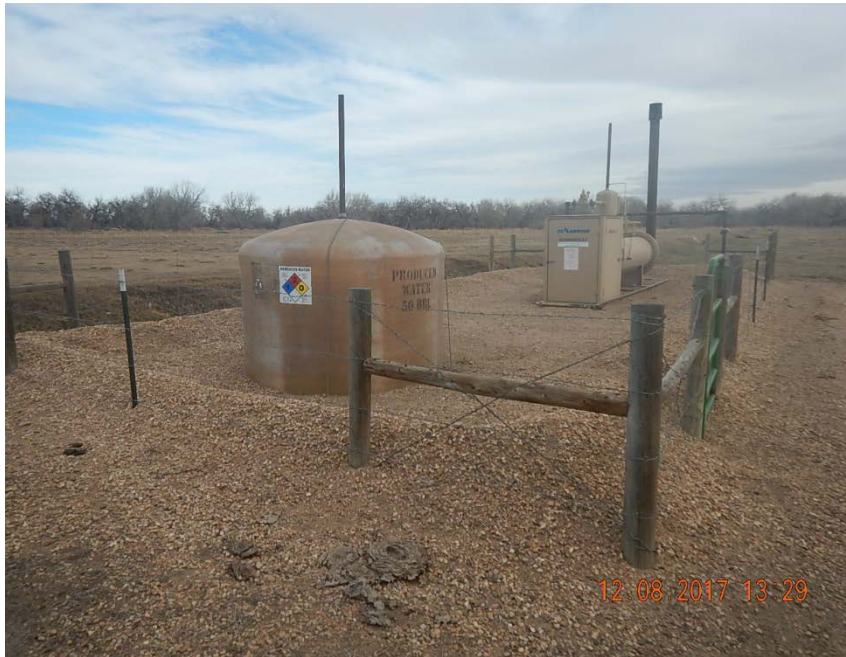
Photo 1: Location, looking NE. Berms are earthen in floodplain.

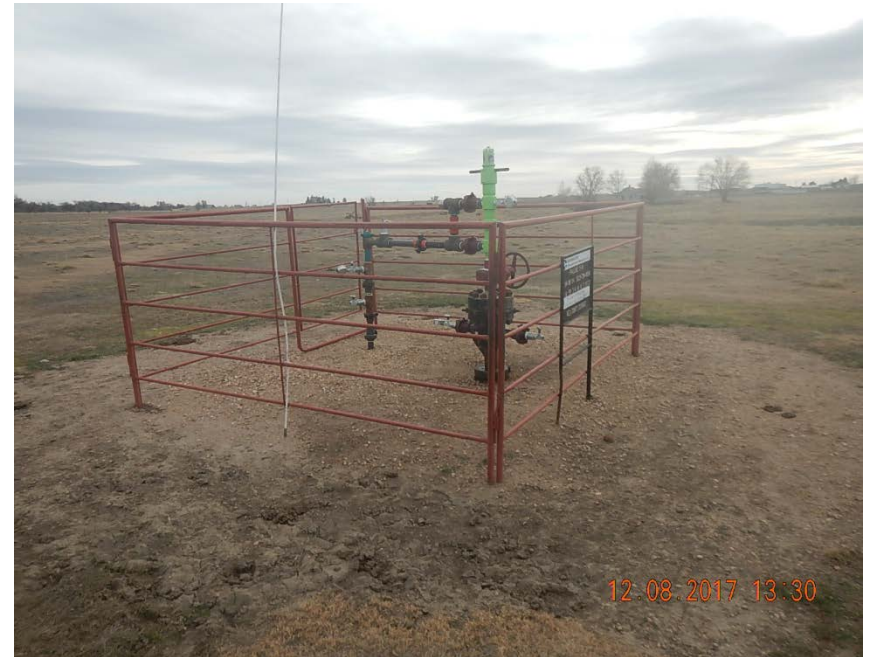
Photo 2: Wellhead, looking SE

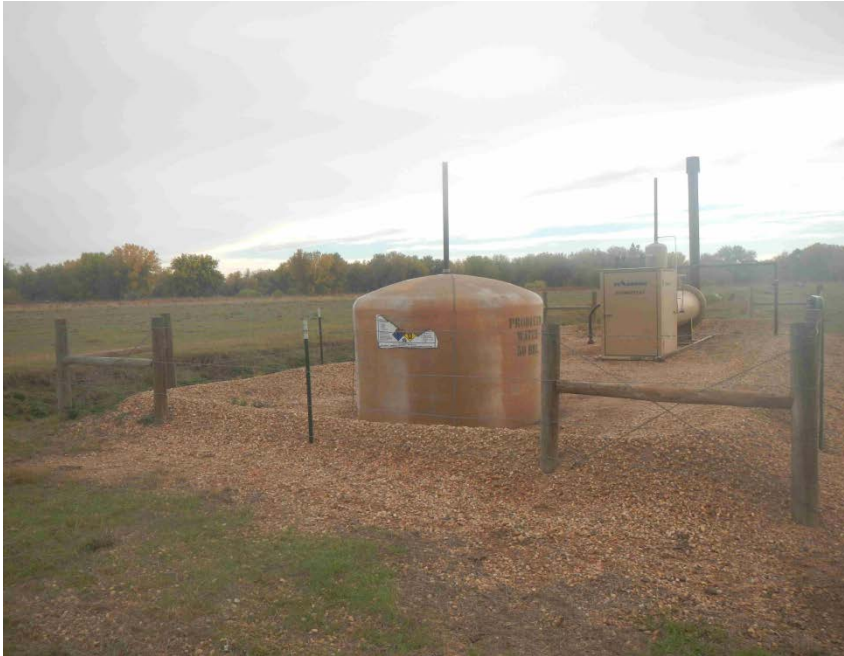
Photo from J Gomez's prior inspection for comparison

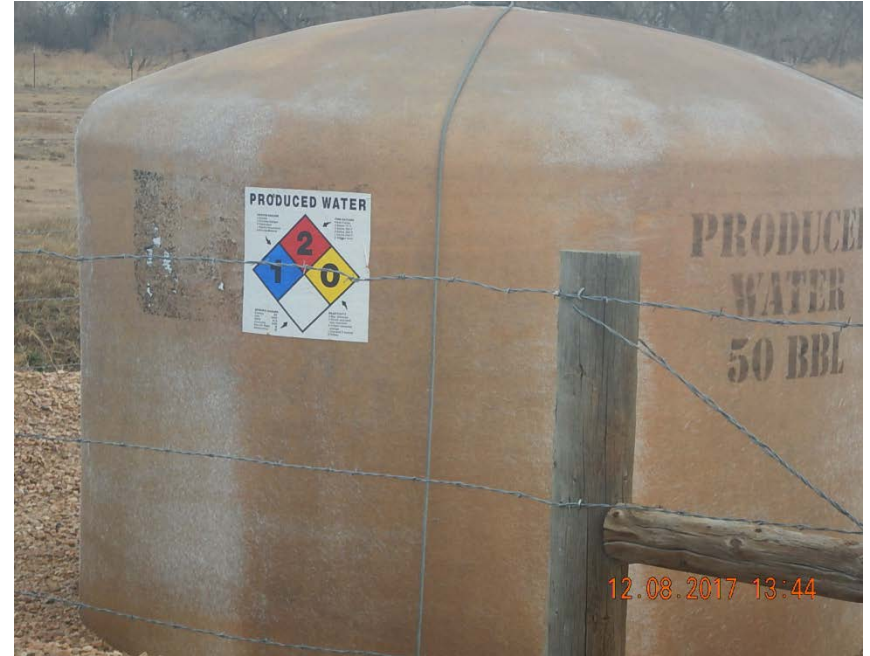
Photo 3: NFPA label replaced.

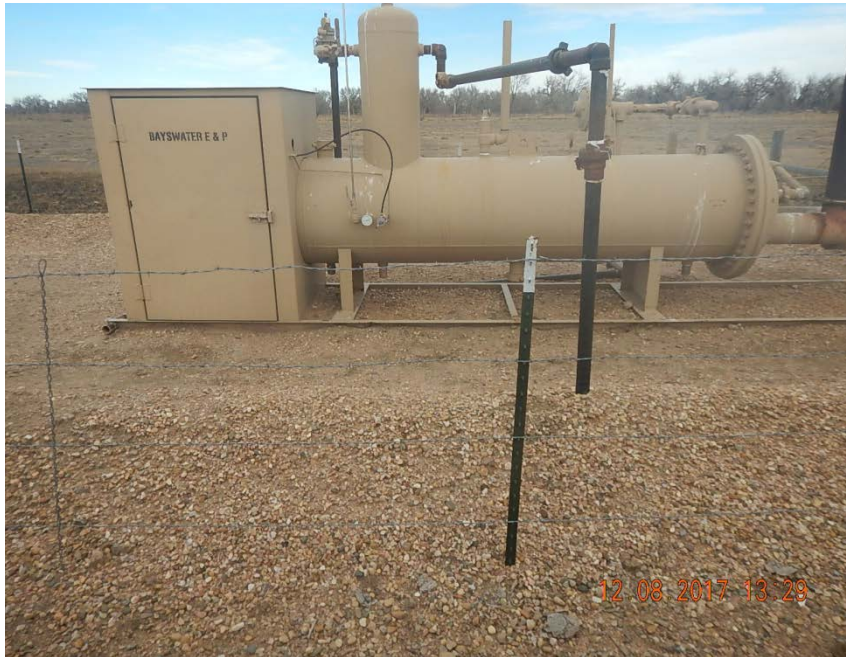
Photo 4: Separator is not properly anchored in floodplain.
