Location Name: XTO API 103-10111

1/02/2018

XTO 103-10111

Inspection 1/02/2018

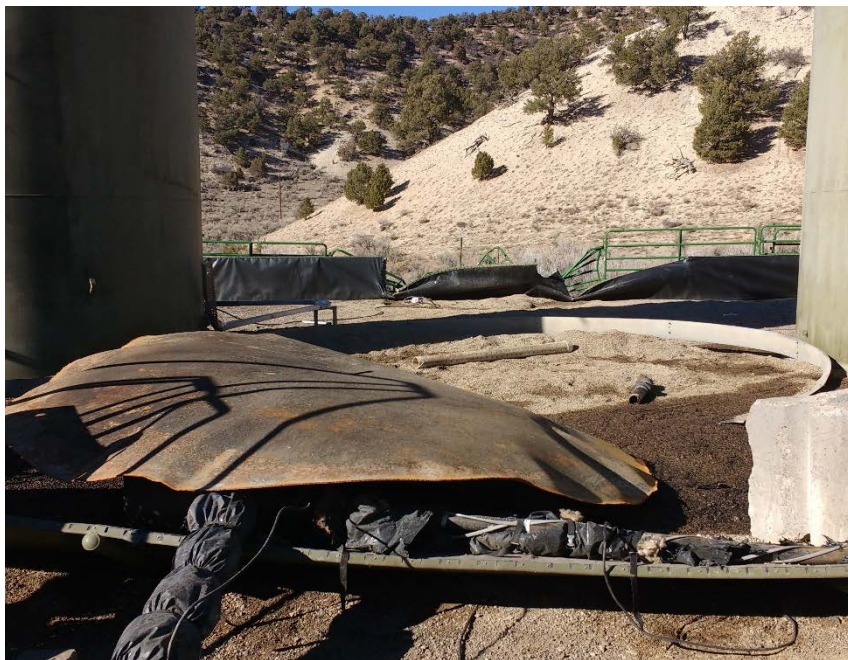
Tank base and bottom looking west

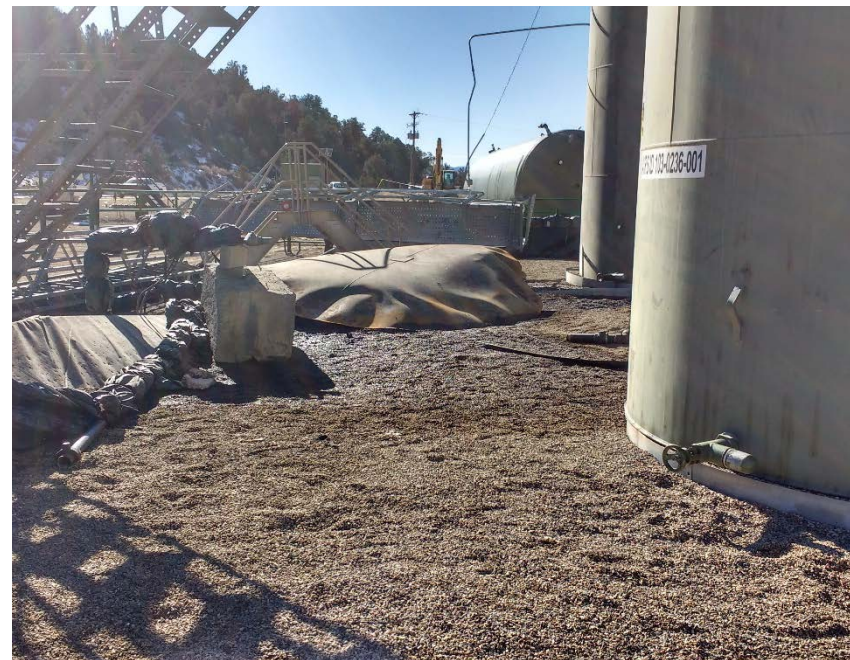
Stained gravel in SPCC looking south

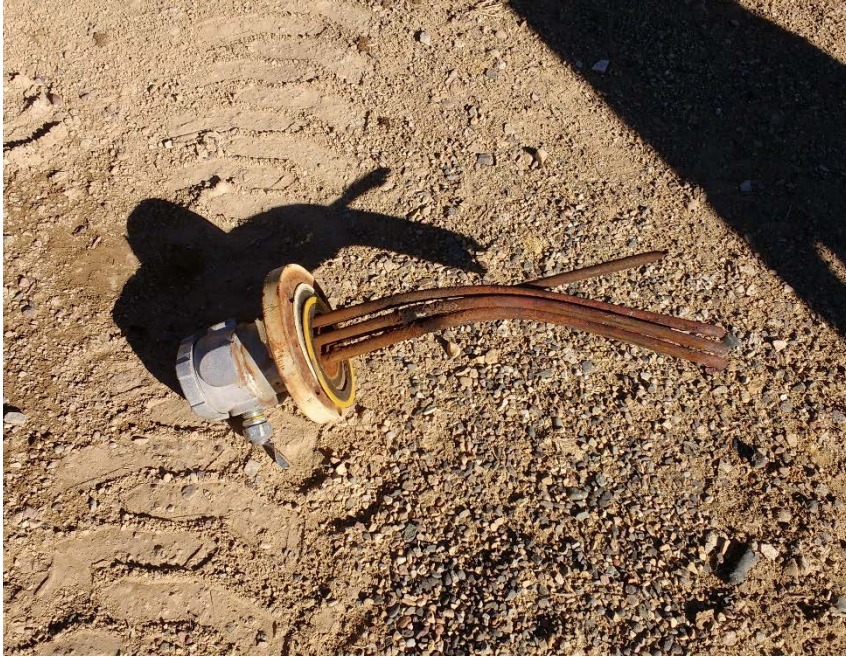
Electric tank heater removed for testing

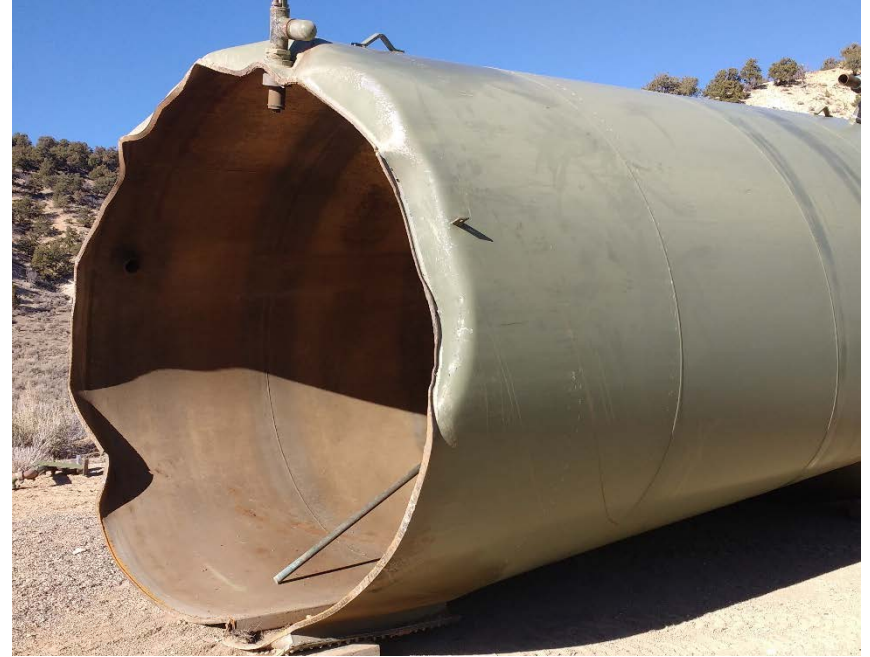
Tank with bottom missing. Tank has been moved from accident area
