Inspection Photos

API: 05-067-06559

Operator: BP AMERICA PRODUCTION COMPANY

Inspection Number: 680602407

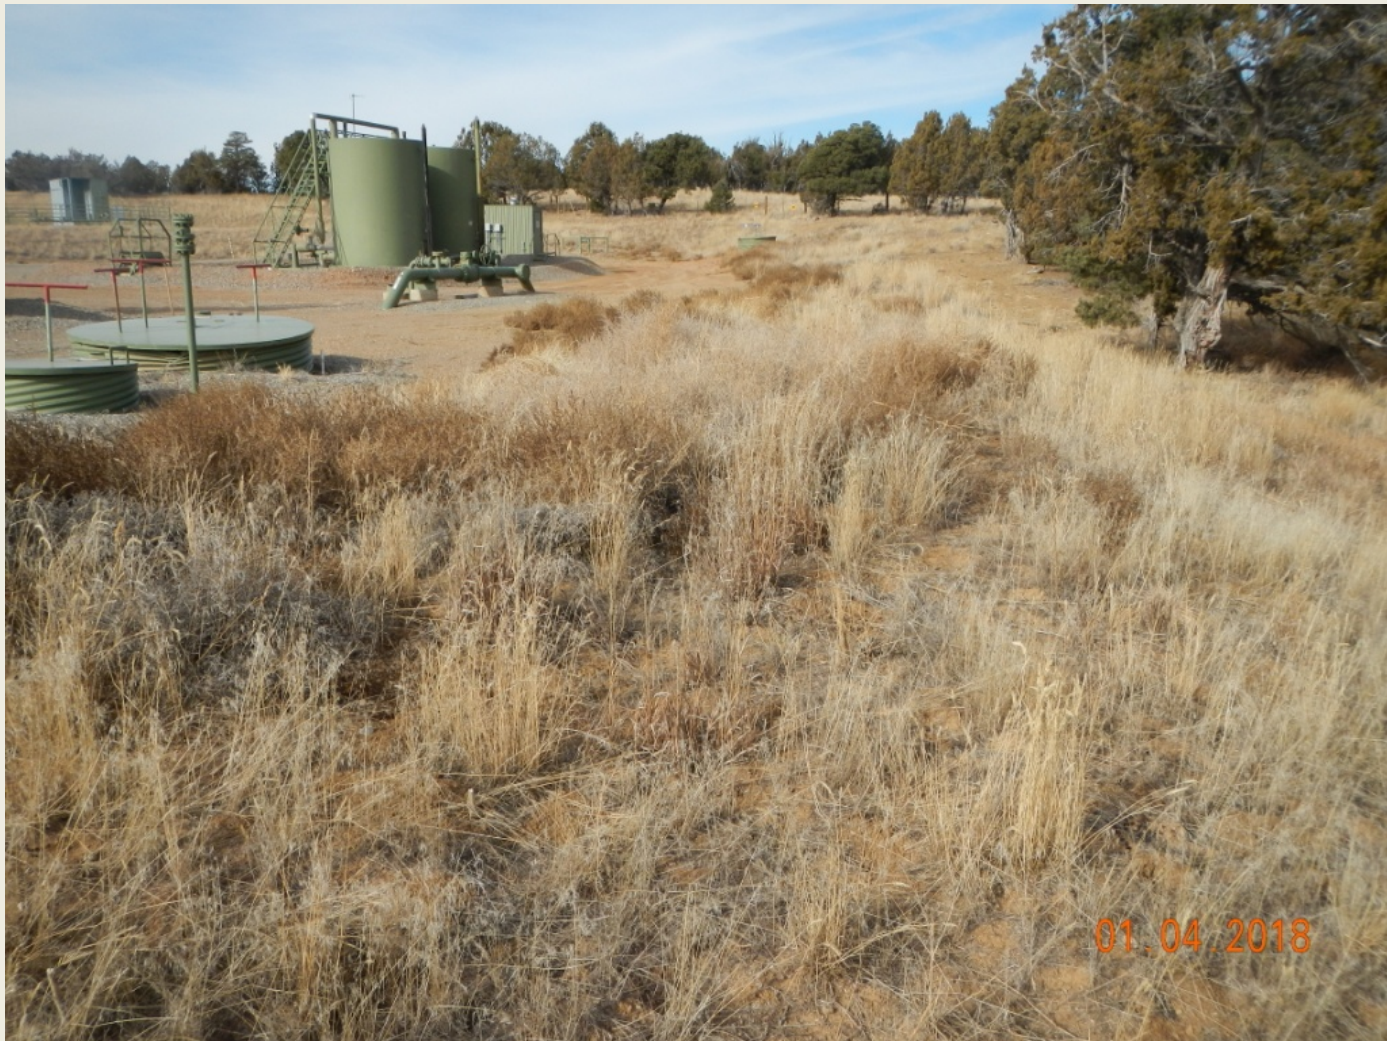
Photo 1. View of the northern portion of the project area from the northeastern corner facing westward.

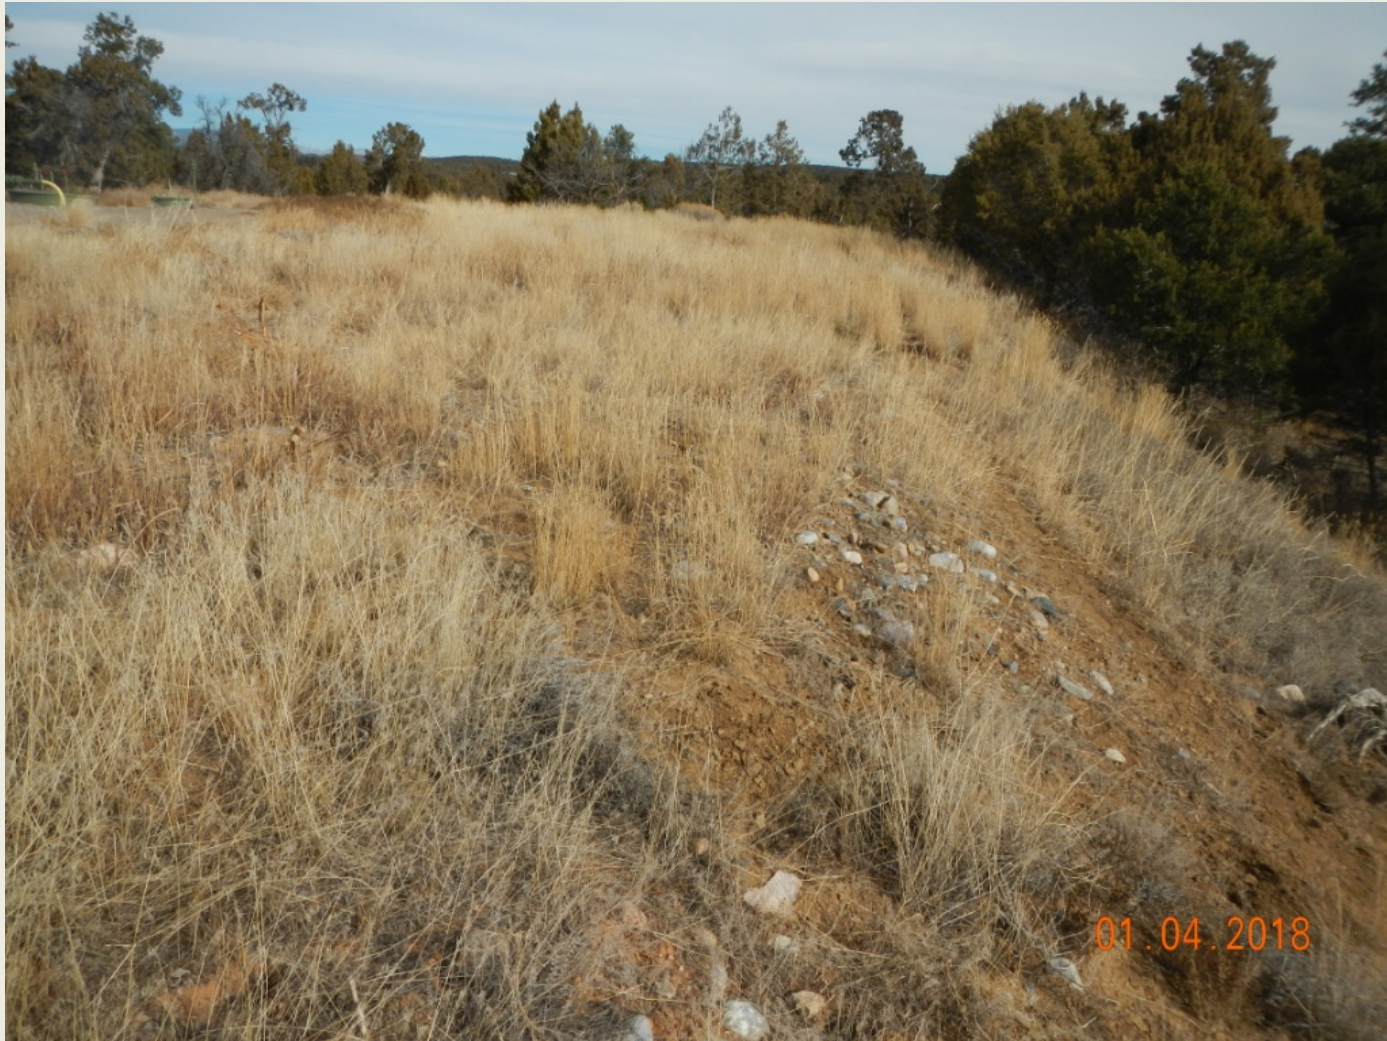
Photo 2. View of the eastern portion of the project area from the southeastern edge facing northward, revegetation is progressing within this portion of the interim reclamation area.

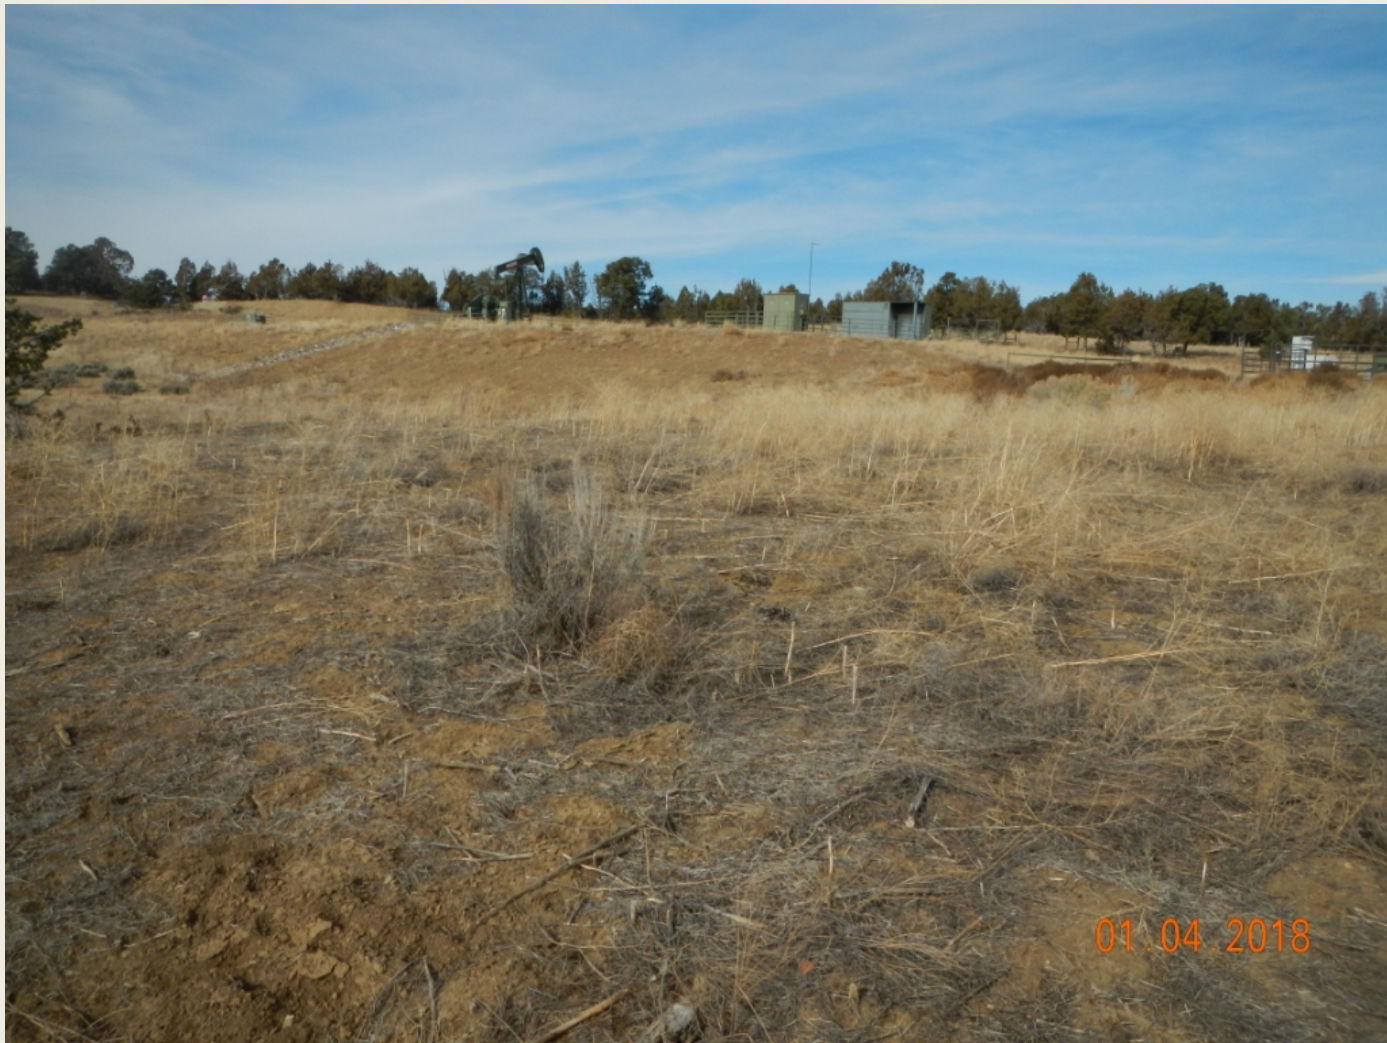
Photo 3. View of the southern portion of the interim reclamation area from the southeastern edge facing westward. Vegetation in this area is largely annual weeds such as yellow tumblemustard (*Sysimbrium altissimum*). This needs to be evaluated during the 2018 growing season and re-seeded by November 1, 2018 if desirable cover is not established.

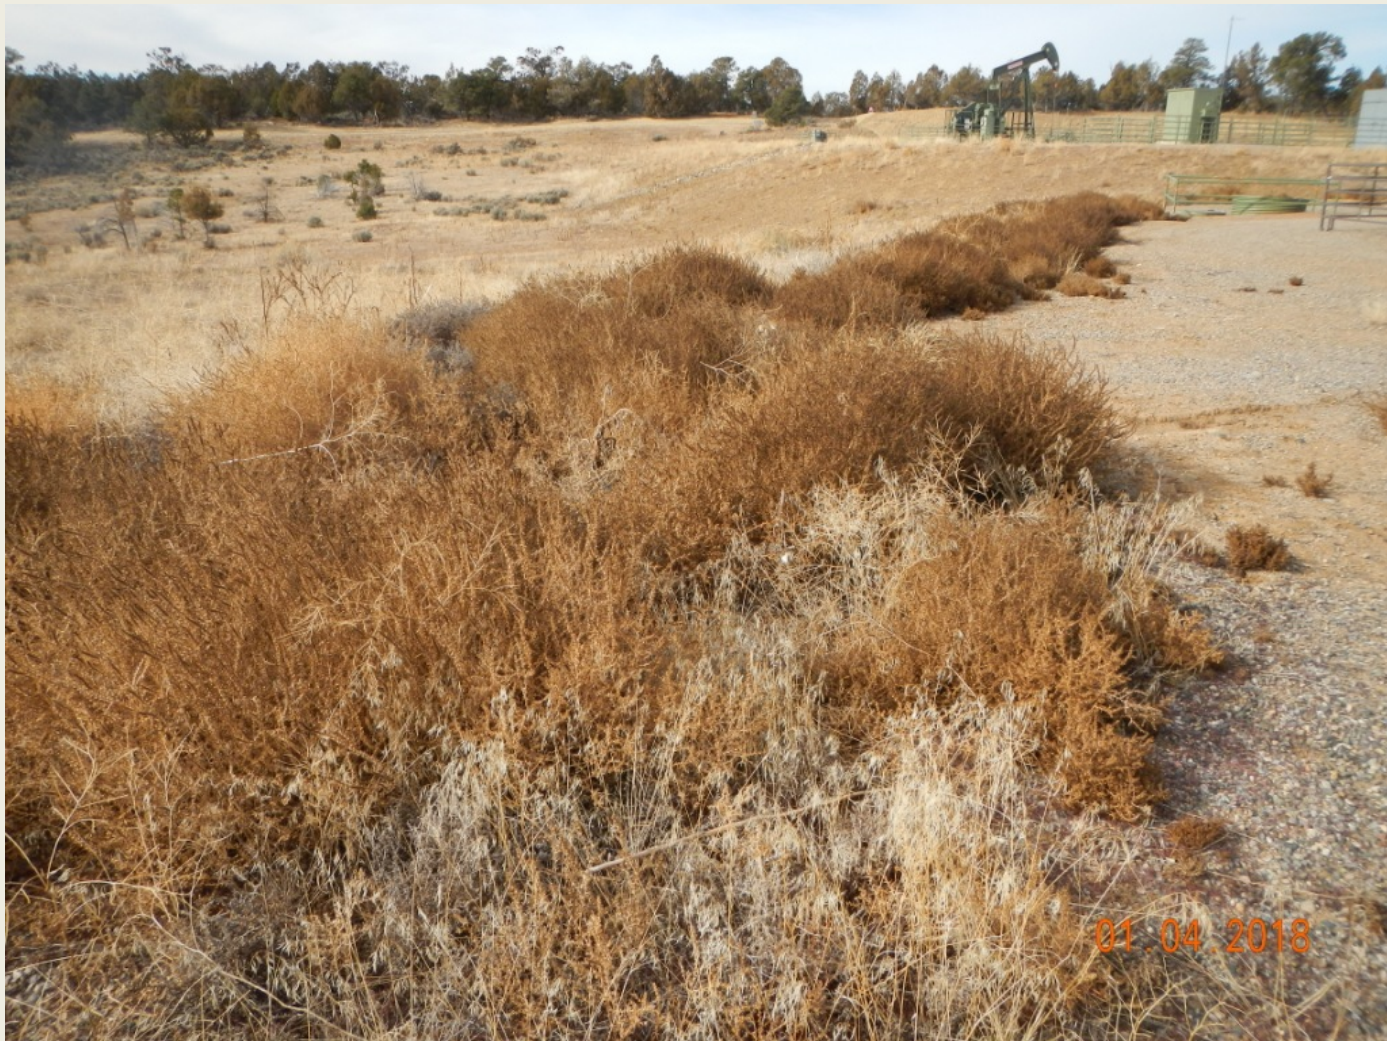
Photo 4. View of Russian thistle (*Salsola tragus*) debris within the southern portion of the project area.

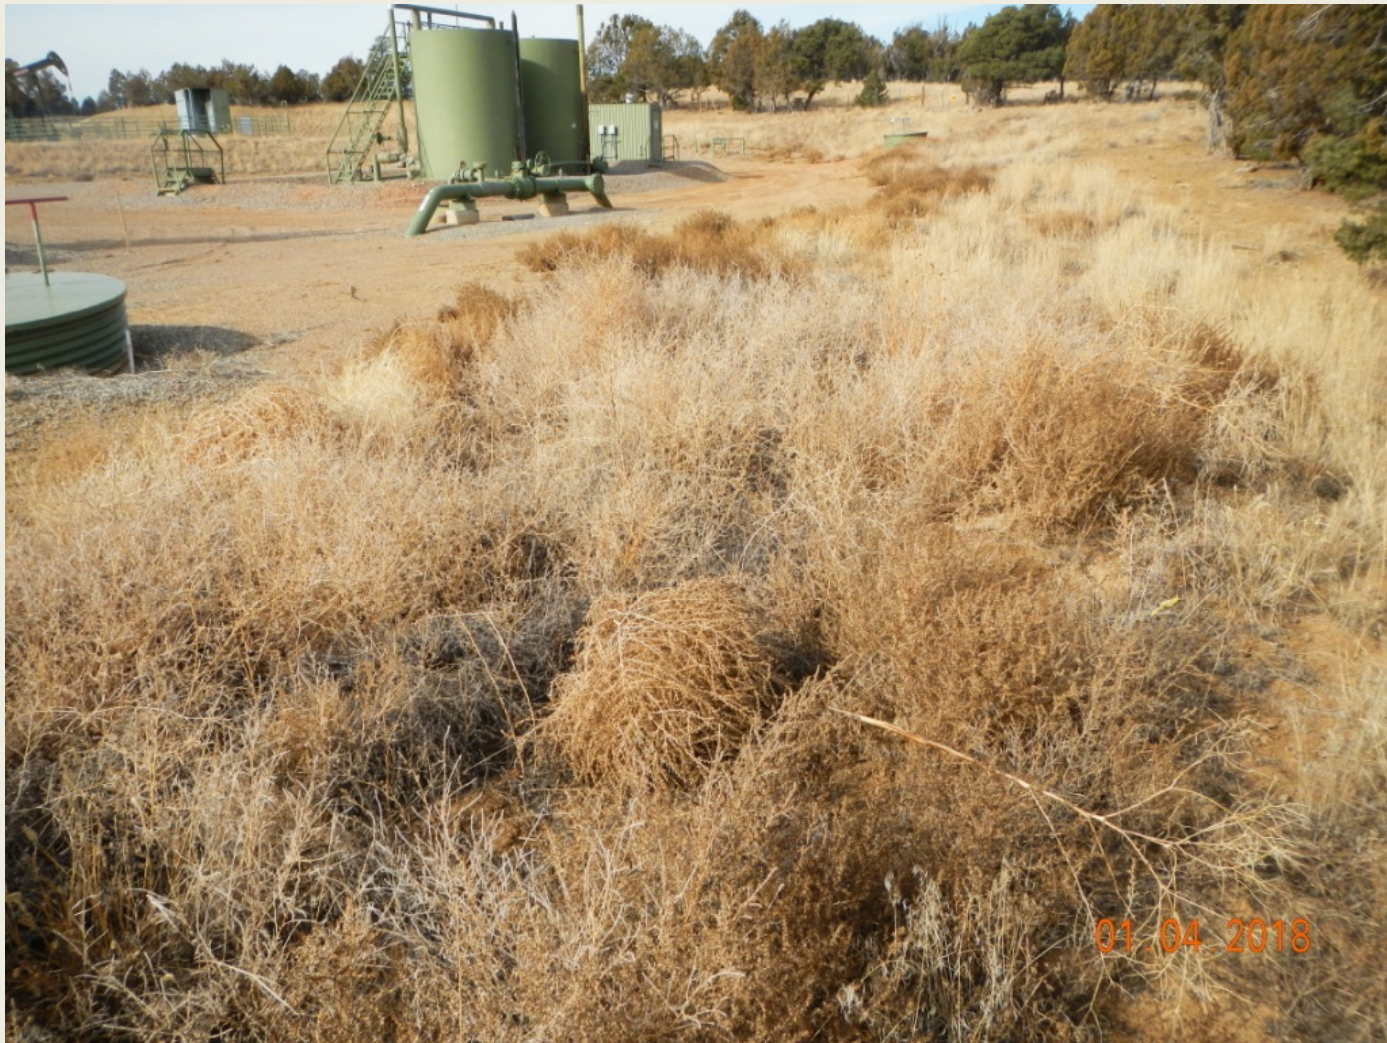
Photo 5. View of Russian thistle debris in the northern portion of the project area.

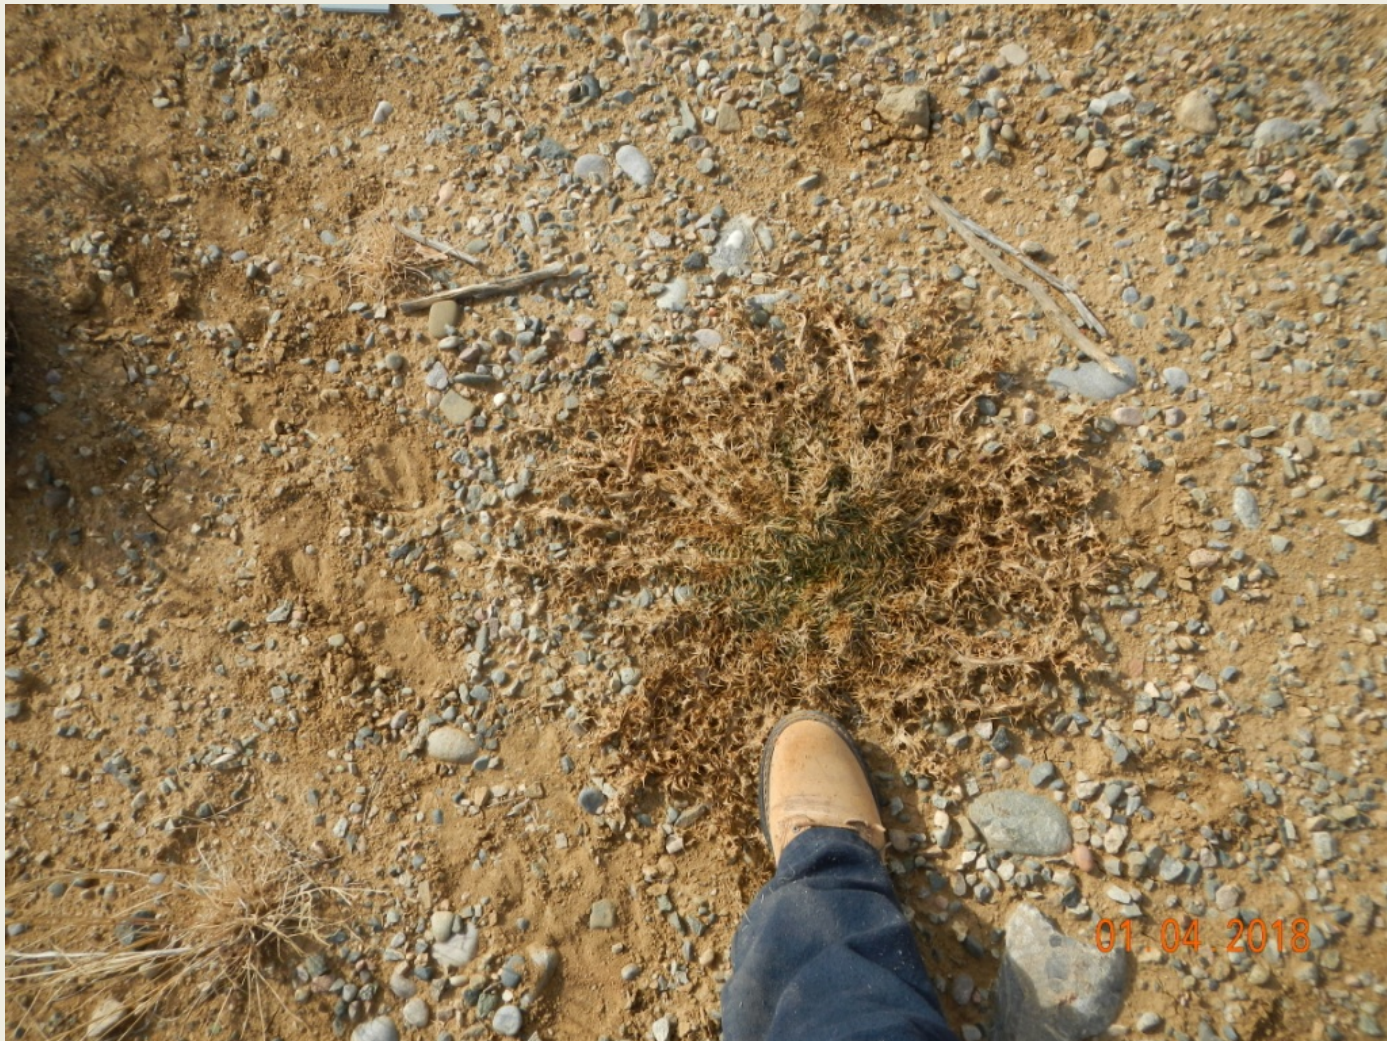
Photo 6. View of musk thistle (*Carduus nutans*) within the project area.

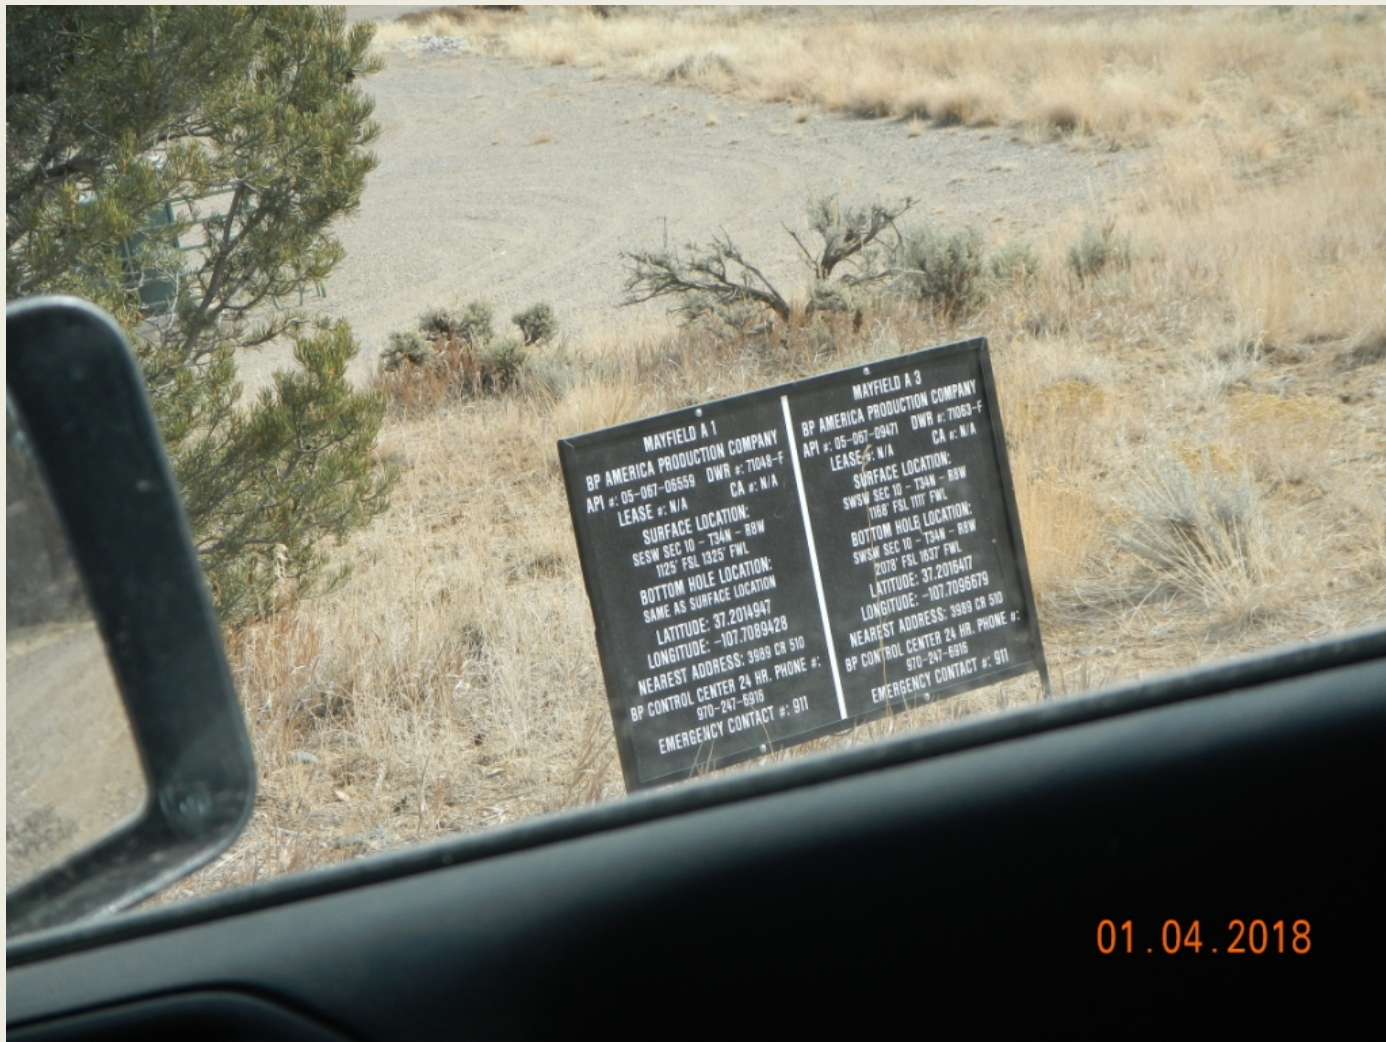
Photo 7. View of sign at the entrance to the well pad.
