Photo log for Response to June 12, 2018 Inspection

COGCC conducted an inspection of the Lilli Field Unit 3-7 location (Location ID 331106) on June 12, 2018 (Document 684905510). During that inspection, COGCC made the following observation:

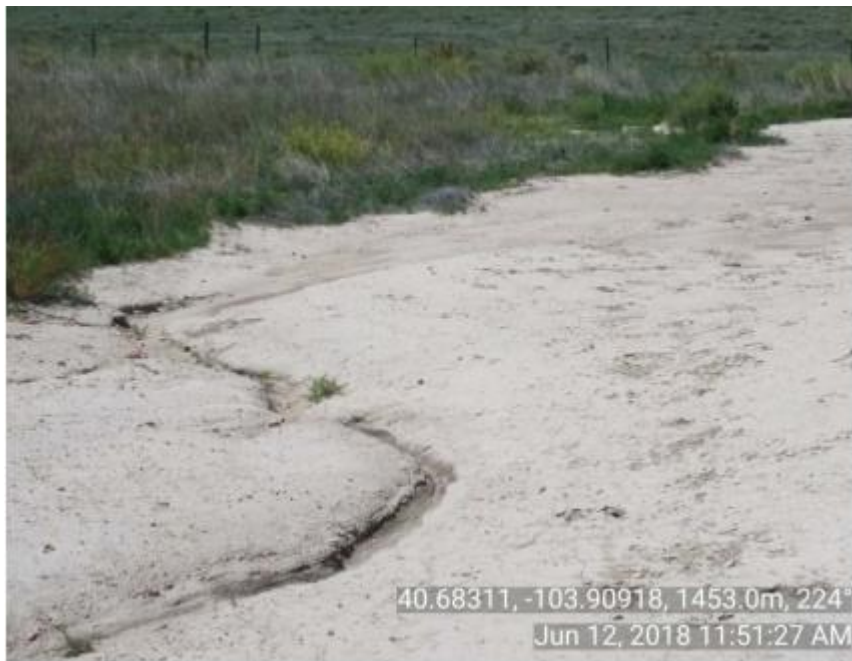
COGCC – 6/12/18

Storm Water: Stormwater erosion from NE corner of location, across location to SW corner of location. Install or repair required BMPs per Rule 1002.f.

COGCC Photo 3: Stormwater erosion SW of location
