**GR 32-34**  
**API# 05-045-06813**  
**Inspection# 689701748**

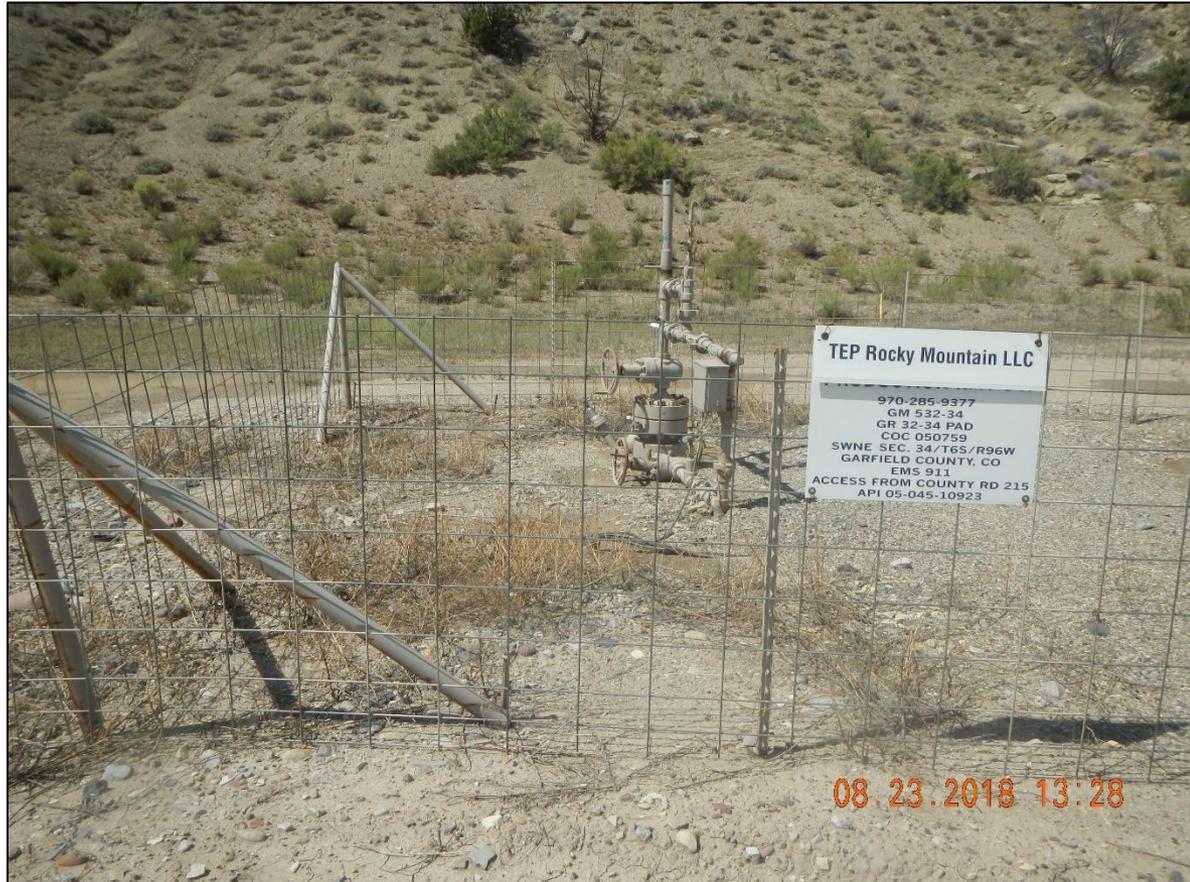
**Well photo.**

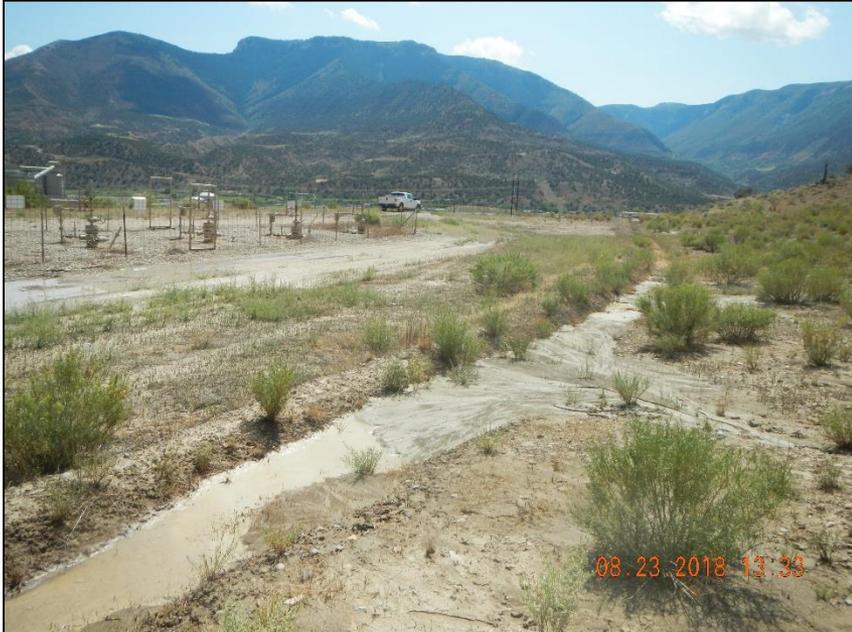
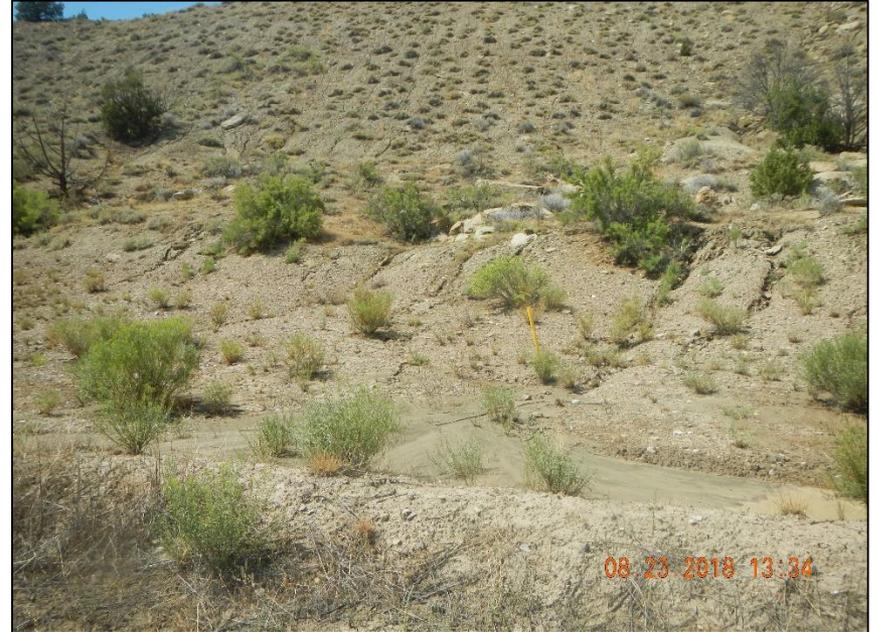
**Sediment build up in location ditch**

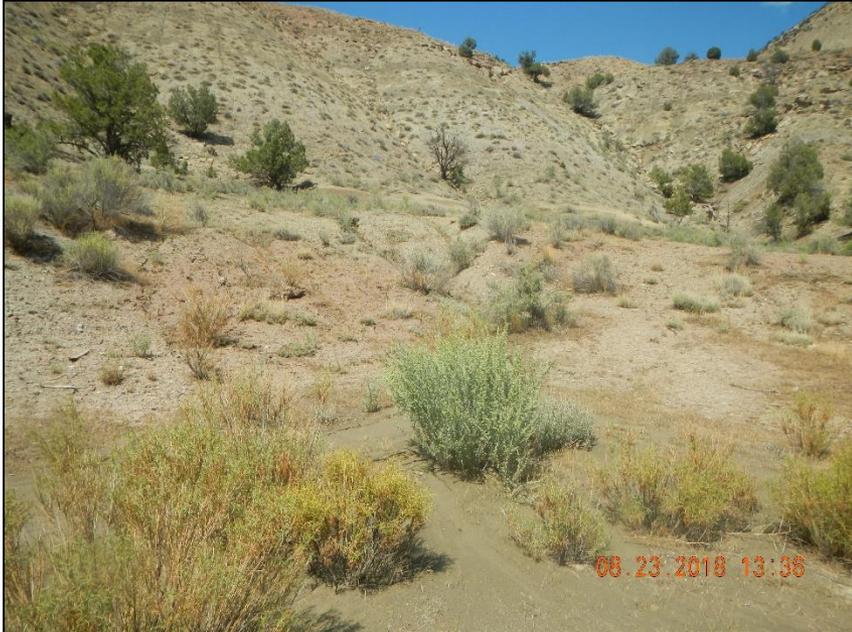
**Sediment washing on to location.**

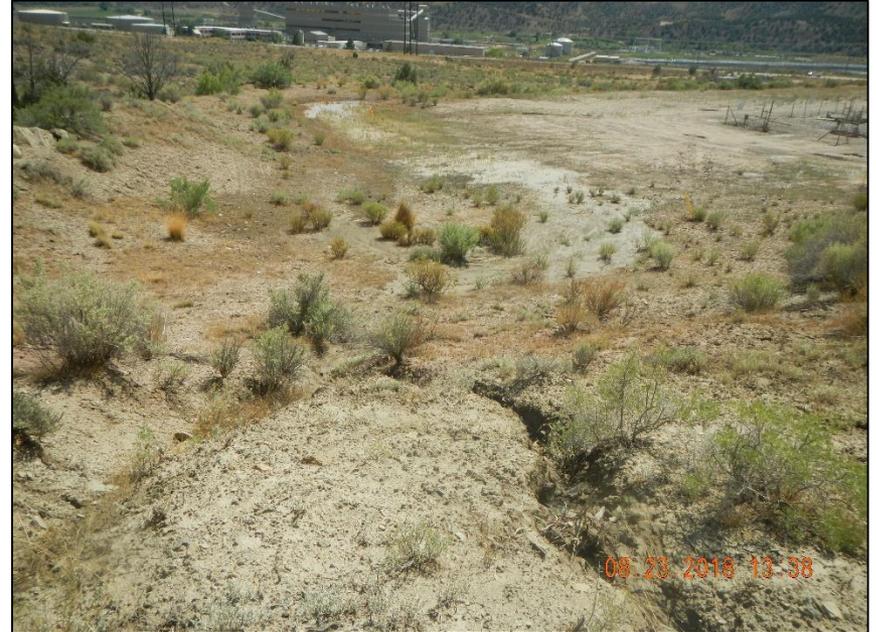
**Erosion of north east hill side.**

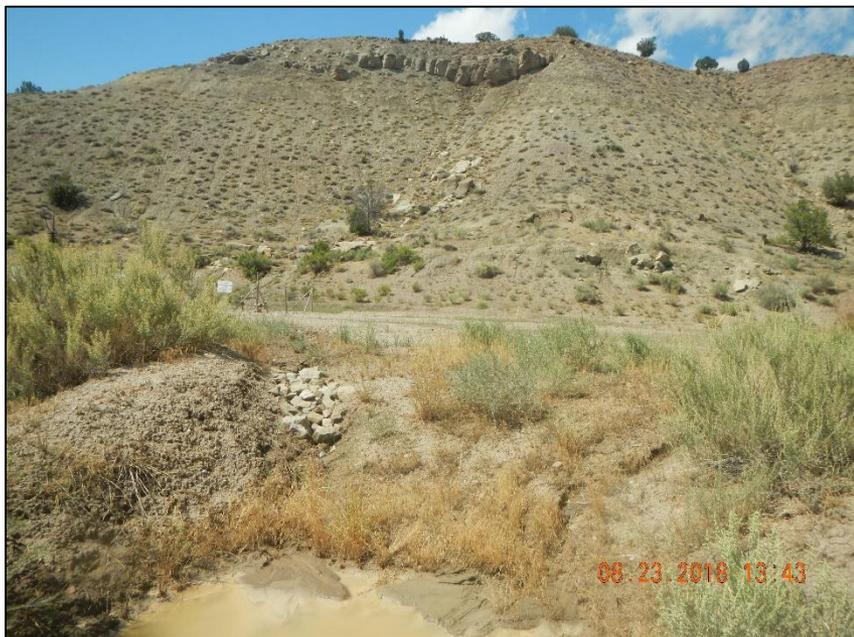
**Erosion of check dam and sediment build up.**

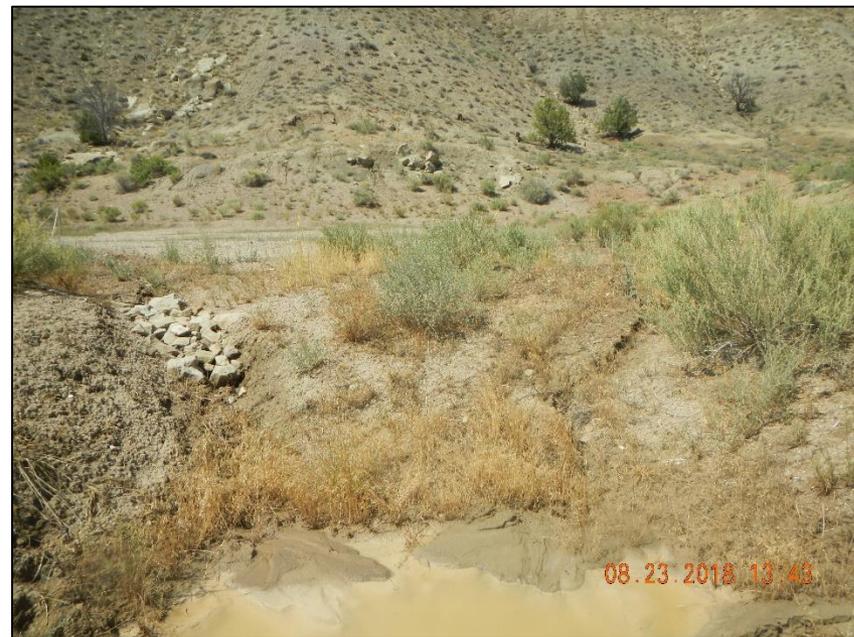
**Erosion of check dam and sediment build up.**

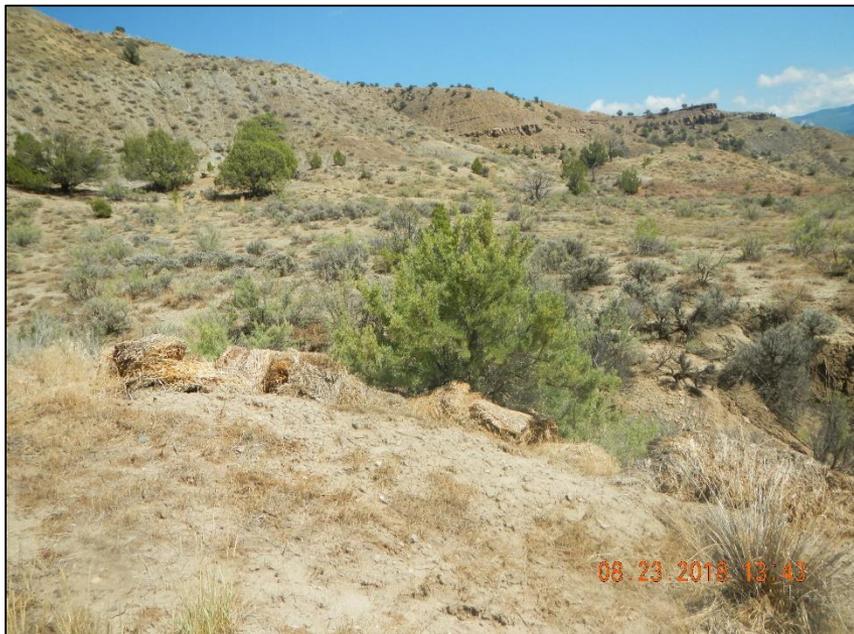
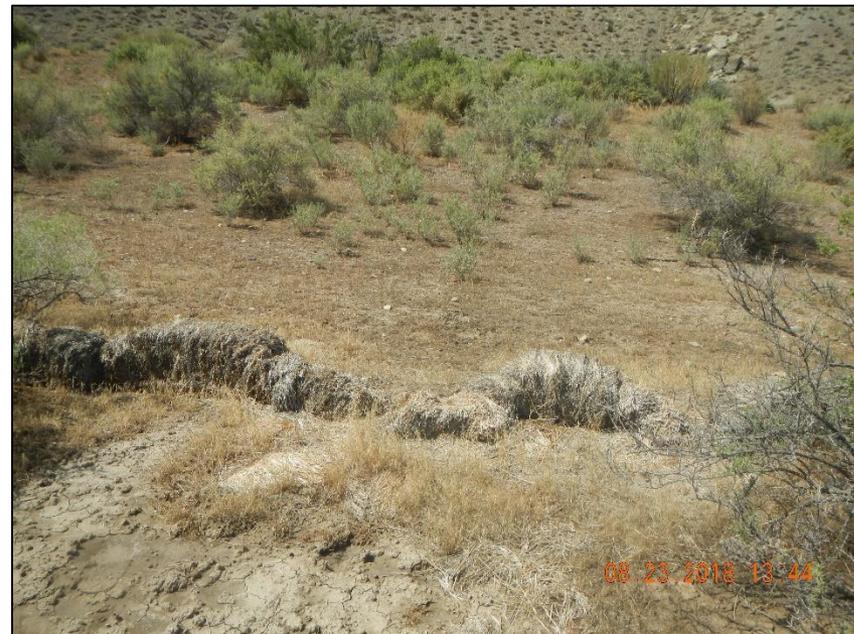
**Damaged and unmaintained bales along south base of well pad.**

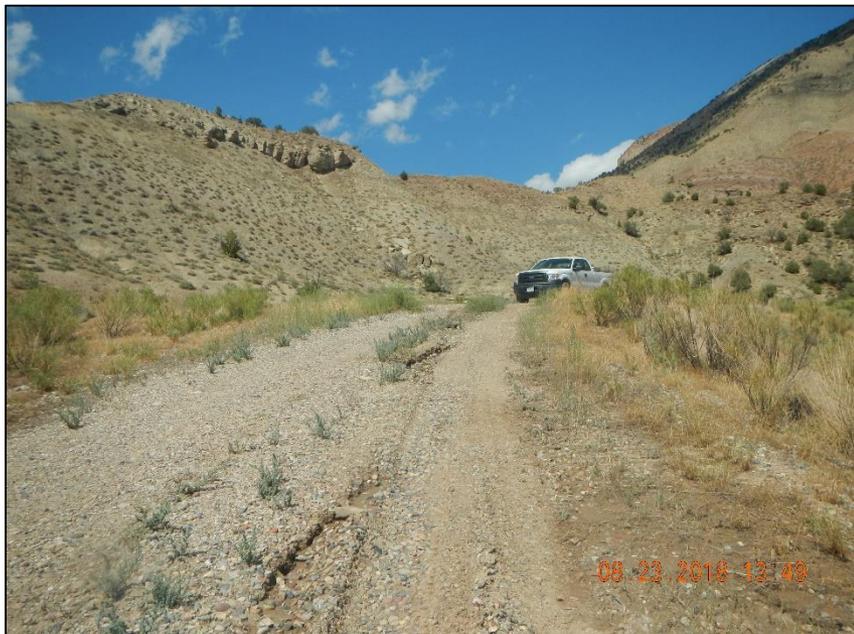
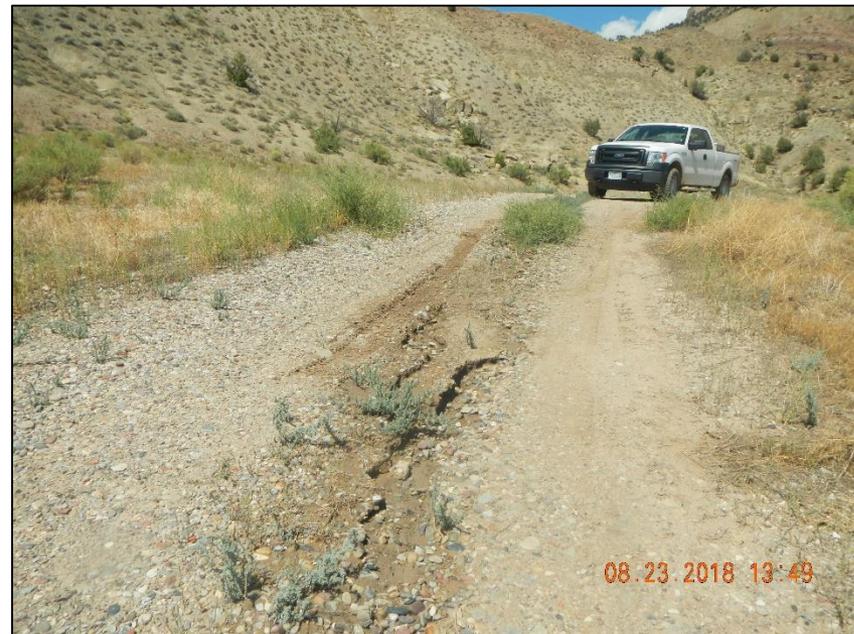
**Damage and erosion of access road.**
