Inspection Photos  
Location Name: State 12-2  
API: 05-057-06281

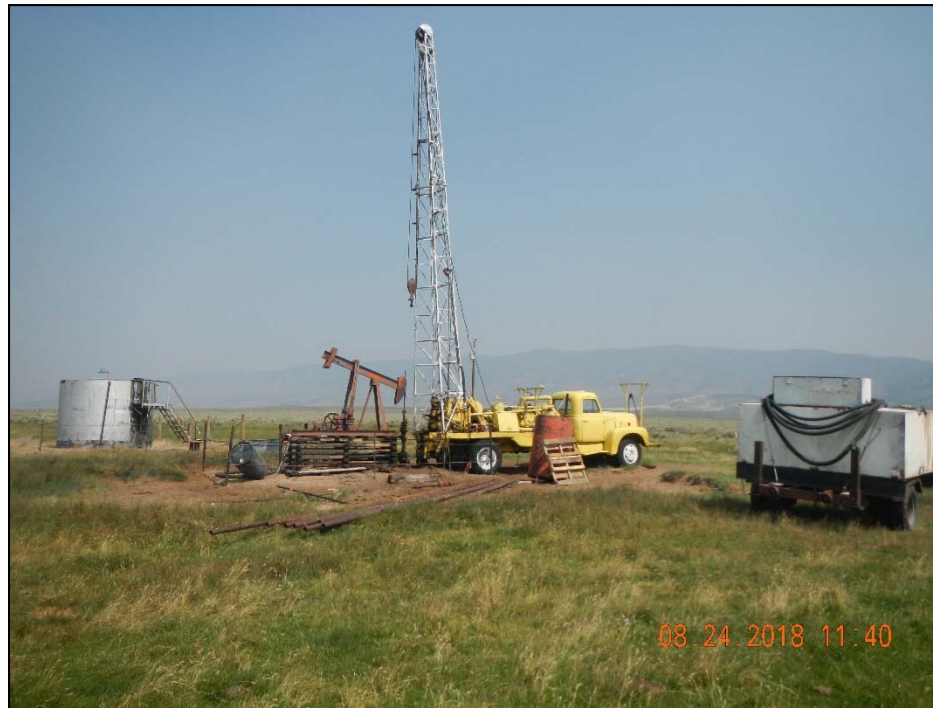
**Photo 1. Overview of location taken at entrance facing northeast.**

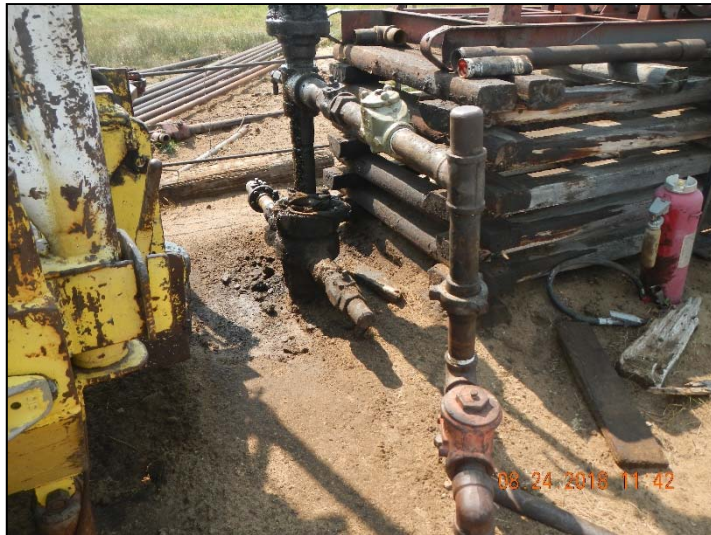
Photo 2. Stained soil at wellhead.

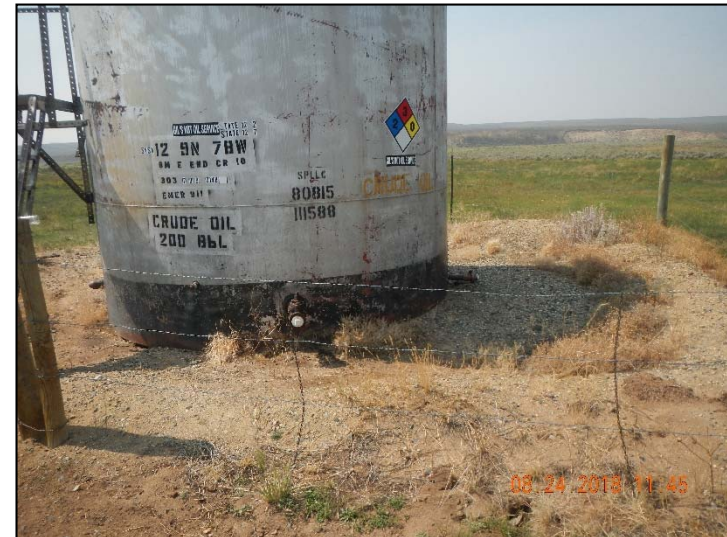
Photo 3. Low berm.
