Inspection Photos

Location Name: Moyer 'A' - 612N56W / 29SESW

Location #: 317532

COLORADO
Oil & Gas Conservation
Commission
Department of Natural Resources

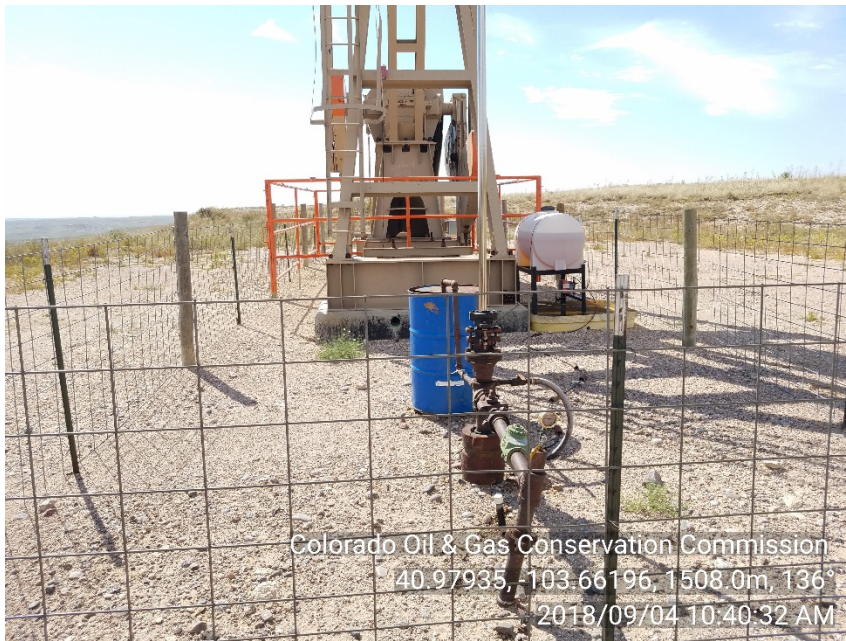
Photo #1

Moyer Unit 14-29 (API 05-123-07025) wellhead

Bradenhead needs plumbed to surface

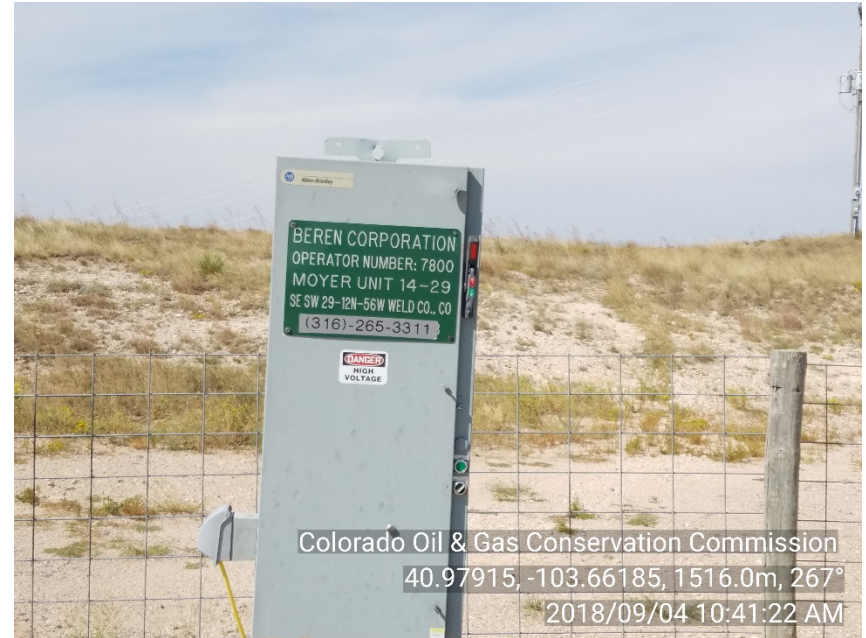
Photo #2

Moyer Unit 14-29 wellsite sign

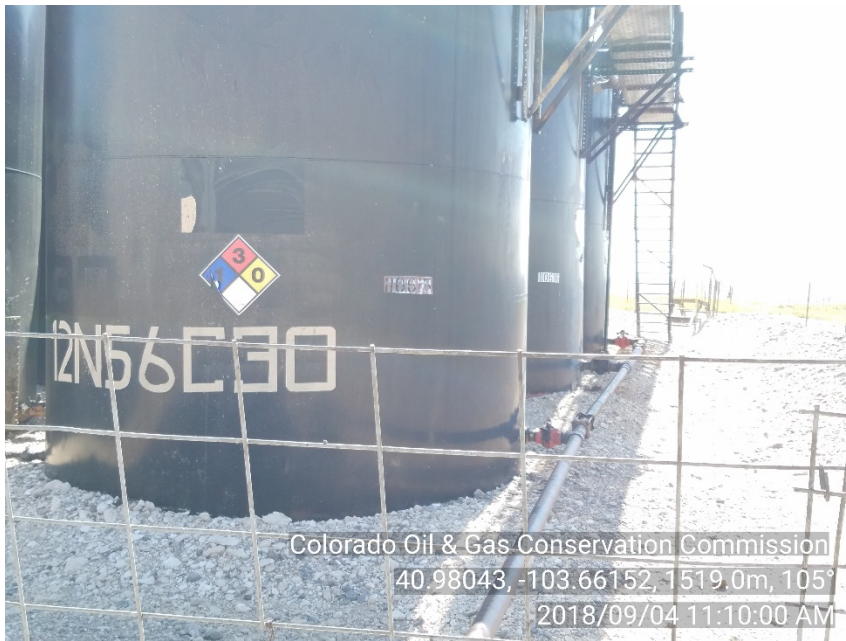
Photo #3

Moyer Unit Battery

Moyer 11-29, 13-29, 15-29, 3-32, 11-32 (UIC wells)
Moyer 10-29, 14-29, 16-29, 15-30, 16-30, 6-32
(Producing wells)

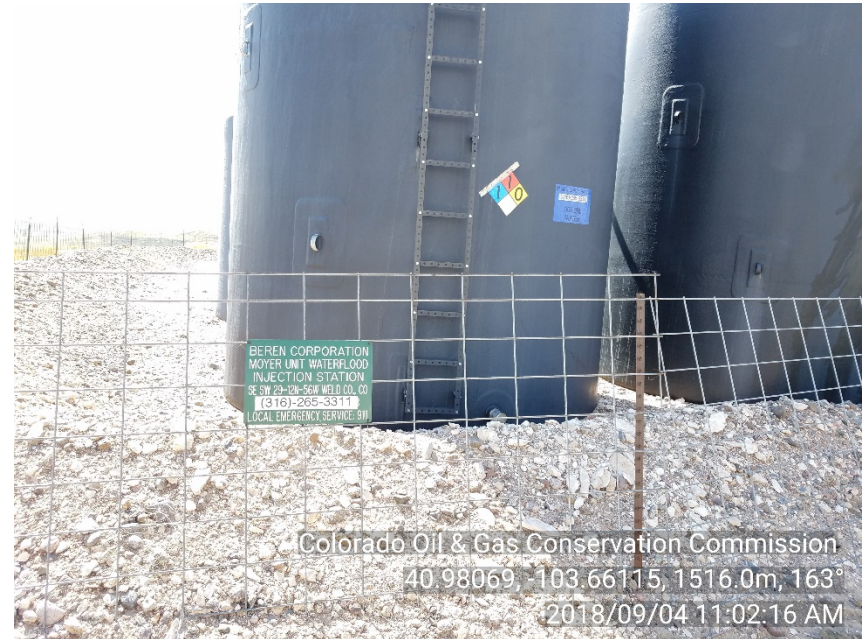
Photo #4

Moyer Unit H2O tanks

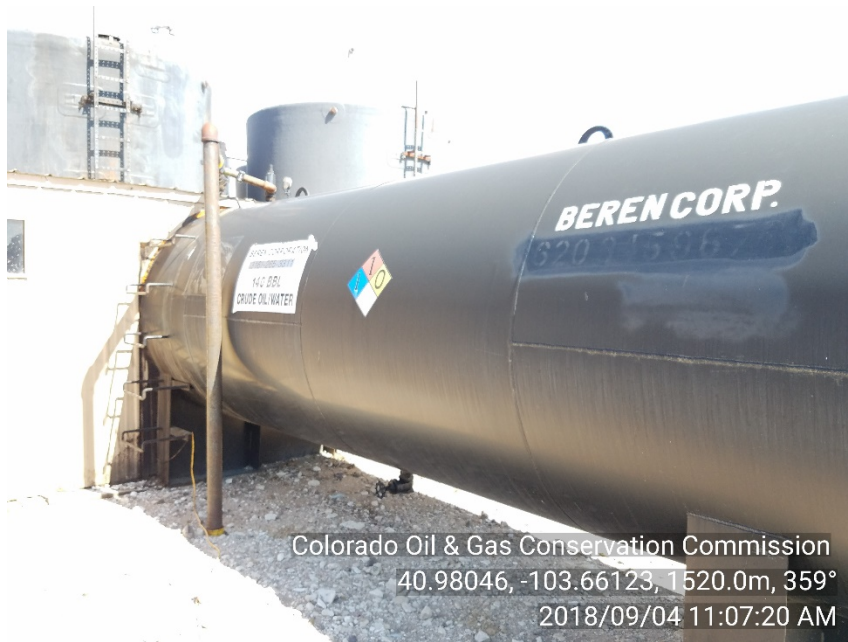
Photo #5
Moyer Unit Battery
Free Water Knockout

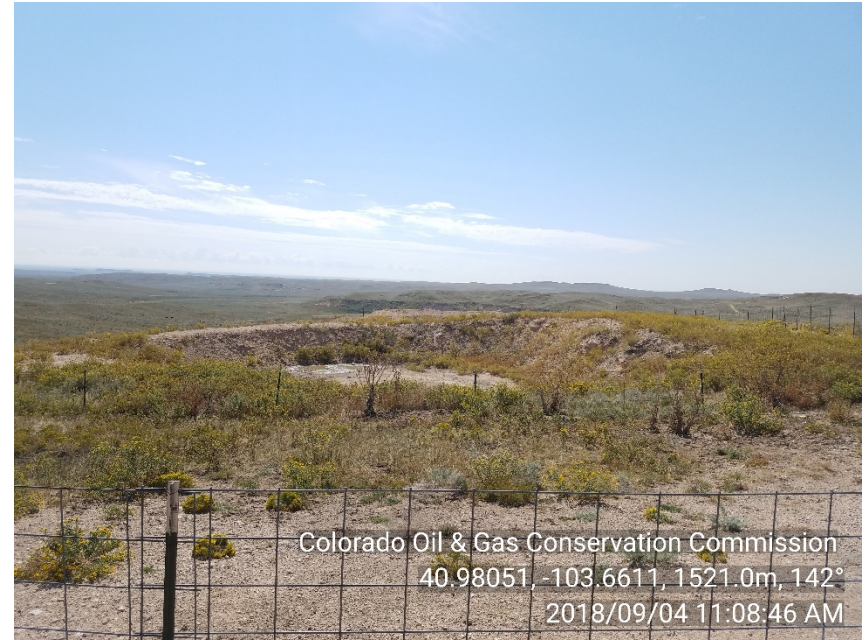
Photo #6
Moyer Unit
H2O pits

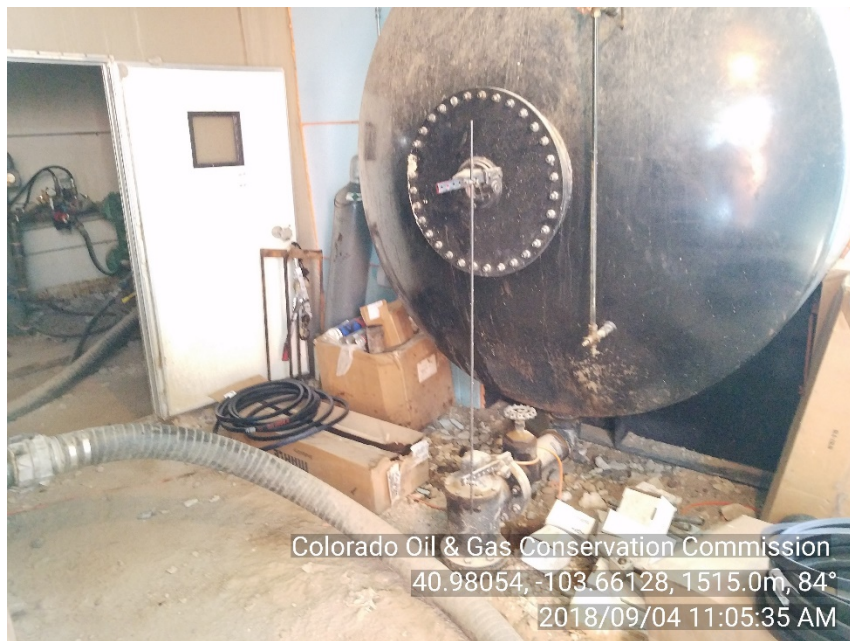
Photo #7

Moyer Unit H2O Knockout house

Trash & Debris

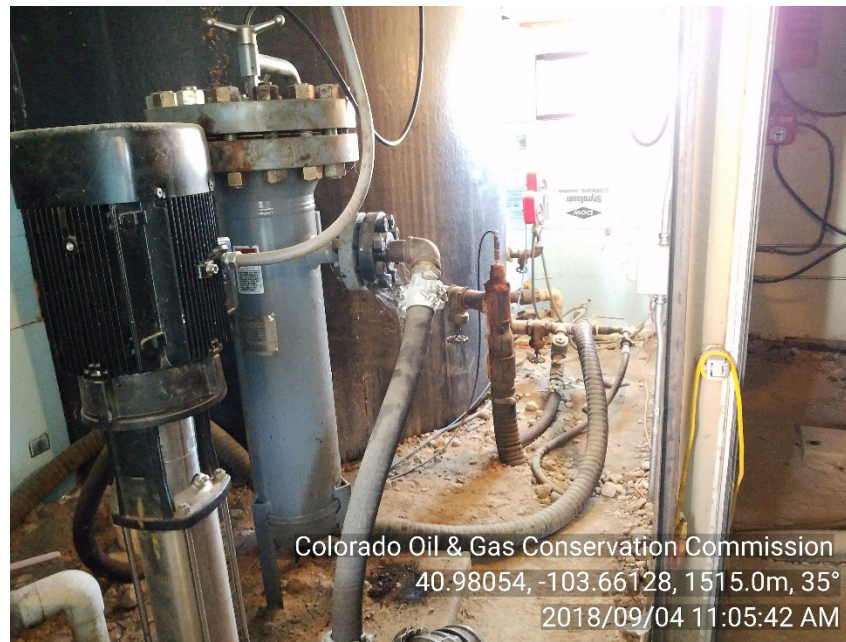
Photo #8

Moyer Unit H2O Knockout house

Stained soil

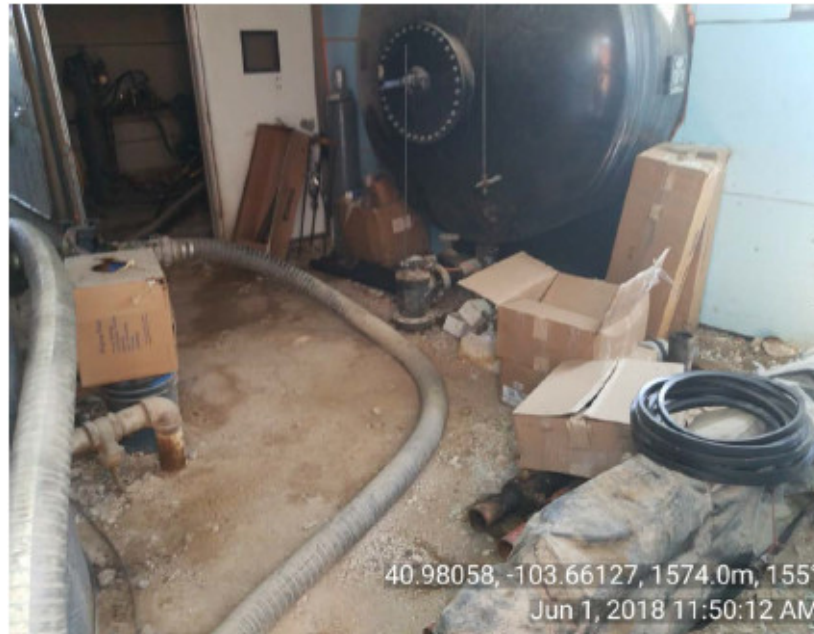
Photo #9

Moyer Unit H2O Knockout house

Trash, debris, & stained soil

From previous FIR
