# Inspection Photos

Operator: BP Production

API: 05-067-07487

Date: 9/13/2018

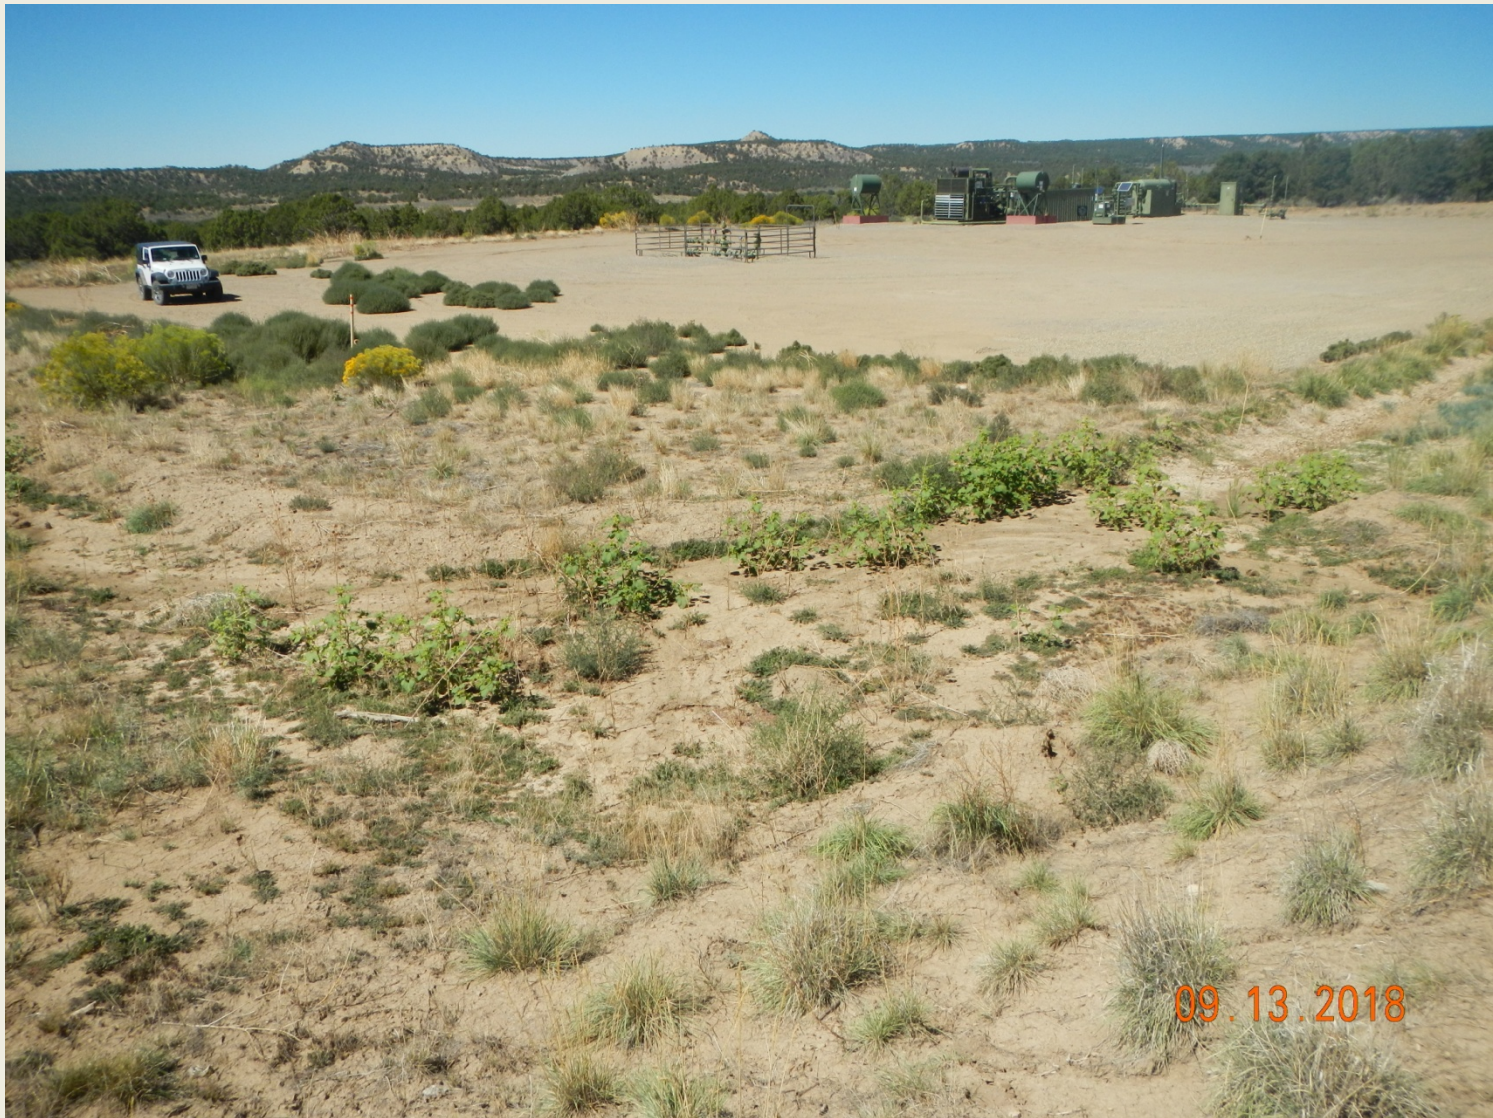
**Photo 1. View of the project area from the southeastern corner facing center.**

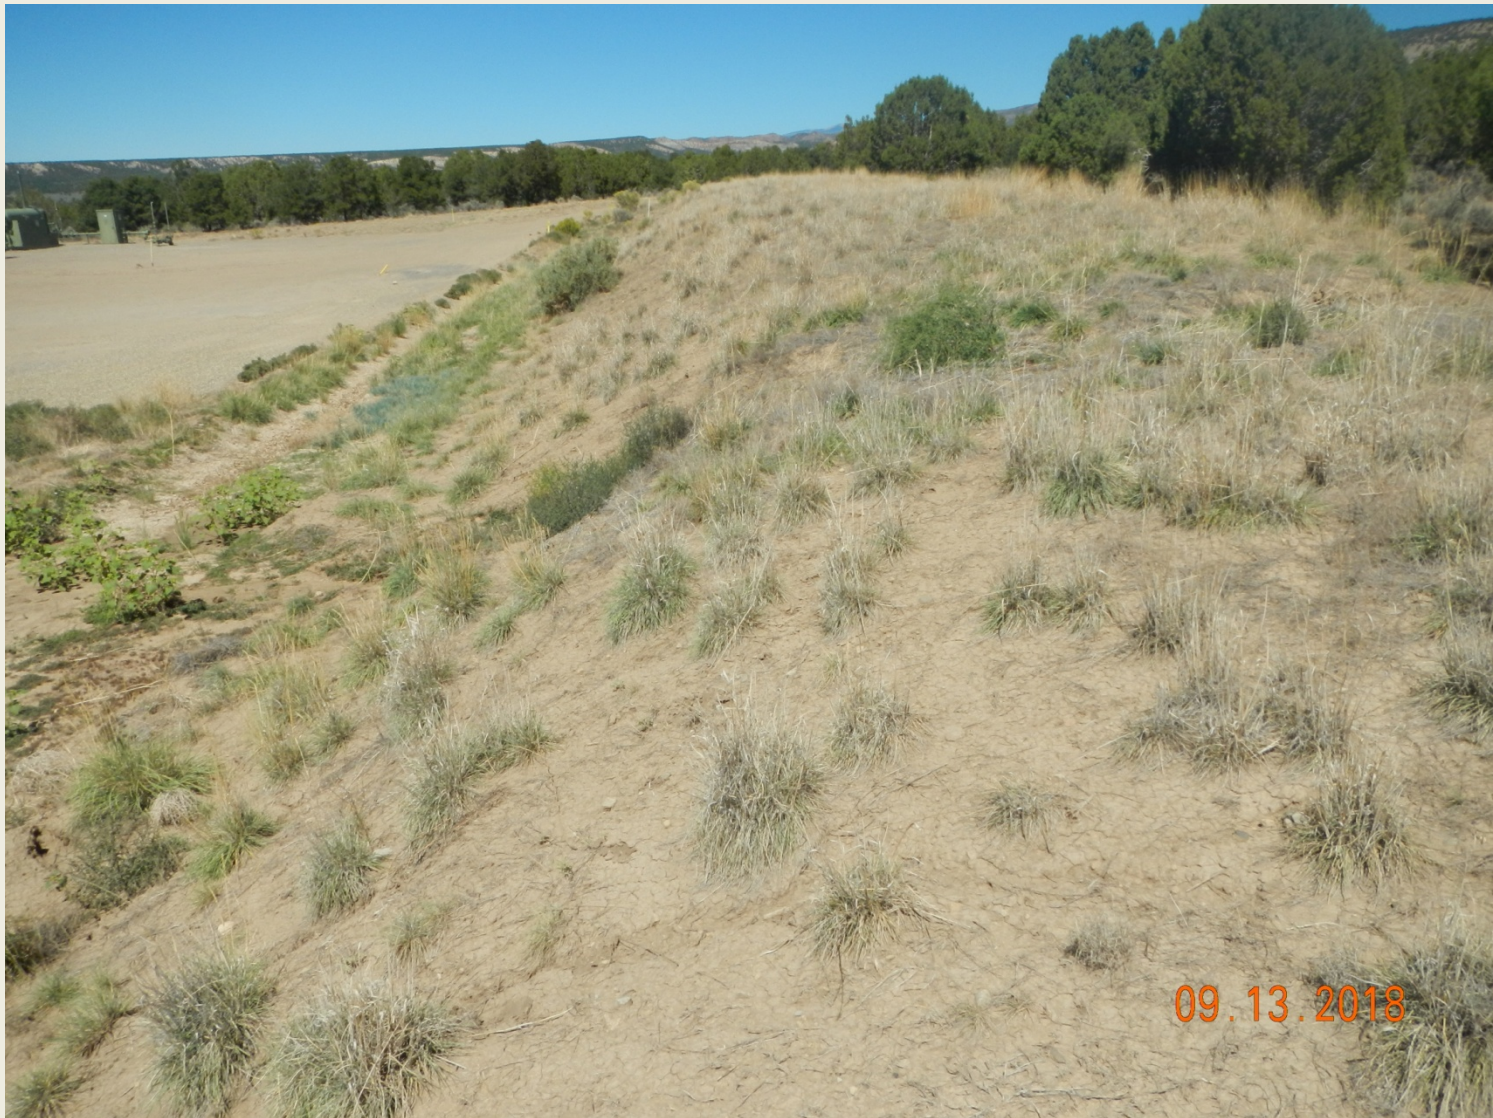
**Photo 2. View of the eastern project area from the southeastern corner facing northward.**

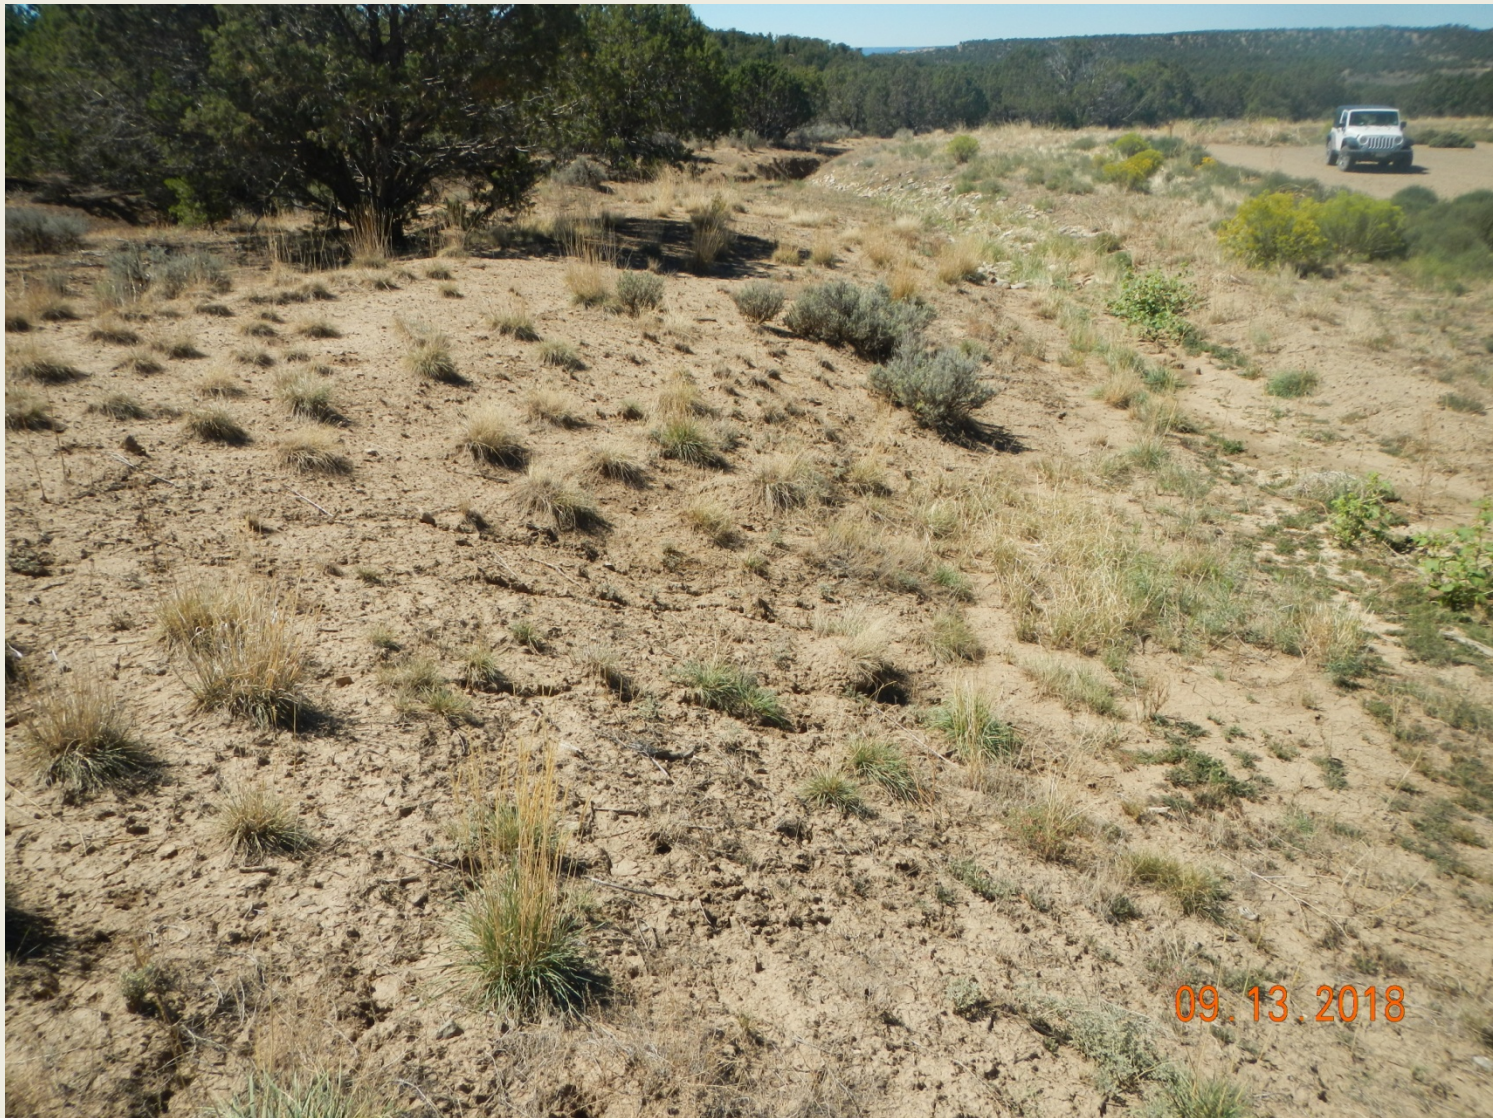
**Photo 3. View of the southern portion of the project area from the southeastern corner facing westward. Revegetation is largely comprised of grasses such as crested wheatgrass (*Agropyron cristatum*), western wheatgrass (*Pascopyrum smithii*), and sand dropseed (*Sporobolus cryptandrus*).**

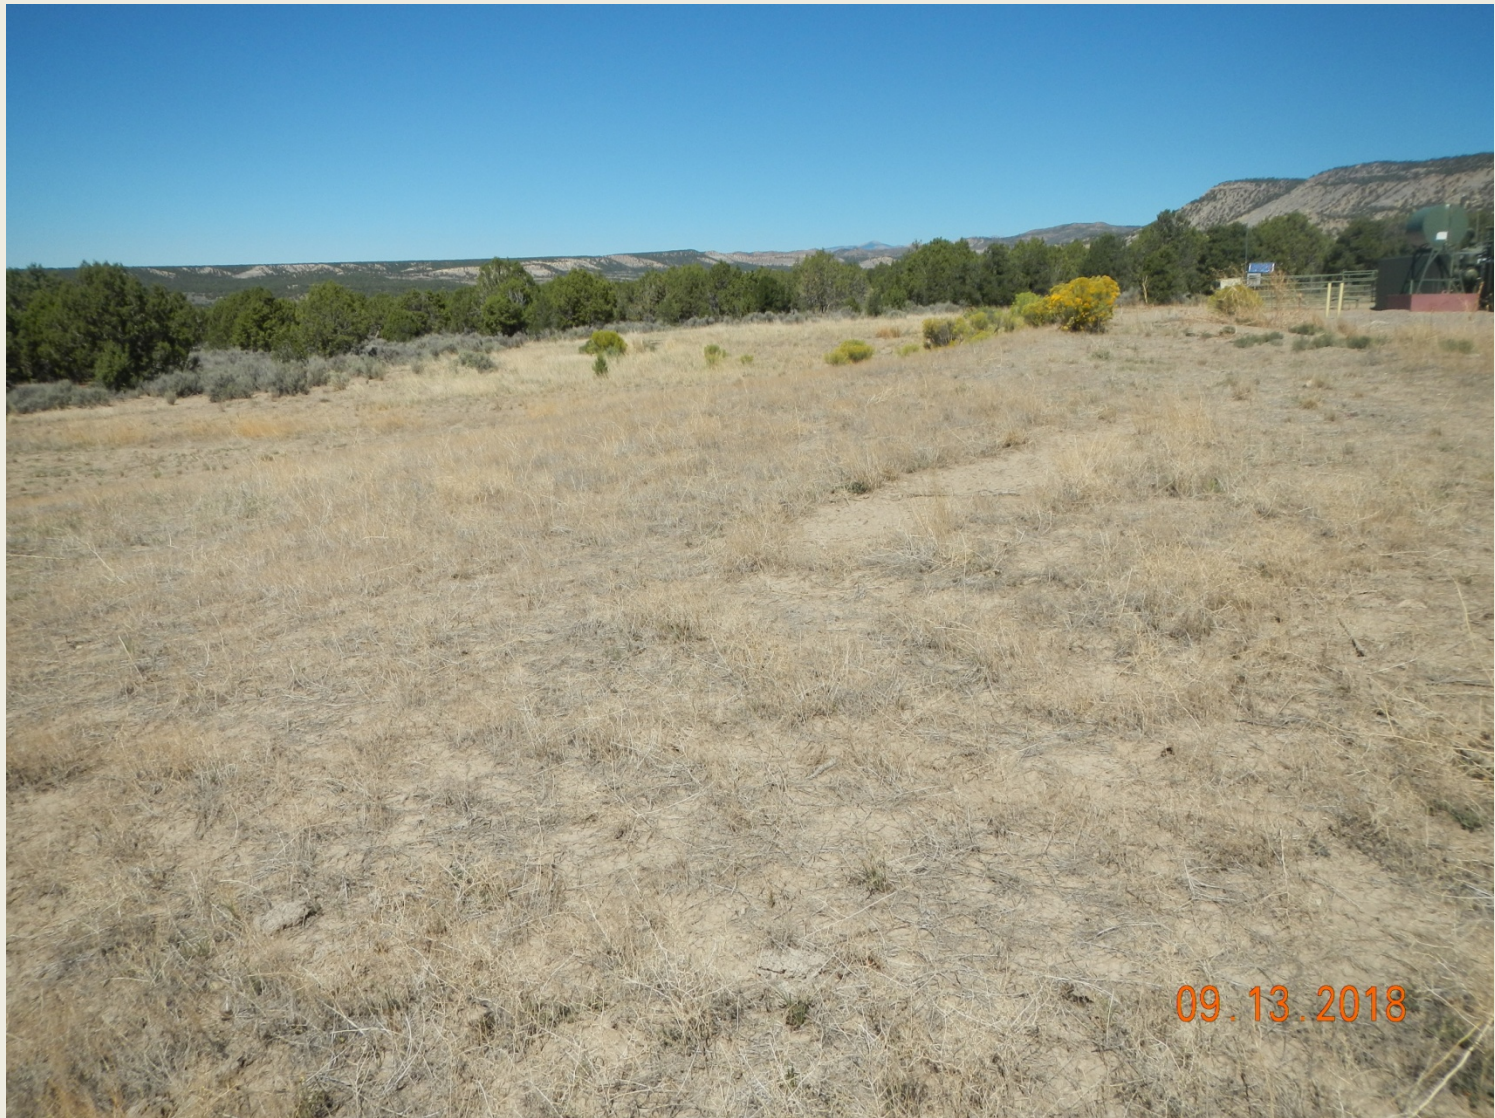
**Photo 4. View of the western project area from the southwestern edge facing northward. Vegetation in the foreground is dry and mostly comprised of annual weeds such as tumblemustard (*Sysimbrium* sp.)**

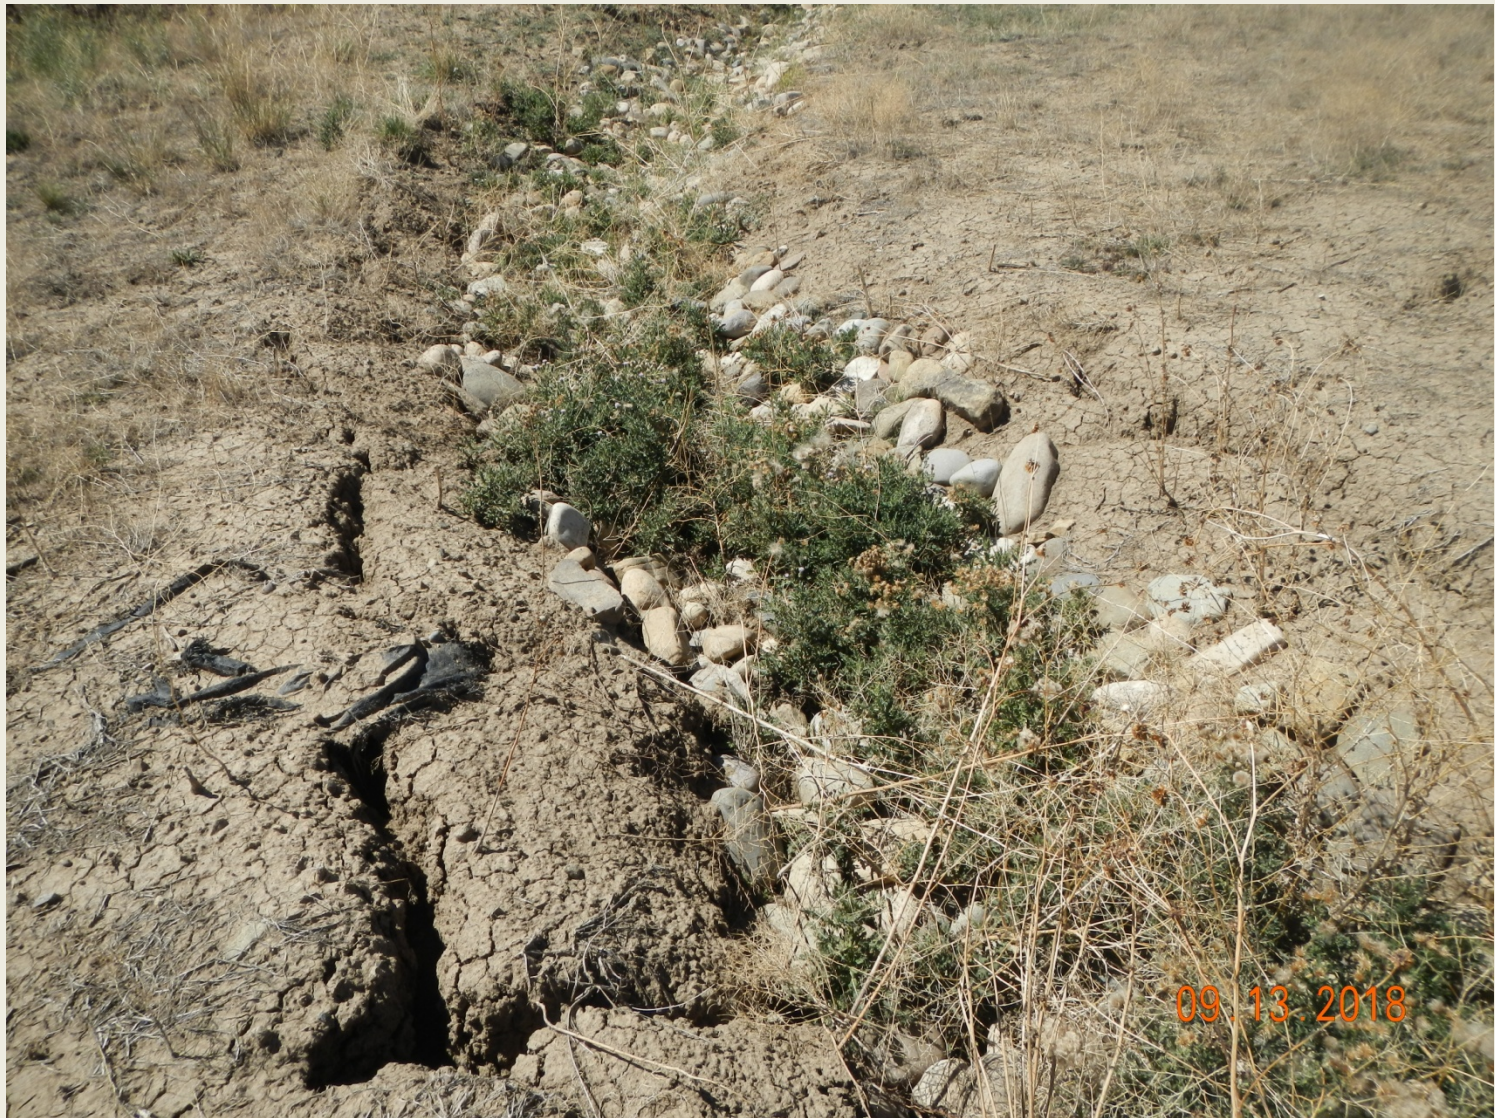
Photo 5. View of Canada thistles (*Cirsium arvense*) in southwestern drainage.

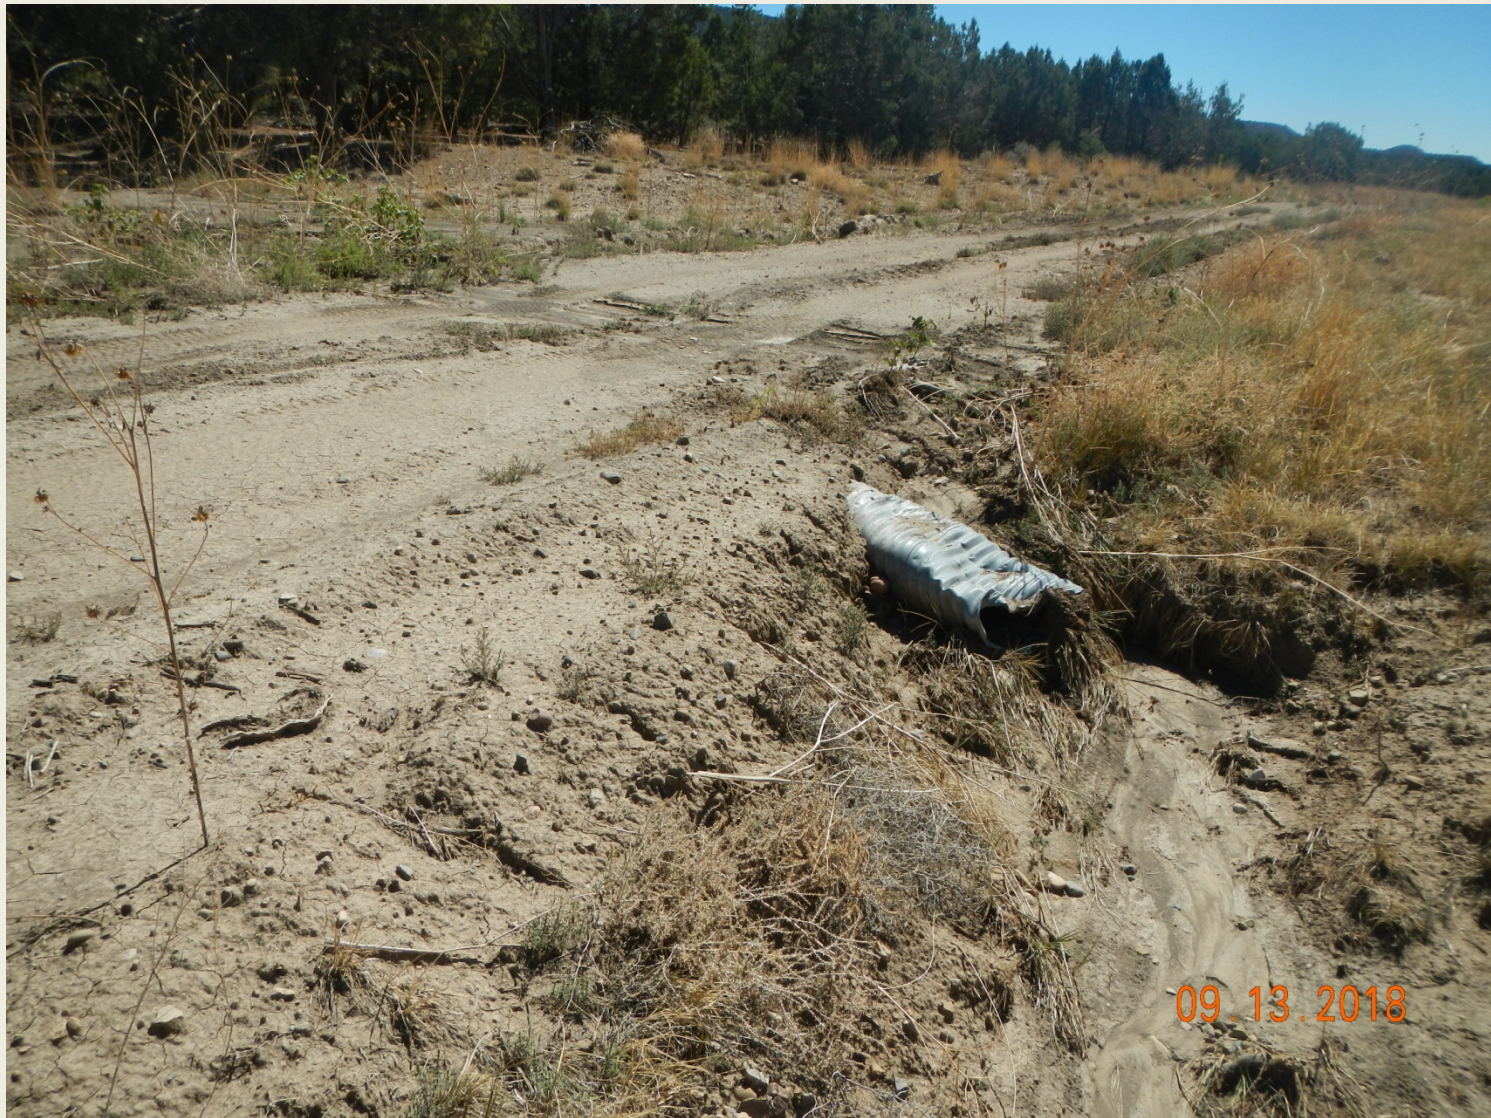
**Photo 6. View of area along the access road where culvert is blocked on upstream side and stormwater flows over the road surface resulting in erosion on the road and where it flows into the drainage.**

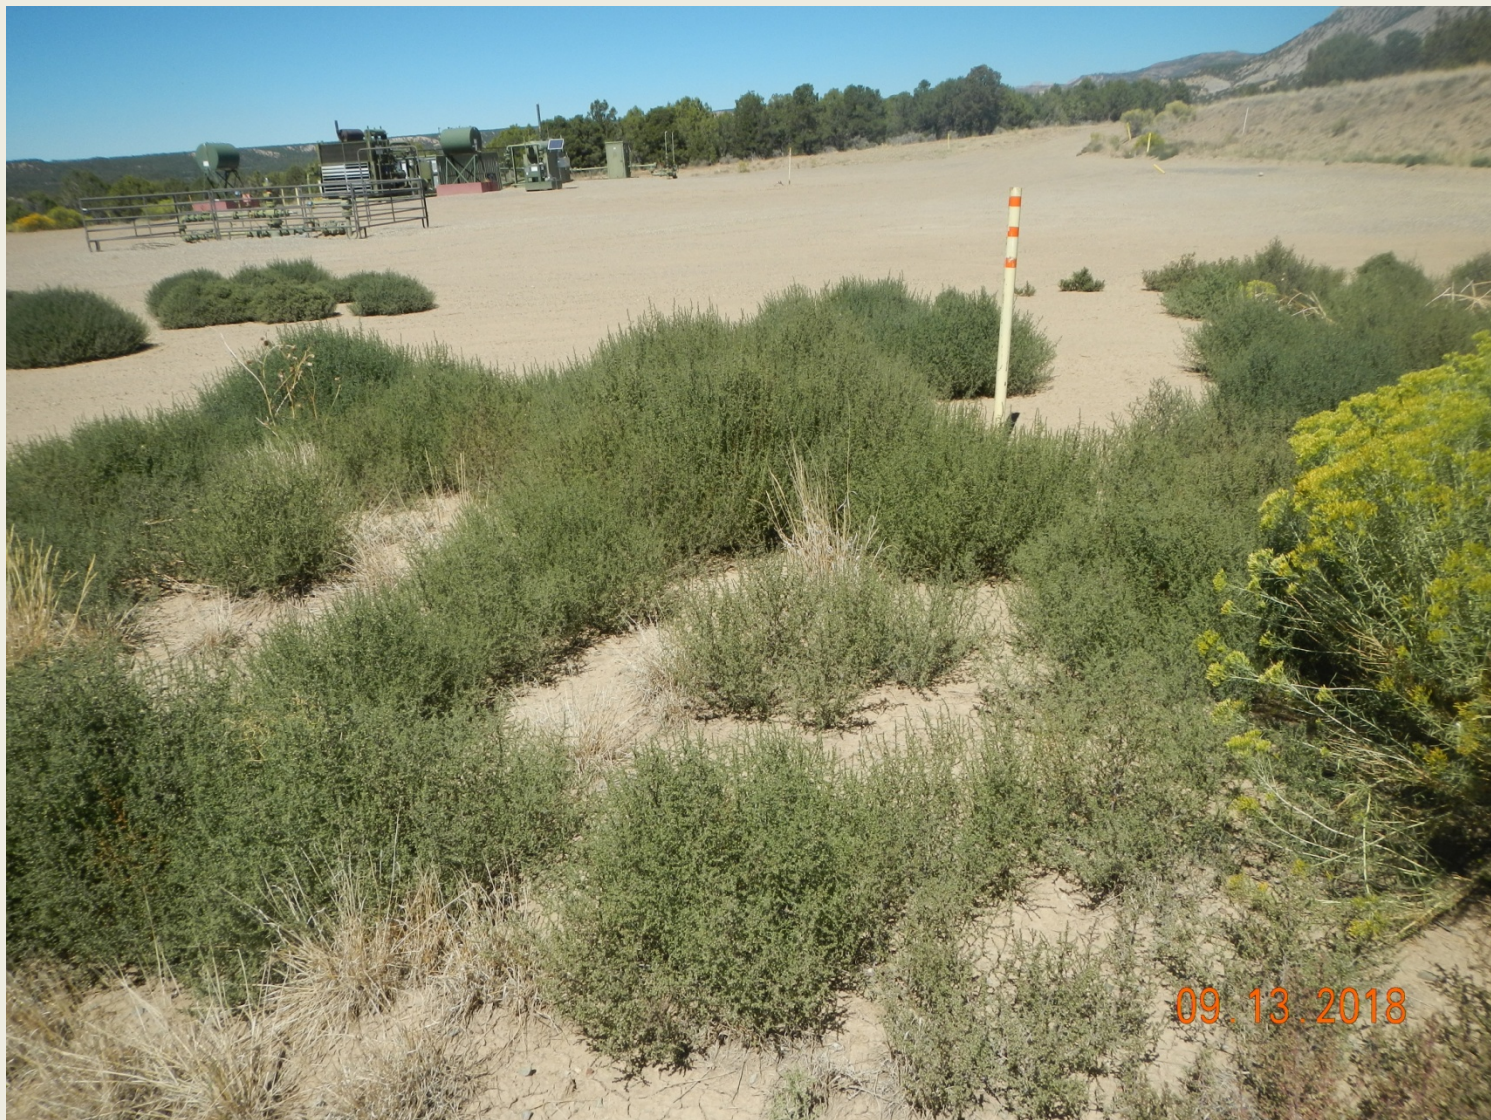
**Photo 7. View of Russian thistles (*Salsola tragus*) on the well pad growing up to 3 feet tall. These will break off and become debris.**

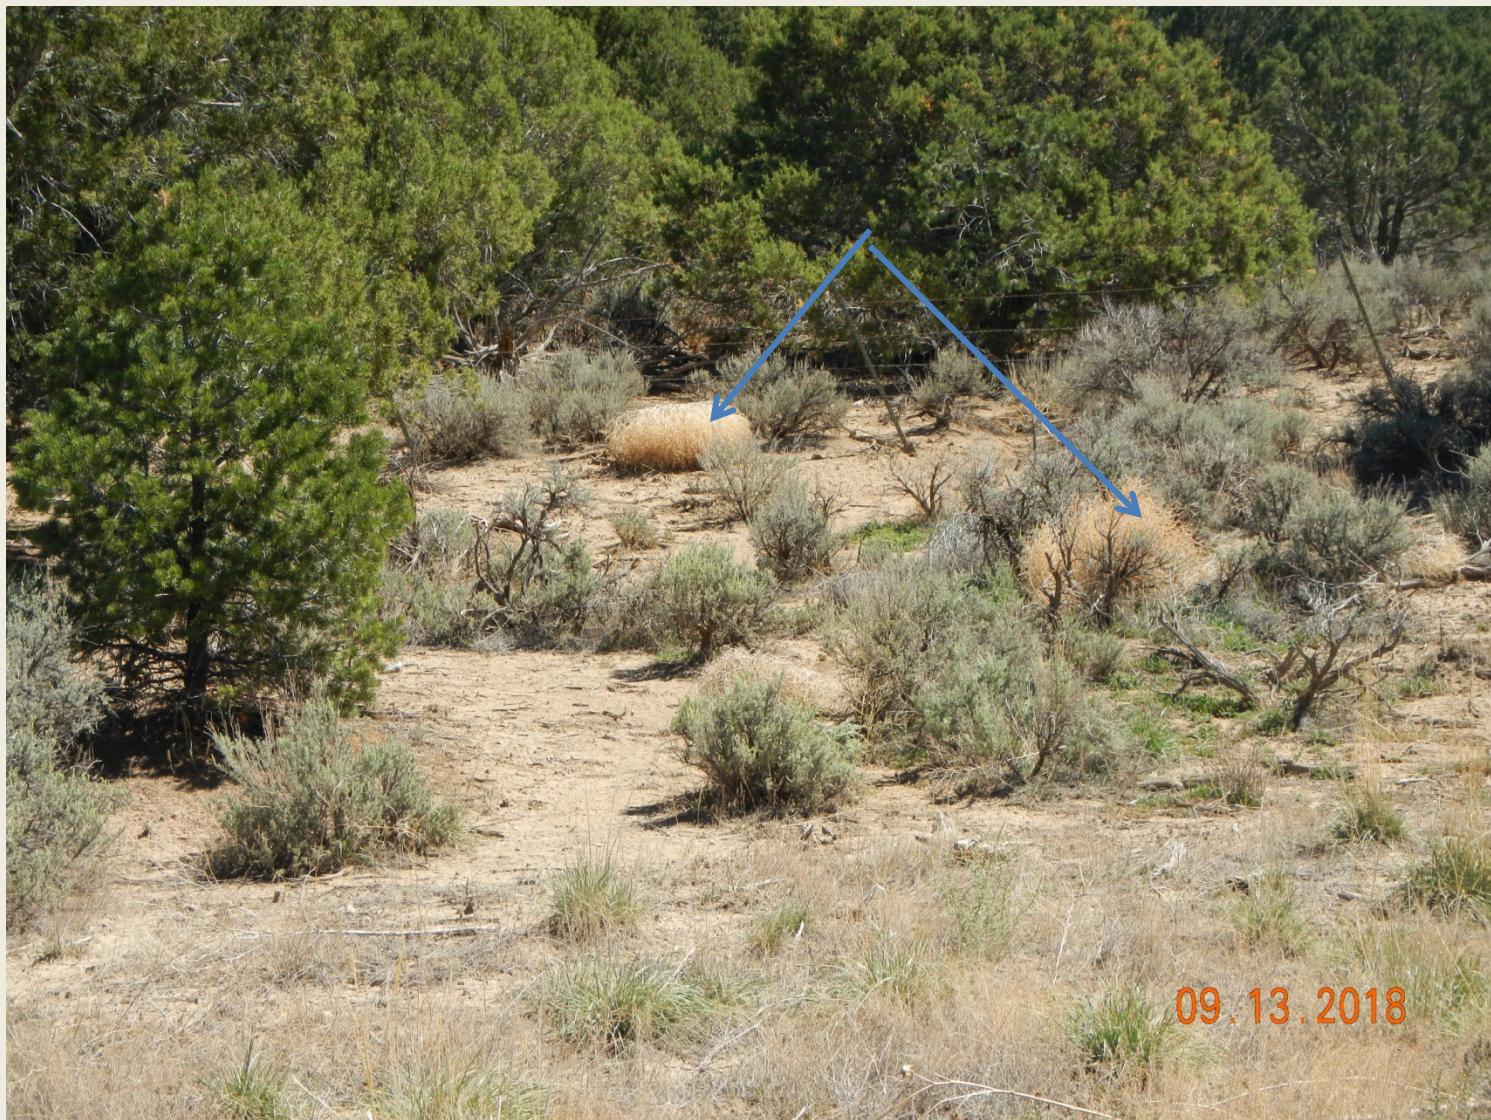
**Photo 8. View Russian thistle debris that has blown off of the project area, east of the well pad.**
