GV 33-22 Frac Pad
API# 05-045-06730
Inspection# 689701812

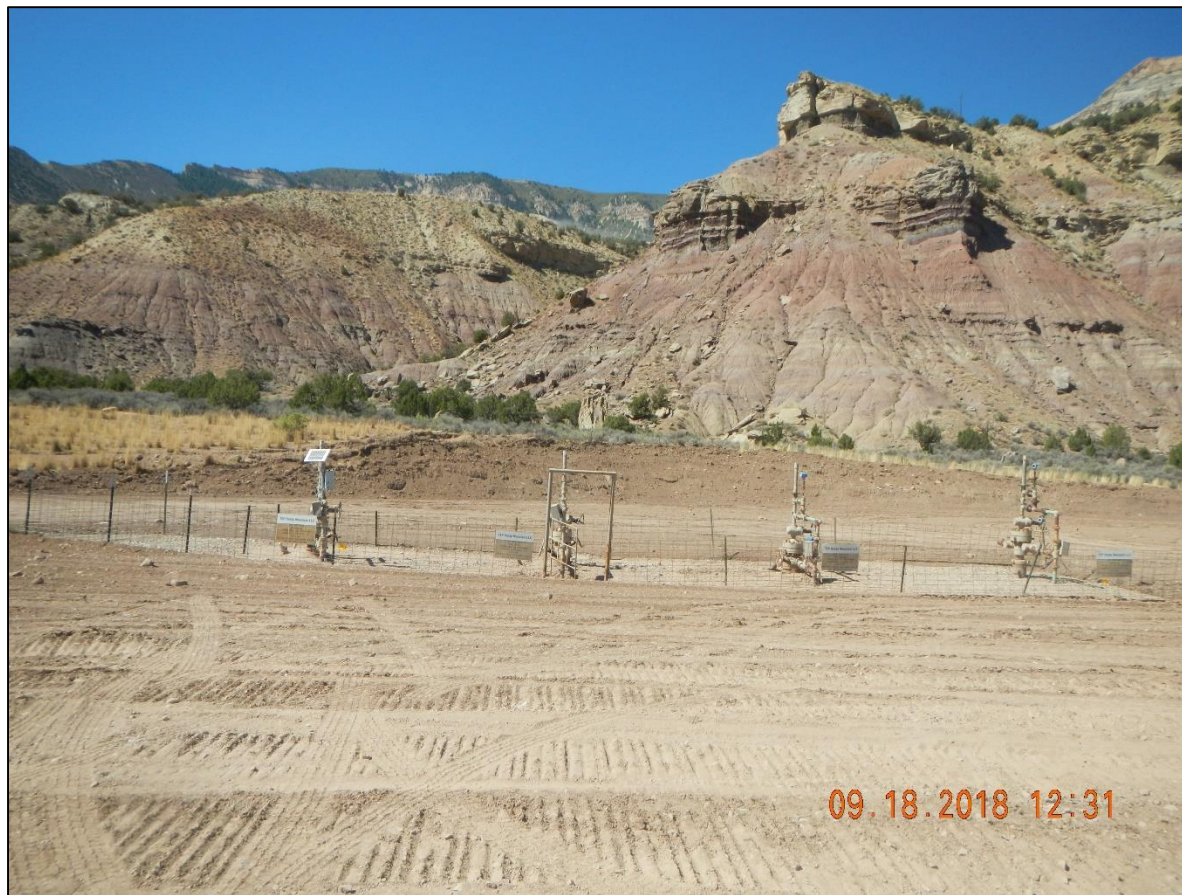
Location photo.

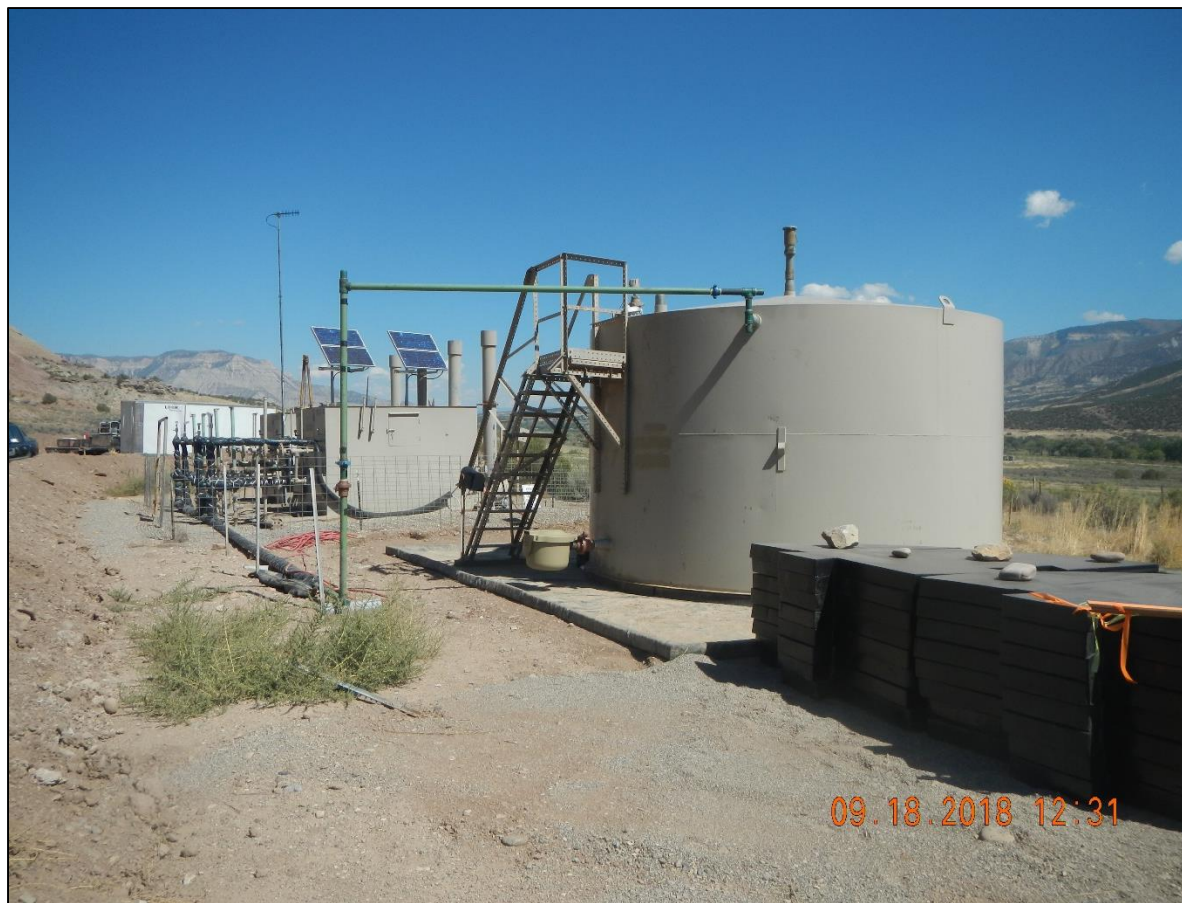
Dead weed debris. Inadequate containment for tank.

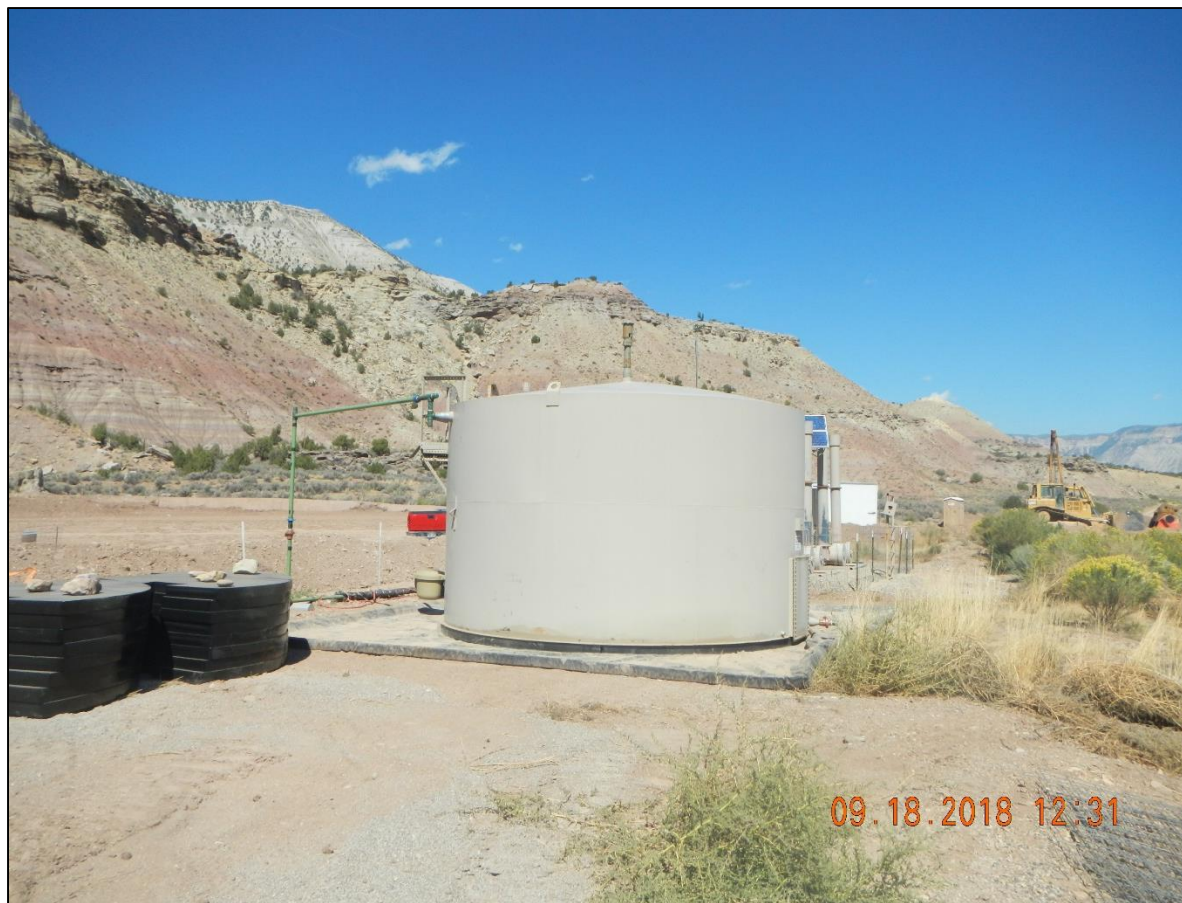
Dead weed debris. Inadequate containment for tank.

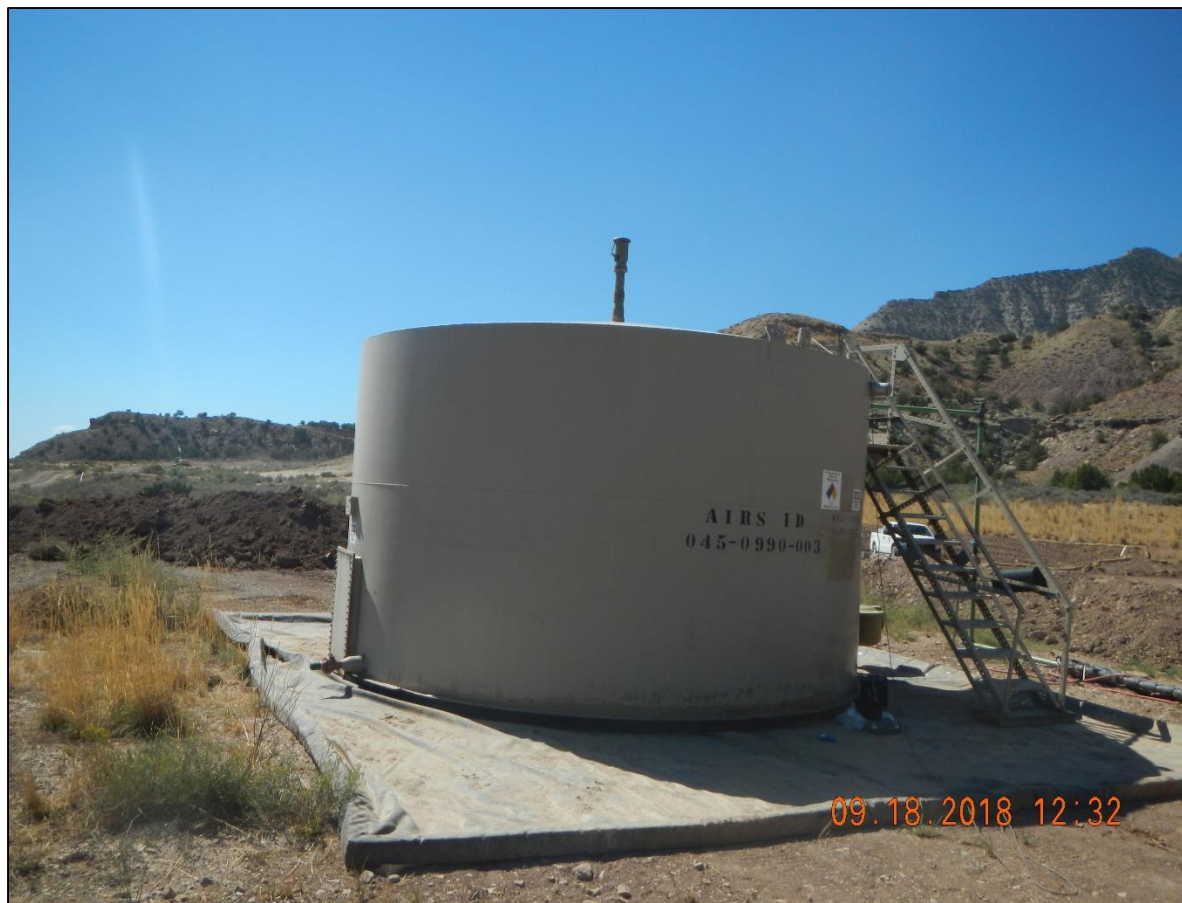
Dead weed debris. Inadequate containment for tank.

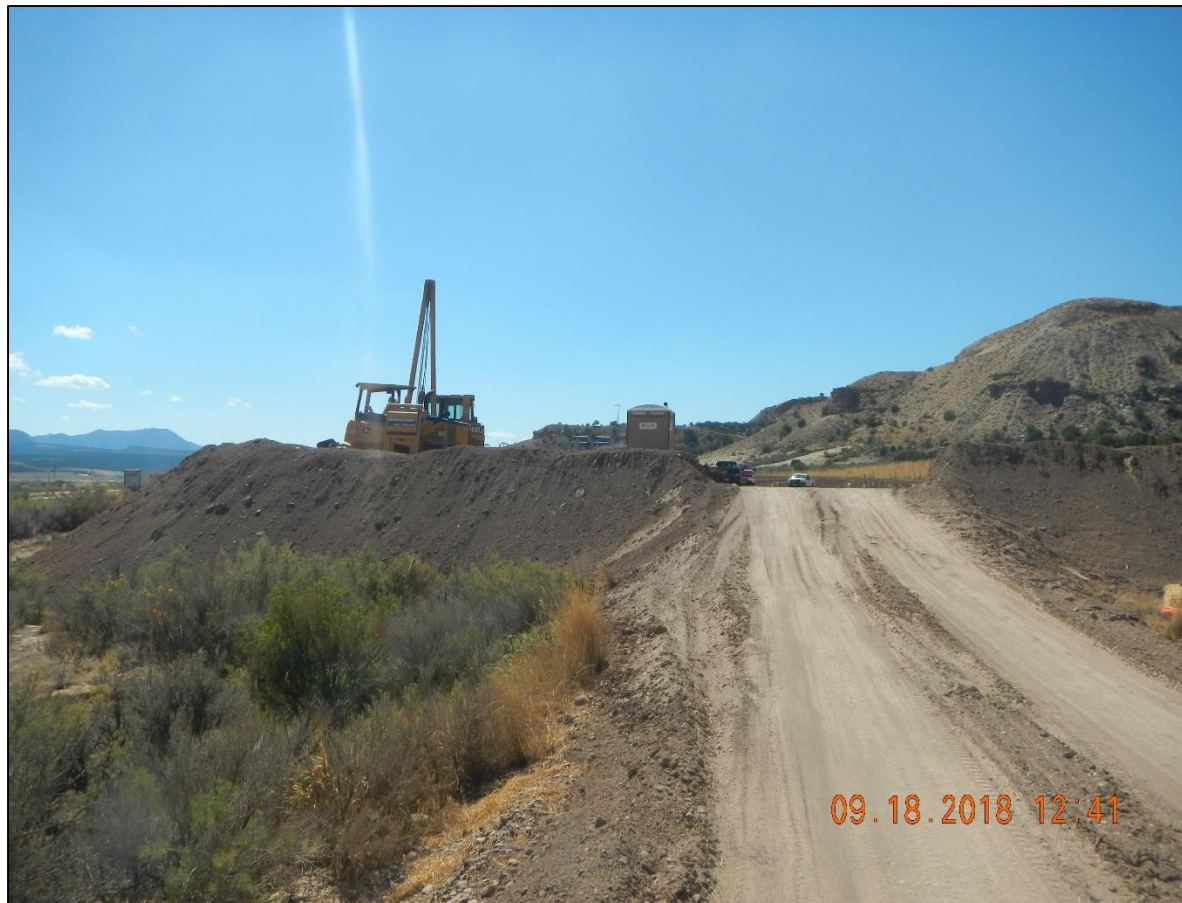
Road damage at entrance of location.

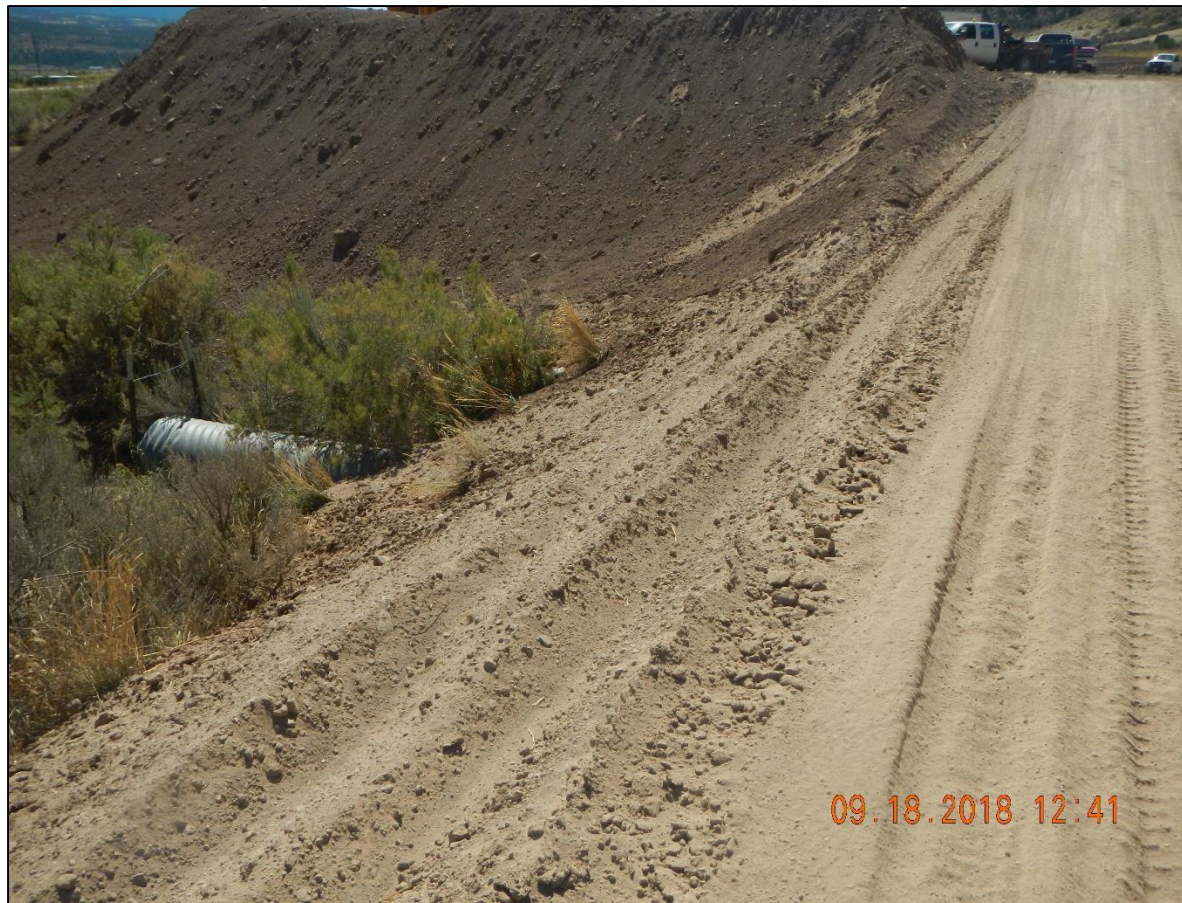
Road damage at entrance of location.
