# Inspection Photos

Operator: Catamount Energy

API: 05-007-06220

Date: 11/06/2018

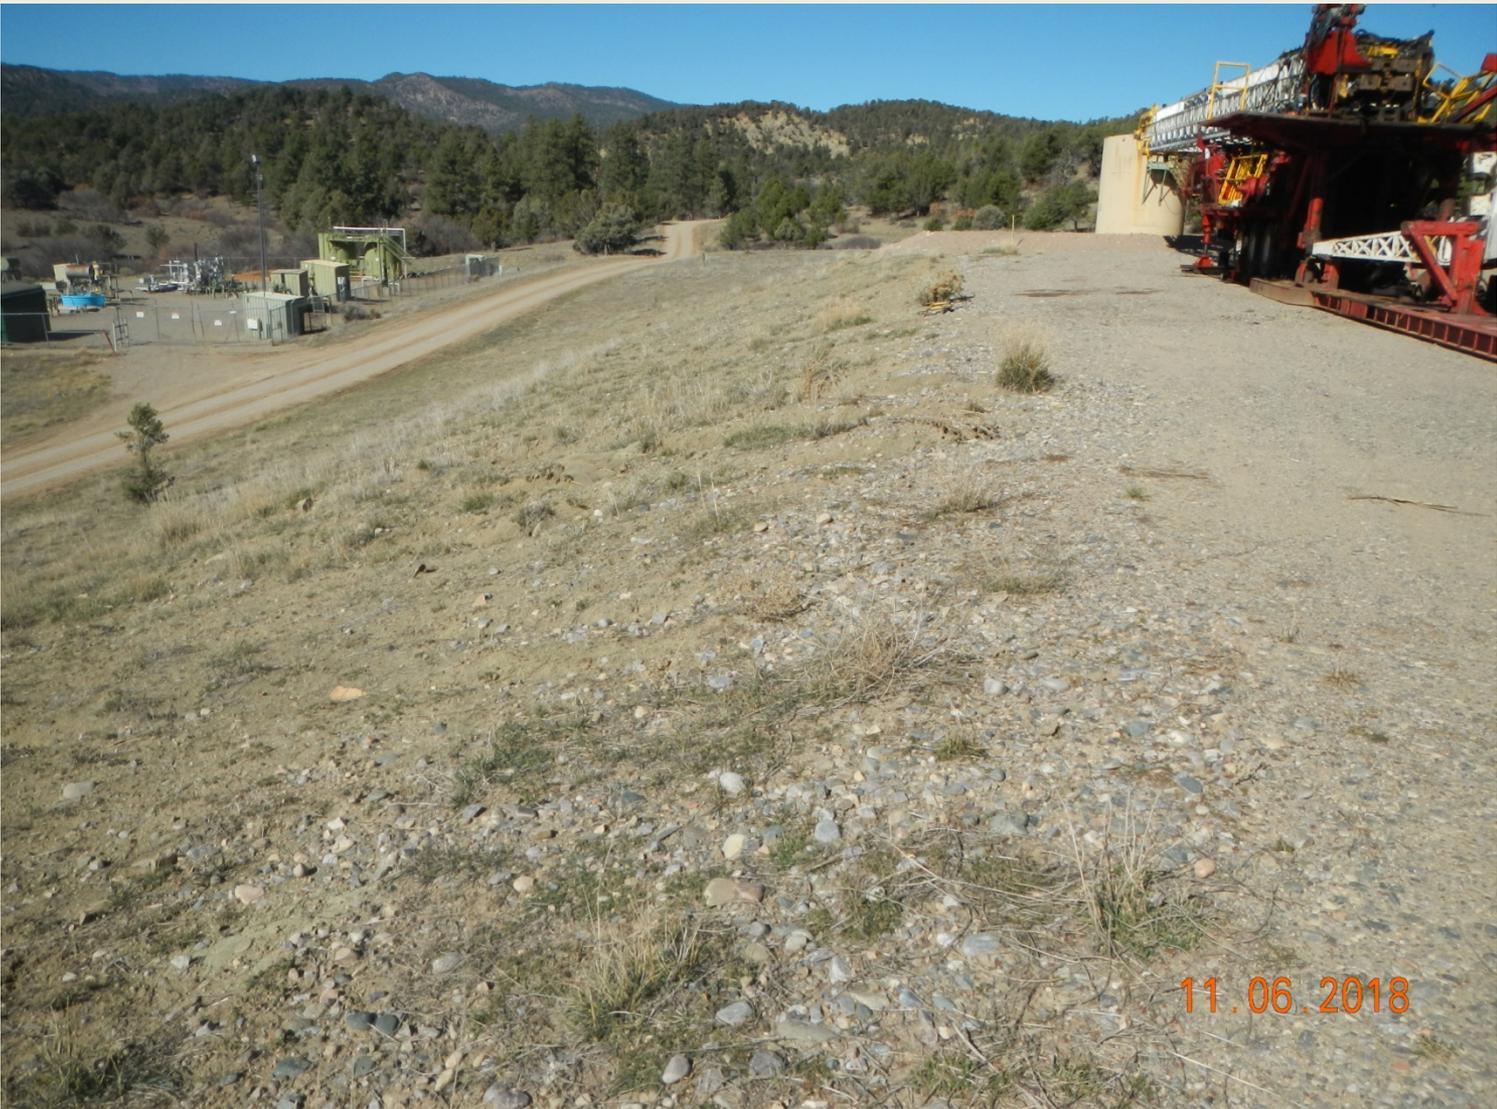
**Photo 1. View of the western project area from southwestern corner facing northward.**

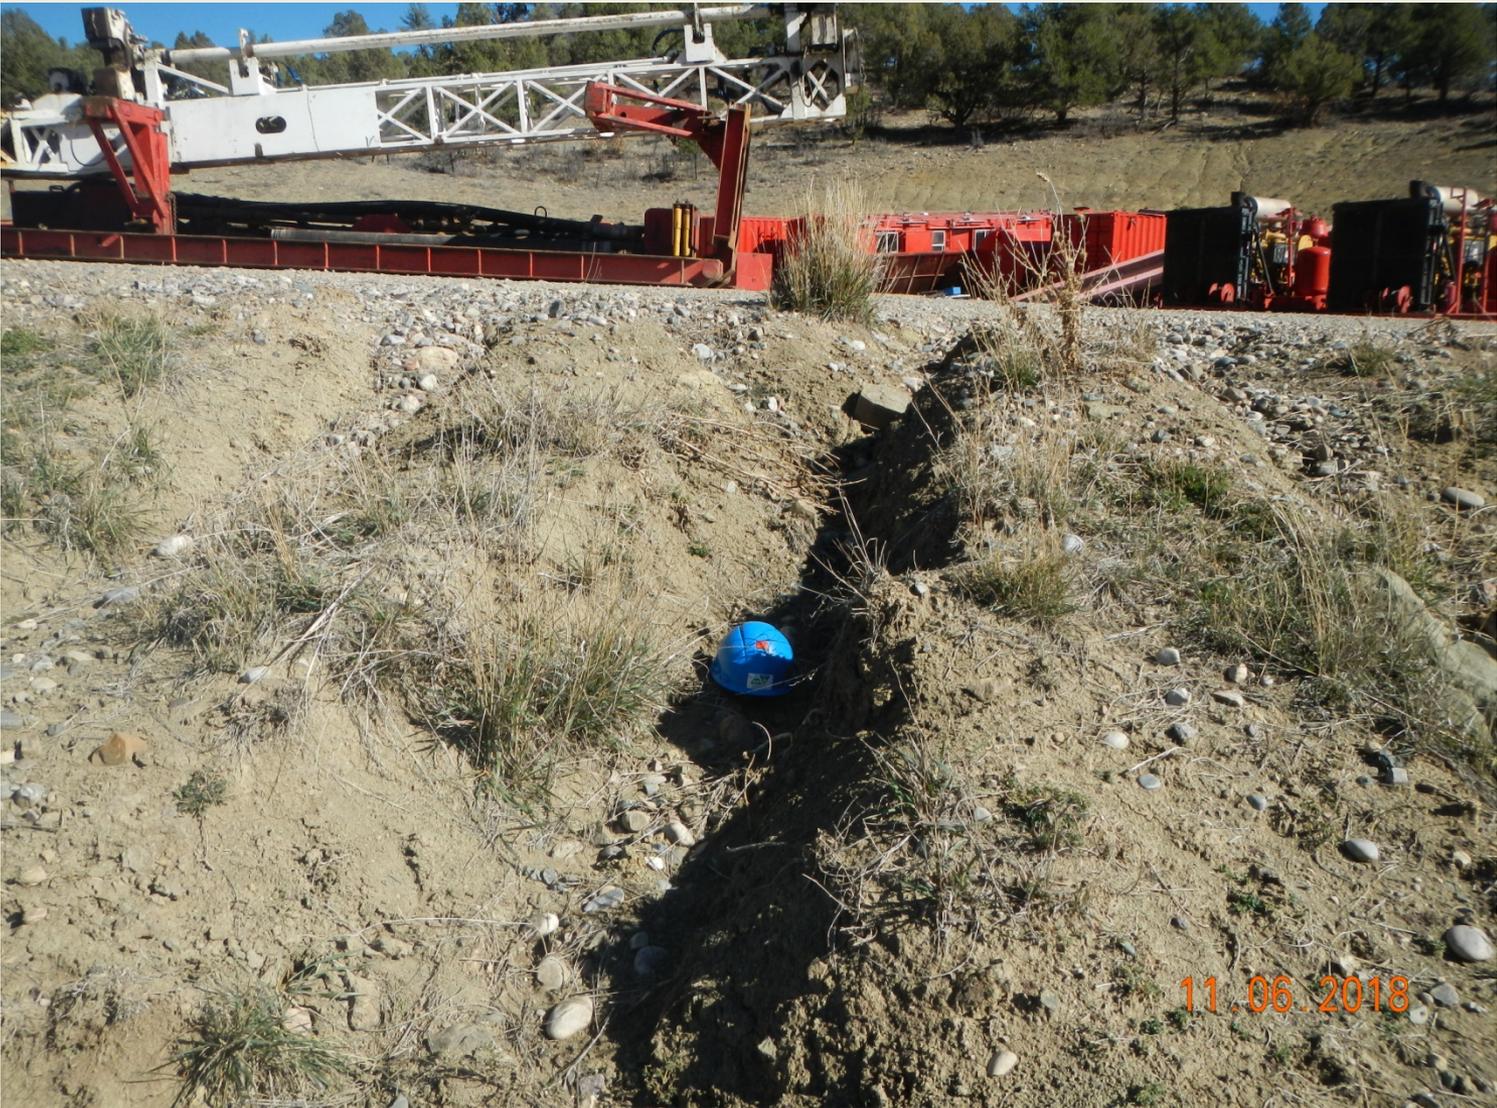
**Photo 2. View of erosional channel approximately 1.5 feet wide and deep within the western project area.**

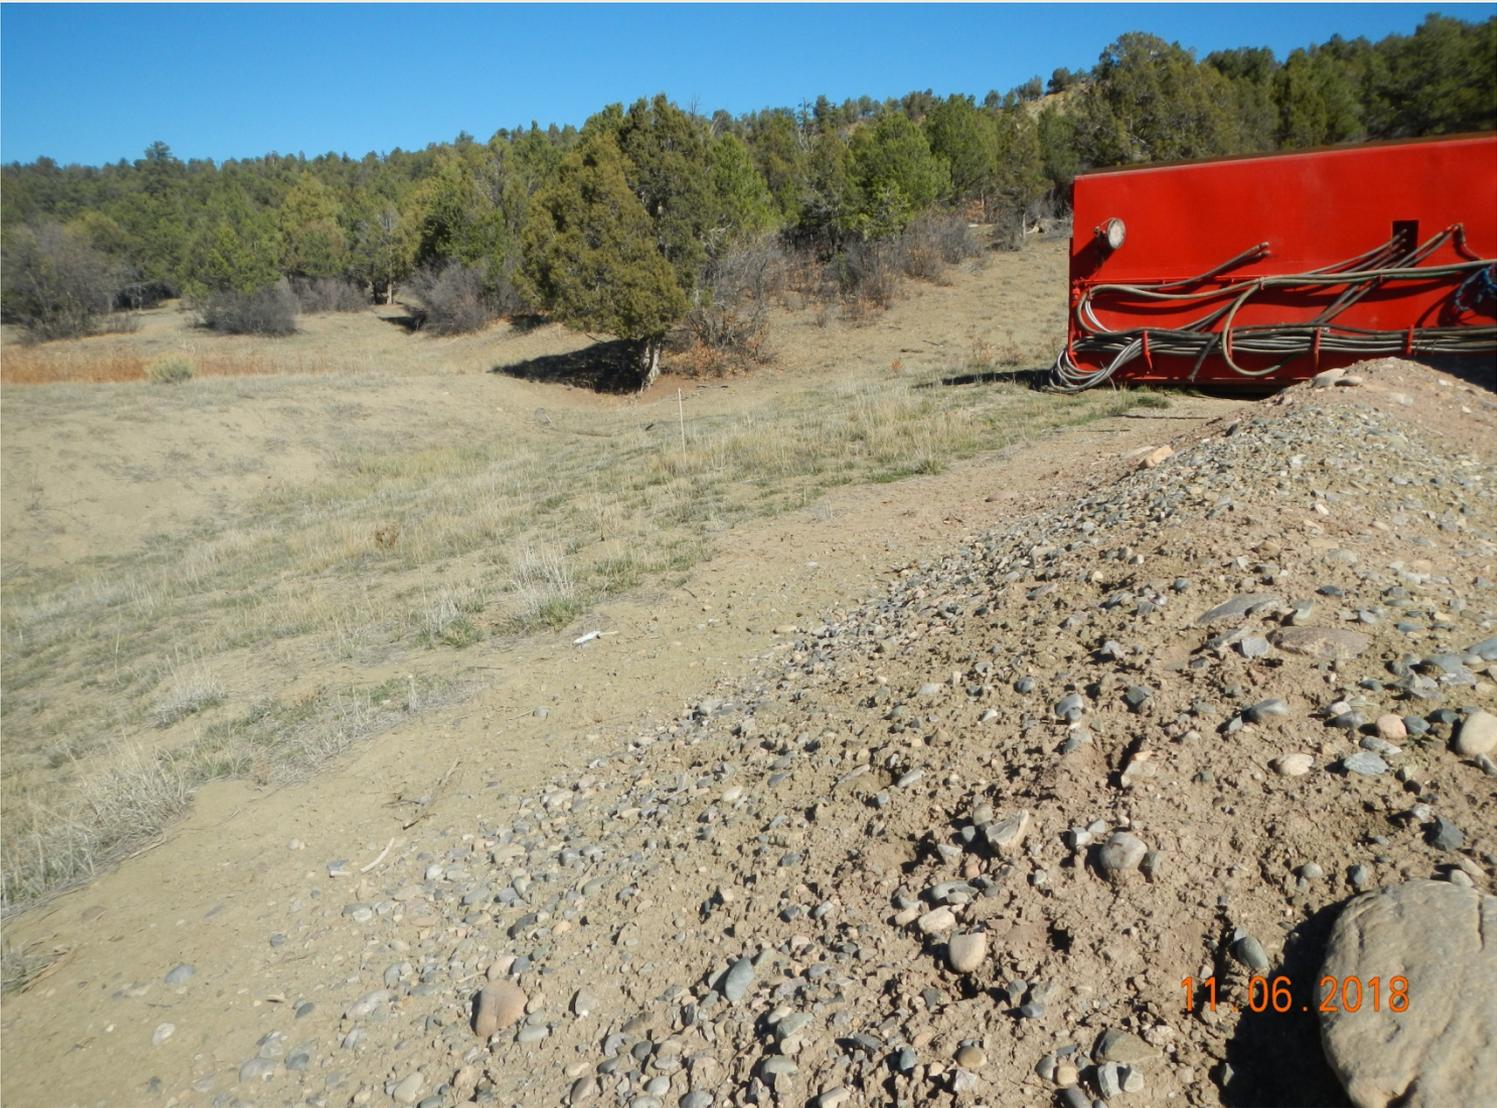
**Photo 3. View of the northern project area from the northwestern corner facing eastward.**

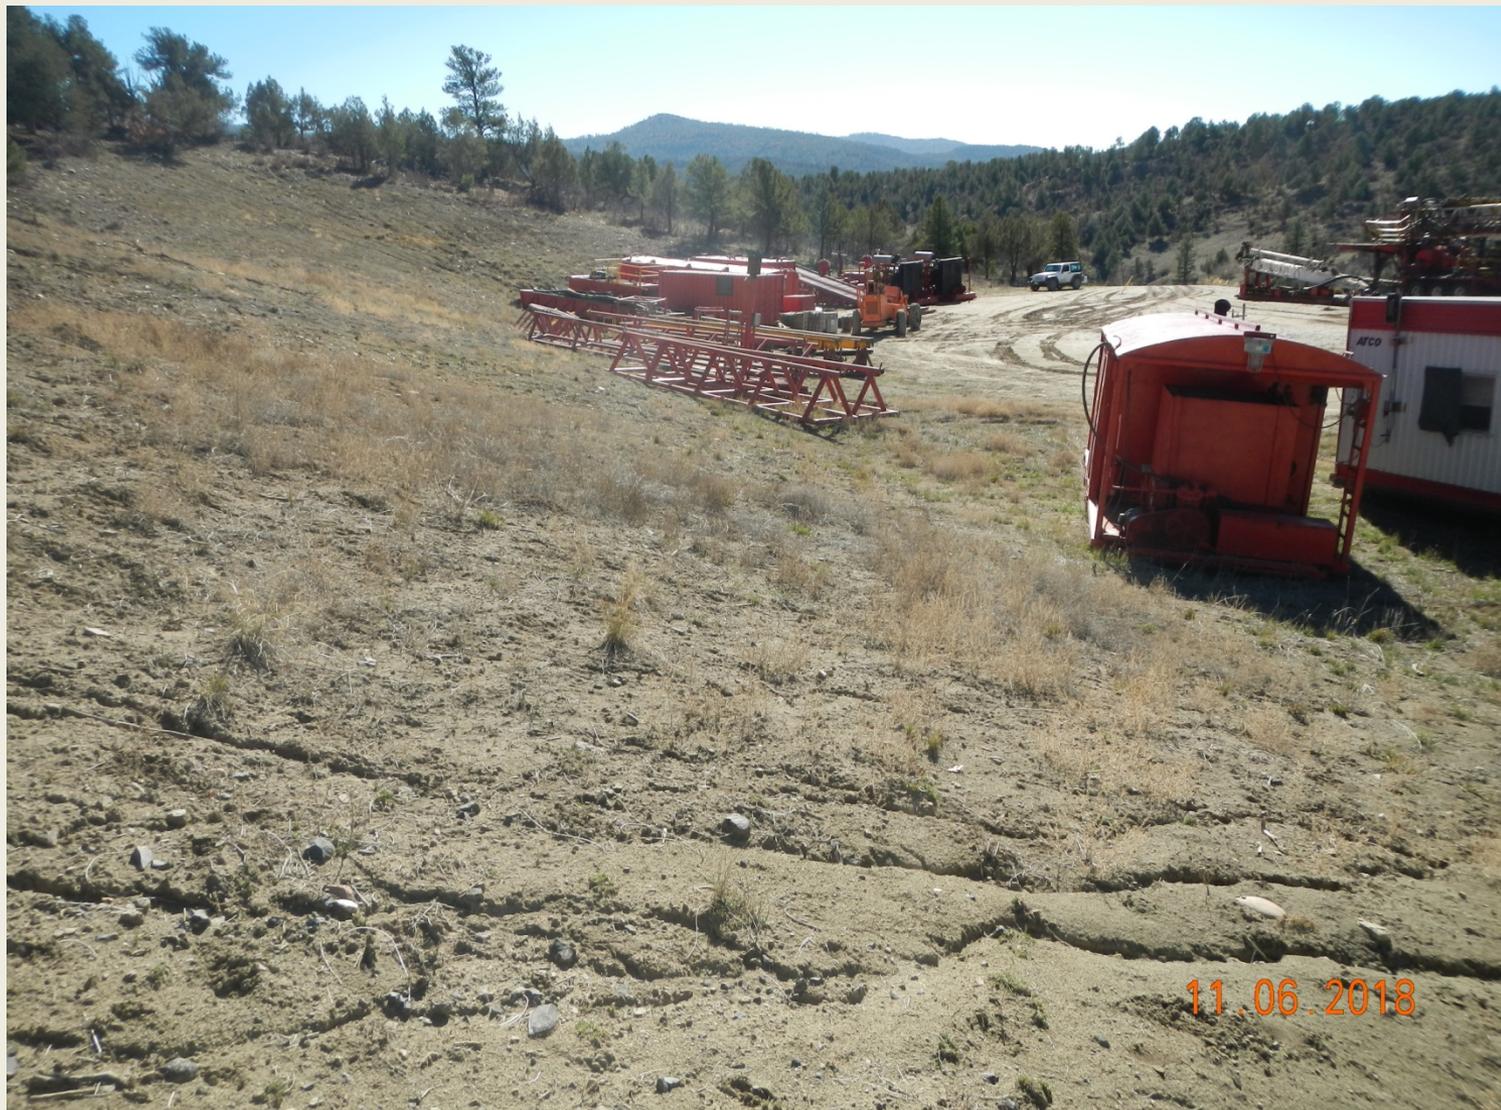
Photo 4. View of the eastern project area from the northeastern corner facing southward. Drilling equipment remains on location. Rilling is occurring in several areas along the cut-slope. Poor vegetative cover here. Some desirable species such as Indian ricegrass (*Achnatherum hymenoides*) and western wheatgrass (*Pascopyrum smithii*) observed. However bare ground and weeds such as Russian thistle (*Salsola tragus*) dominate.

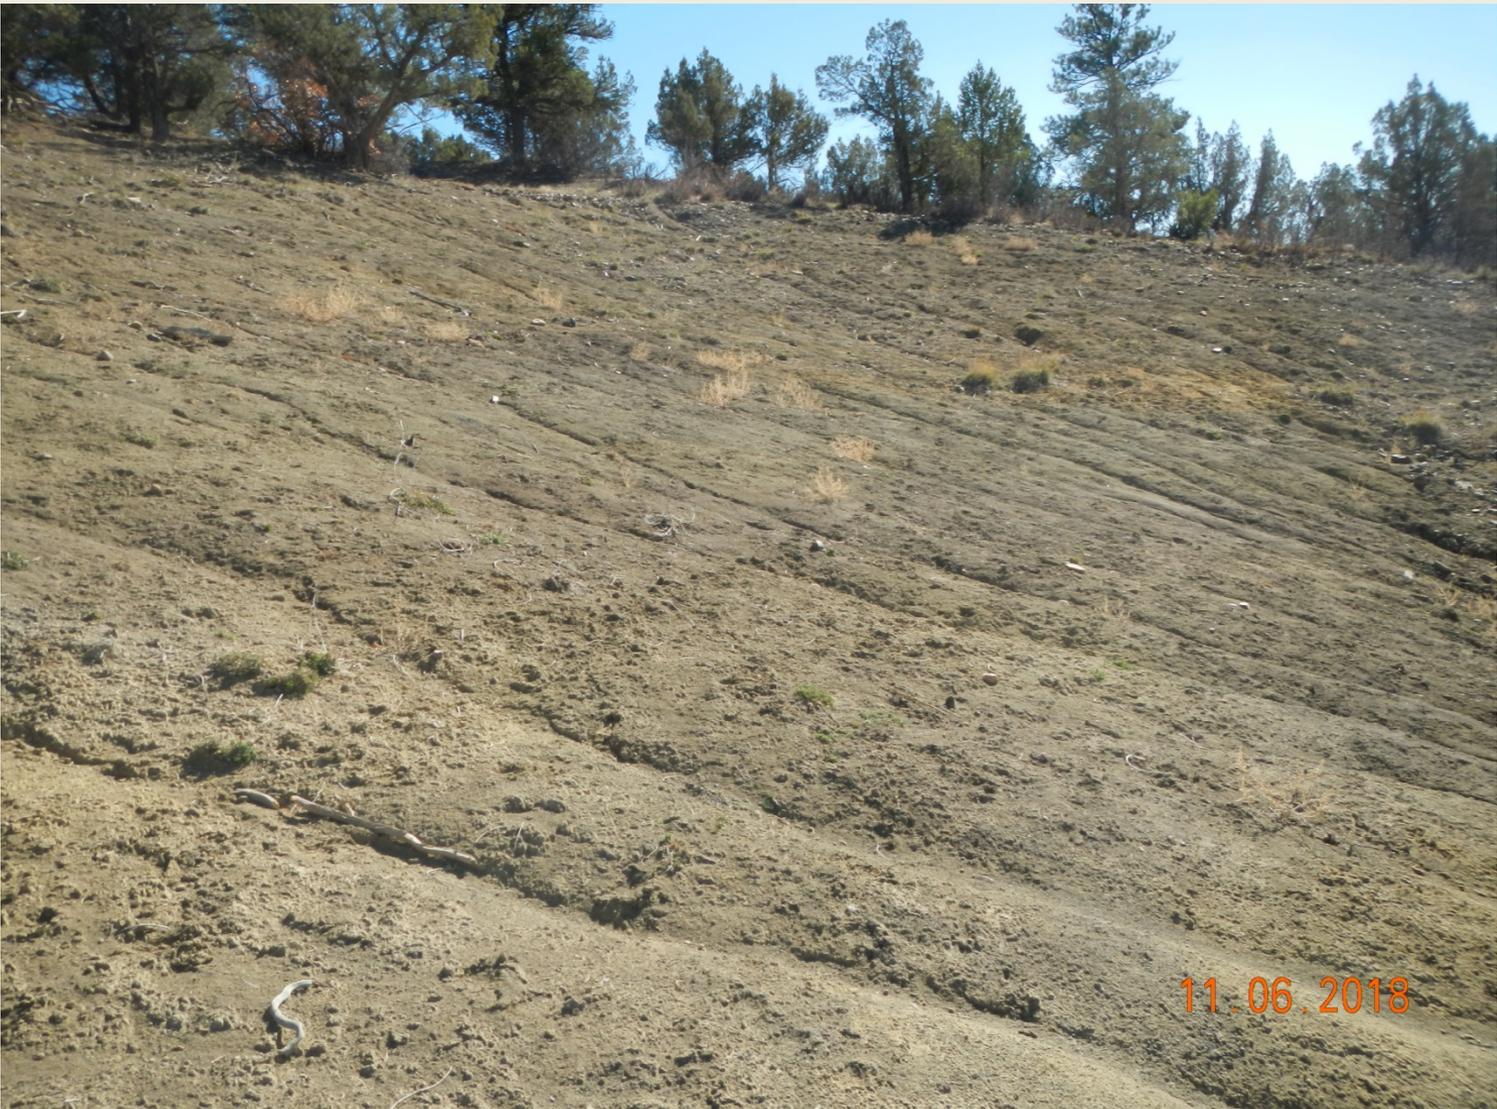
**Photo 5. View of the southeastern cut-slope. Poor revegetation and rilling is occurring throughout.**
