Inspection Photo (s)
Shideler 19-9B1
API # 05-045-07968
Inspection # 689302587

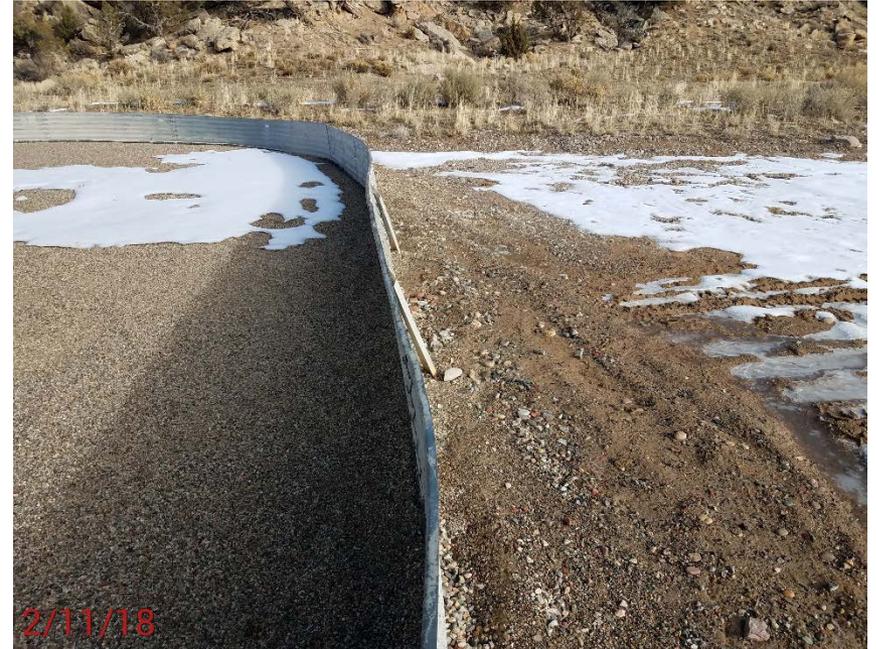
Location Photo #2, containment wall damage.

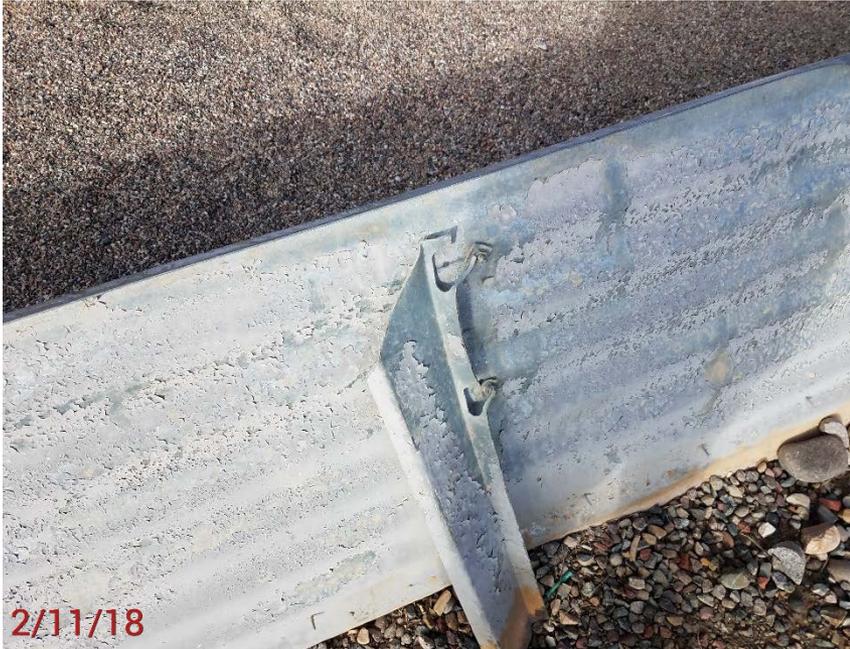
Location Photo #3, Support bracket broken.

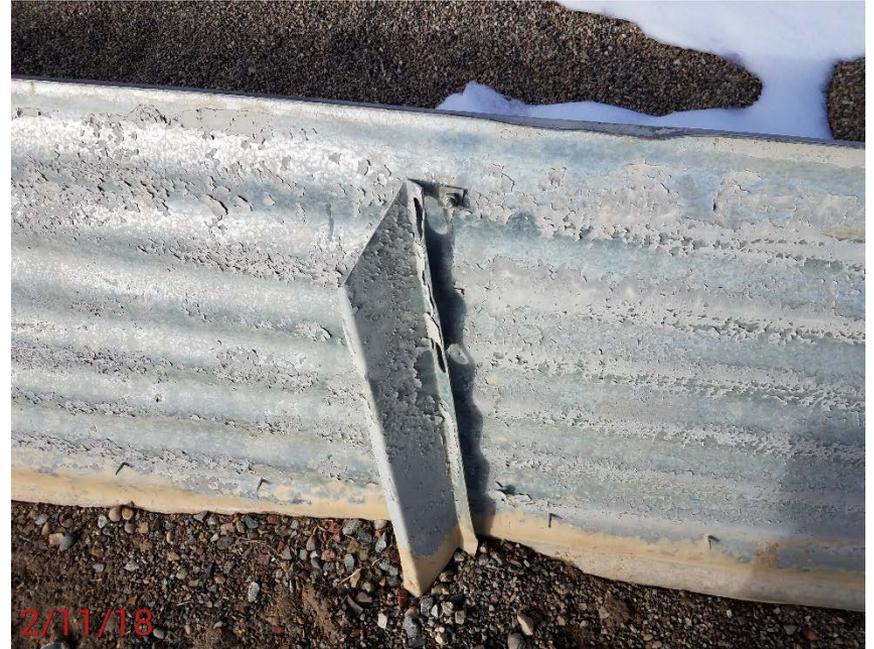
Location Photo #4, Support bracket broken.
