Inspection Photos

Operator: Hilcorp Energy

API: 05-067-09460

Date: 12/19/2018

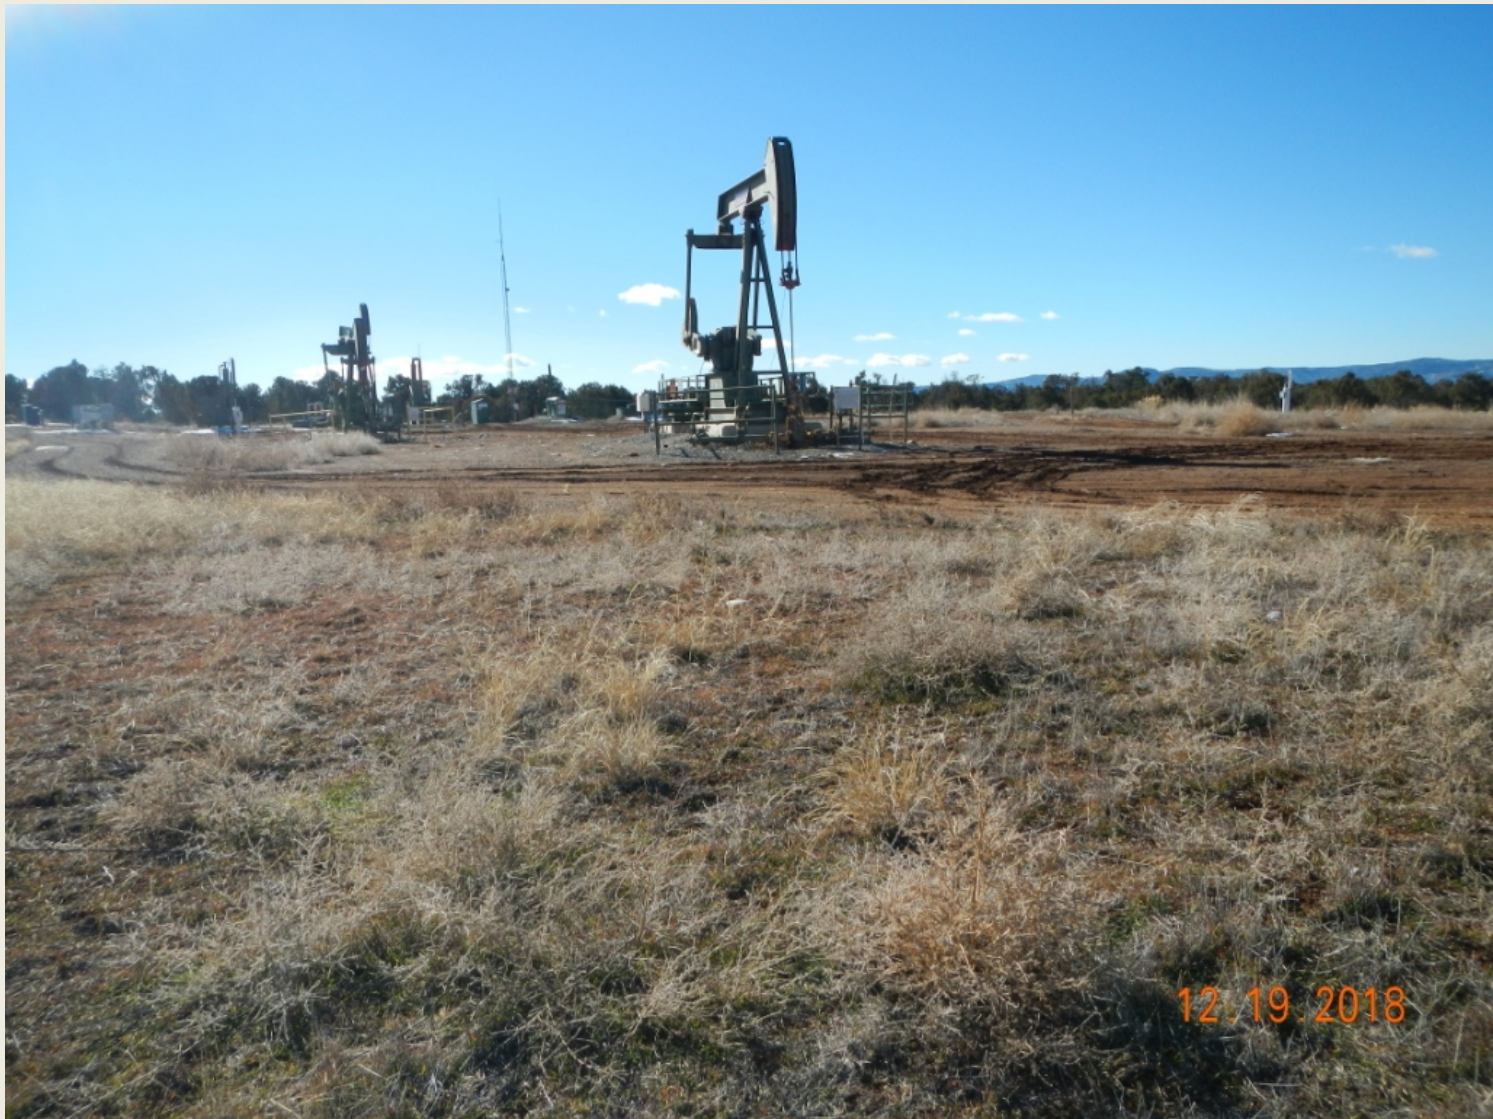
Photo 1. View of the project area from the northeastern corner facing center.

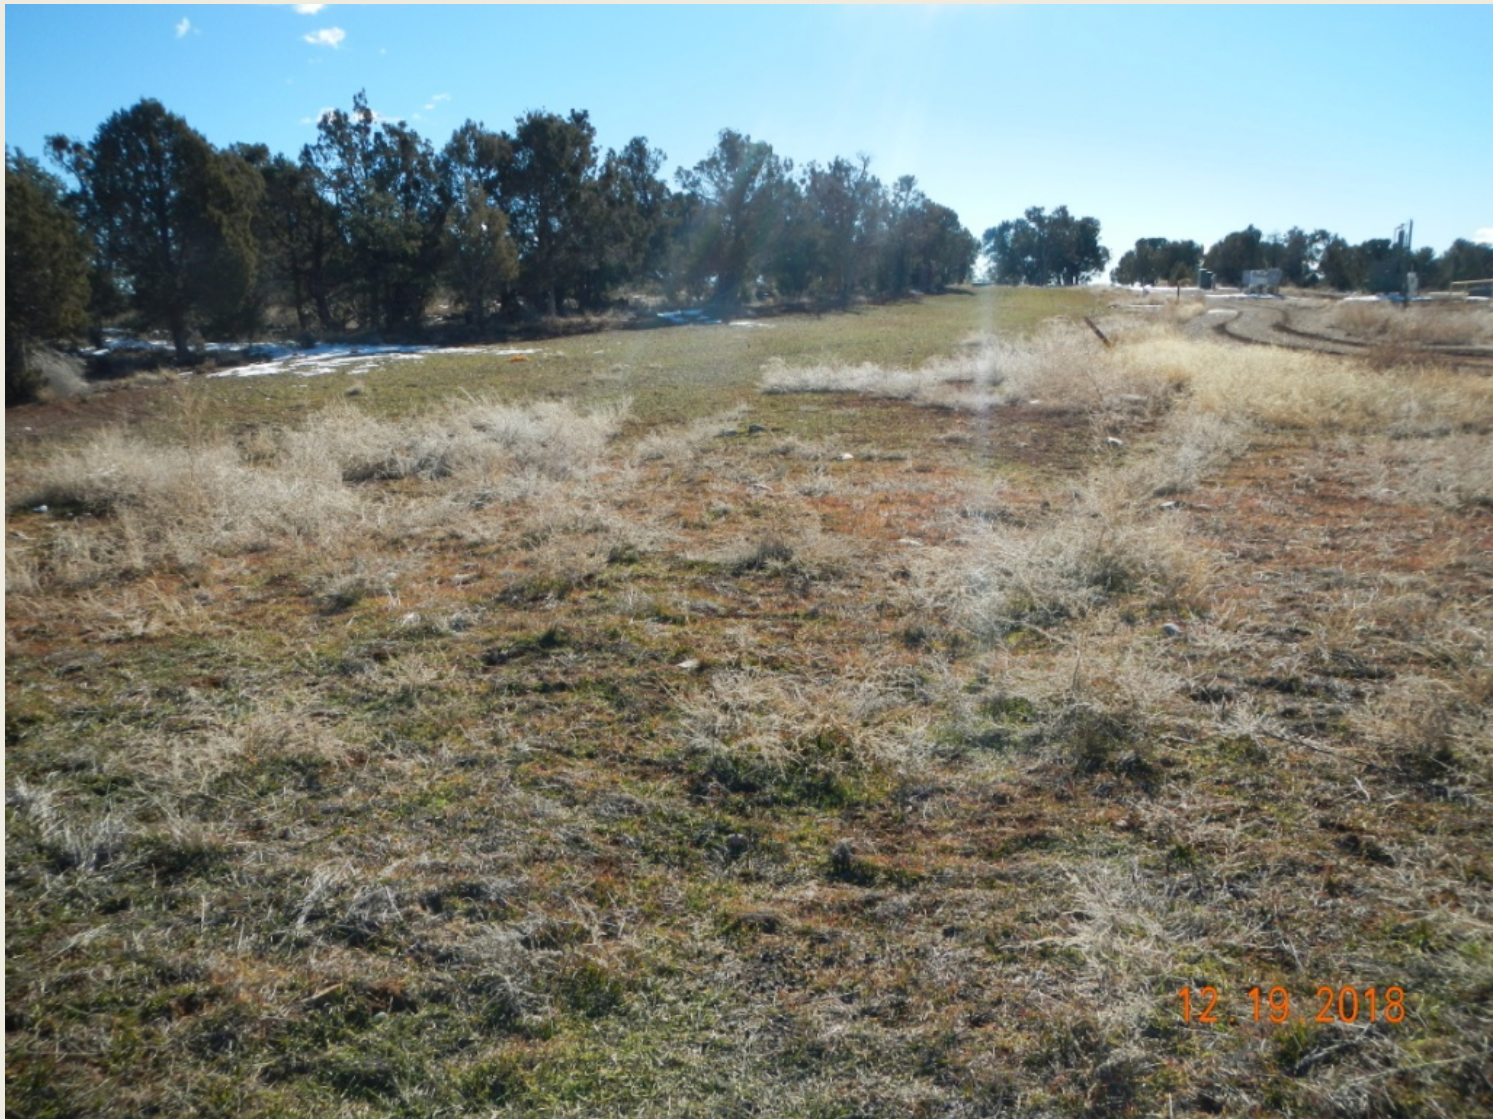
Photo 2. View the eastern project area from the northeastern corner facing southward. Revegetation is progressing in areas, but weedy with annual weeds in other areas.

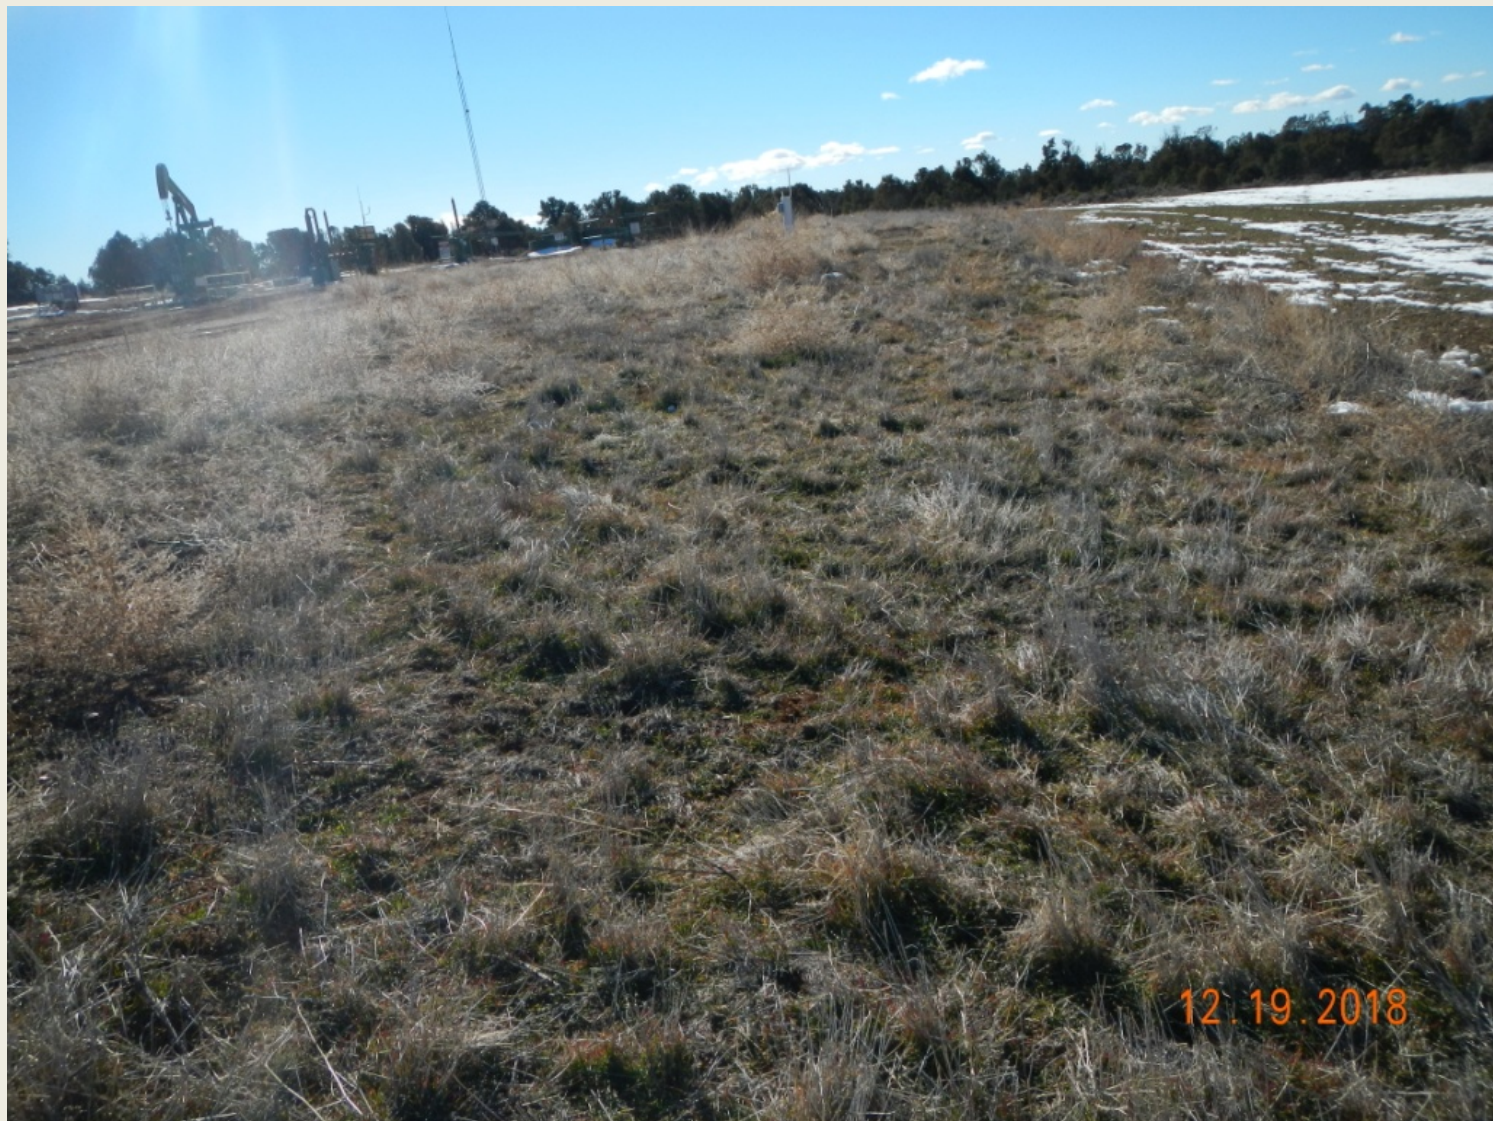
Photo 4. View of the western project area from the northwestern corner facing southward.
