Inspection Photo (s)
Speciality 43C
API # 05-045-15758
Inspection # 689302993

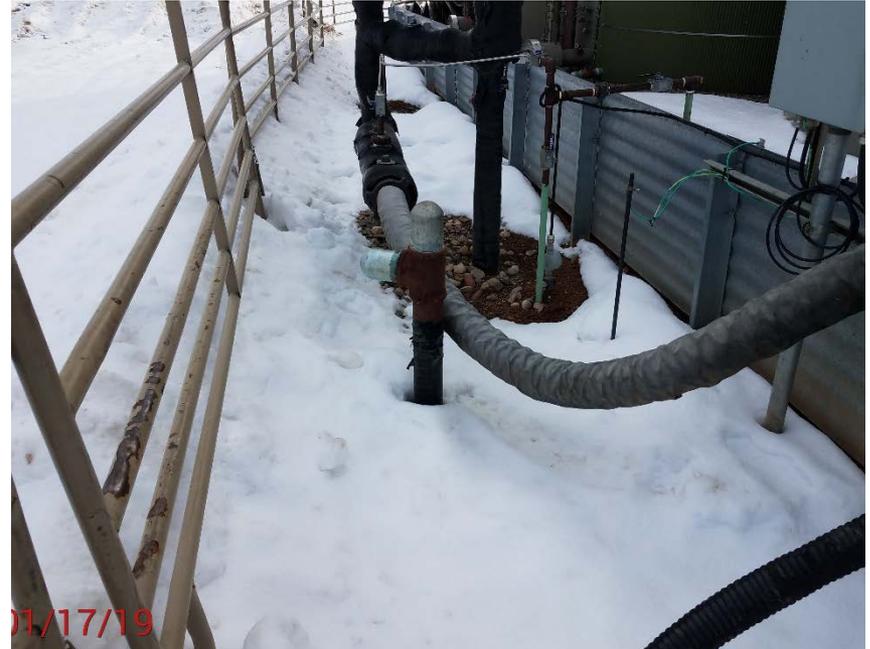
**Location Photo #4, Unmarked/unused
flowline near tank containment.**
