Inspection Photos

Operator: BAYHORSE PETROLEUM LLC - 10234

Location ID: 384907

Inspection Doc. Number: 682504428

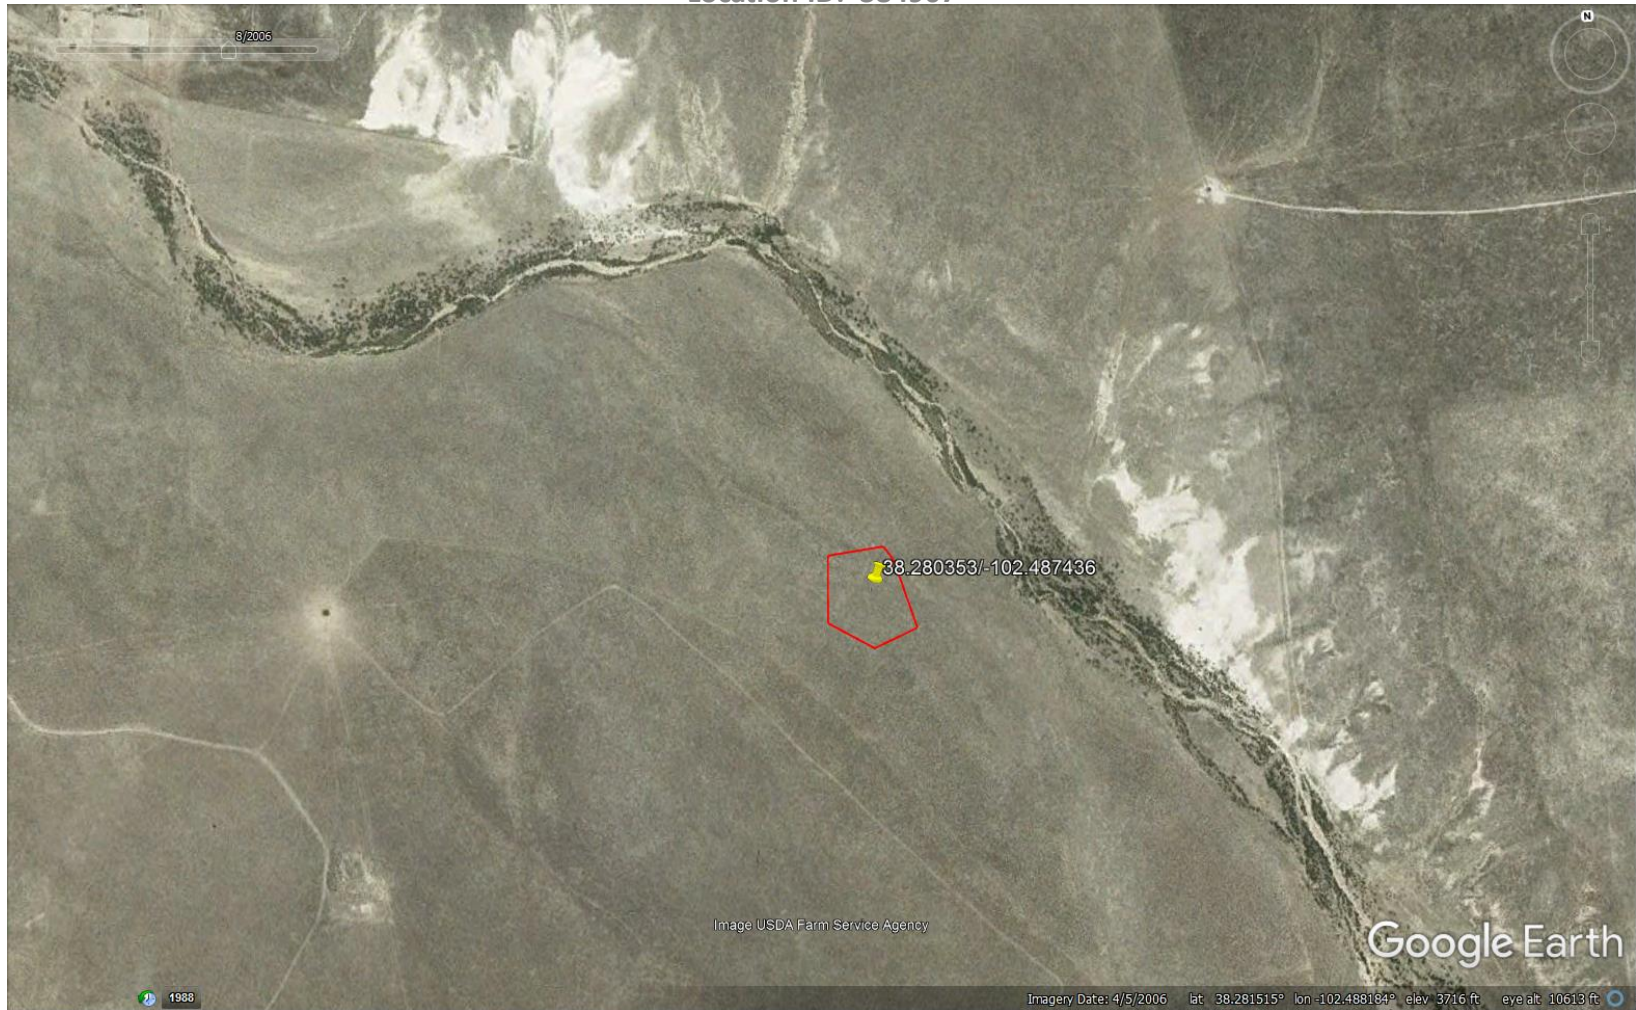
Photo 1: 2006 Google Earth aerial image. Photo location prior to oil and gas disturbance

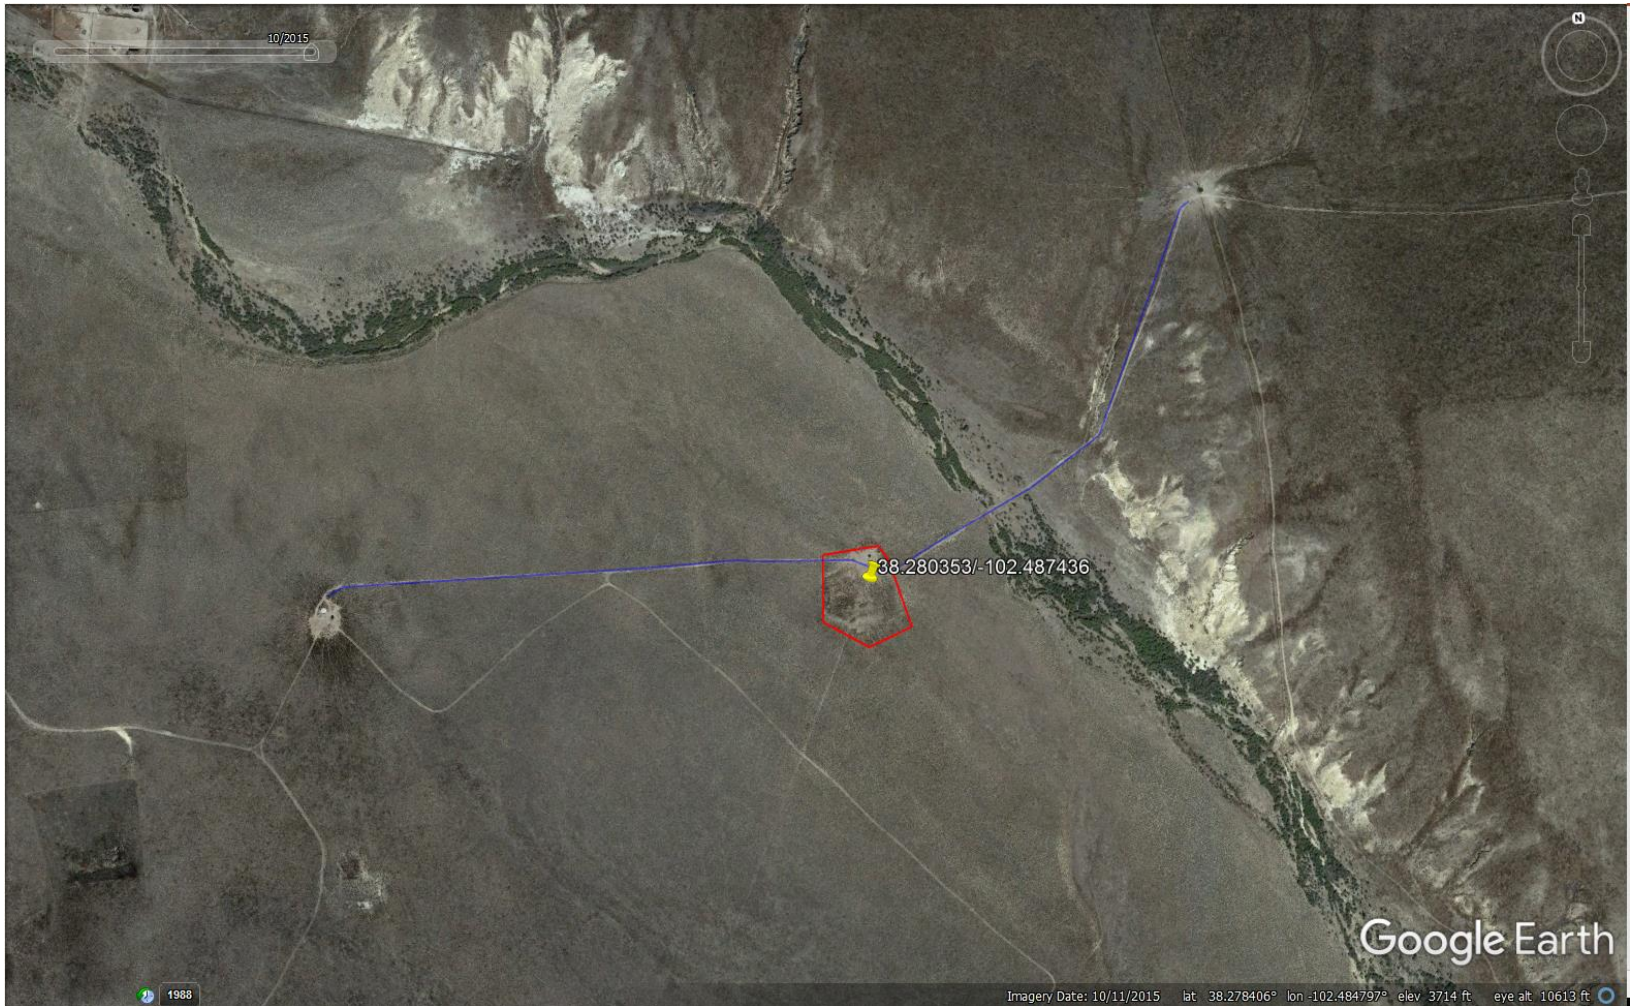
Photo 2: 2015 Google Earth aerial image. Photo shows the O&G location and access road. It appears as though an oil and gas access road has been constructed west to the location constructed and to the northeast. Access roads do not appear to have been pre-existing the oil and gas location. Surface owner does appear to be utilizing roads to access stock tanks.

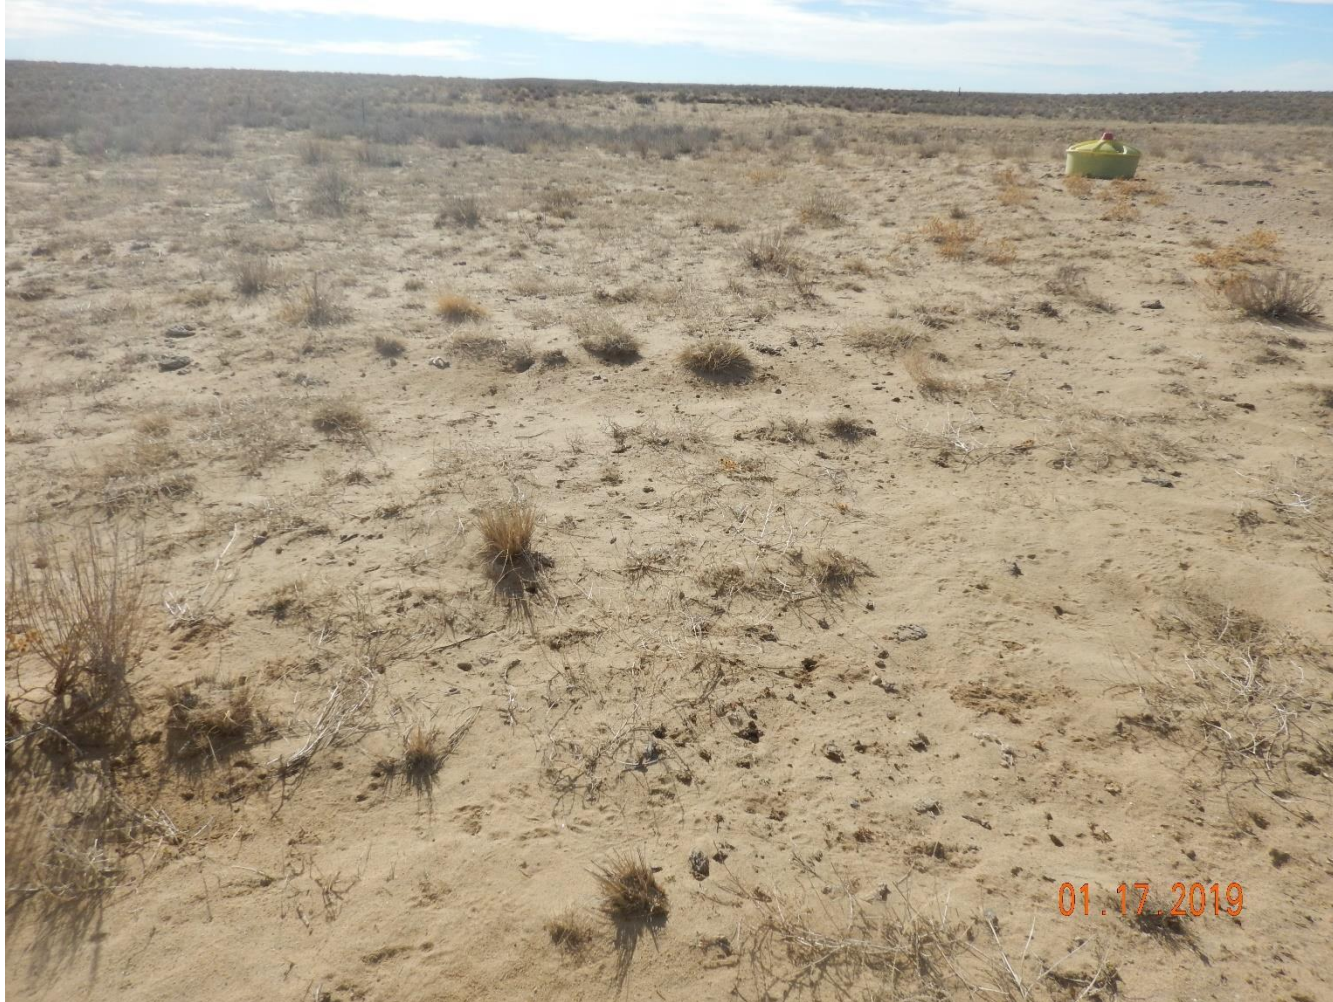
Photo 3: Photo taken from the northeast end of the location, facing south. Photo shows location remains predominantly bare and exposed soil.

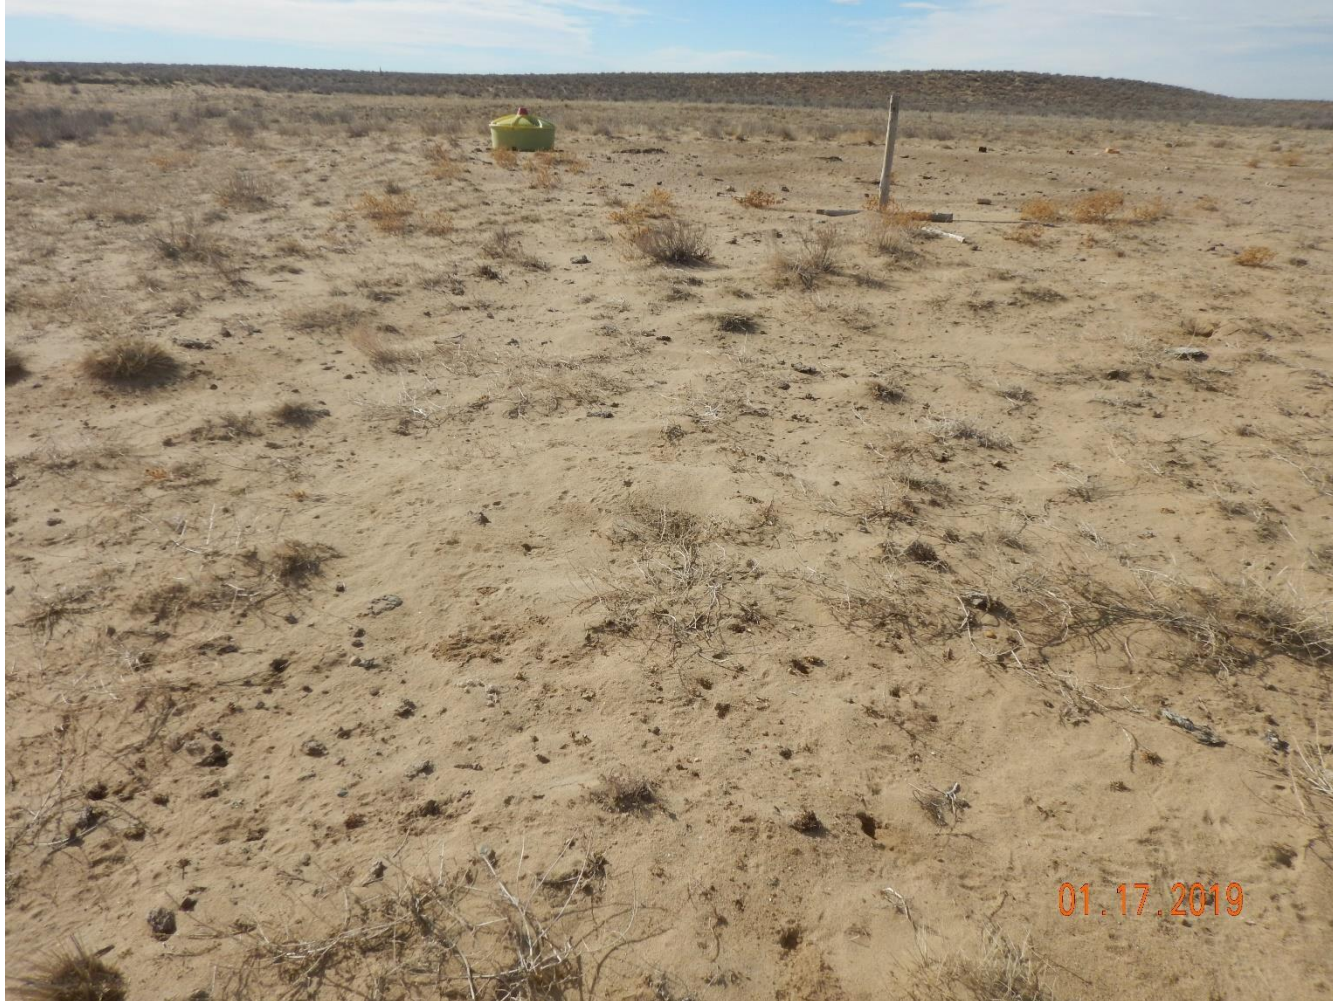
Photo 4: Photo taken from the northeast end of the location, facing southwest. Photo shows location remains predominantly bare and exposed soil.

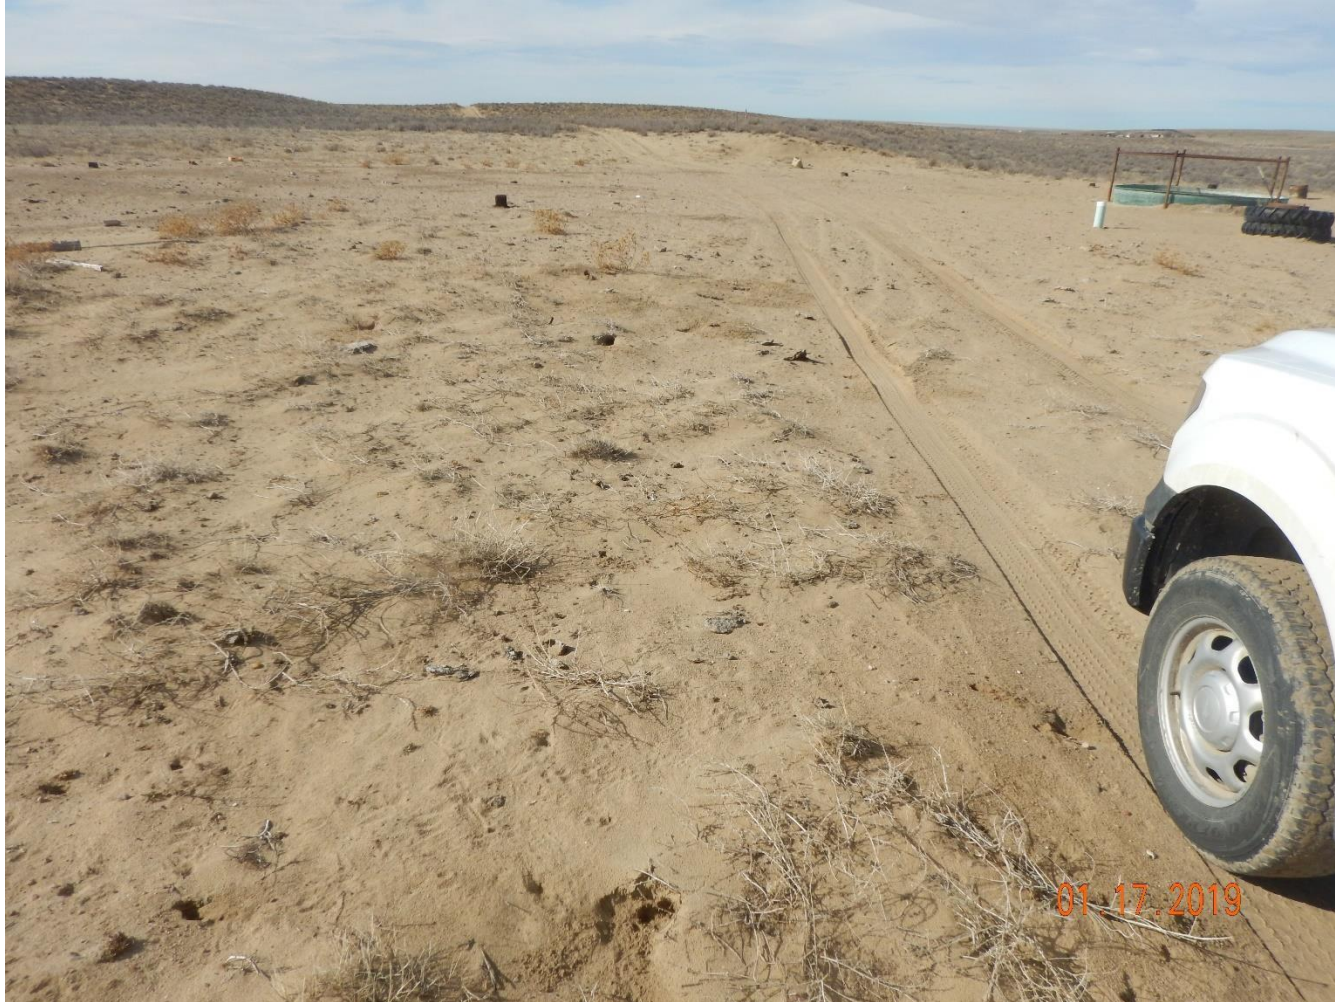
Photo 5: Photo taken from the northeast end of the location, facing west. Photo shows location remains predominantly bare and exposed soil.

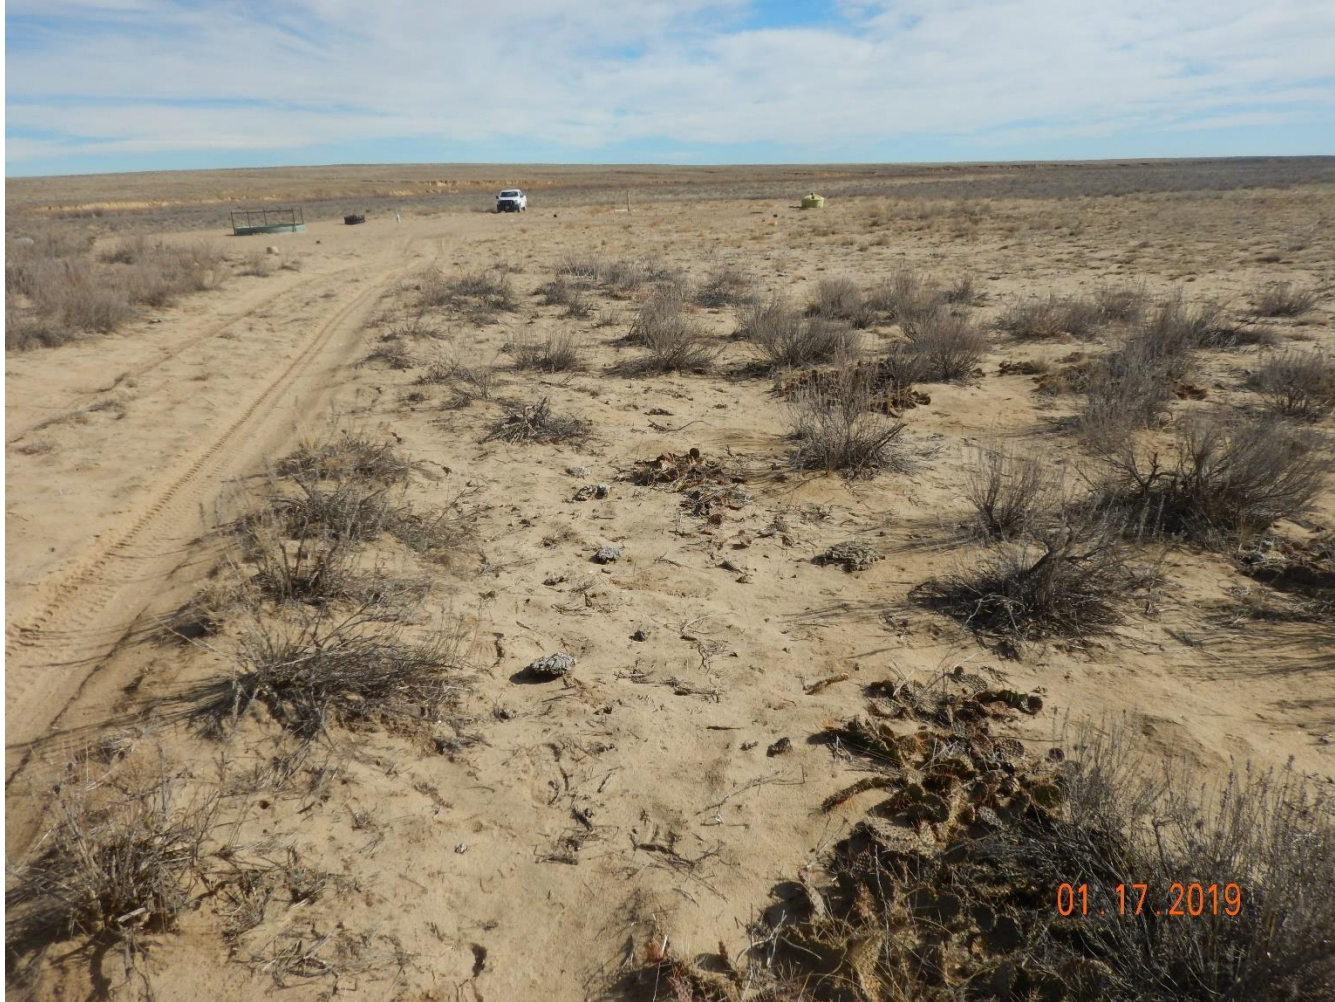
Photo 6: Photo taken from the northwest end of the location, facing east. See comments under photo 5

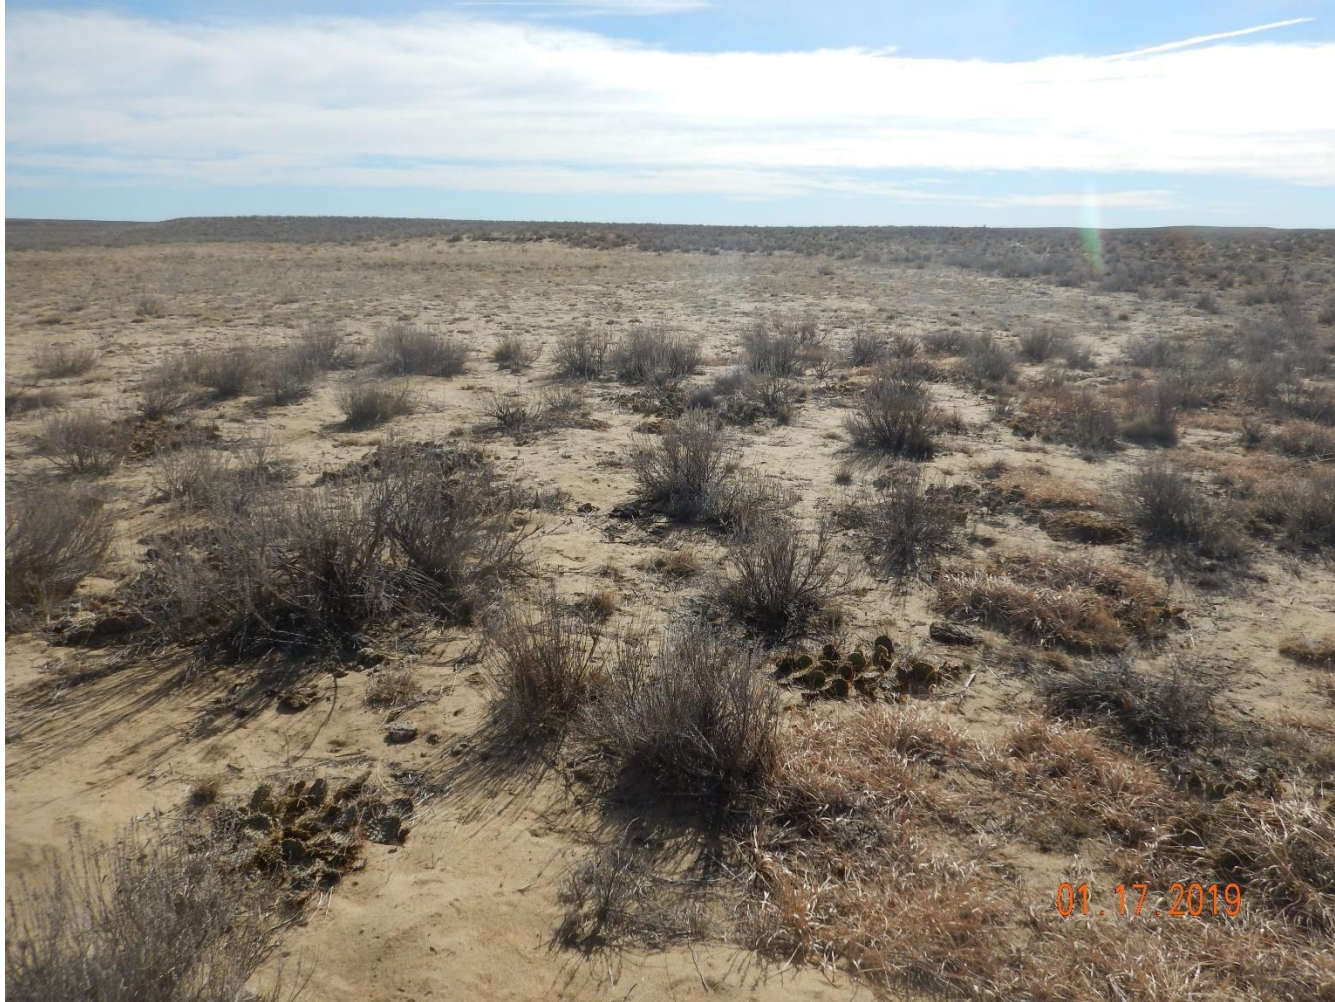
Photo 7: Photo taken from the northwest end of the location, facing north. See comments under photo 5

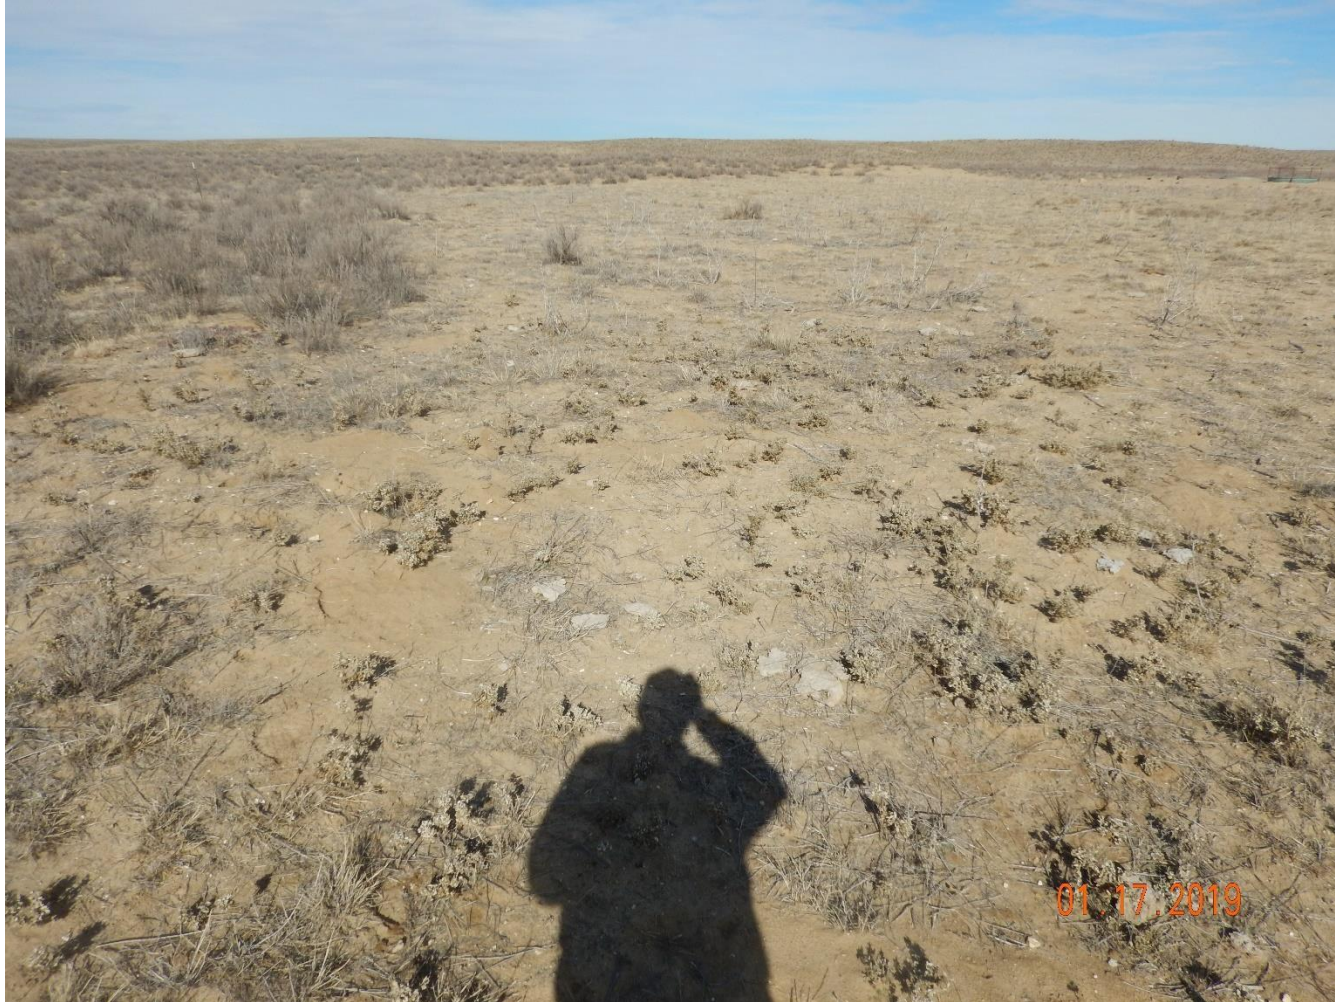
Photo 8: Photo taken from the southwest end of the location, facing north. See comments under photo 5

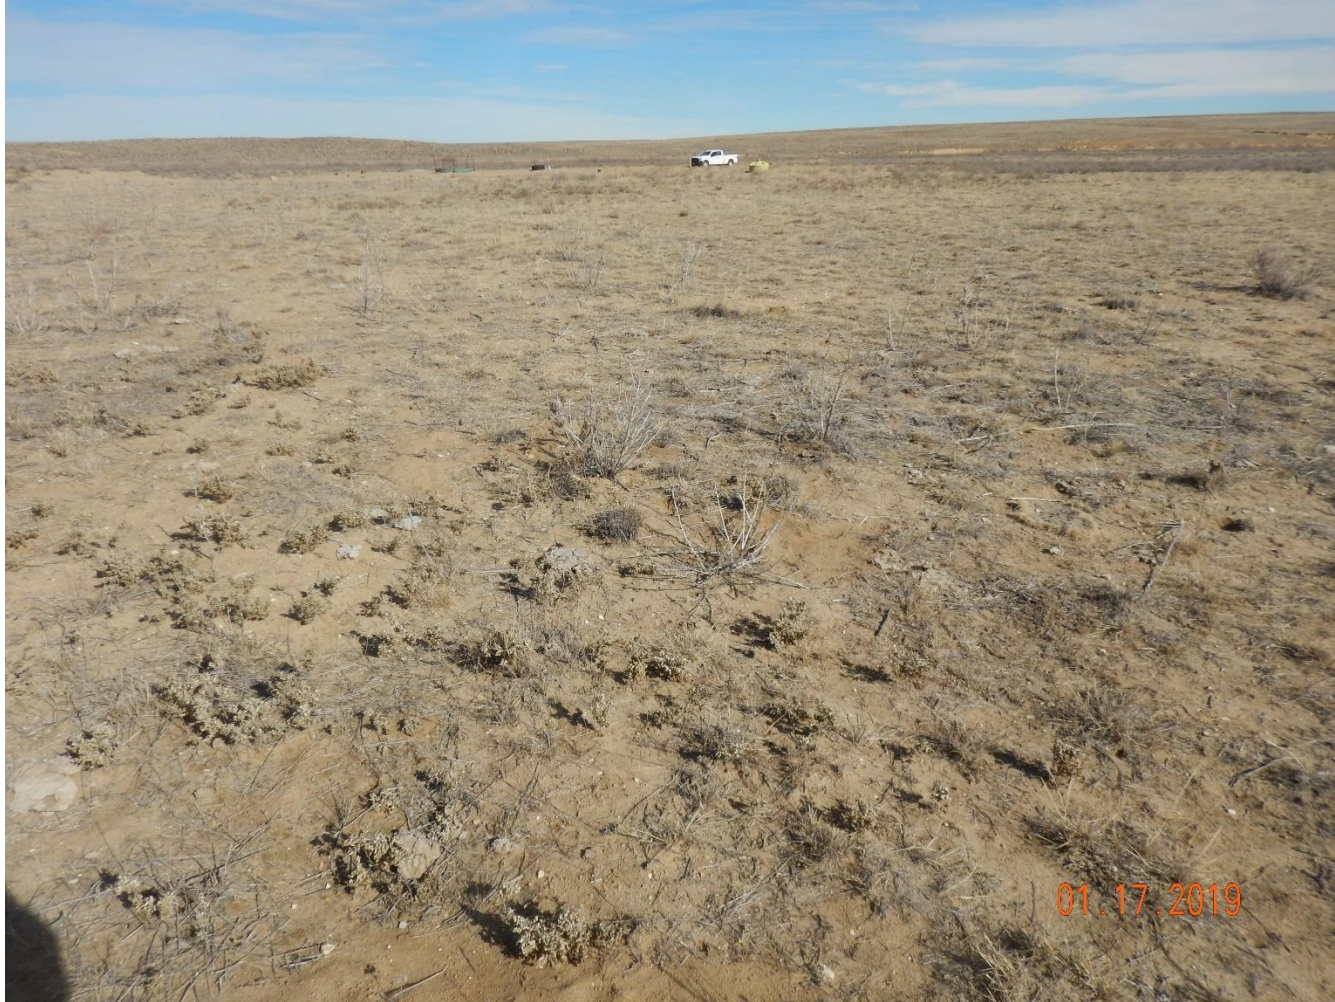
Photo 9: Photo taken from the southwest end of the location, facing northeast. See comments under photo 5

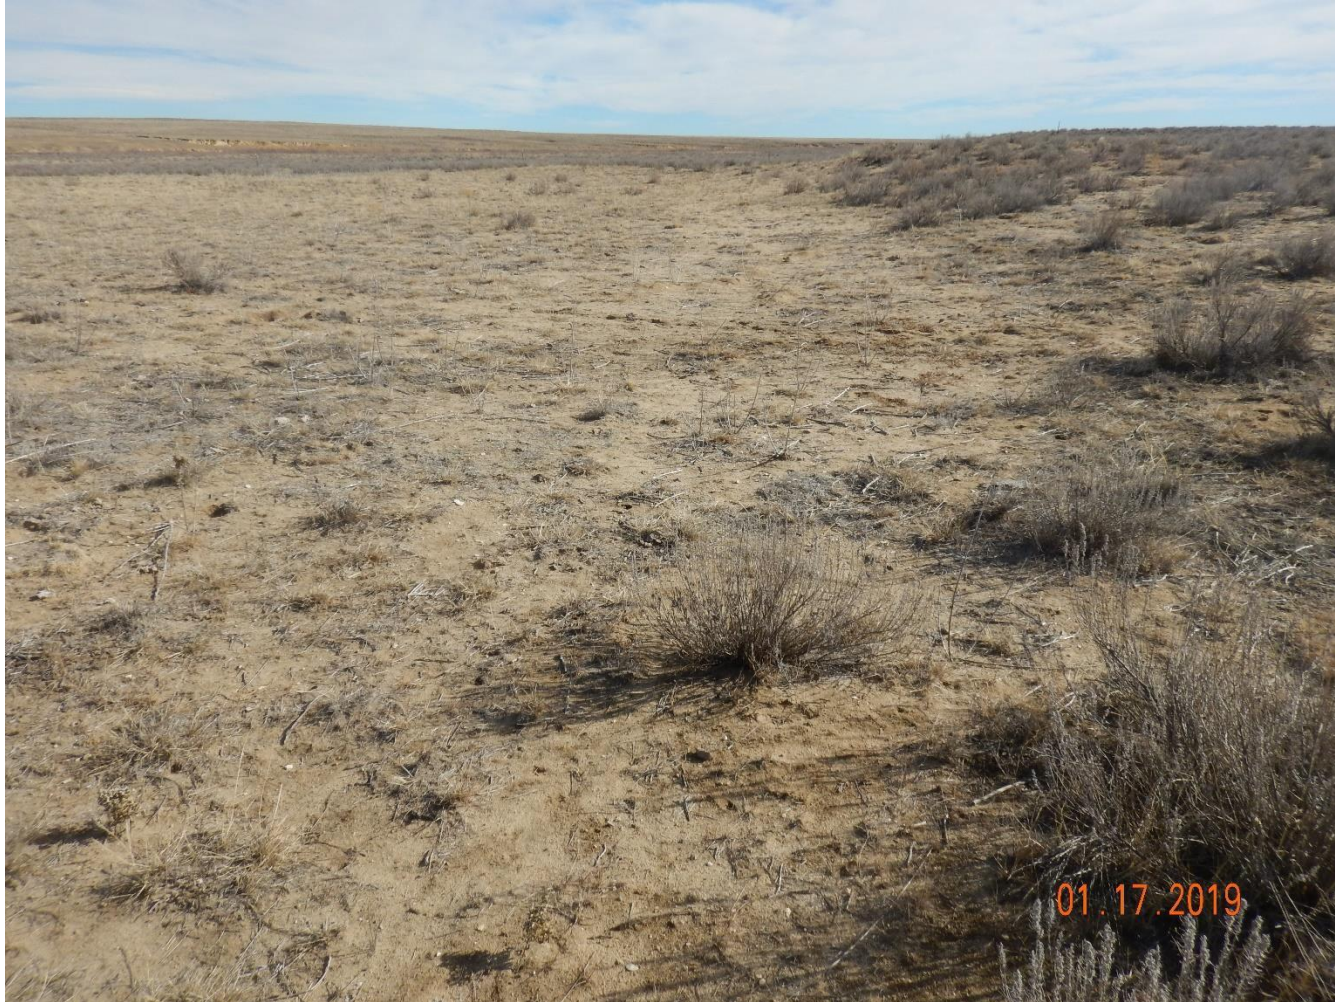
Photo 10: Photo taken from the southwest end of the location, facing east. See comments under photo 5

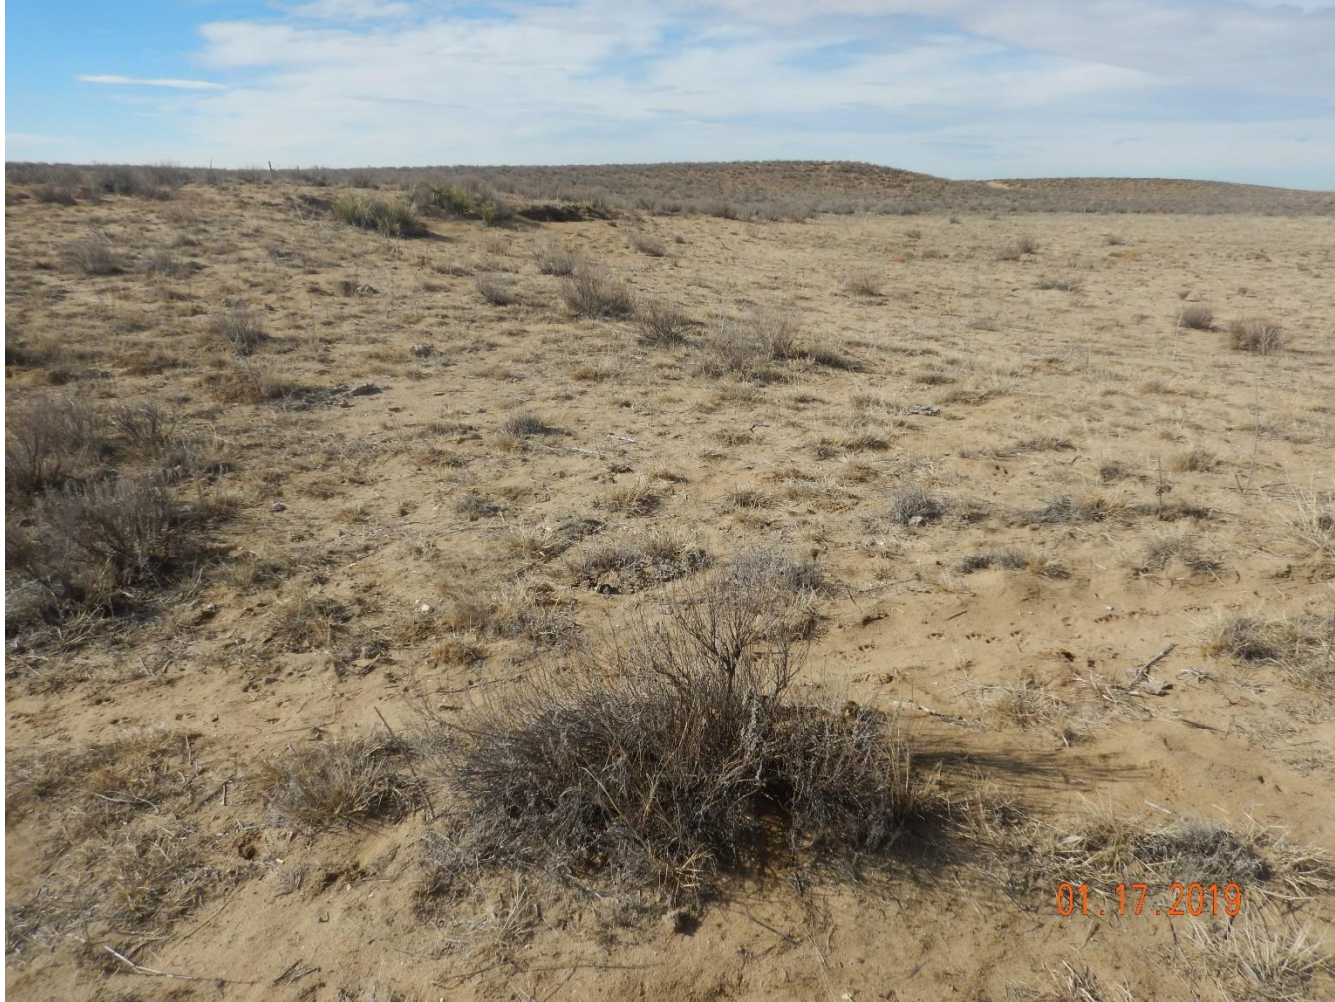
Photo 11: Photo taken from the southeast end of the location, facing west. See comments under photo 5. Photo also shows area of cut-slope that does not appear to have been recontoured/regraded.

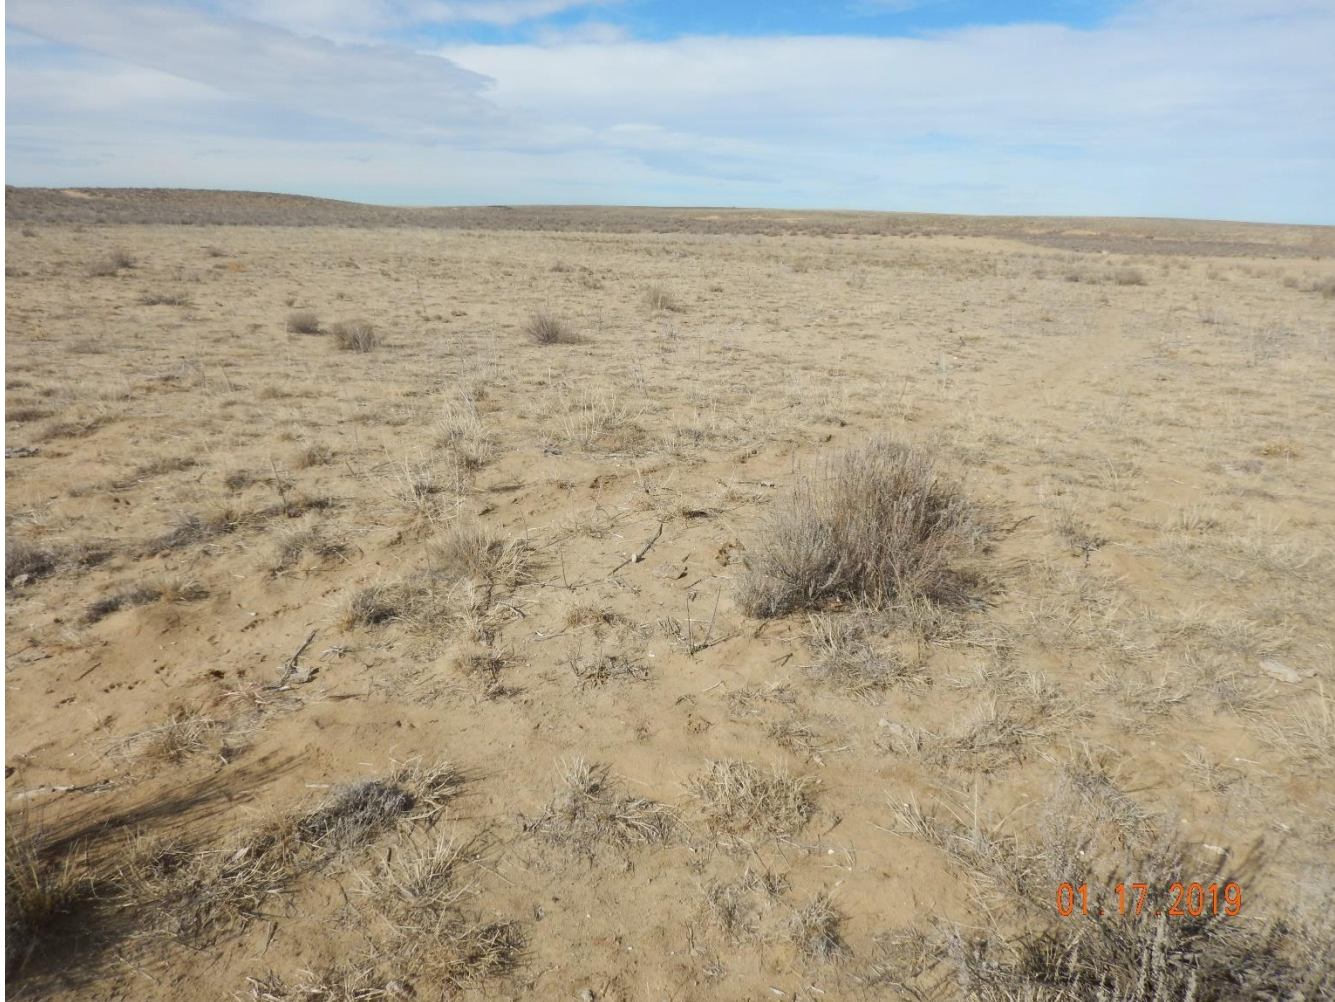
Photo 12: Photo taken from the southeast end of the location, facing northwest. See comments under photo 5

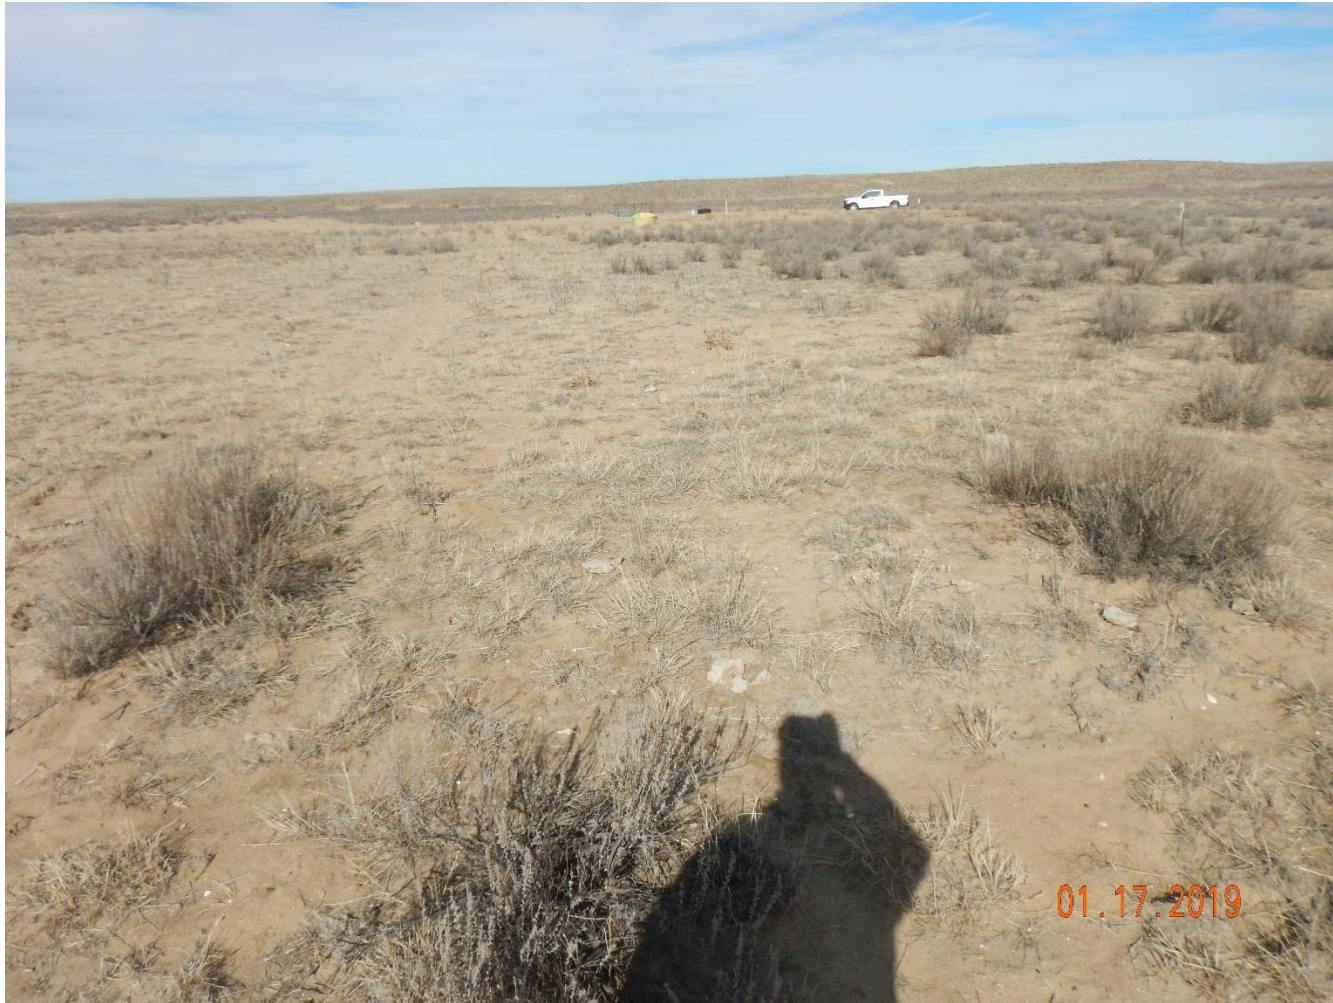
Photo 13: Photo taken from the southeast end of the location, facing north. See comments under photo 5

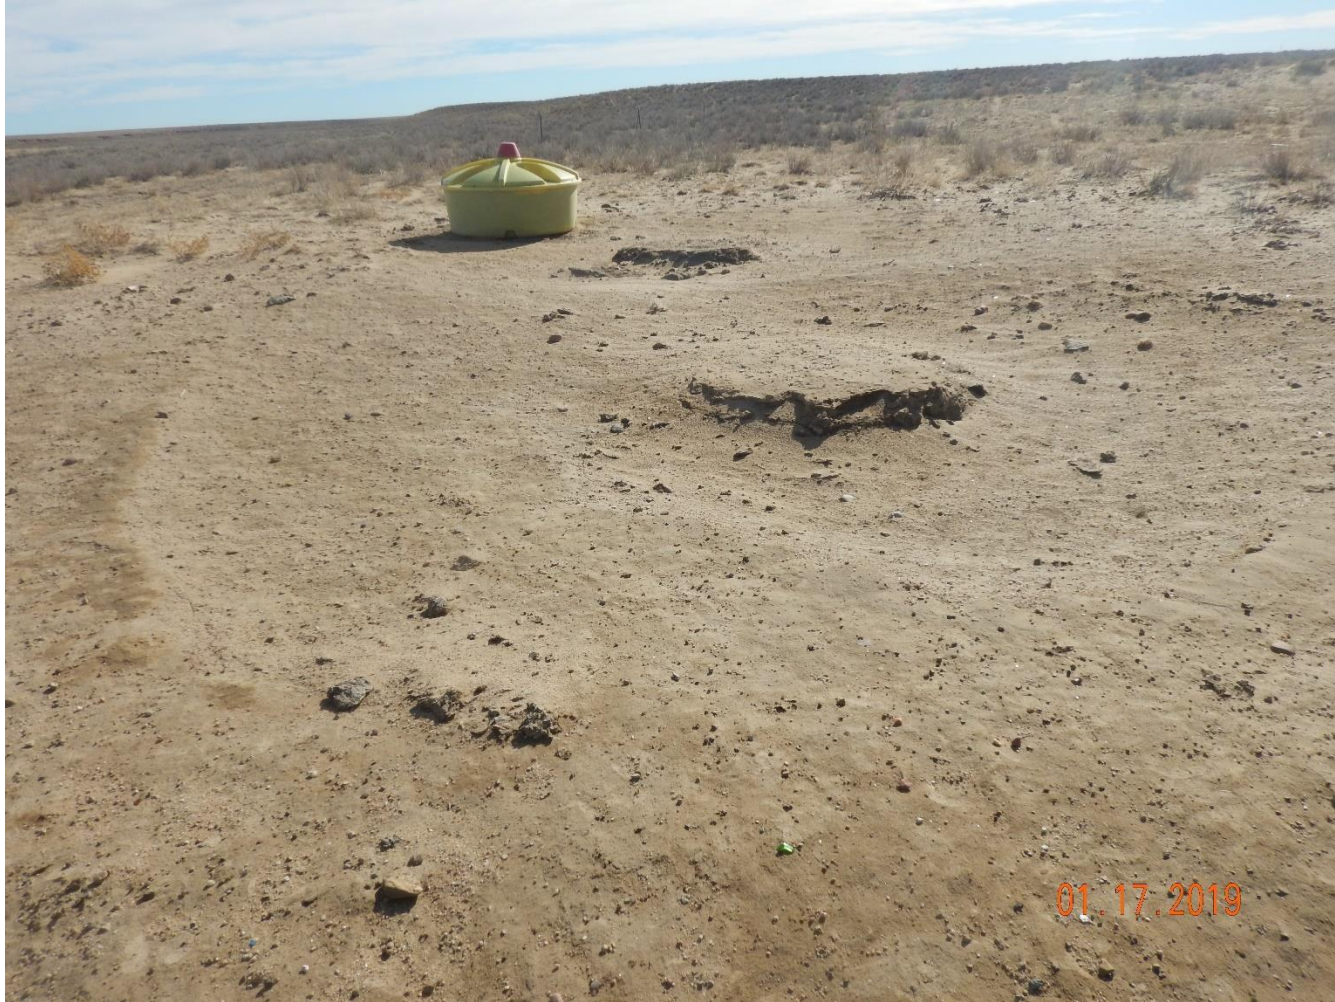
Photo 14: Photo taken from the northeast end of the location, facing south. Photo show evidence of erosion occurring on location

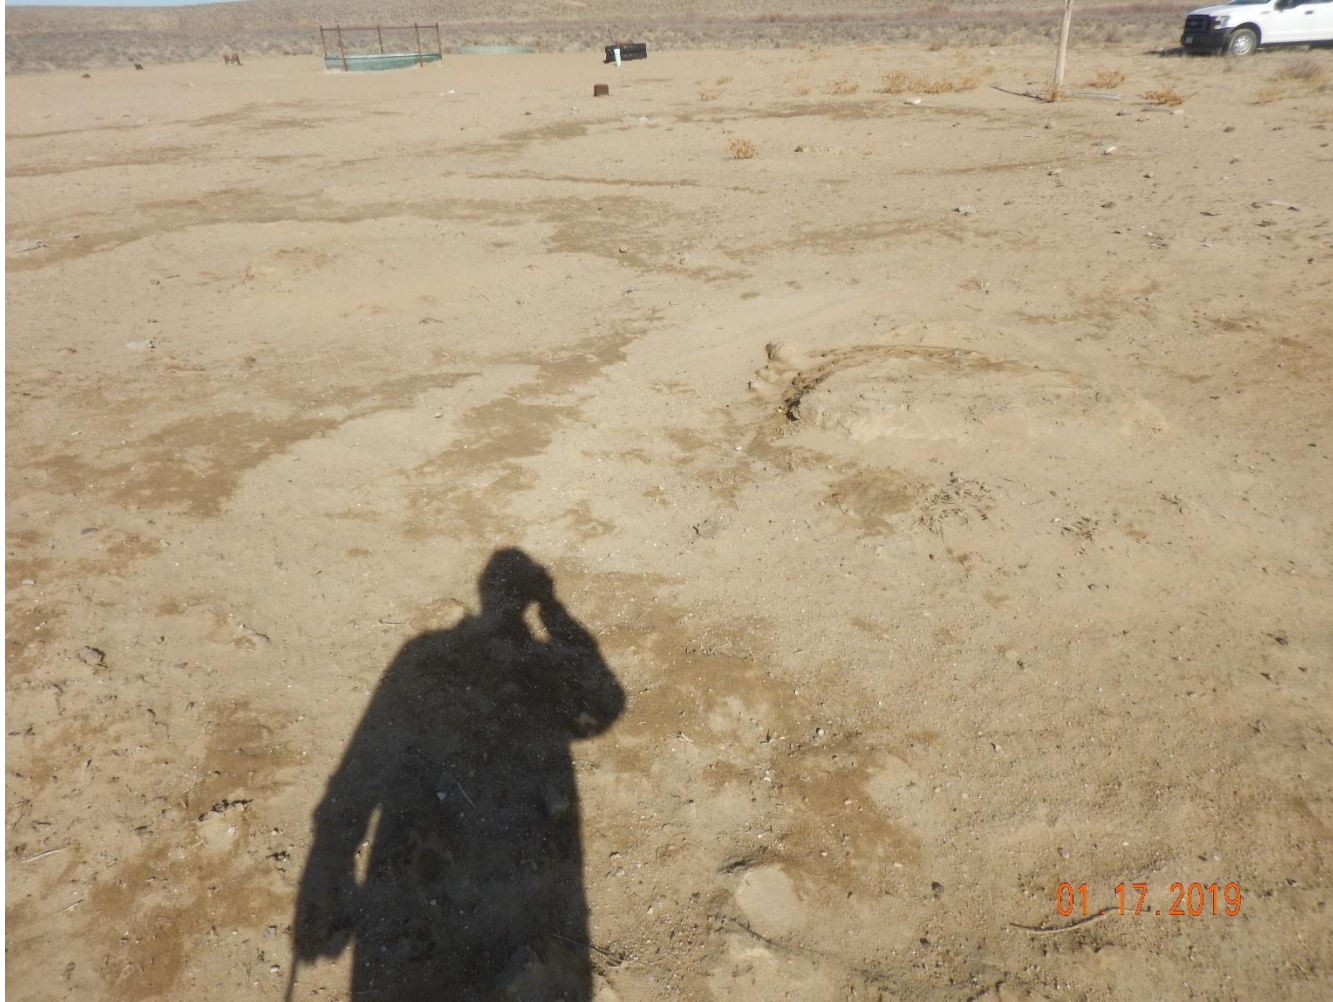
Photo 15: Photo taken from the northeast end of the location, facing north. See comments under photo 14. Photo also shows a stock tank that has been placed on the north end of the location.

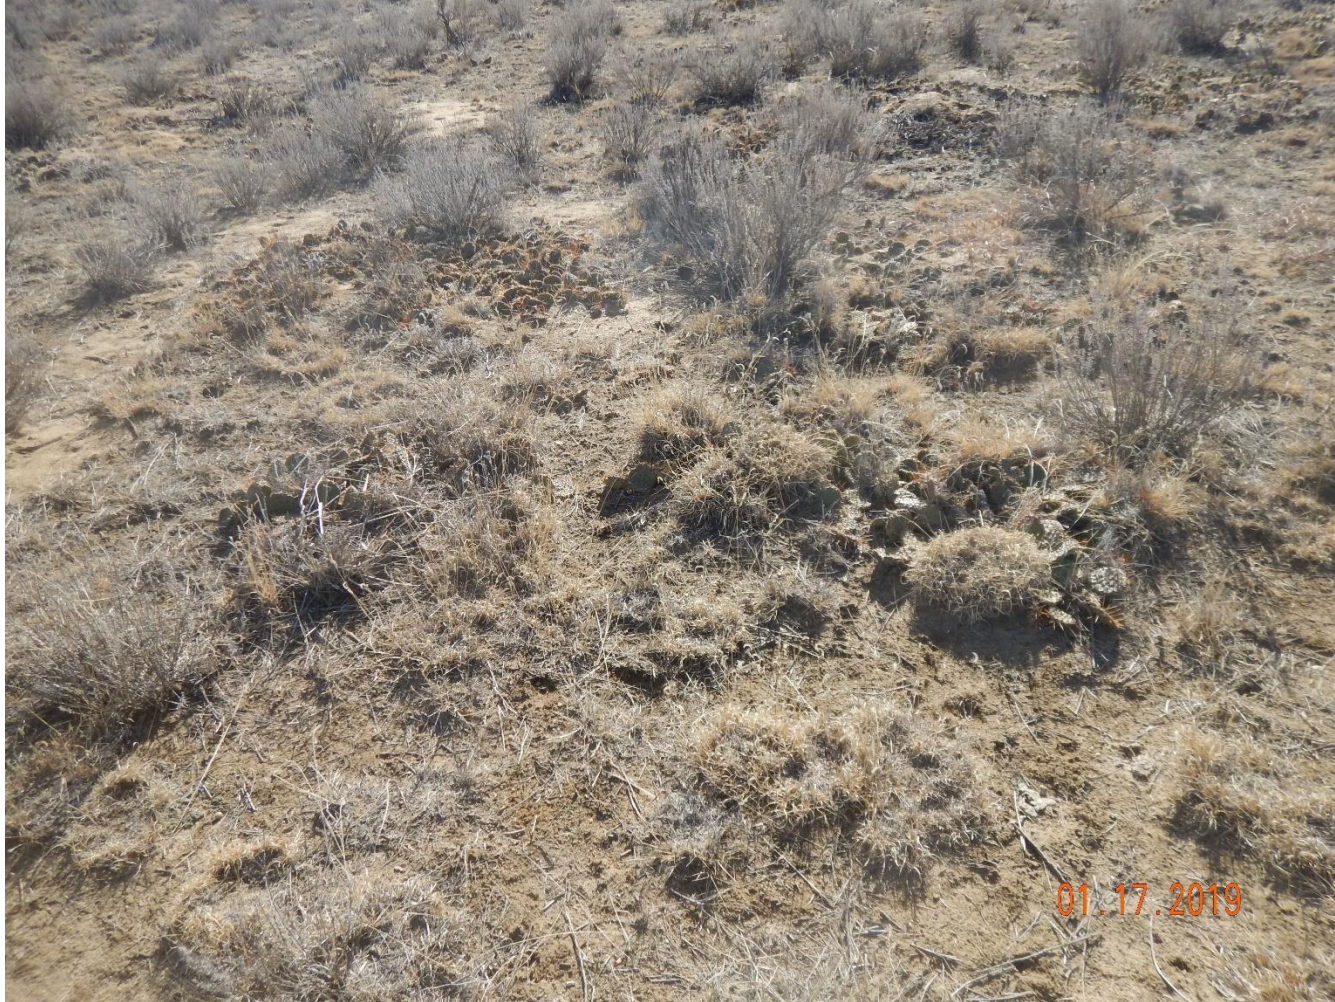
Photo 16: Photo taken from the adjacent reference area. Vegetation observed included Blue grama, Sand Sage, Prickly pear cactus, etc... Photo shows location is not reflective of the reference areas.
