Inspection Photos
Location Name: Roy Annala A #2
API: 05-067-08834

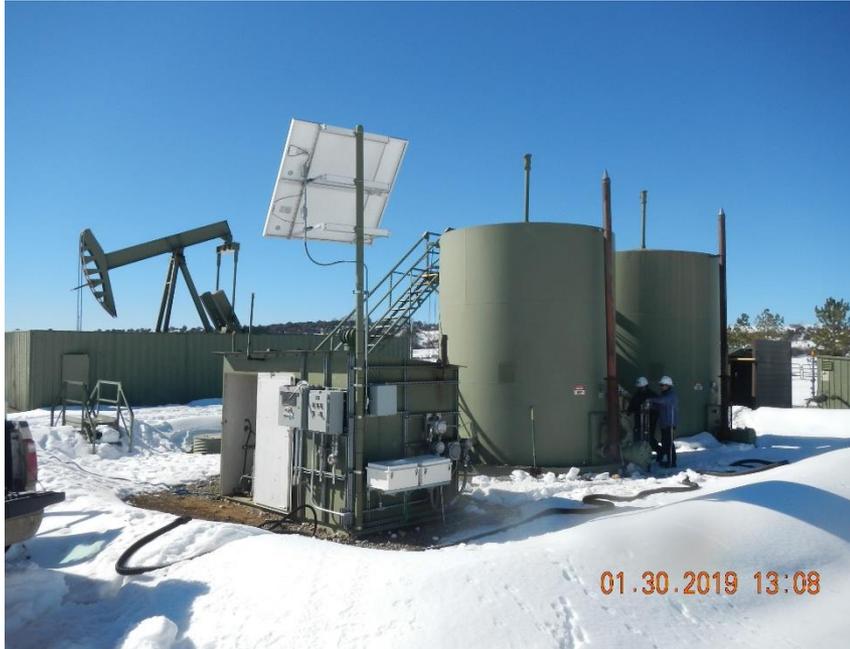
Tank heater being repaired during this inspection.

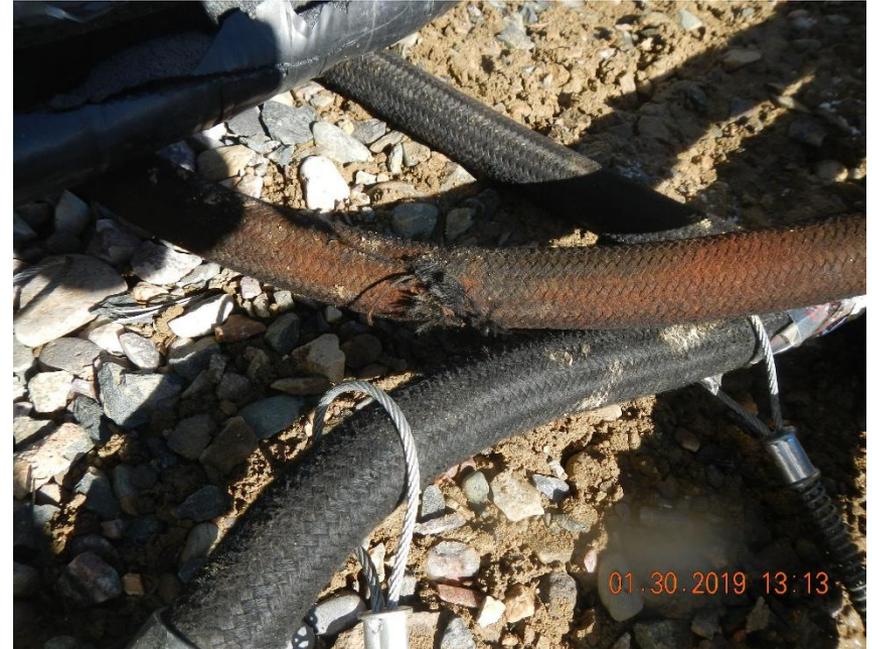
Damaged 1" high pressure hose where release occurred.

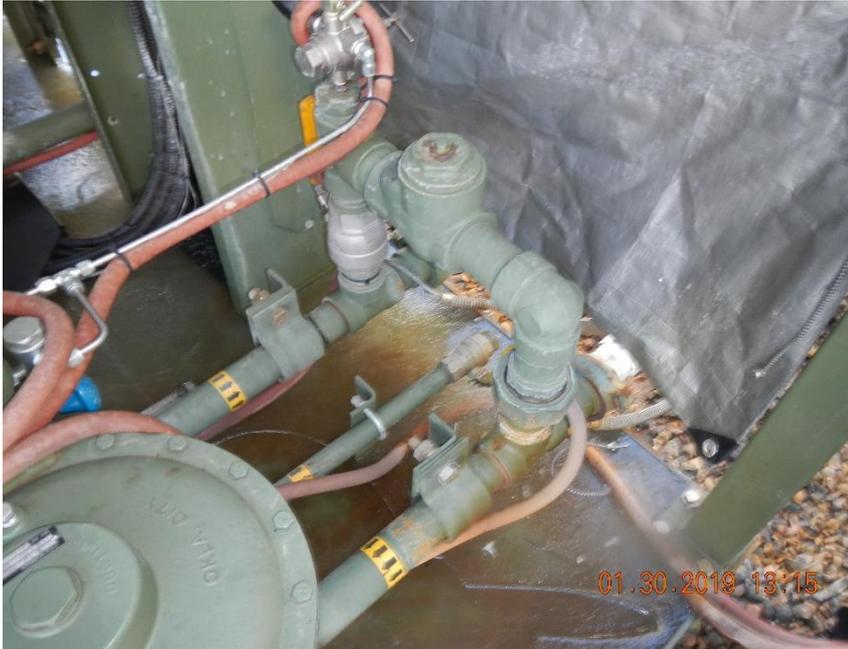
Fitting that failed hose was attached to in center of photo.

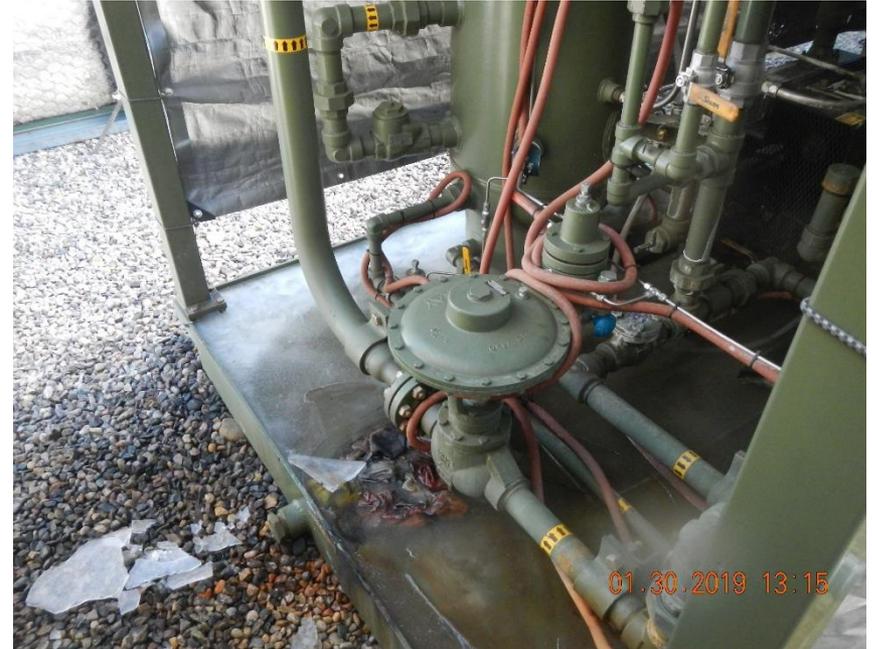
Skid mounted compressor with containment area full of ice.

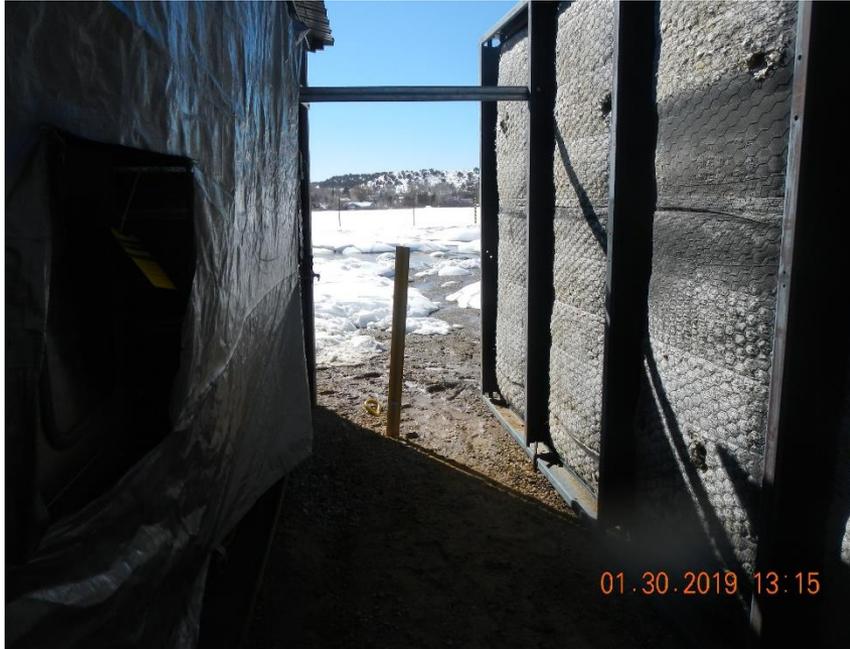
Flow path from compressor skid.

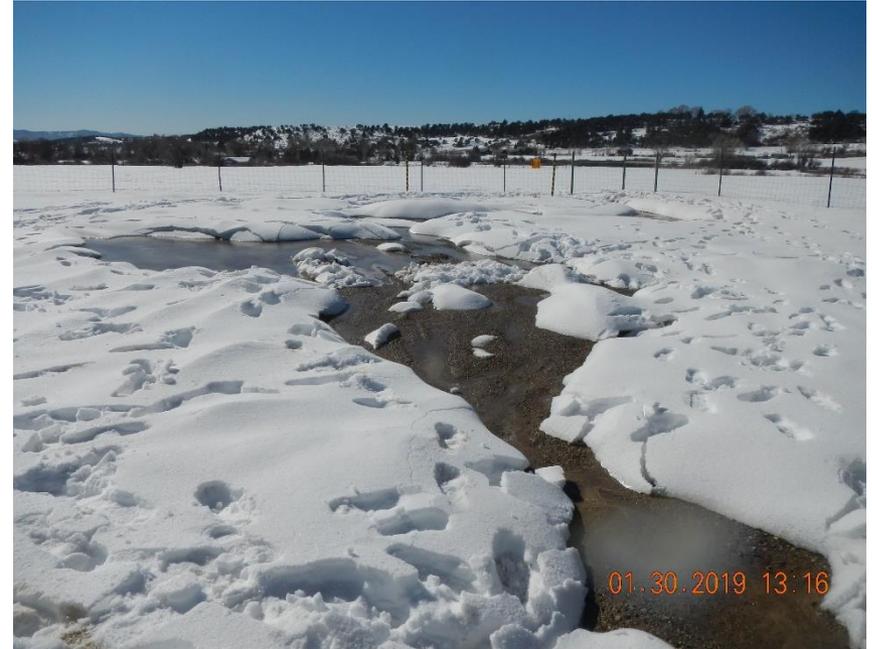
Produced water puddled up in SW corner of location.

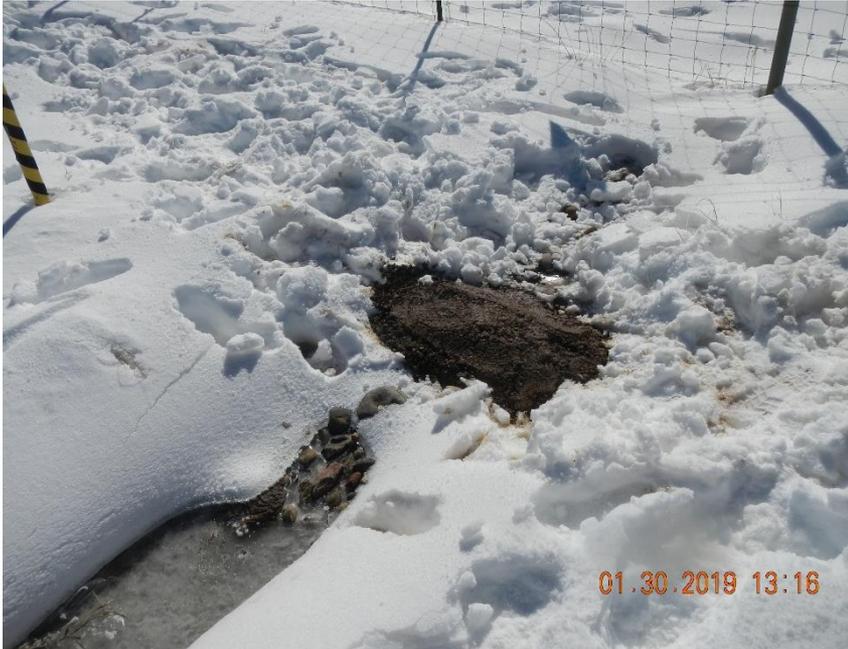
Earthen berm observed during this inspection. Reportedly stopped flow from exiting location.

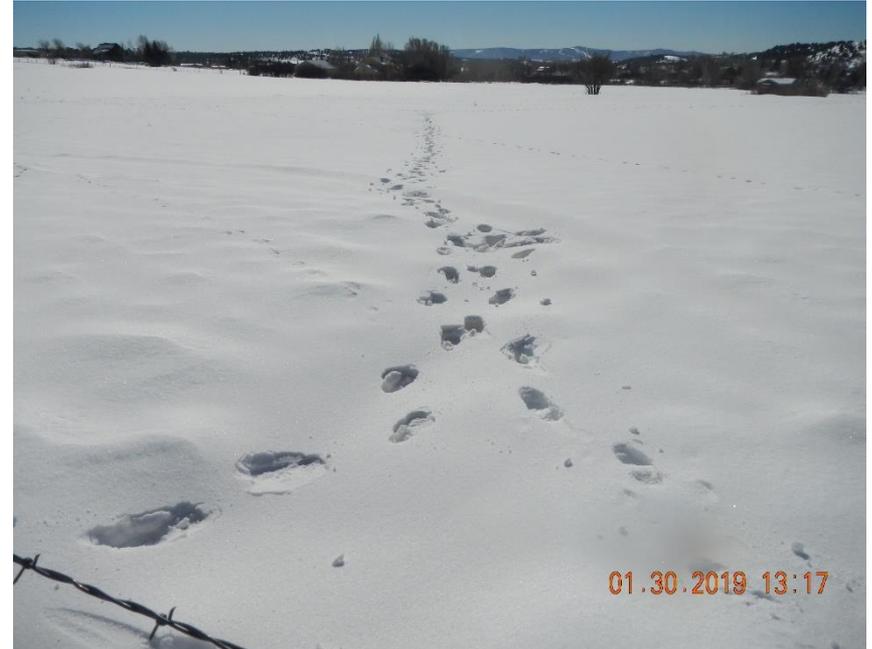
Down gradient of previous photo.

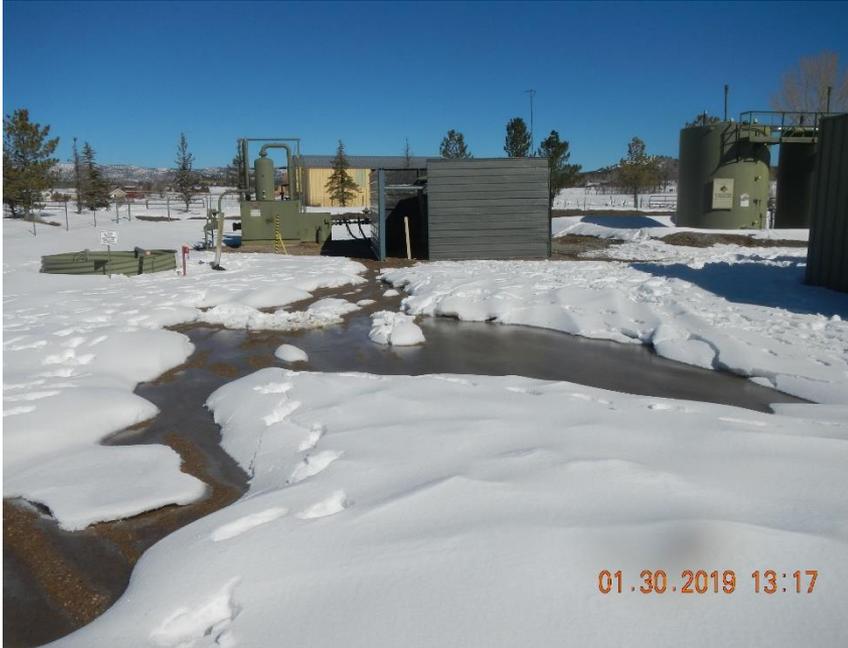
Photo of release flow path from SW corner of location.

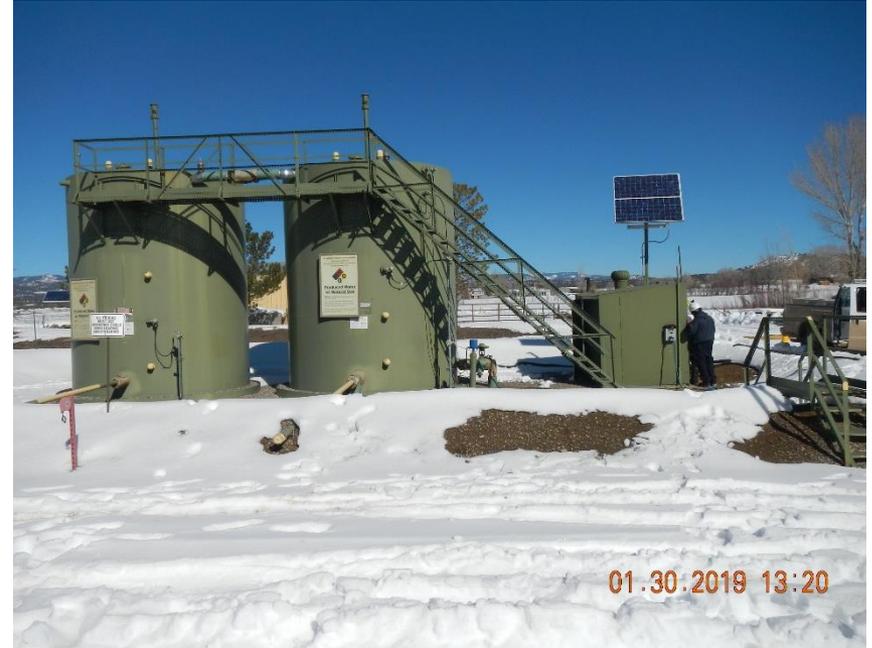
Roy Annala A #2 tank battery.

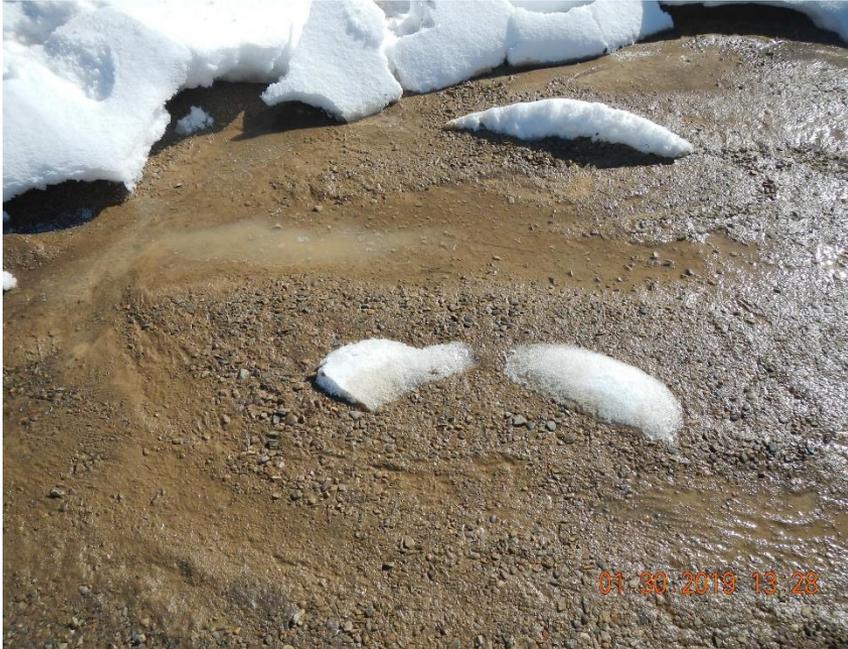
Close up photo along flow path of release.

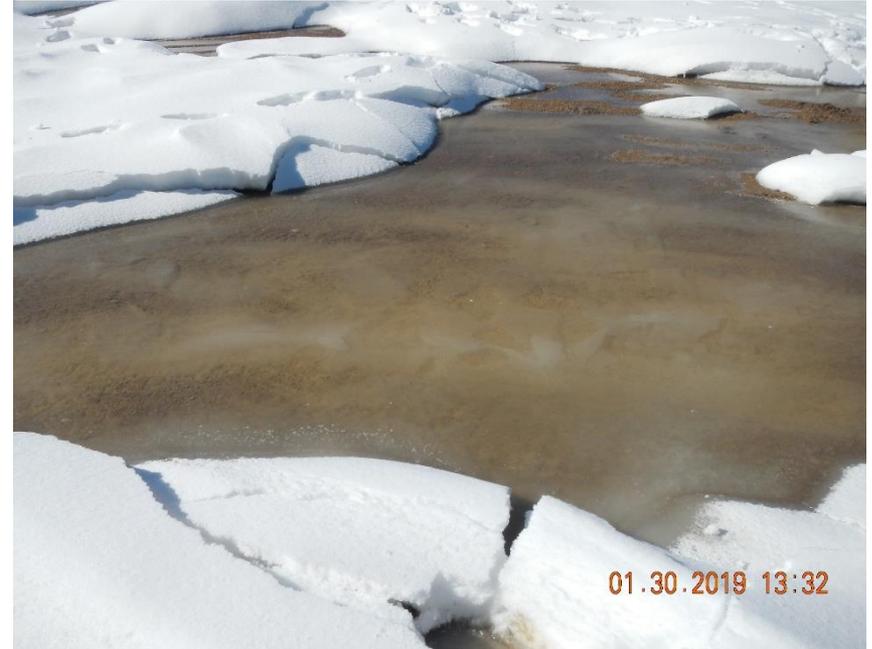
Frozen puddle of alleged E and P waste.
