Inspection Photos

Operator: BISON OIL & GAS II LLC - 10661

Location ID: 425364

Inspection Doc. Number: 682504459

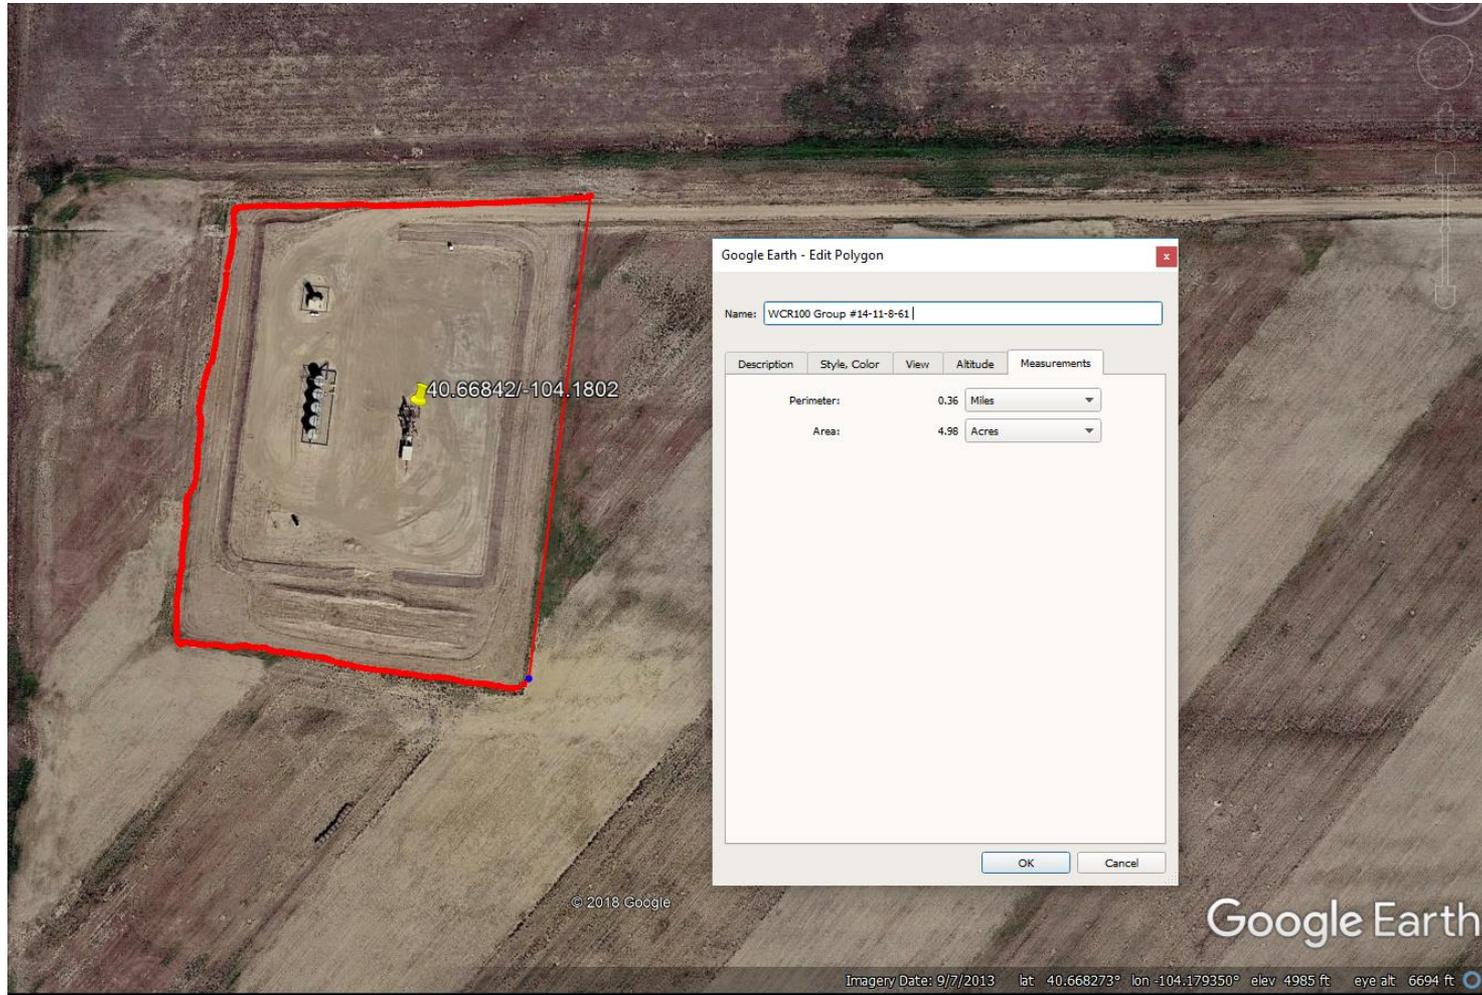
Photo 1: 2013 Google earth aerial imagery. A disturbance area of 4.98 acres was measured using a Trimble Juno 3B handheld device

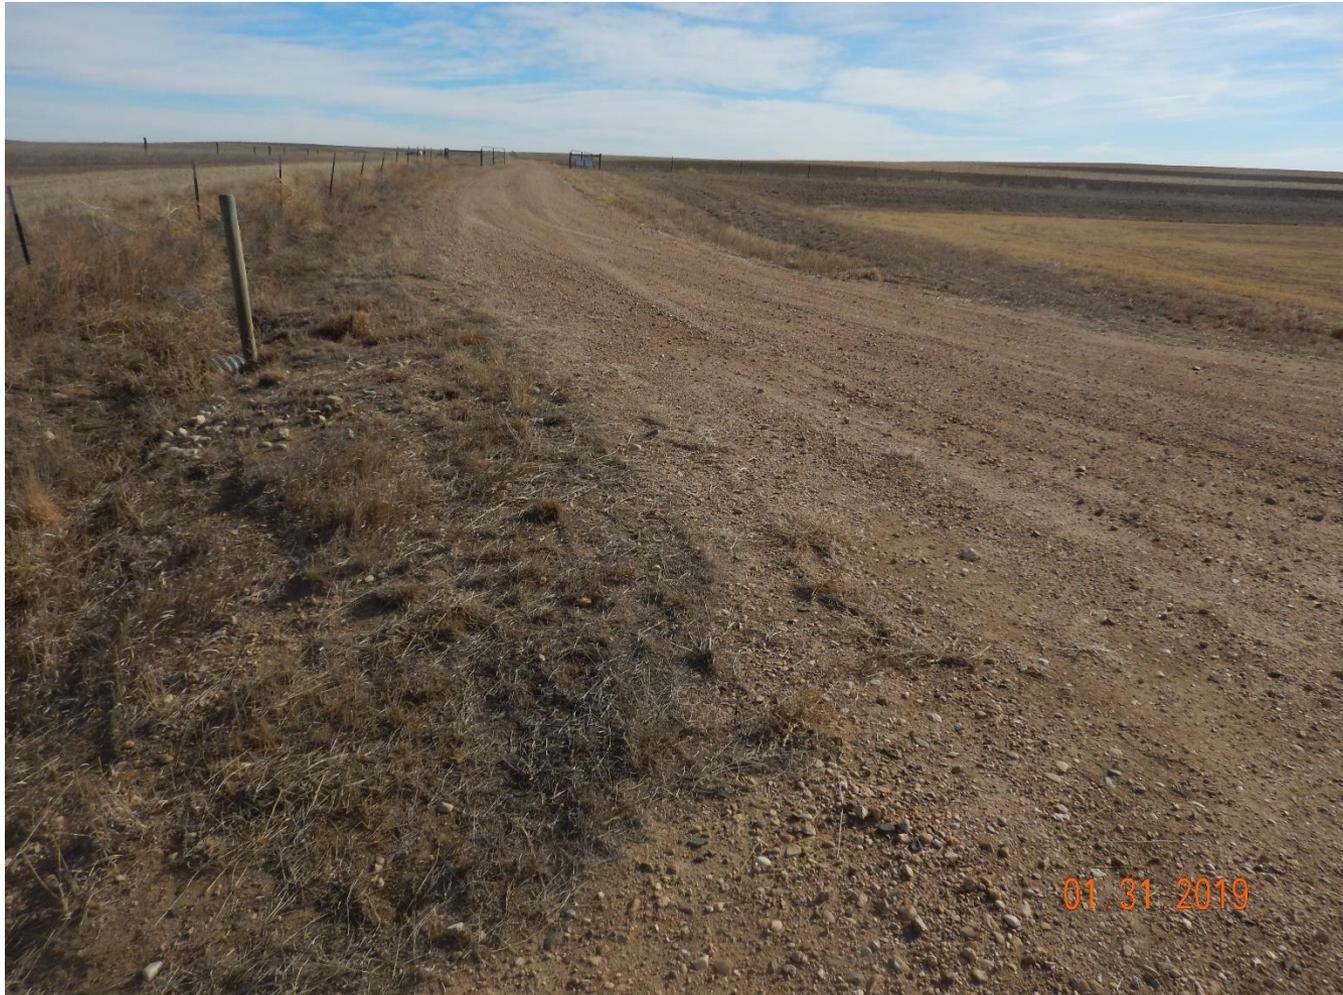
Photo 2: Photo taken from the north end of the location, facing east. Photos 2- 5 provide an overview of the location from east, southeast, southwest, to west.

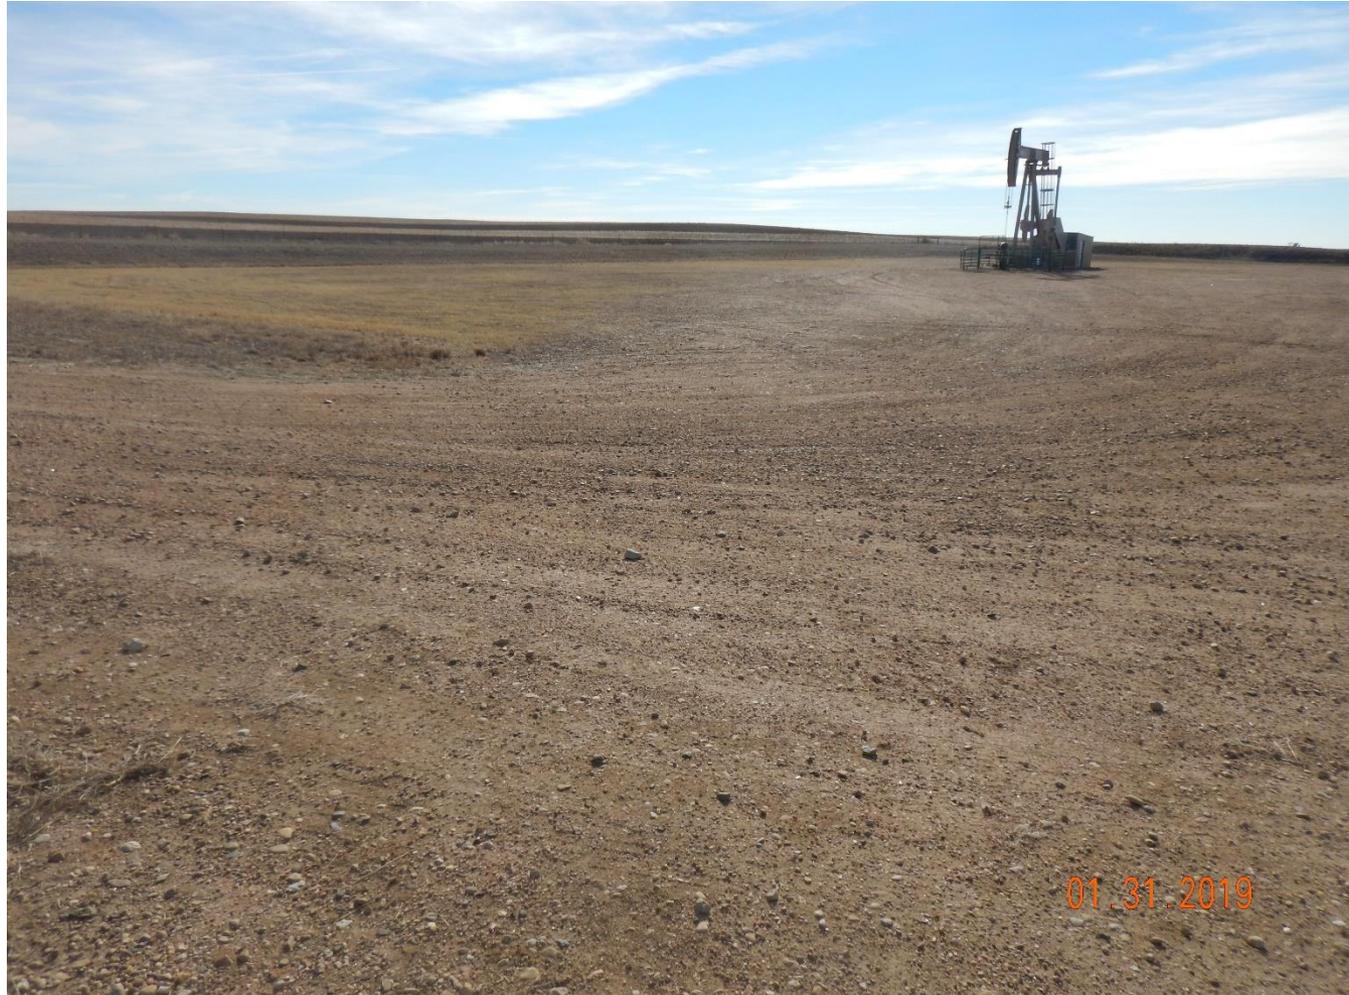
Photo 3: See comments under photo 2.

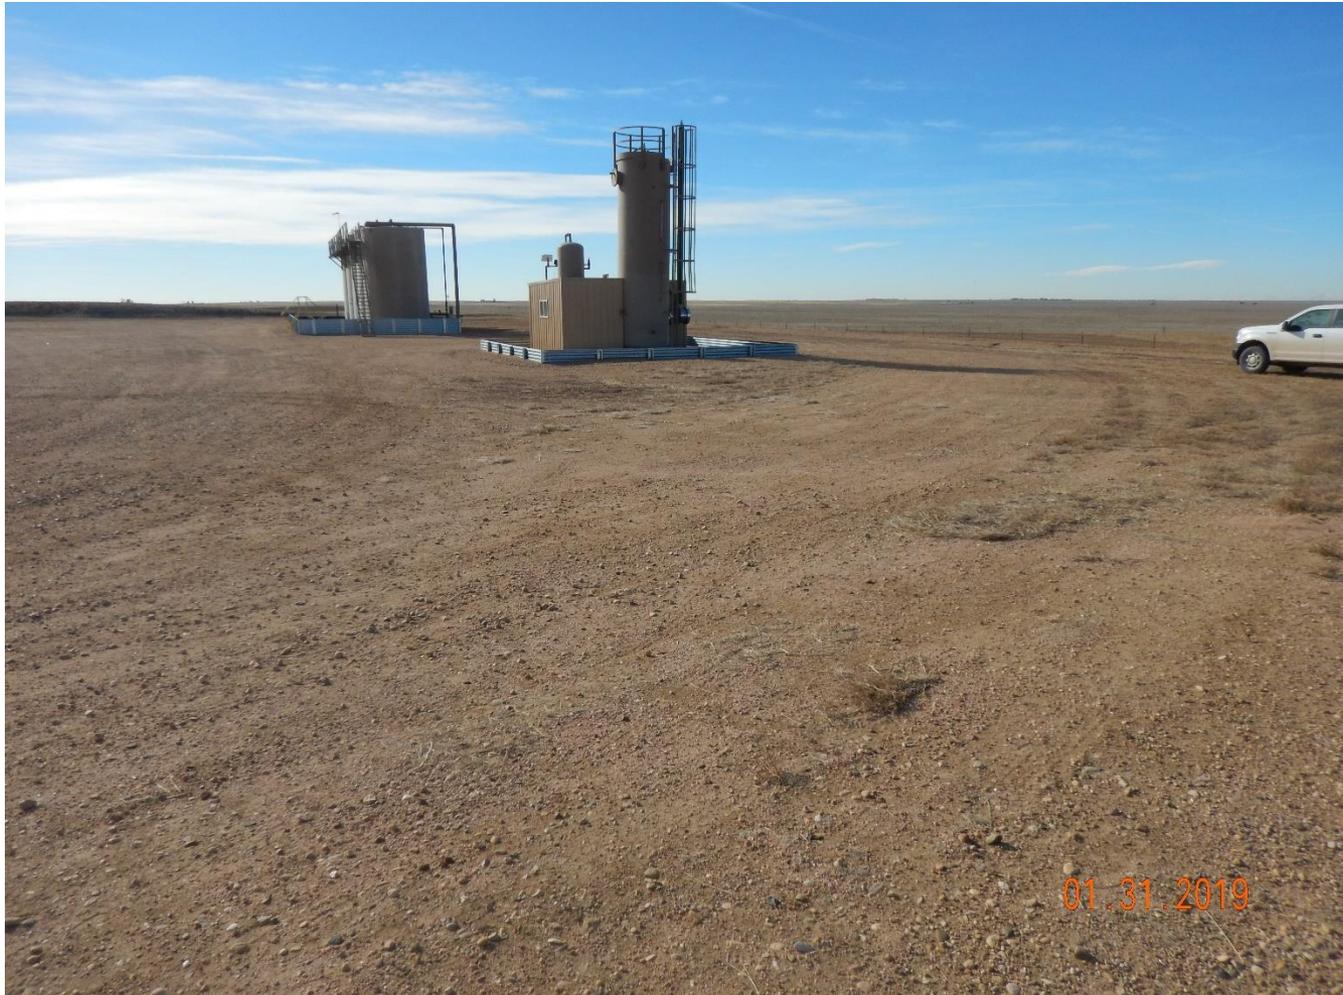
Photo 4: See comments under photo 2.

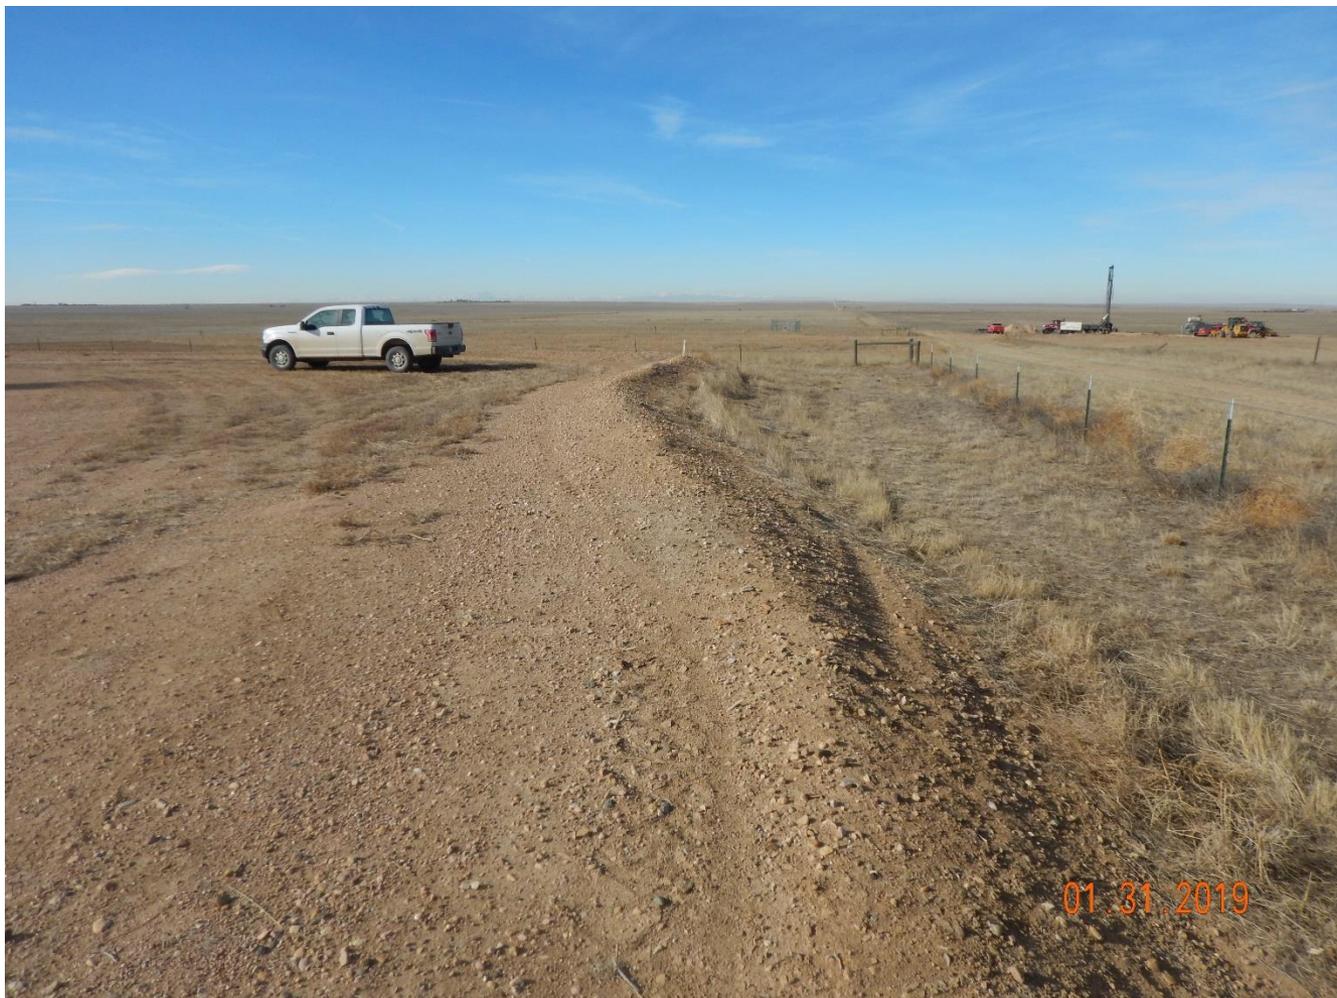
Photo 5: See comments under photo 2.

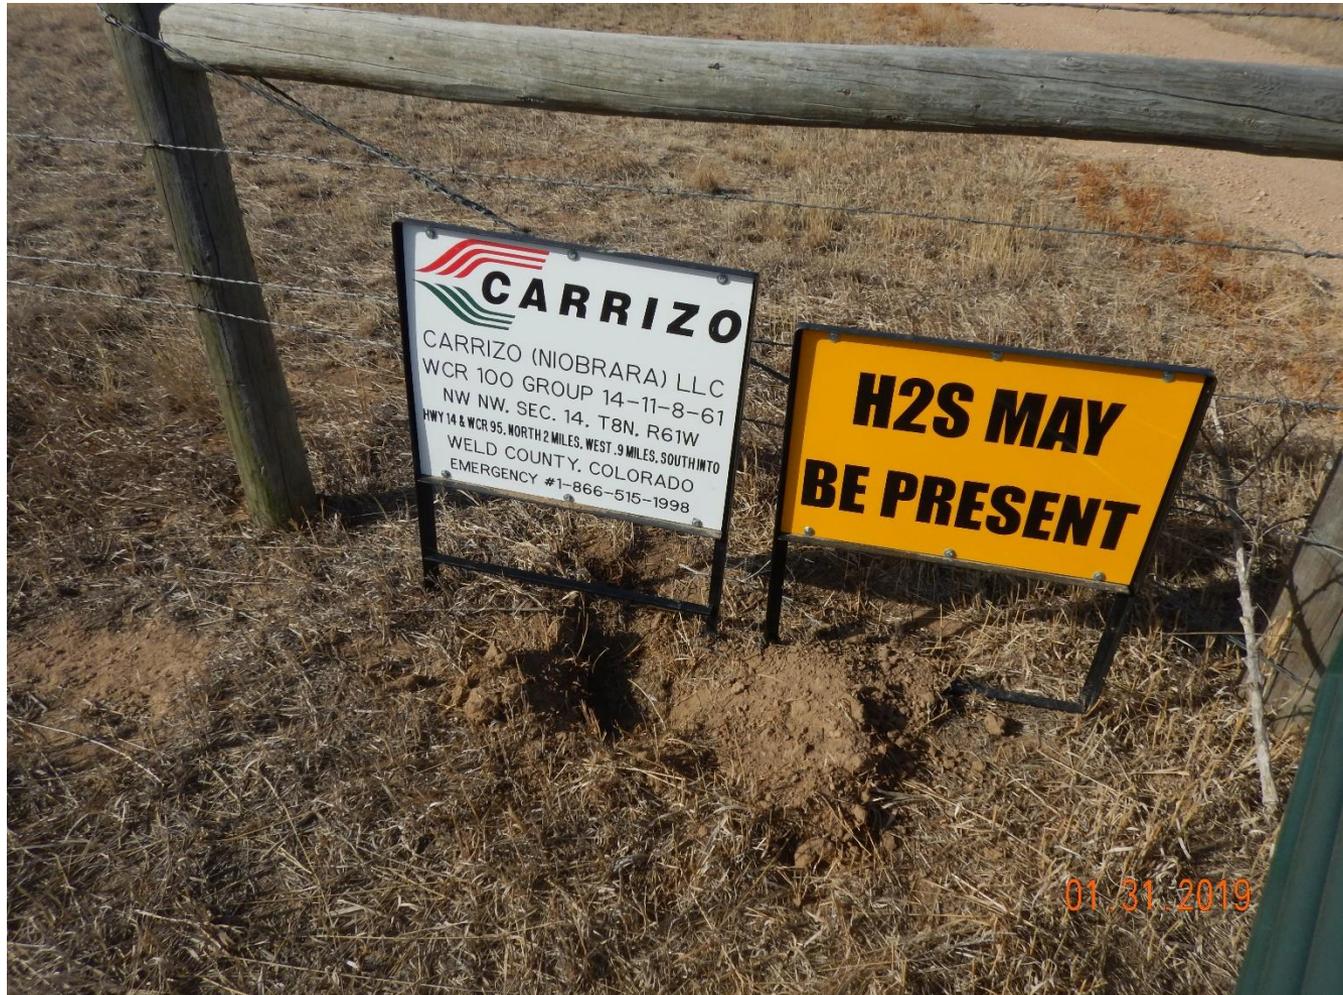
Photo 6: Photo taken from the location entrance. Photo shows sign with incorrect operator information.

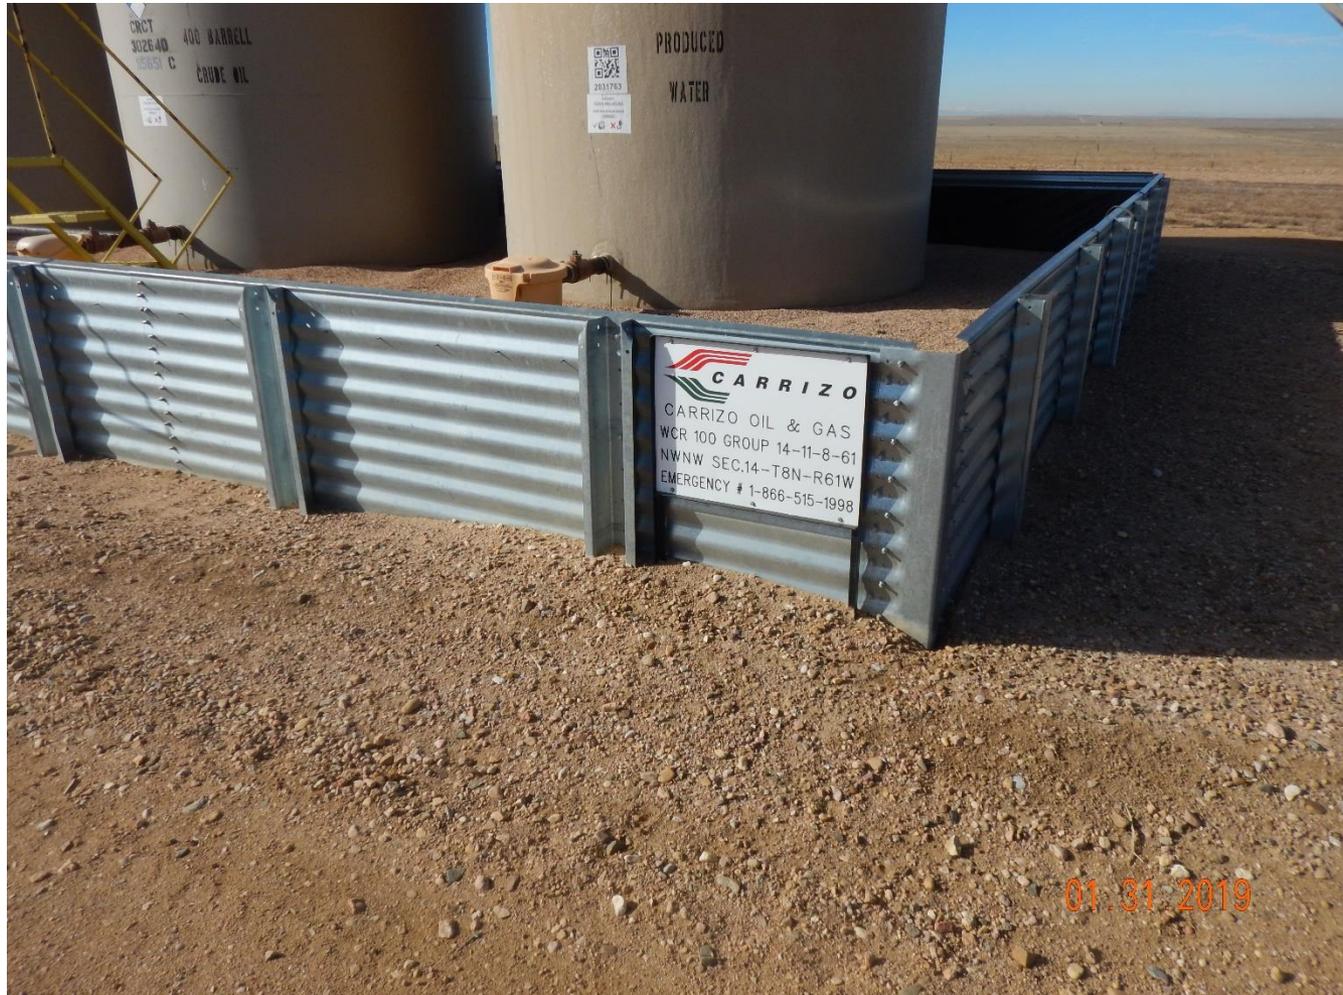
Photo 7: Photo taken from the tank battery. Photo shows sign with incorrect operator information.

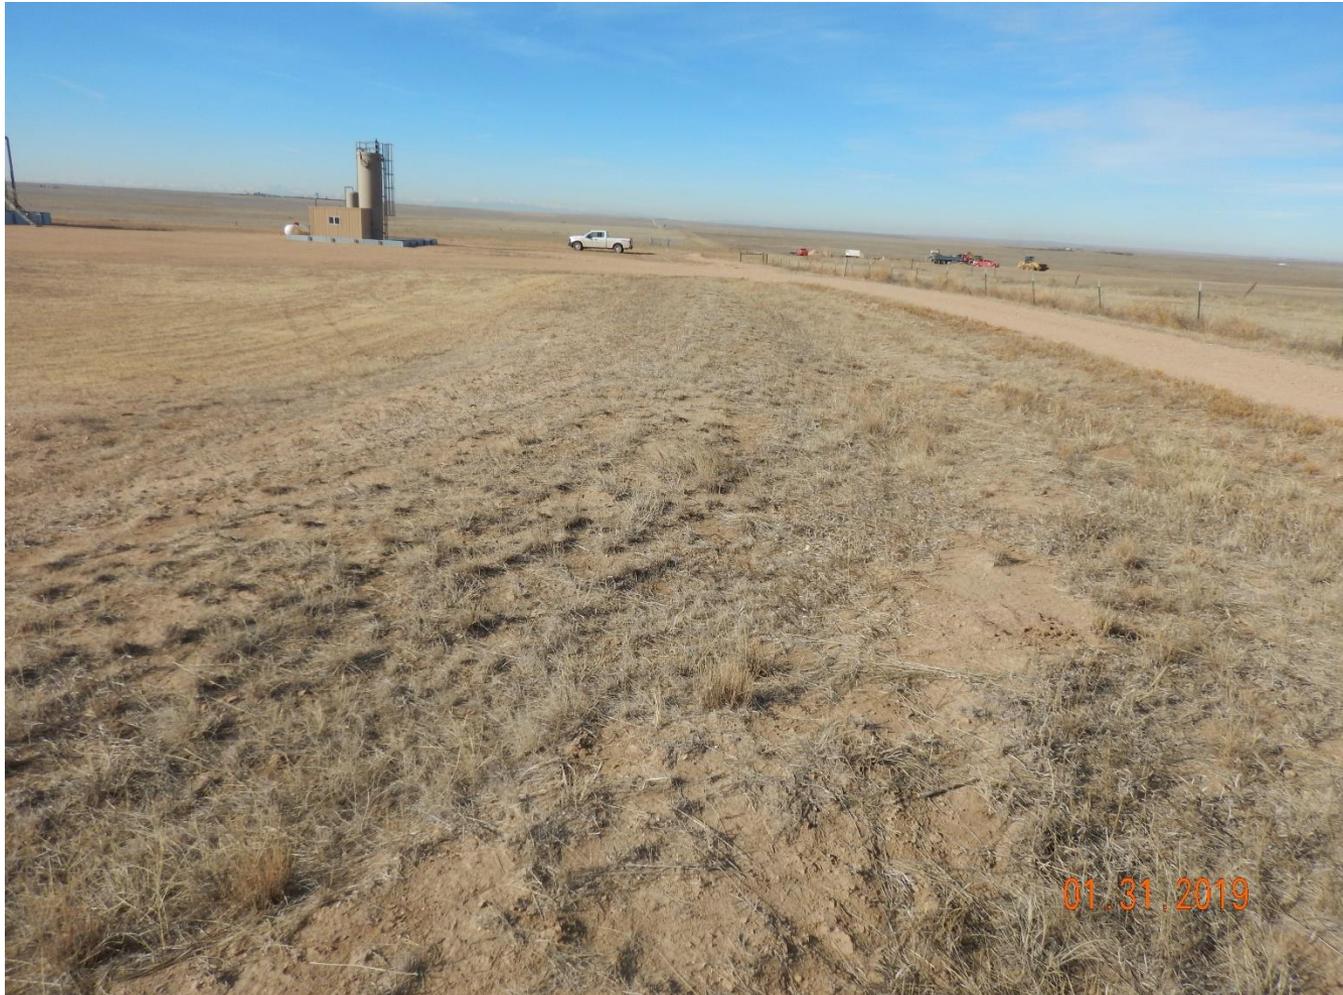
Photo 8: Photo taken from the northeast corner of the location, facing west. Photo shows current interim areas and the location.

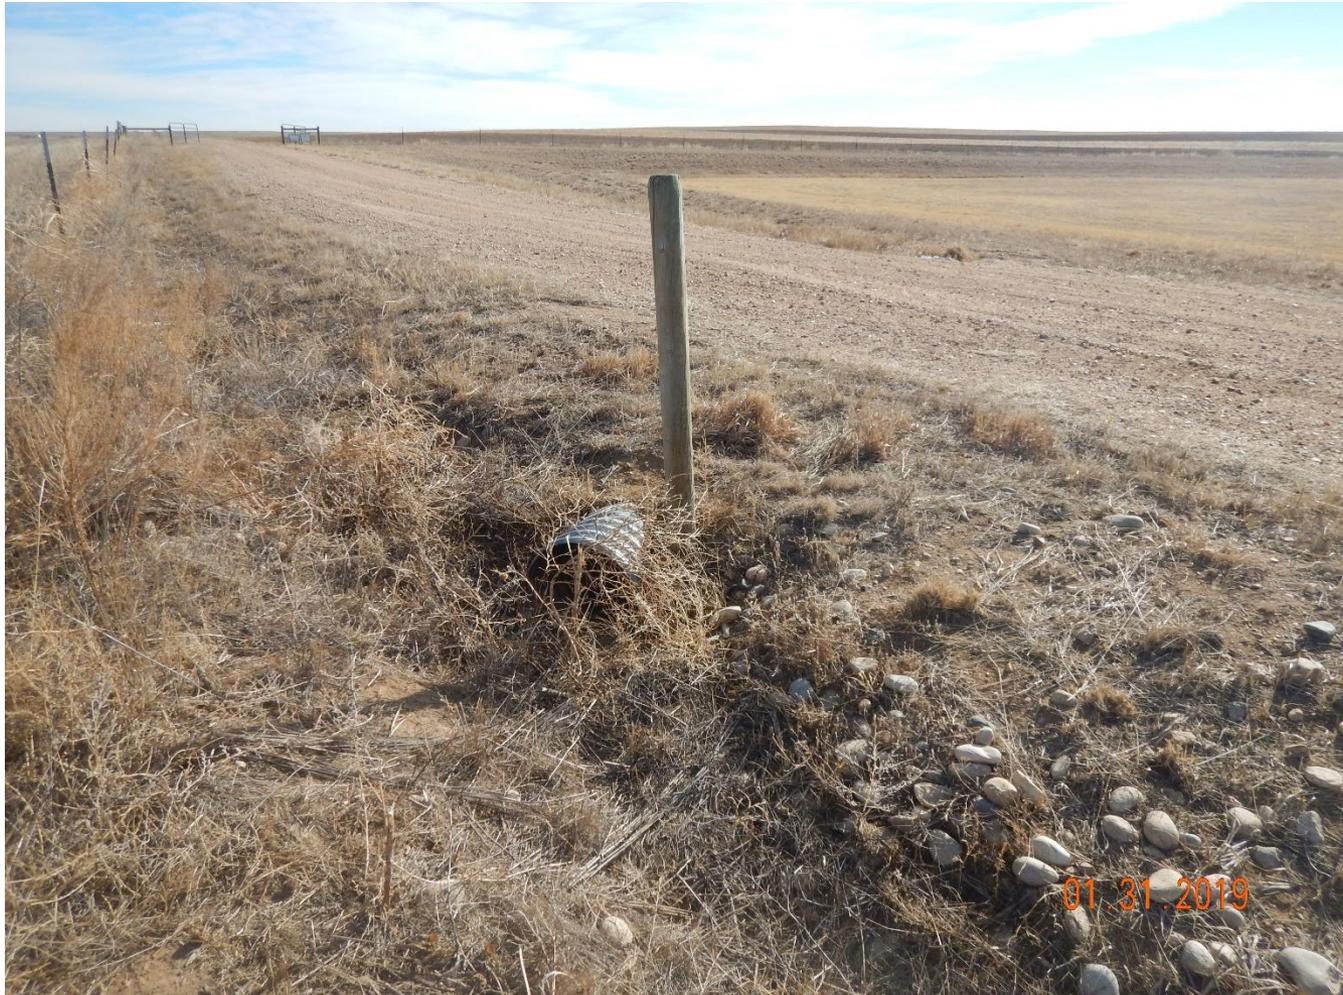
Photo 9: Photo of culvert at access road. Culvert appears to be in proper functioning condition.

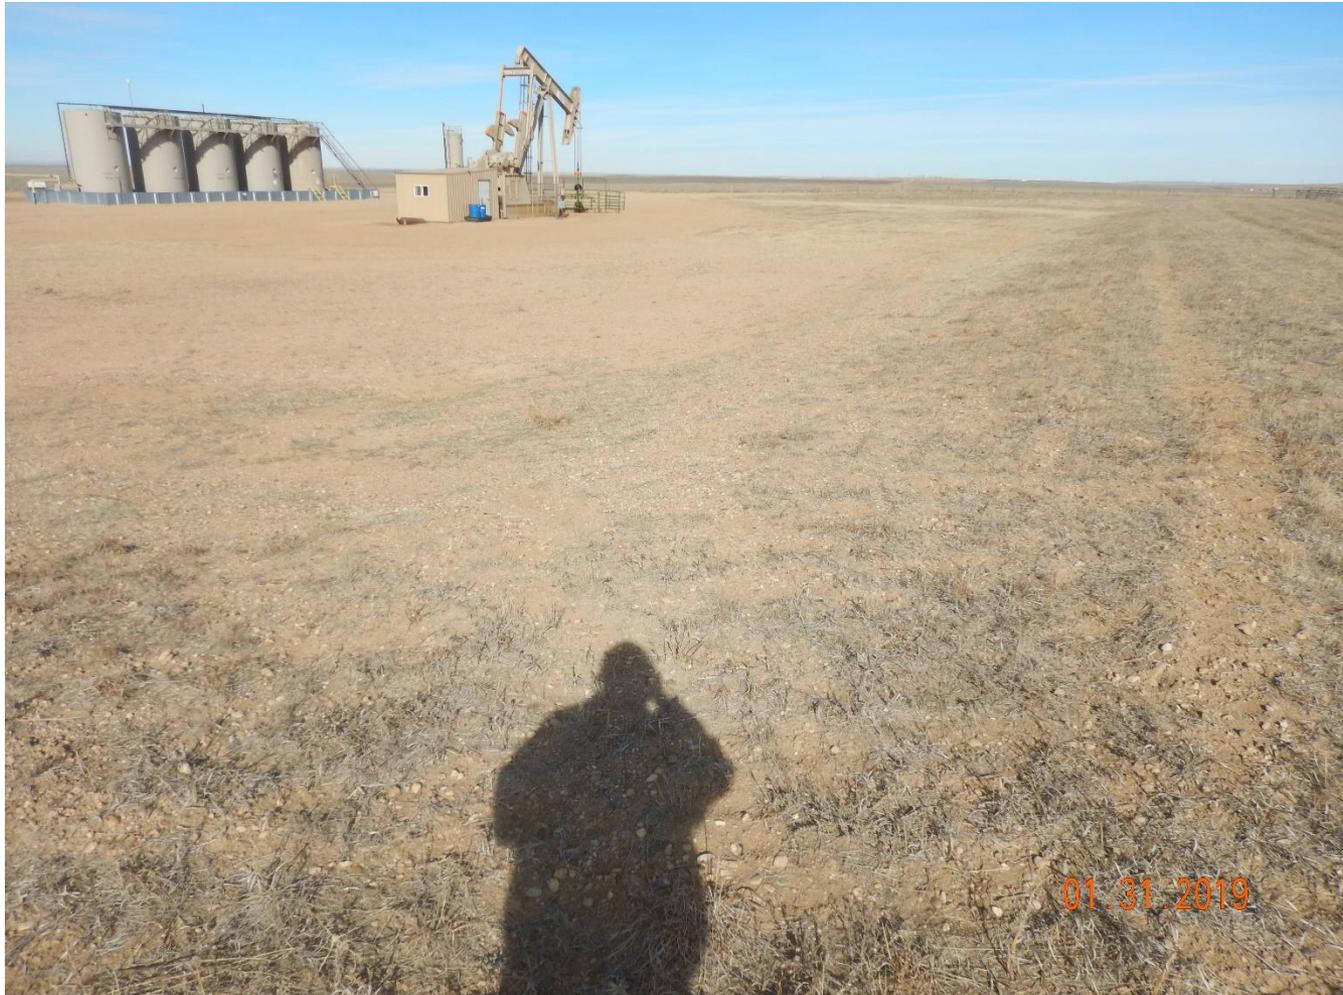
Photo 10: Photo taken from the southeast corner of the location, facing north. Photo shows current interim areas and the location.

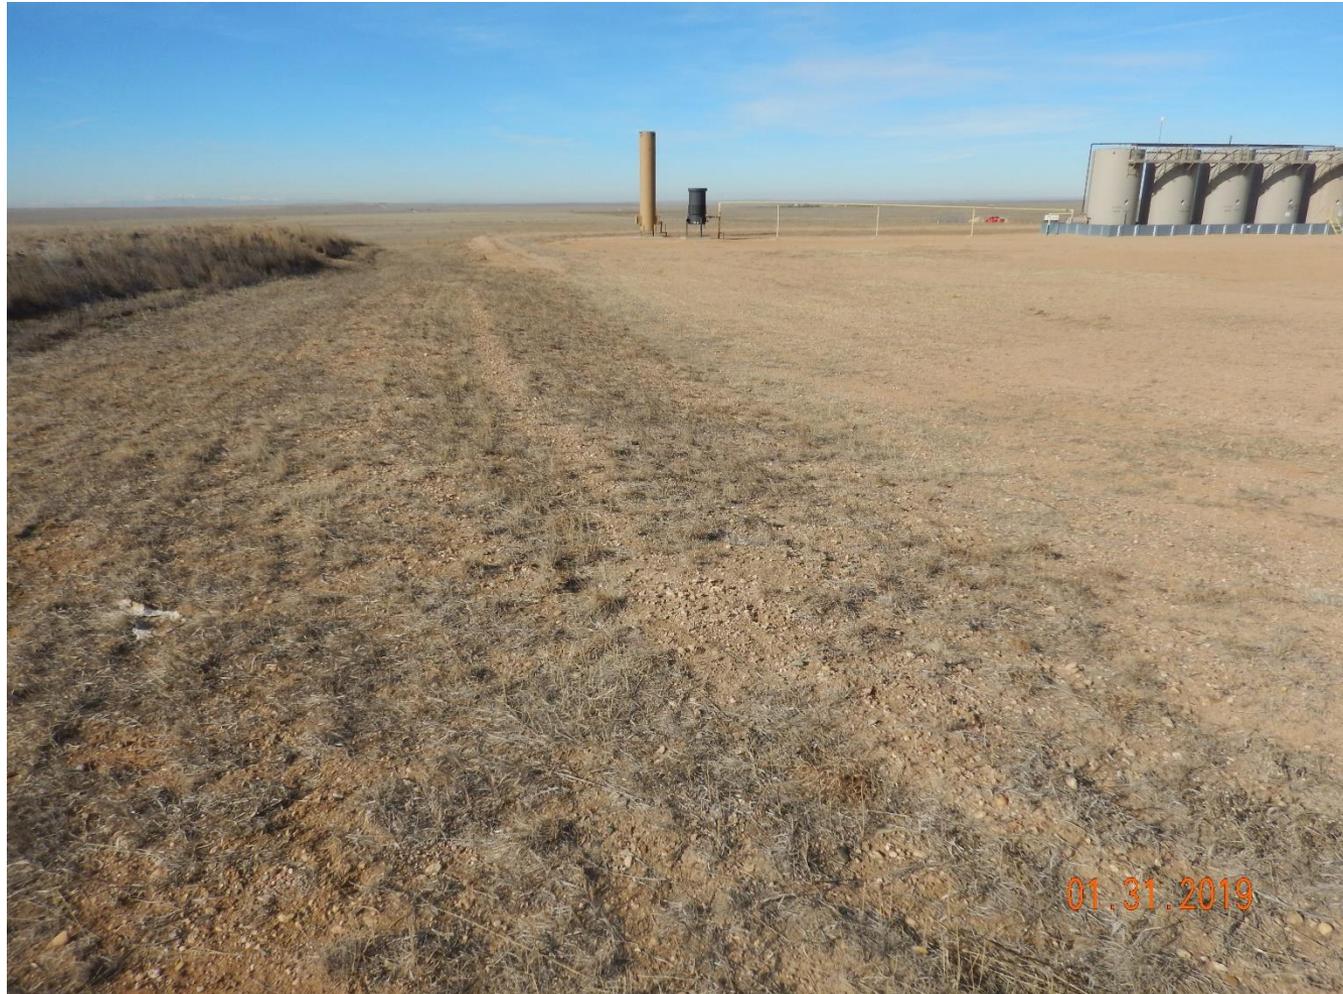
Photo 11: Photo taken from the southeast corner of the location, facing west. Photo shows current interim areas and the location.

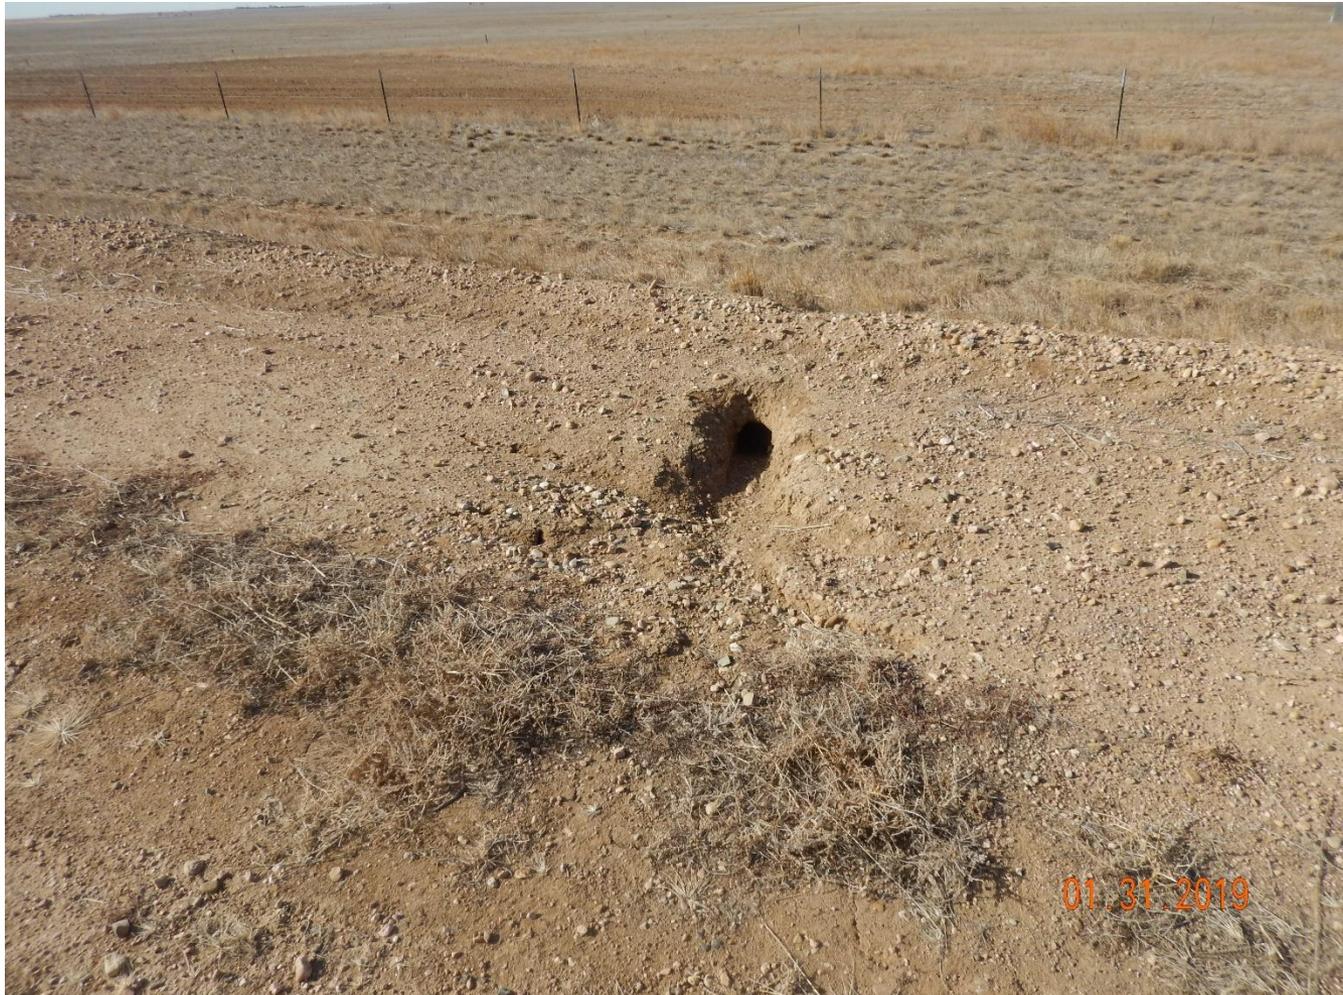
Photo 12: Photo taken from the west end of the location. Photo shows wildlife appears to have burrowed into the stormwater berm. Maintenance required.

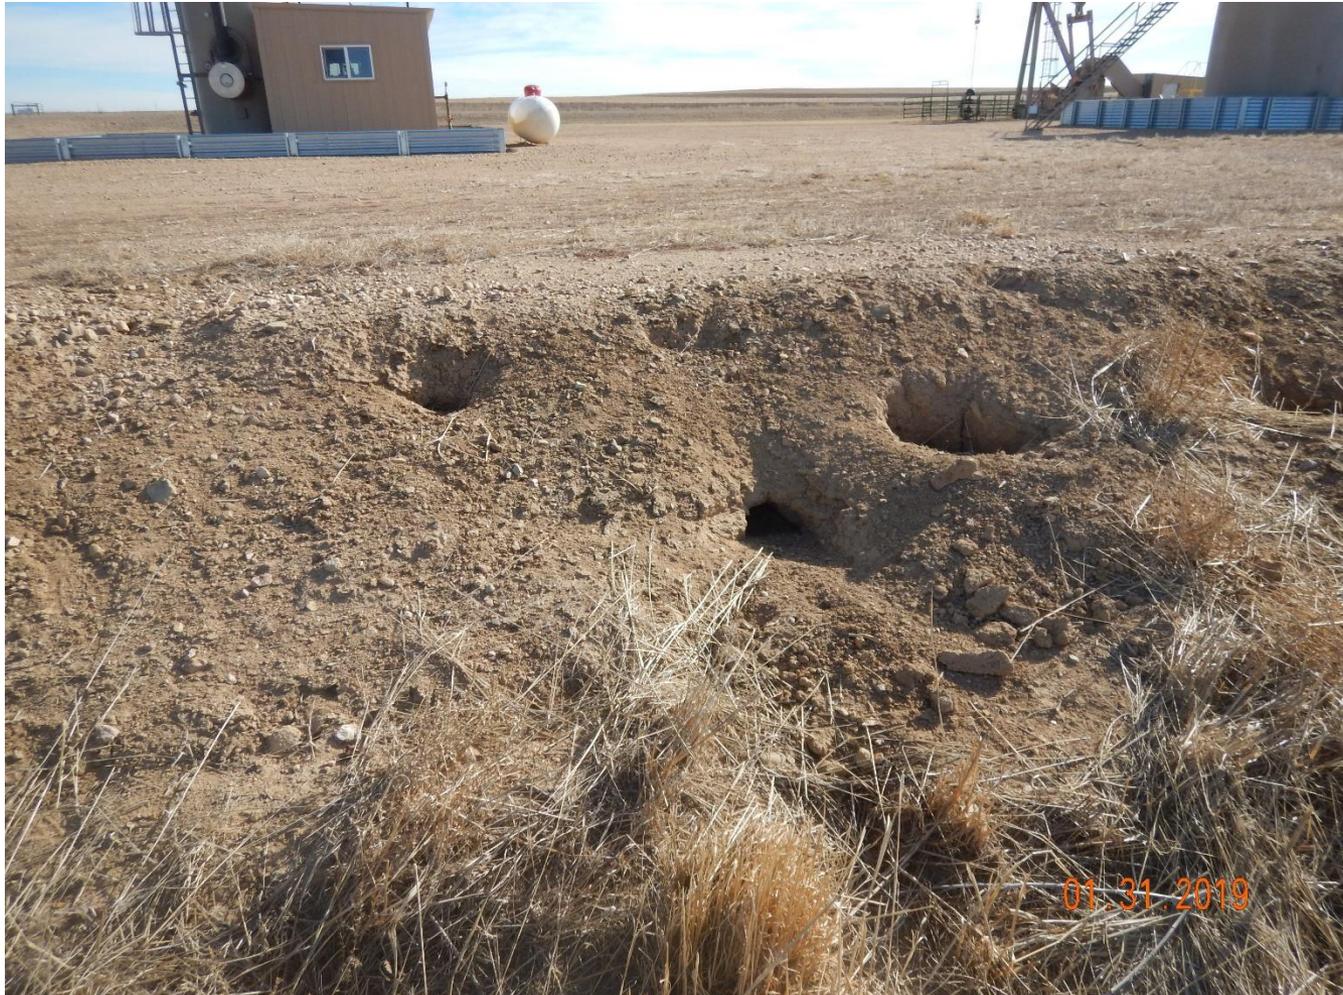
Photo 13: Photo taken from the west end of the location. Photo shows wildlife appears to have burrowed into the stormwater berm. Maintenance required.
