Inspection Photos
Location Name: Cosslett A #5
Location ID:318122

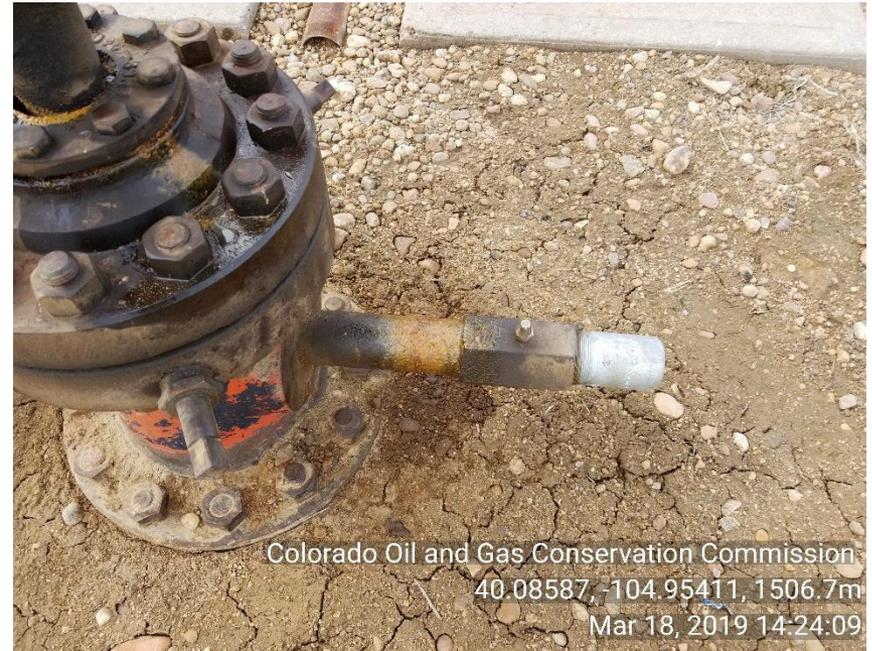
Photo 2 Mechanical issues (2' VLV appears to be leaking fluid) and stained soil
