Interim Reclamation and Stormwater Inspection

March 19, 2019

Operator: EXTRACTION OIL & GAS INC #10459

Location ID: 450197

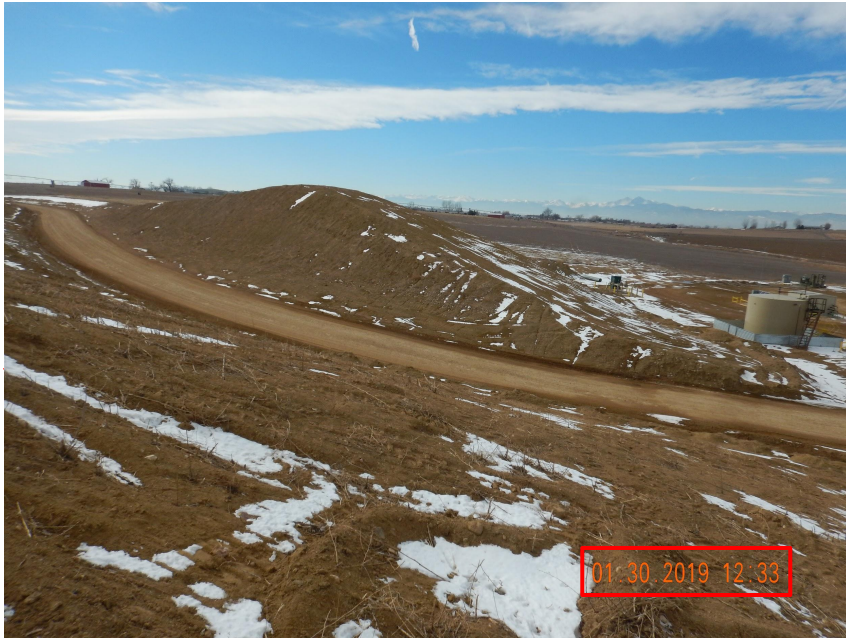
Photo 1. Photo taken from the eastern stockpile on January 30, 2019, facing West. Photo illustrates that no interim reclamation has been performed.

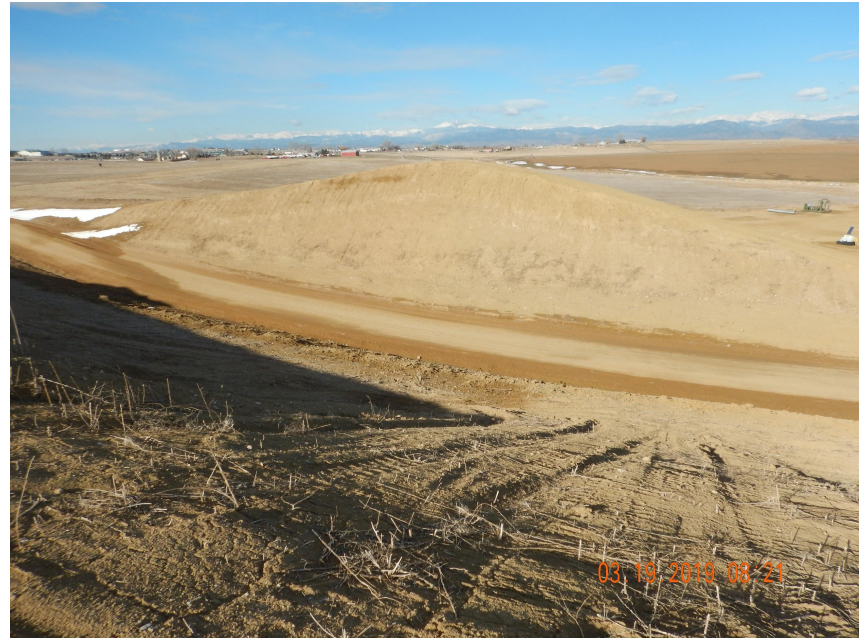
Photo 2. Photo taken from the eastern stockpile on March 19, 2019, facing West. Photo illustrates that no interim reclamation has been performed.

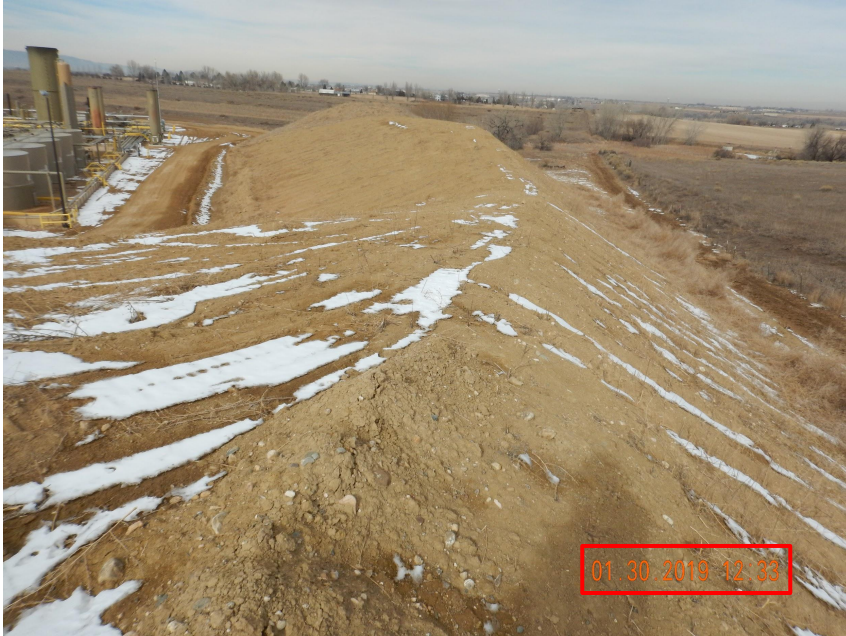
Photo 3. Photo taken from the eastern stockpile on January 30, 2019, facing North. See comments under Photo 1.

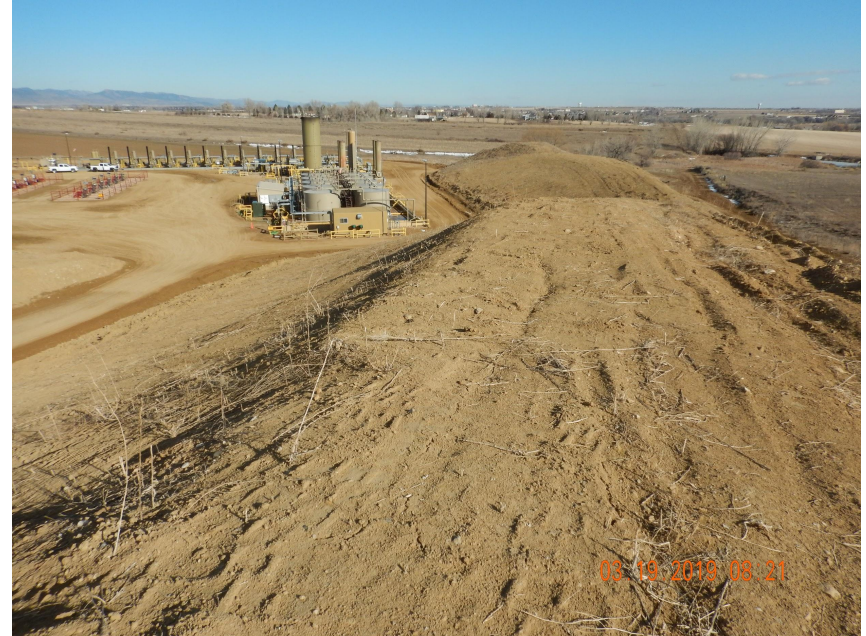
Photo 4. Photo taken from the eastern stockpile on March 19, 2019, facing North. See comments under Photo 2.

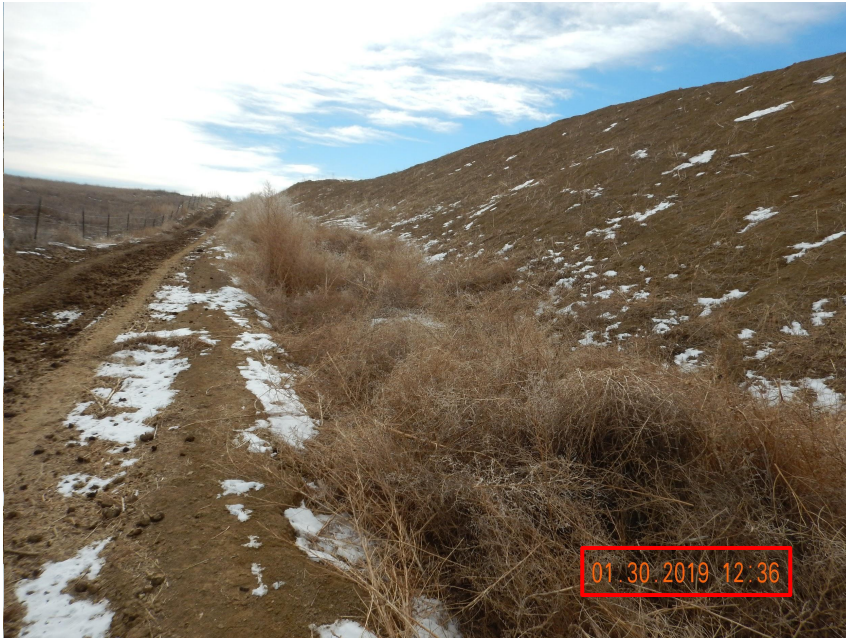
Photo 5. Photo taken from the eastern perimeter of location on January 30, 2019, facing South. Photo illustrates unmanaged weeds and weed debris. Operator failed to control and manage weeds to prevent weed waste and prevent the spread of seeds onto adjacent lands per Rule 603.f. Note: Weeds were in excess of 6 feet tall along portions of the eastern perimeter.

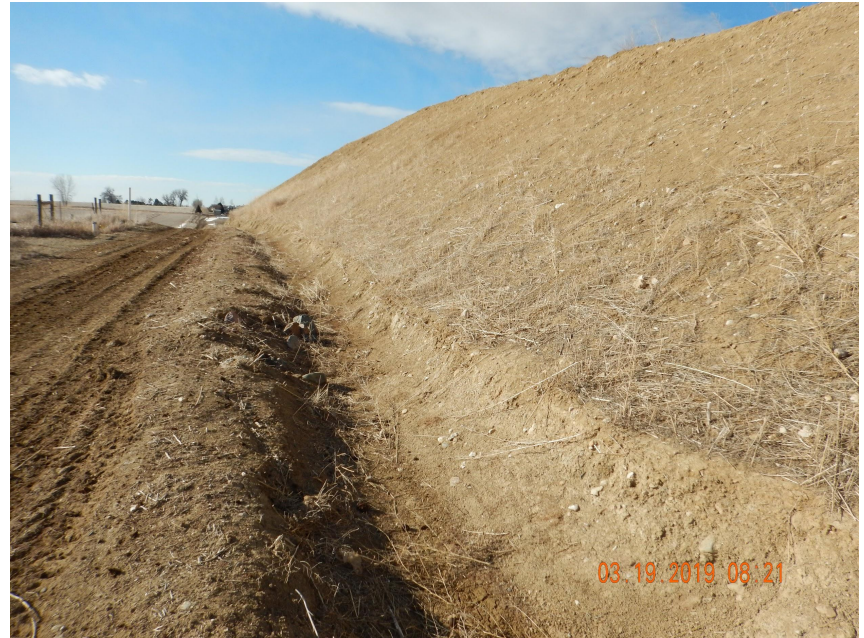
Photo 6. Photo taken from the eastern perimeter of location on March 19, 2019, facing South. Appears the Operator has mowed and removed weeds.

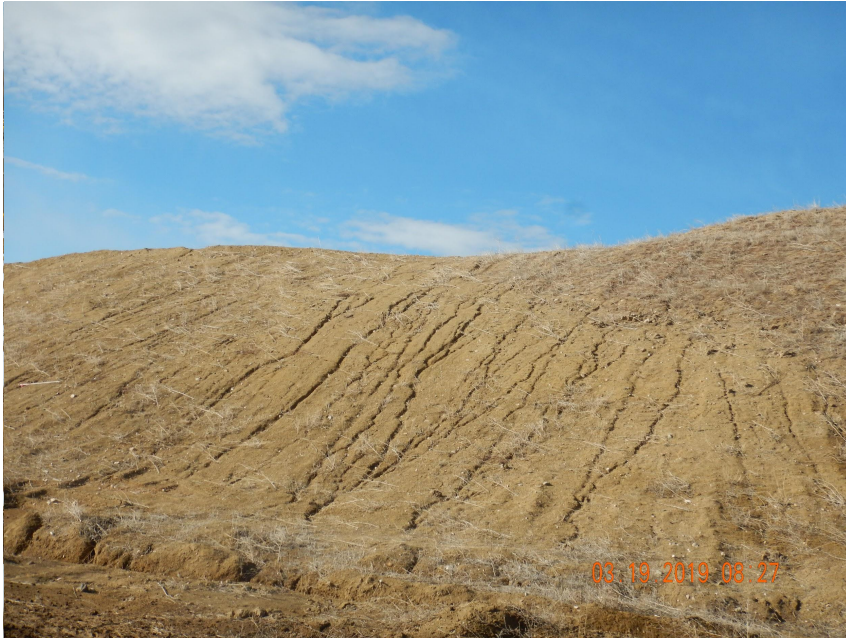
Photo 7. Photo taken from the northeastern perimeter of location on March 19, 2019, facing West. Photo illustrates rill erosion along the the stockpile. Rill erosion was observed throughout most of the location. Operator has failed to adequately stabilize stockpiles and fill slopes to minimize erosion and site degradation per Rule 1002.f.

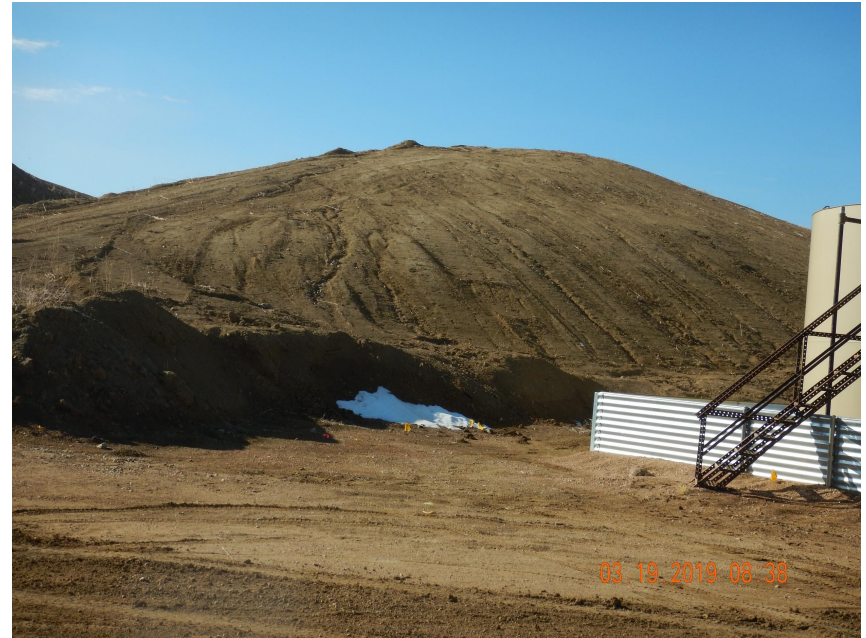
Photo 8. Photo taken from the southern well location on March 19, 2019, facing South. See comments under Photo 7.

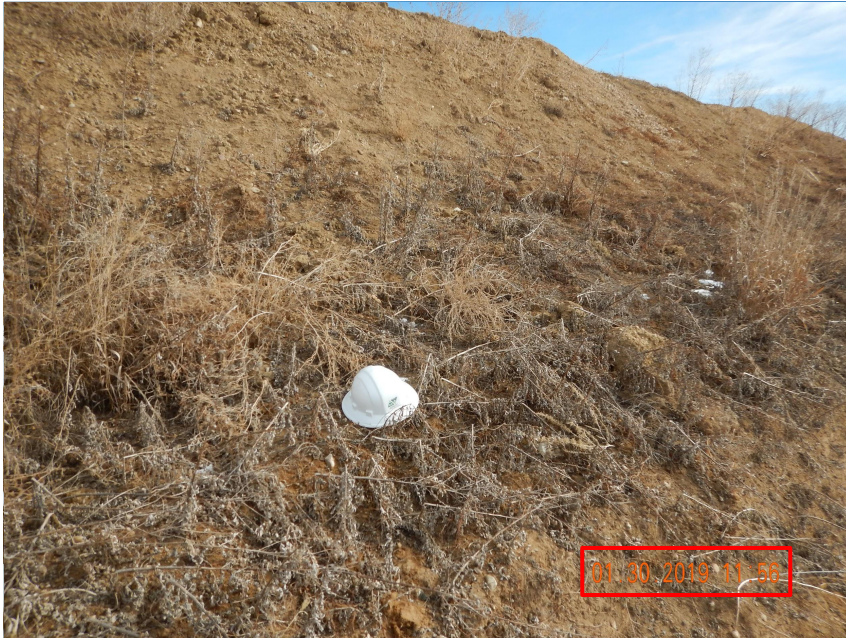
Photo 9. Photo taken from the northwestern perimeter of location on January 30, 2019, facing Southeast. Photo illustrates unmanaged Canada thistle (*Cirsium arvense*), a List B Colorado Noxious weed. Operator has failed to control and manage noxious weeds.

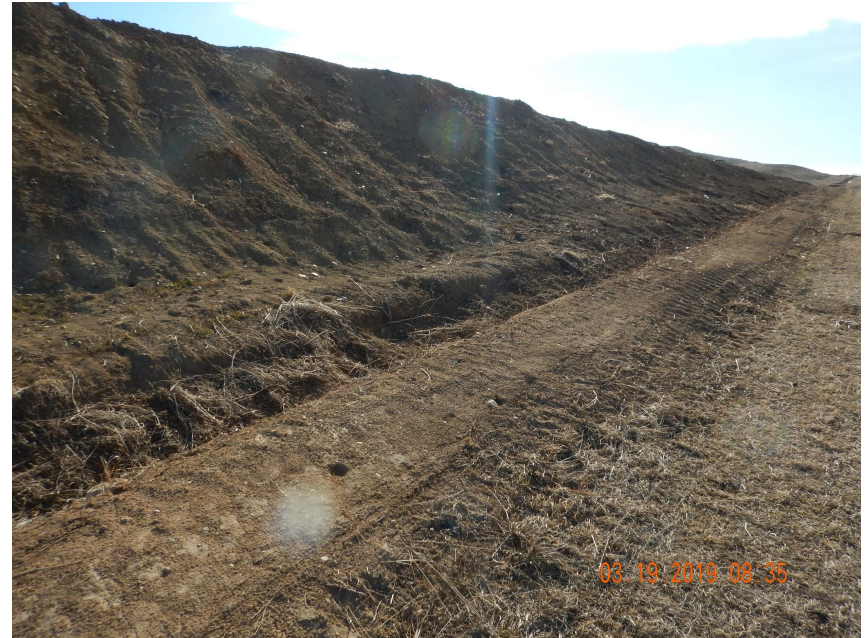
Photo 10. Photo taken from the northwestern perimeter of location on March 19, 2019, facing Southeast. Appears the Operator has mowed, collected and removed the previously observed noxious weeds. However, Operator has failed to adequately stabilize fill slopes to minimize erosion and site degradation per Rule 1002.f.

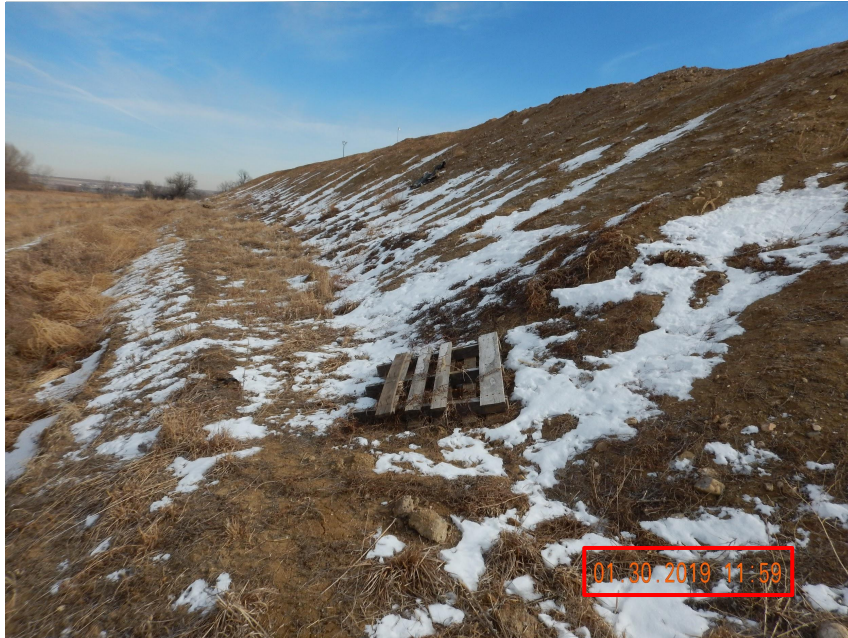
Photo 11. Photo taken from the northwest perimeter of location on January 30, 2019, facing East. Photo illustrates trash along the northern fill slope. Operator has failed to comply with Rule 603.f.

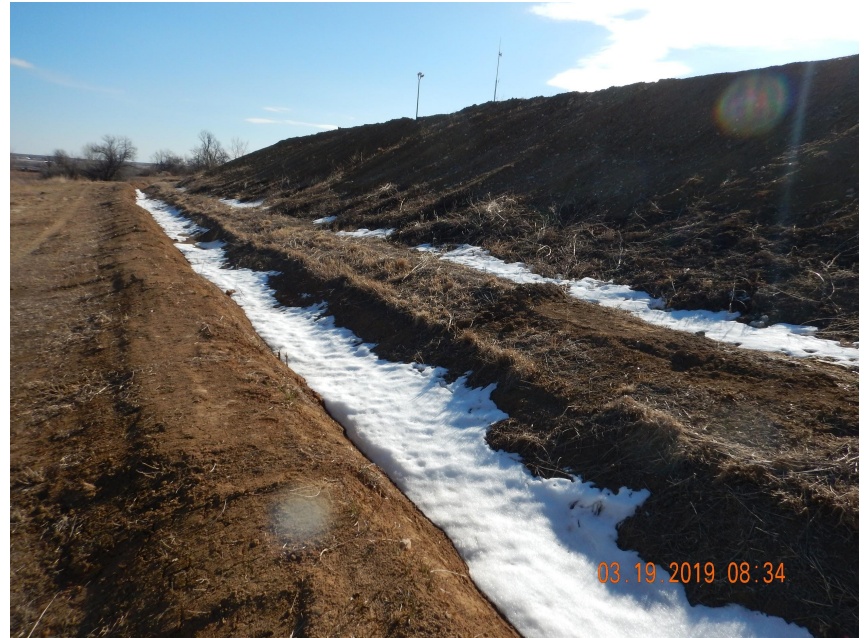
Photo 12. Photo taken from the northwest perimeter of location on March 19, 2019, facing East. Operator has removed trash from the location.

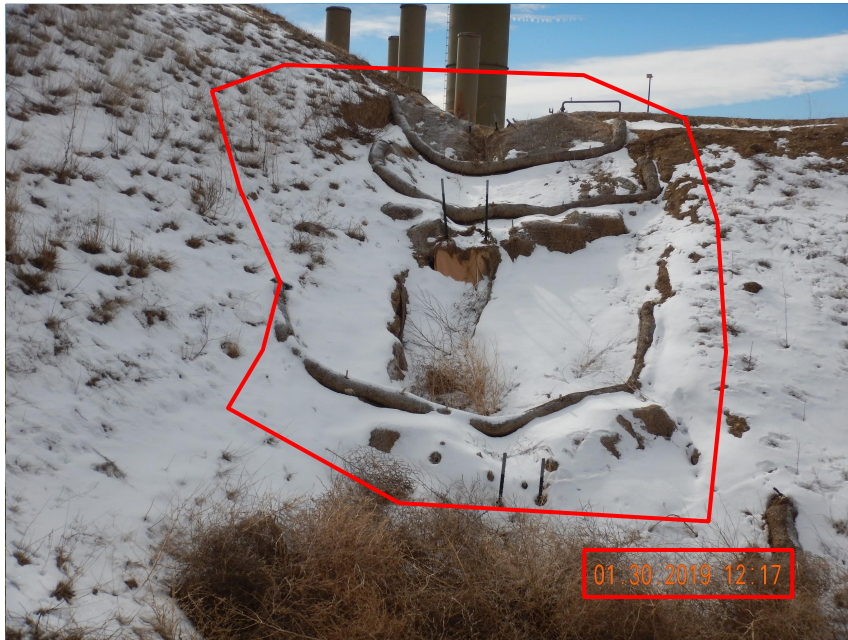
Photo 13. Photo taken from the southern inlet for the sediment basin on January 30, 2019, facing West. Photo illustrates maintenance is needed, as gully erosion was observed. Operator has failed to maintain BMPs per Rule 1002.f.

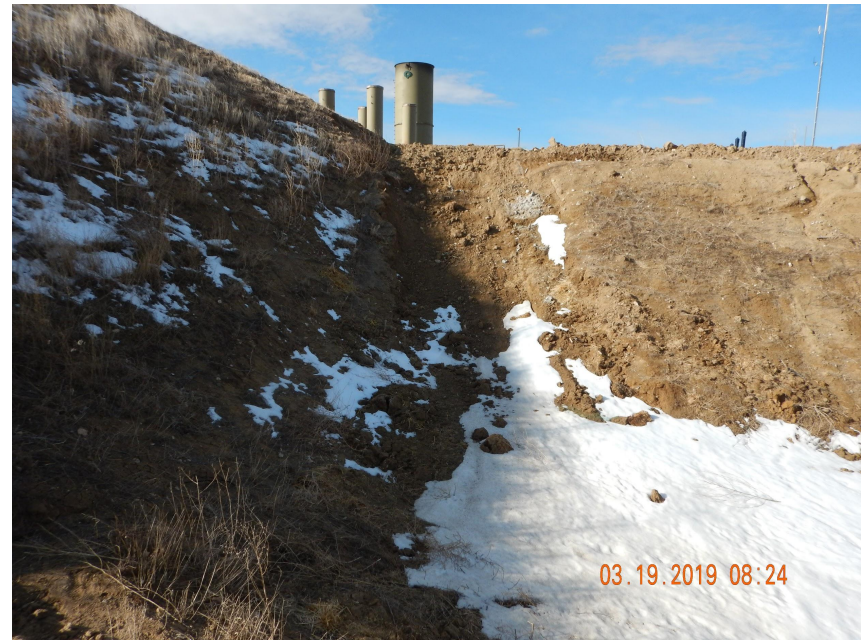
Photo 14. Photo taken from the southern inlet for the sediment basin on March 19, 2019, facing West. Operator has made repairs to the gully erosion observed along an inlet of the sediment basin.
