# Inspection Photos

Operator: Enervest Operating  
Location/API #: 067-07306  
Date: 4-9-2019

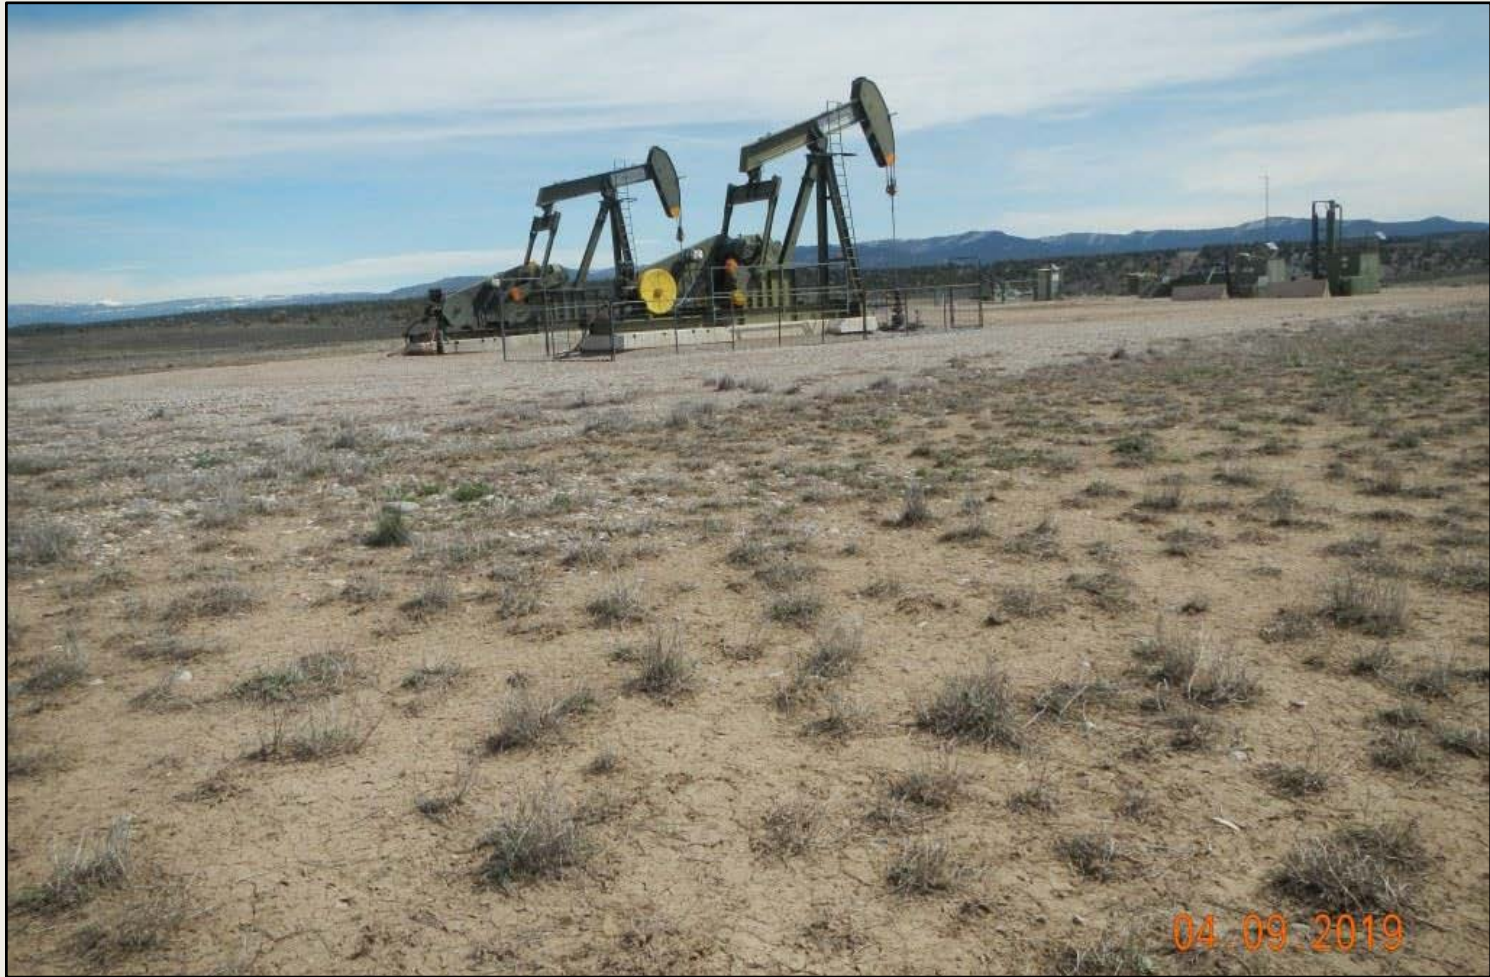
Photo 1. View of the project area from the southwestern corner facing center.

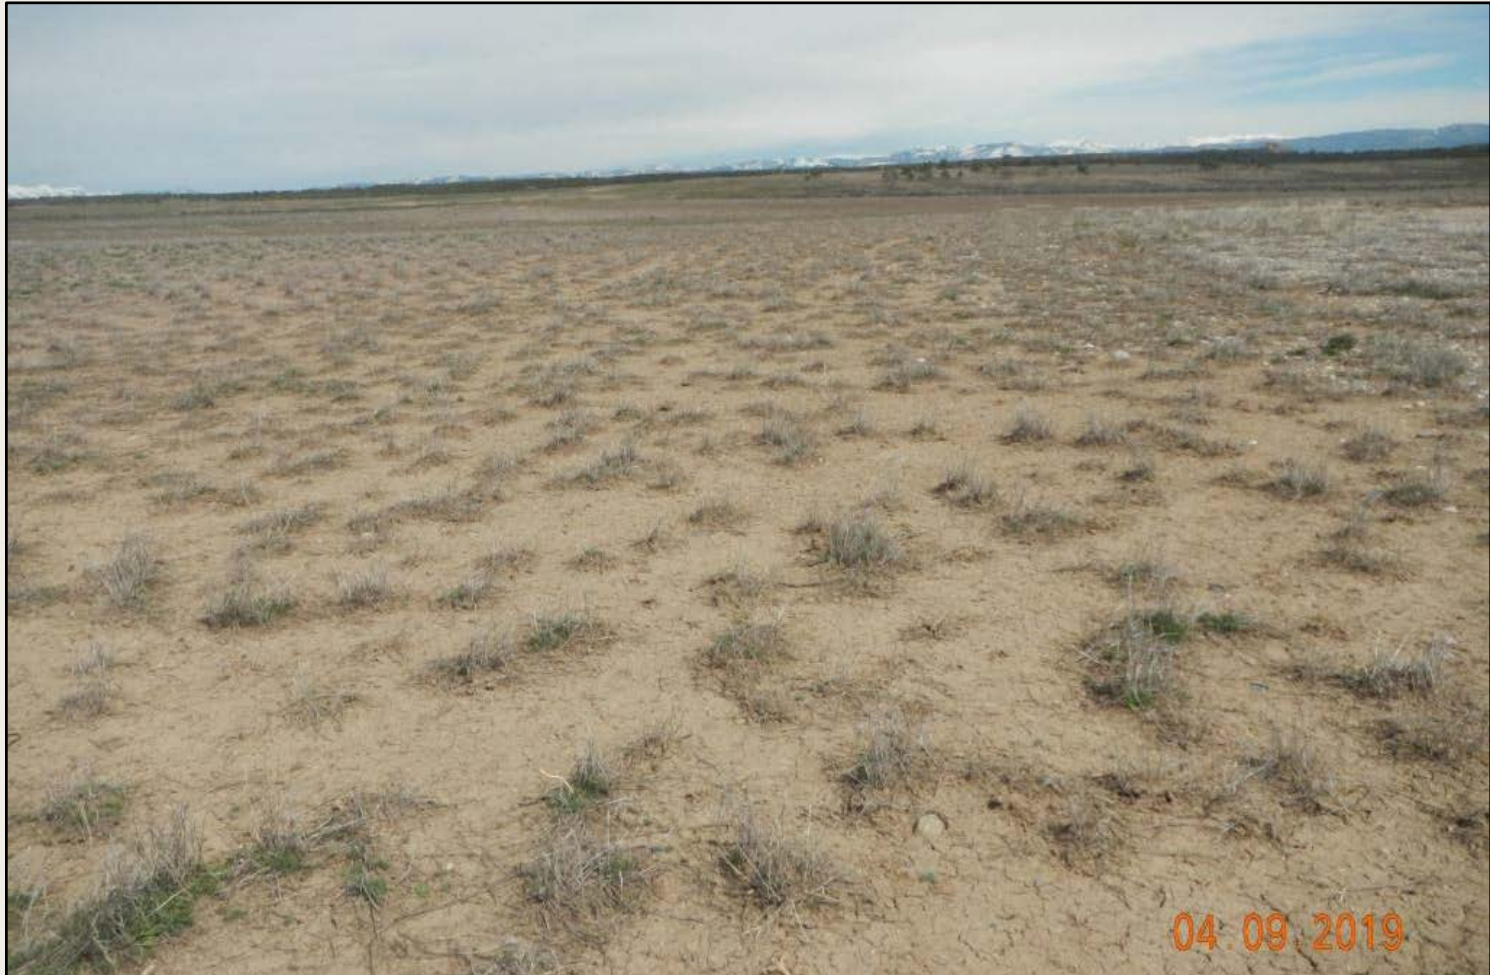
Photo 2. View of the western project area from the southwestern corner facing northward.

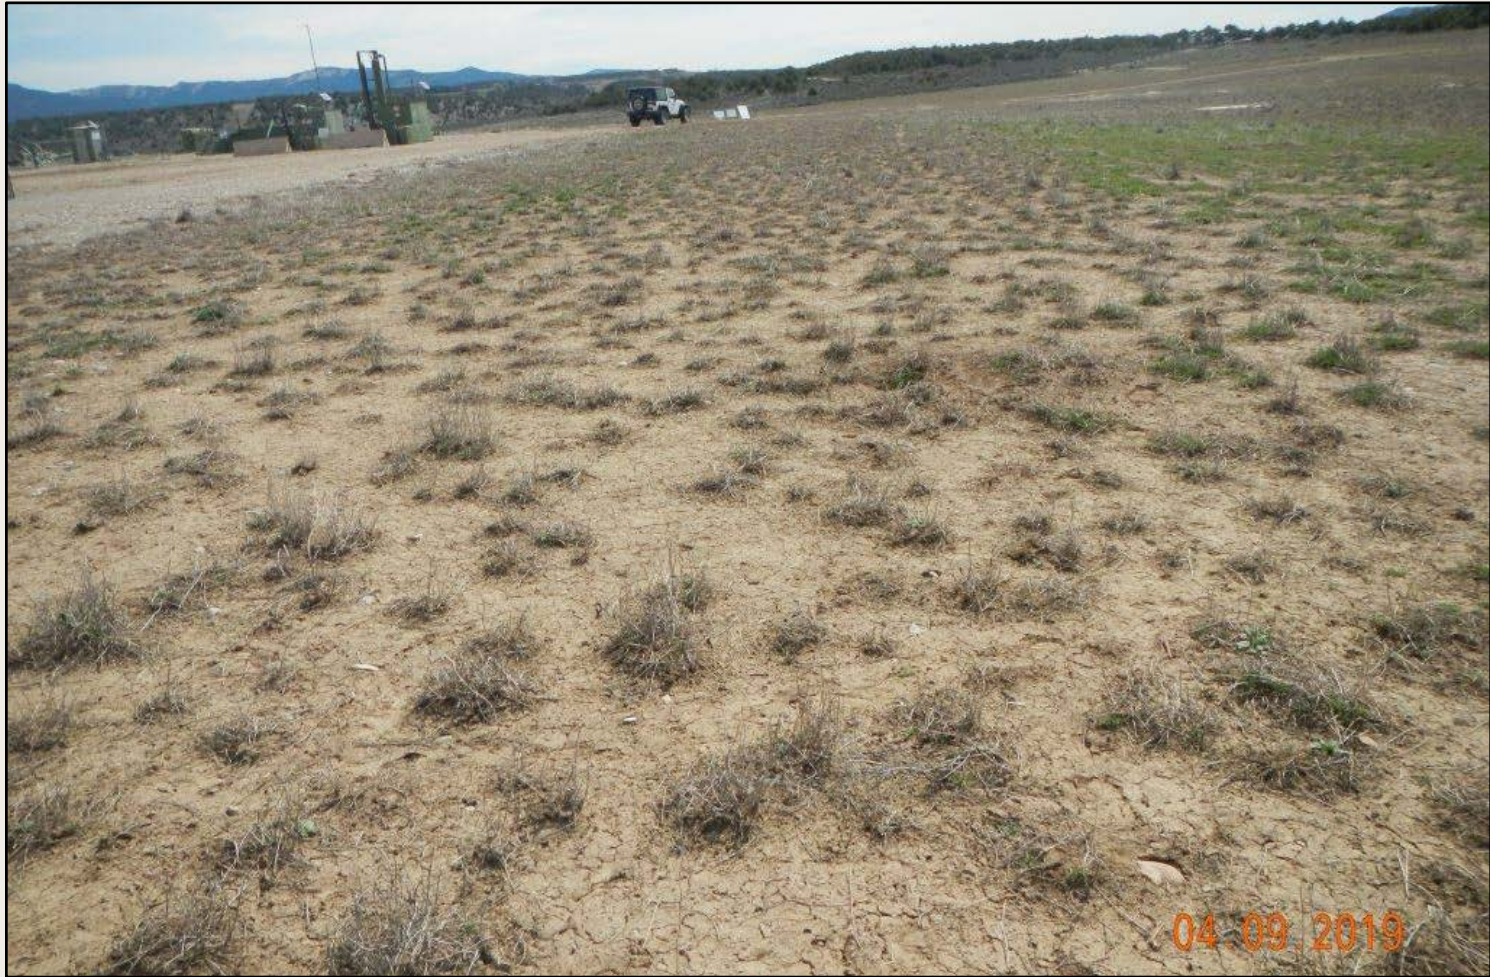
Photo 3. View of the southern project area from the southwestern corner facing eastward.

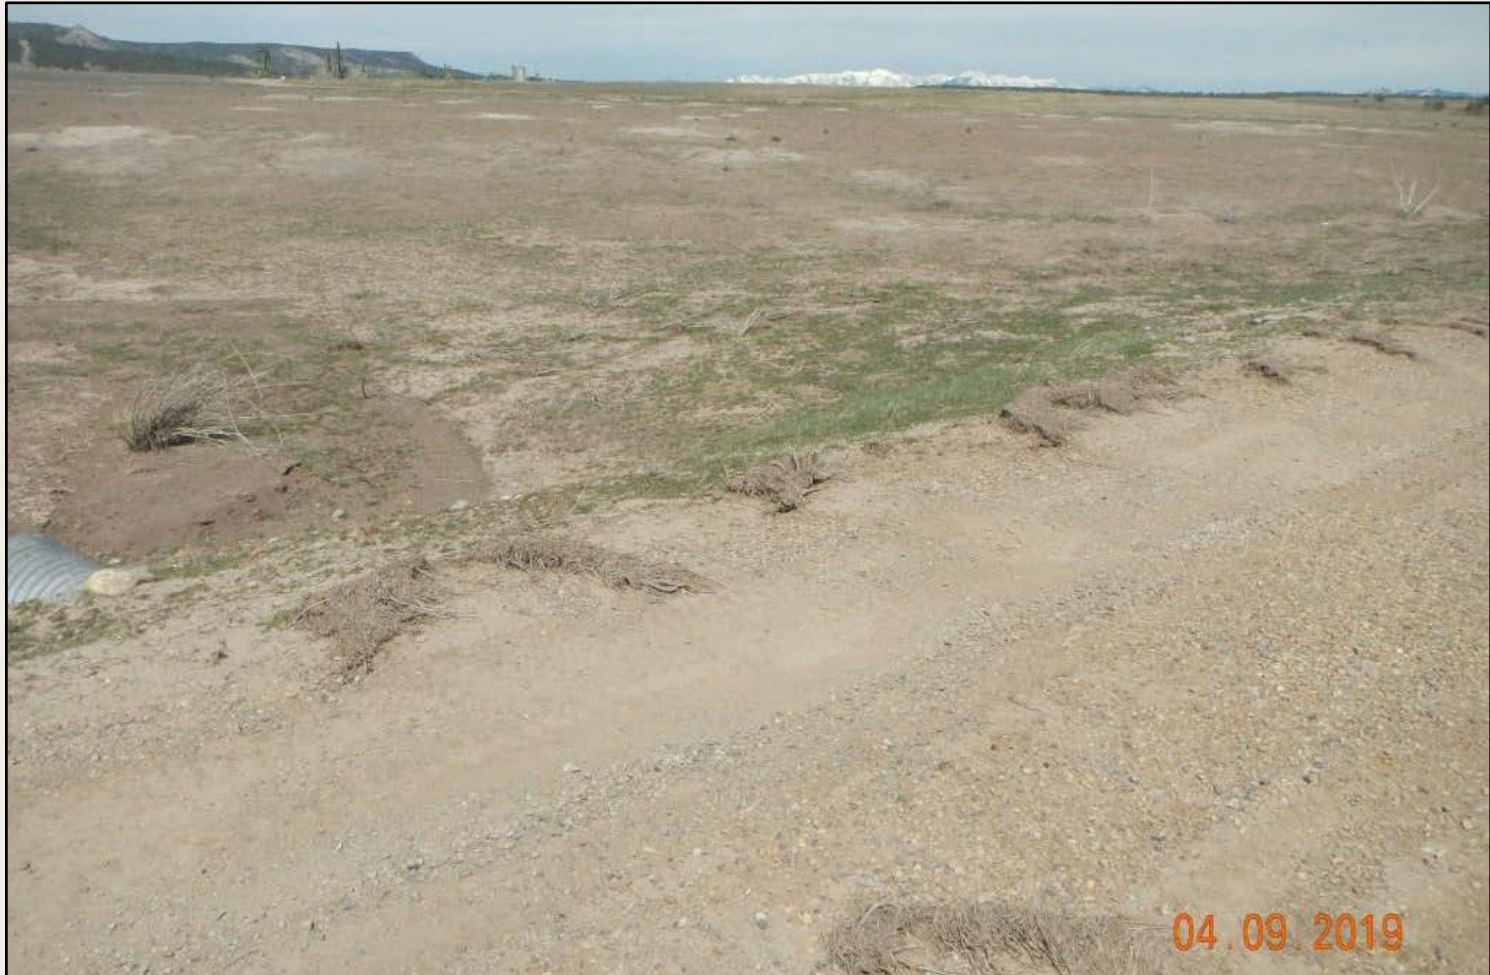
Photo 4. View of area along access road where it appears stormwater flows recently crossed over the road (facing upstream), indicating that culvert is not adequately sized/designed.

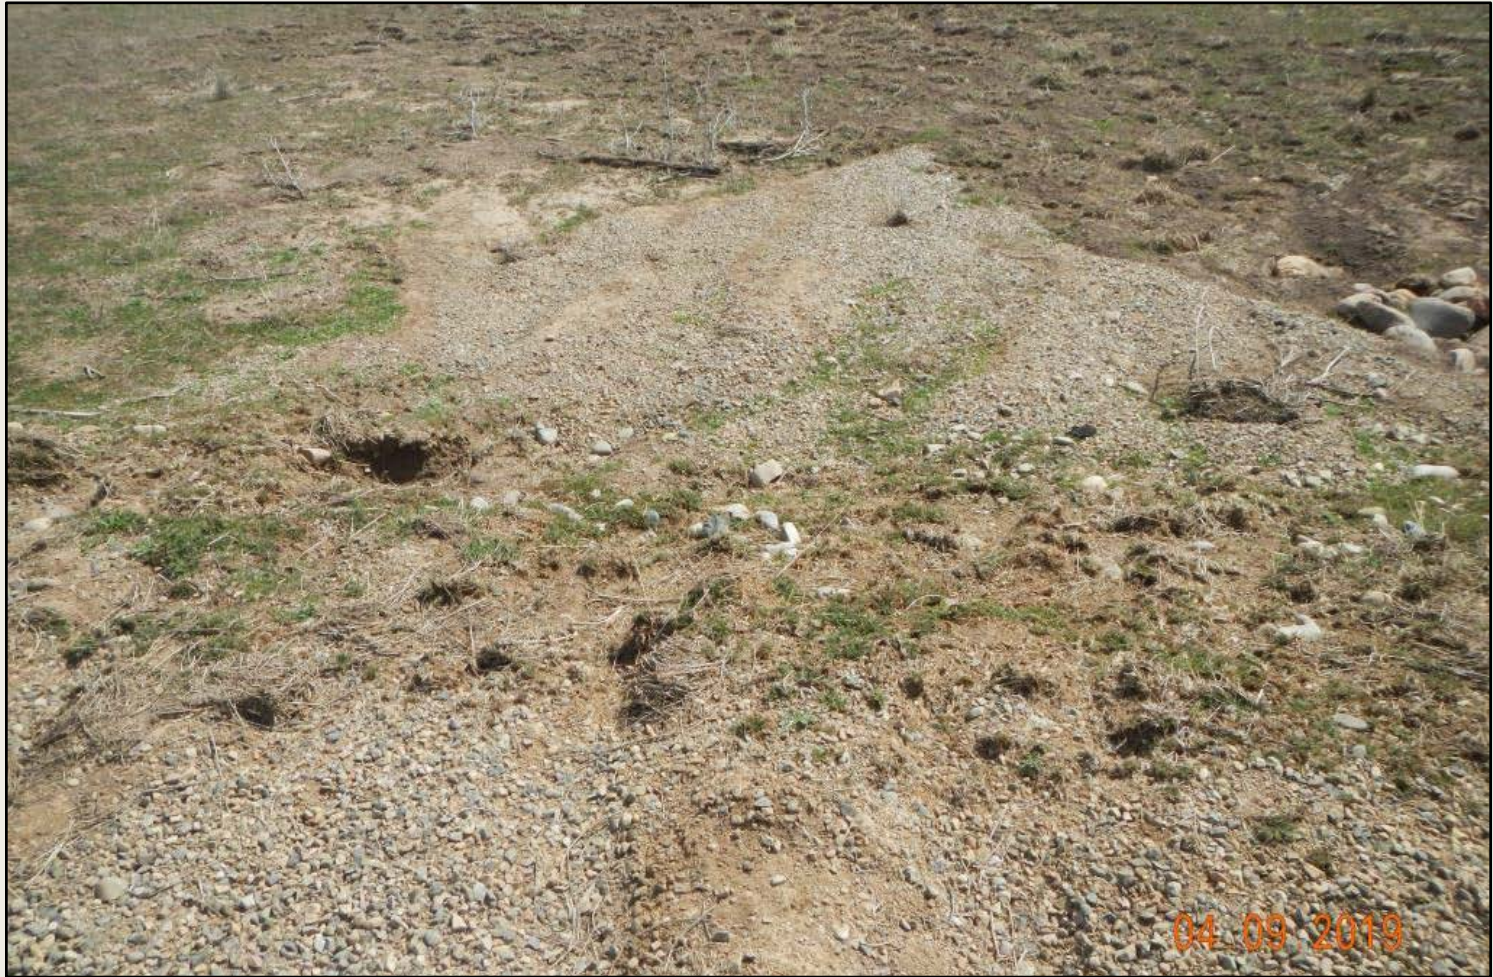
Photo 5. View of area downstream from Photo 4, where stormwater flows recently crossed over the road, depositing sediment from the road.

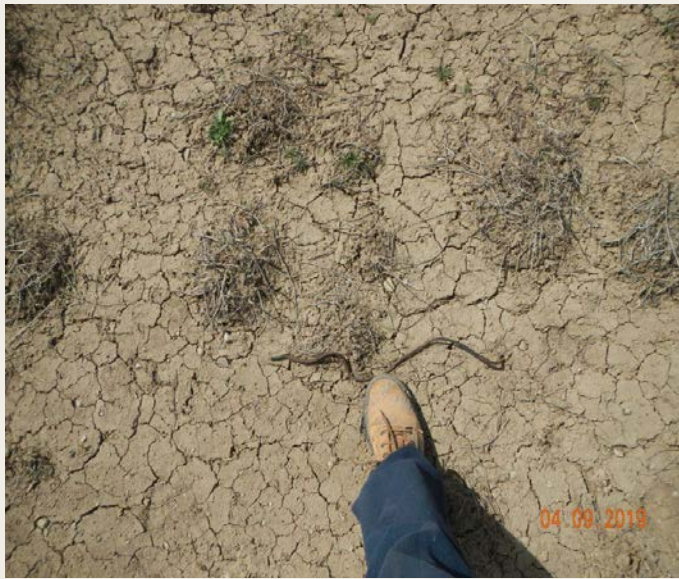
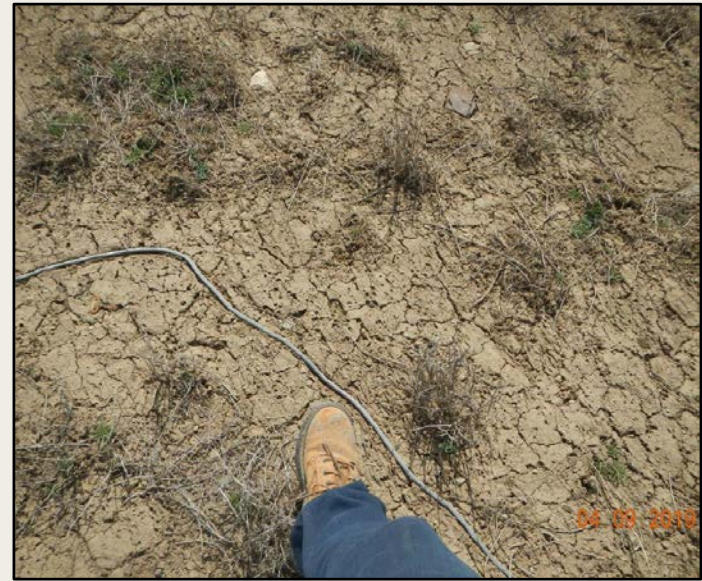
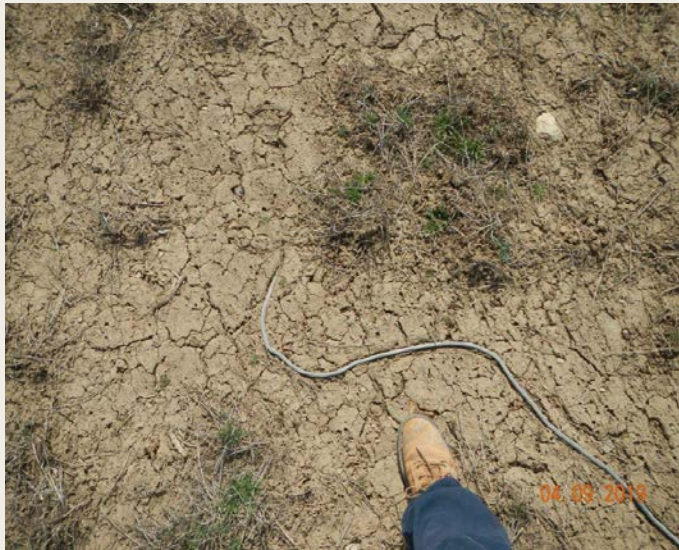
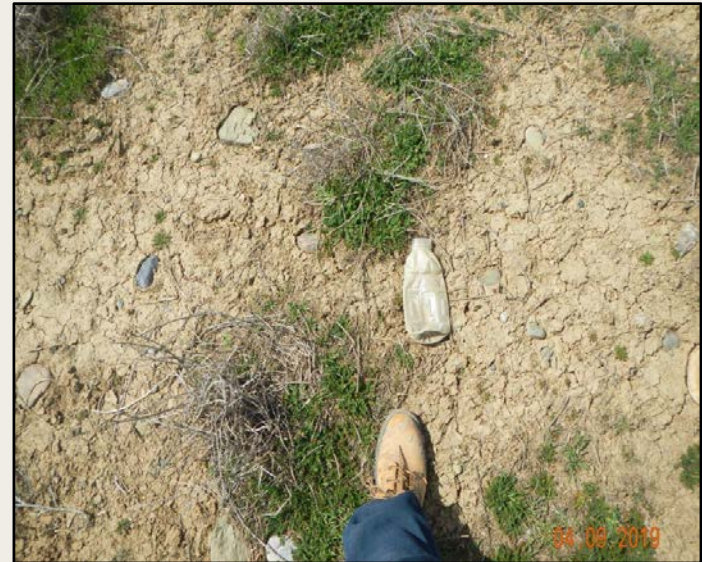
Photos 6-9. View of wire debris and waste within the interim reclamation area.
