Inspection Photos

Operator: Catamount Energy
Location/API #: 067-05464
Date: 4-17-2019

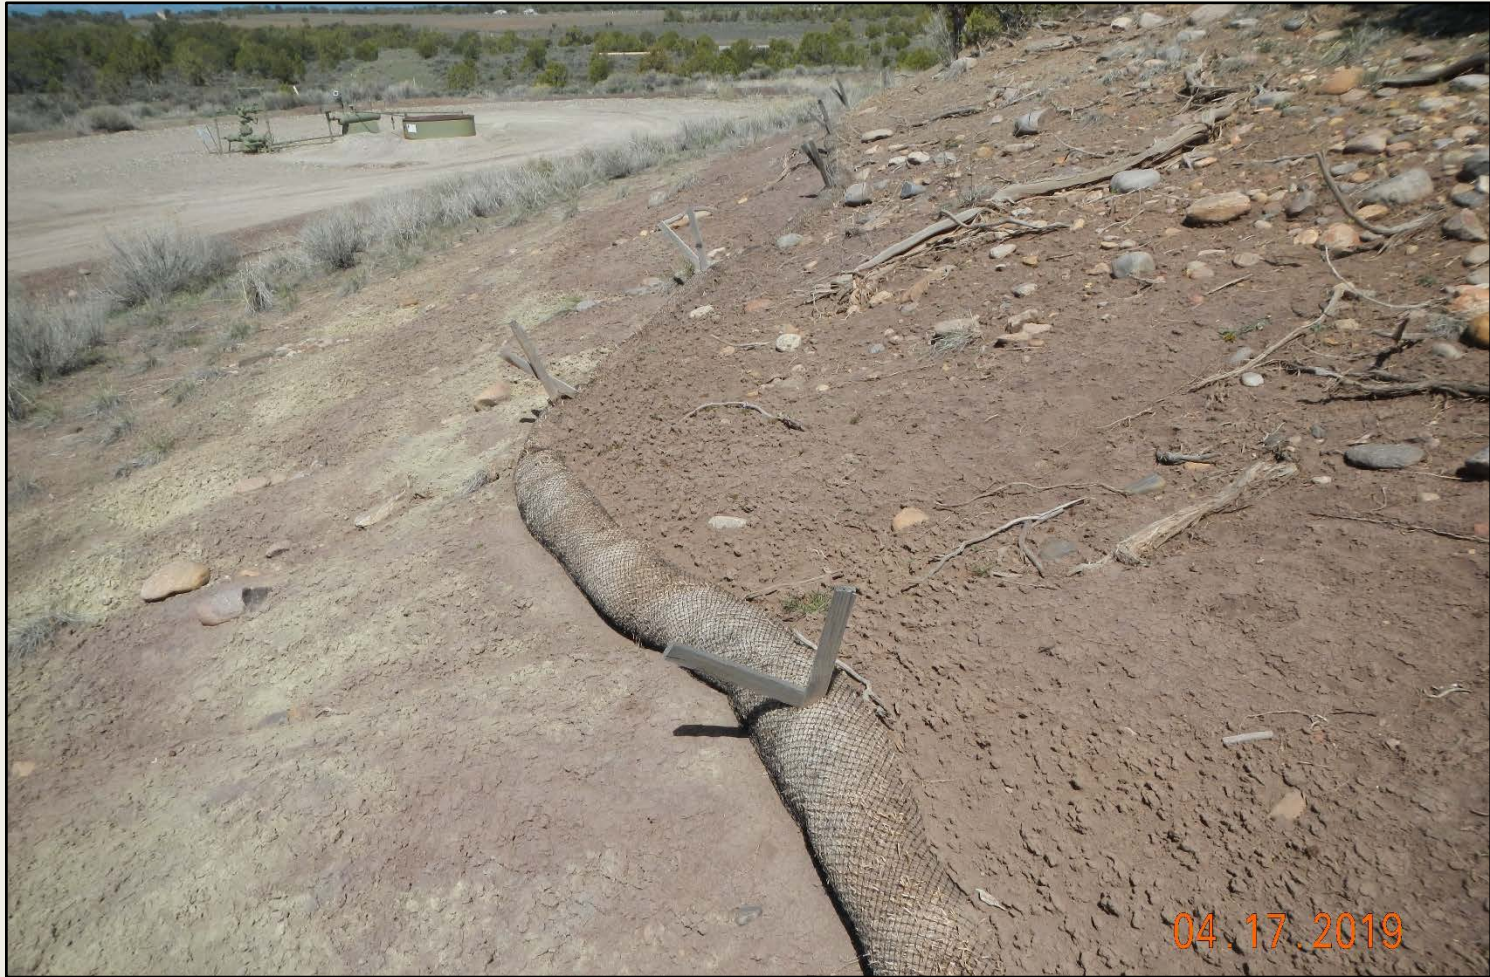
Photo 1. View of wattles in the eastern project area that are full of sediment.

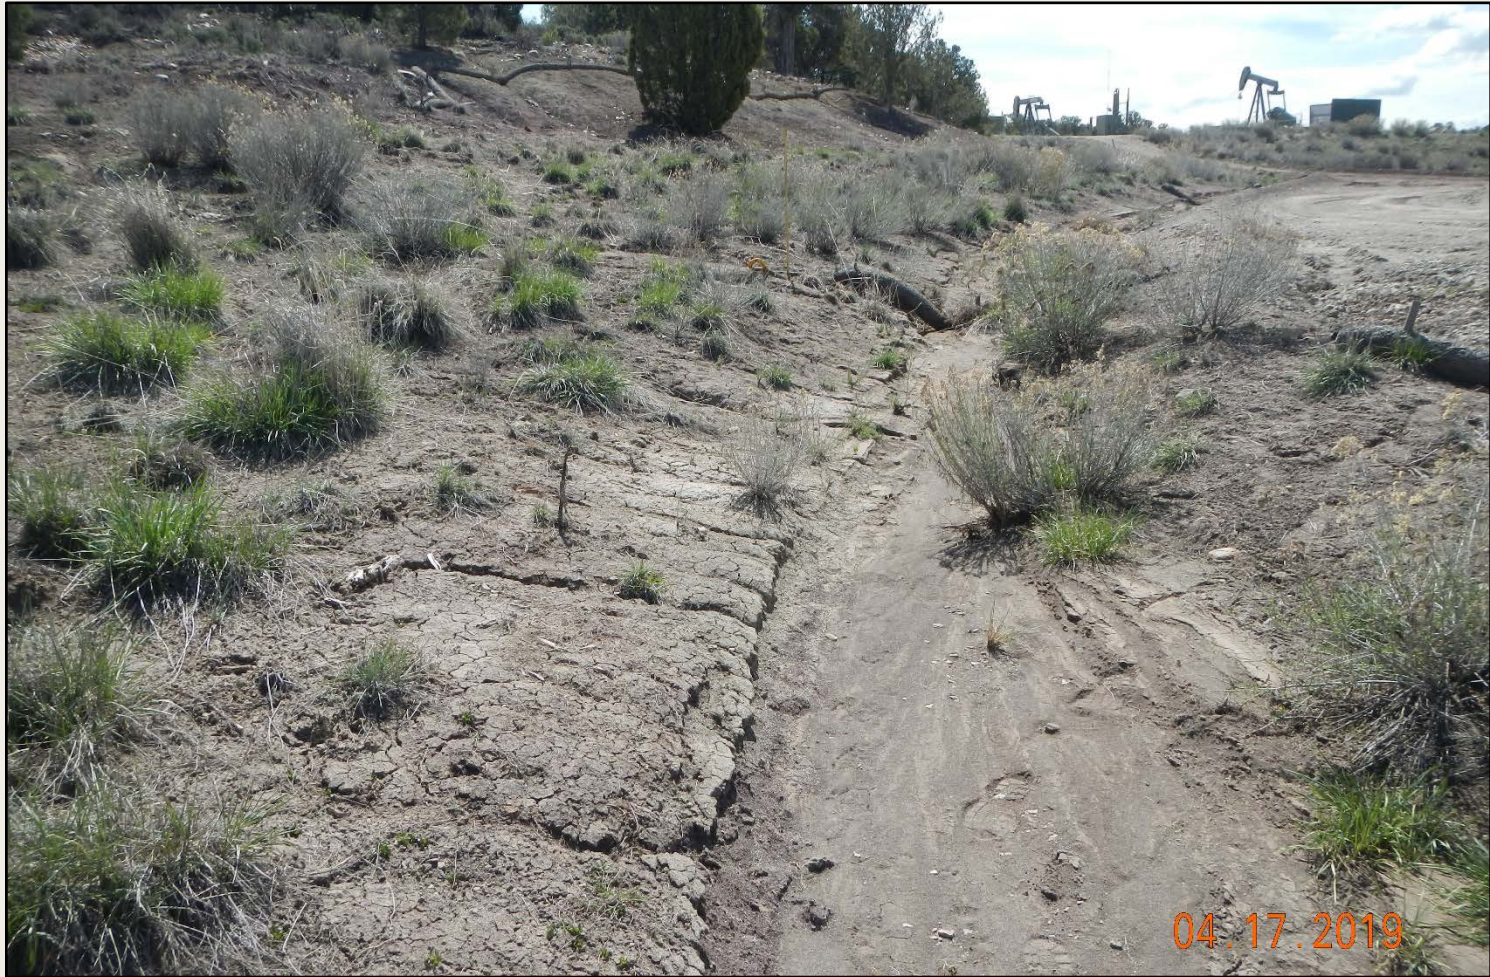
Photo 2. View of eastern diversion ditch that is full of sediment and eroding. Additional stabilization is needed here.

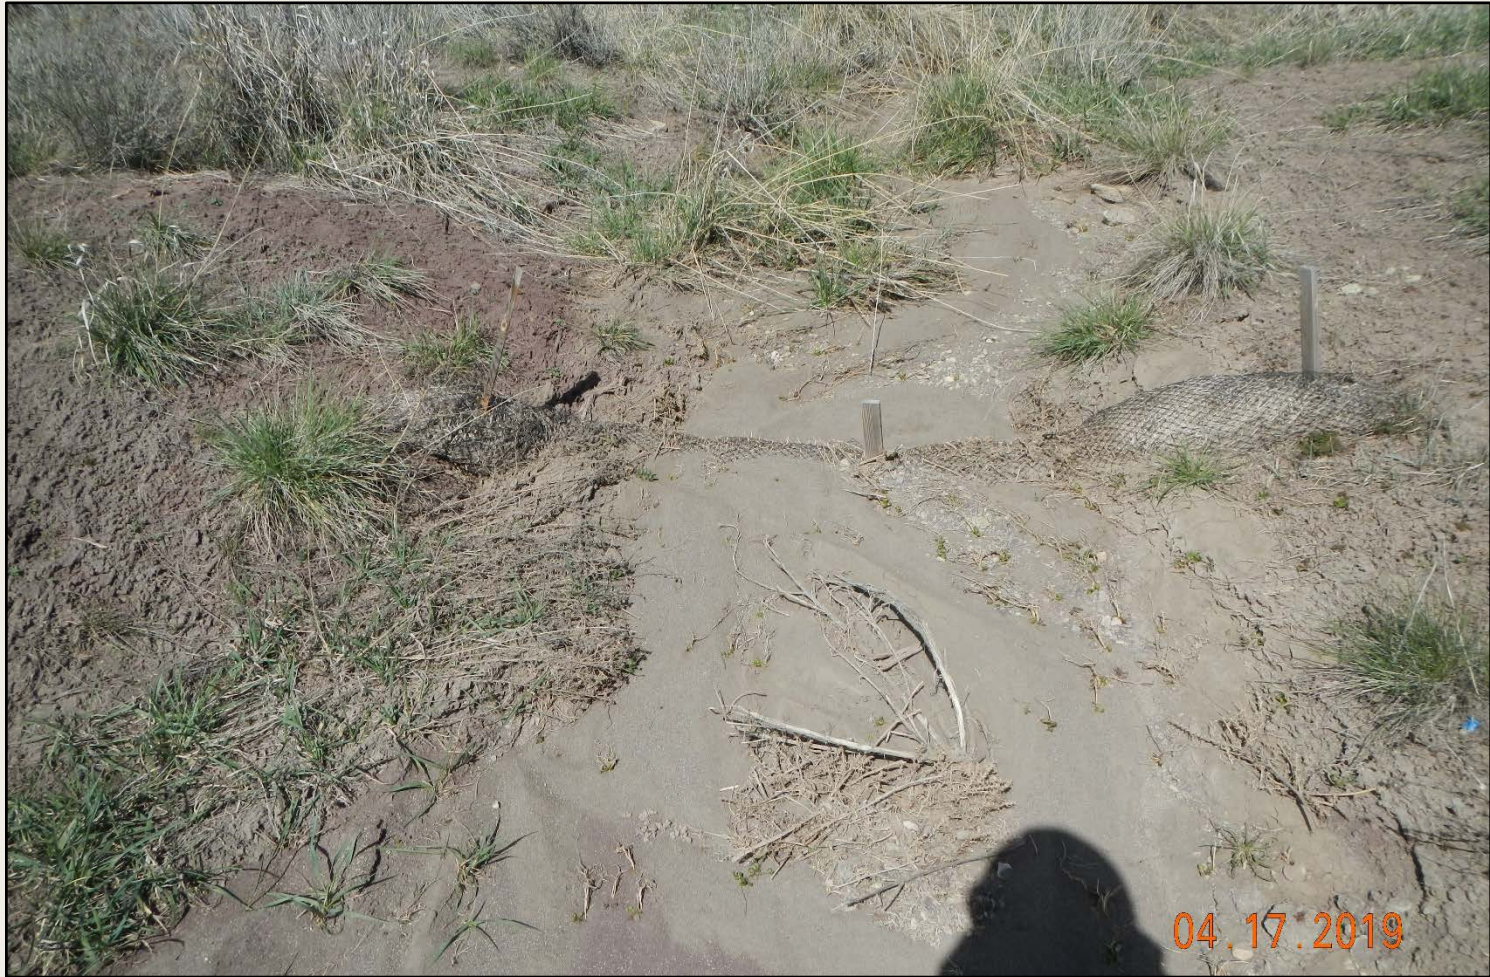
Photo 4. View of wattle in the northern project area that is full of sediment.

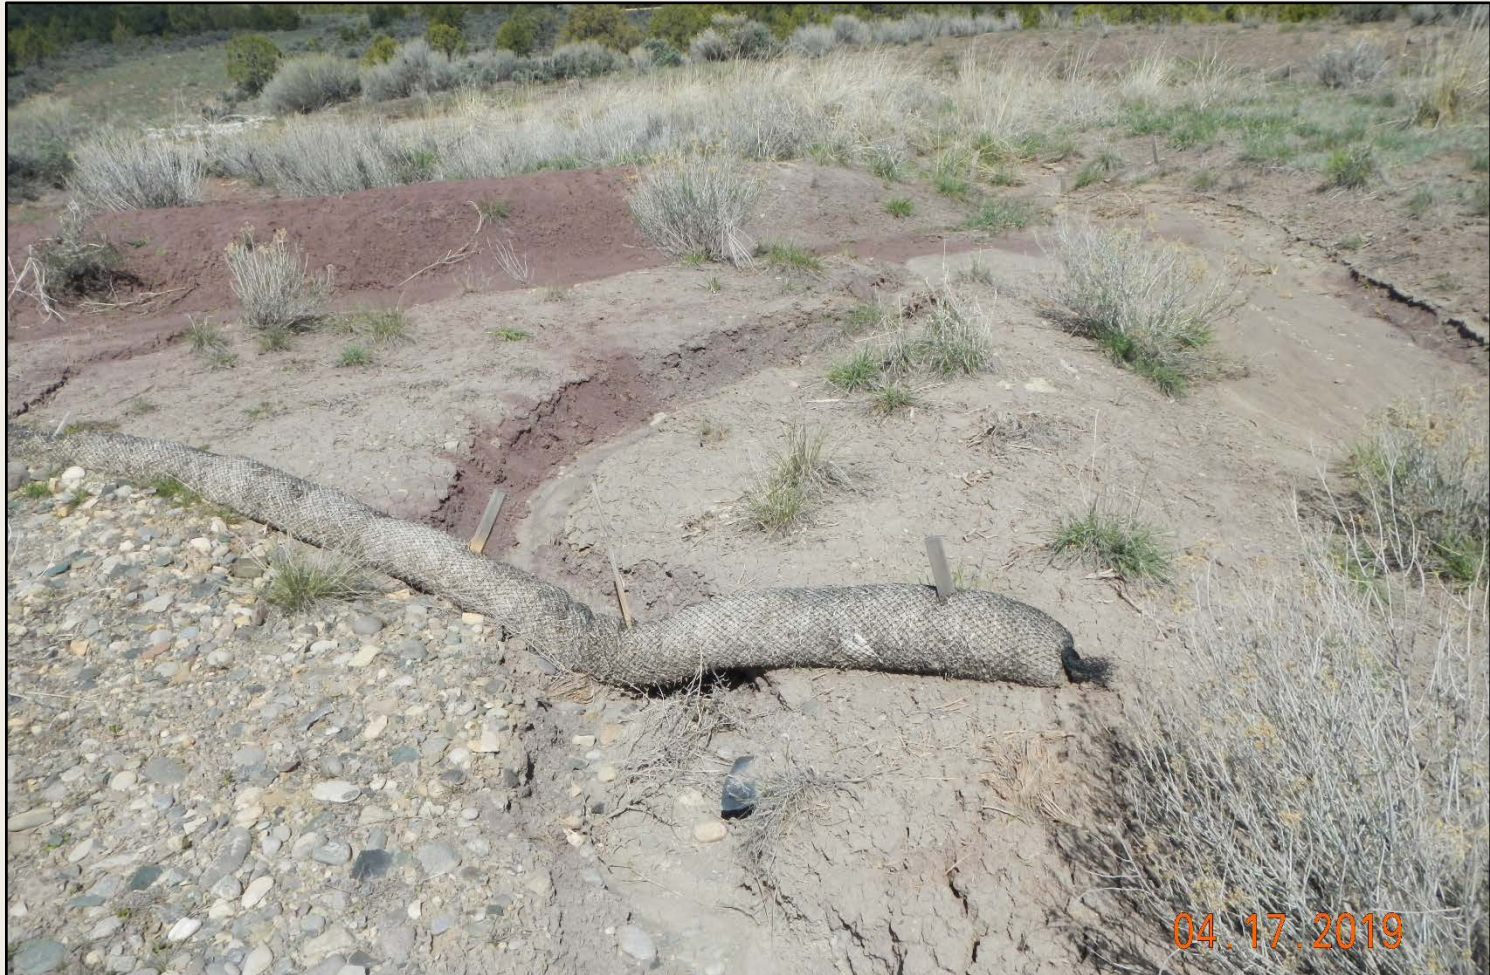
Photo 5. View of wattle in the northern project area that is not functioning.

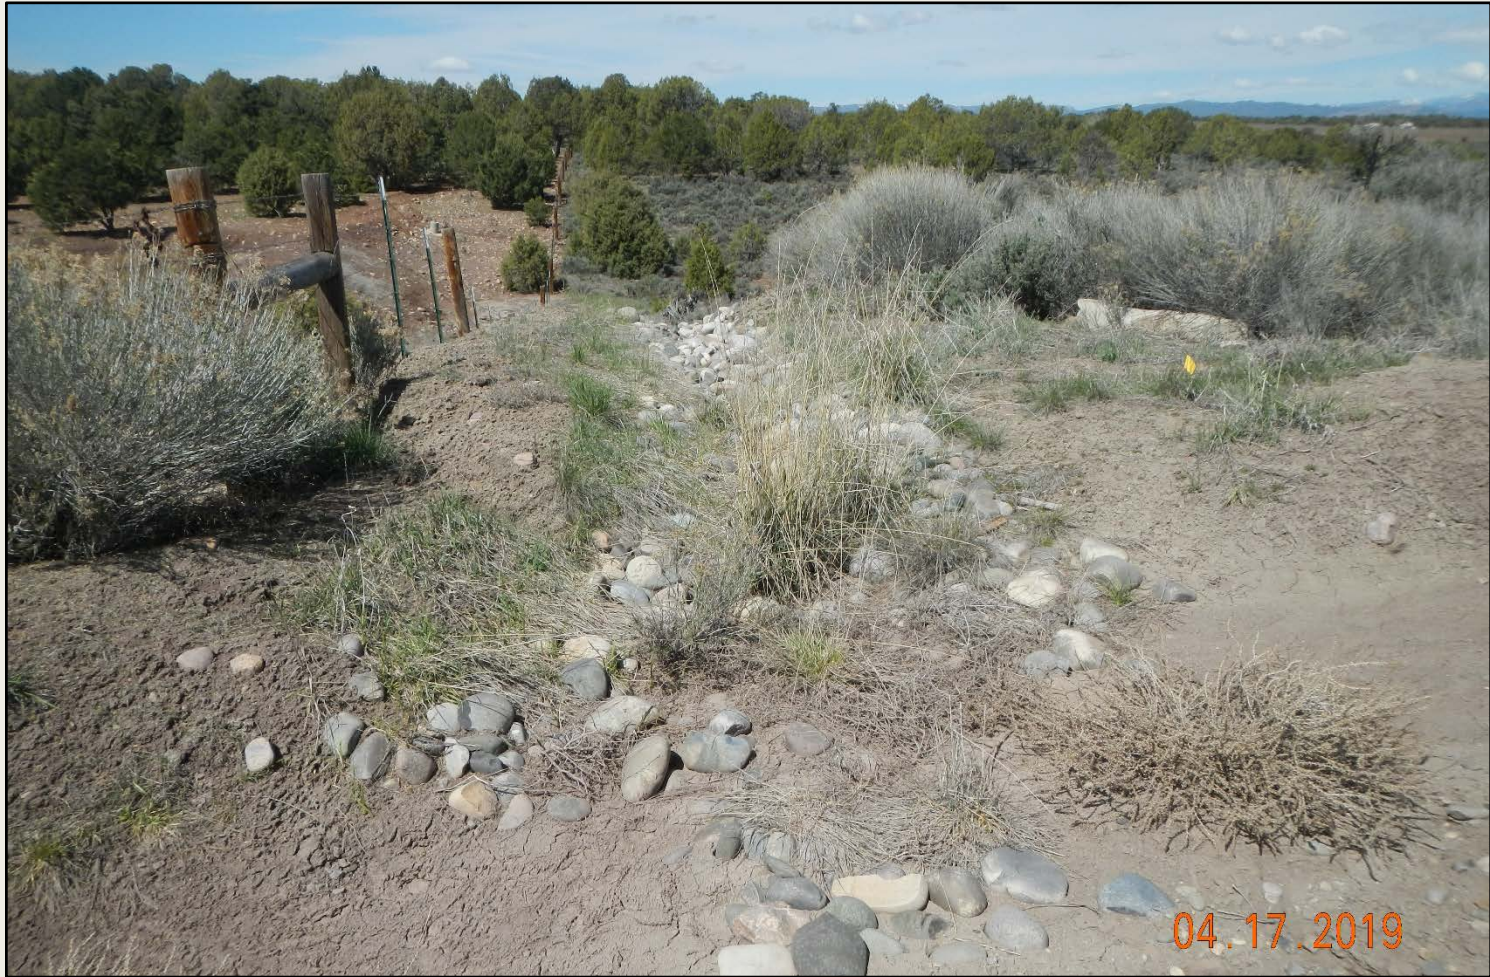
Photo 6. View of cobble run-down within the western project area that needs maintenance due to sediment accumulation.
