Inspection Photos

Operator: Enduring Resources
Location/API #: 067-07636
Date: 4-22-2019

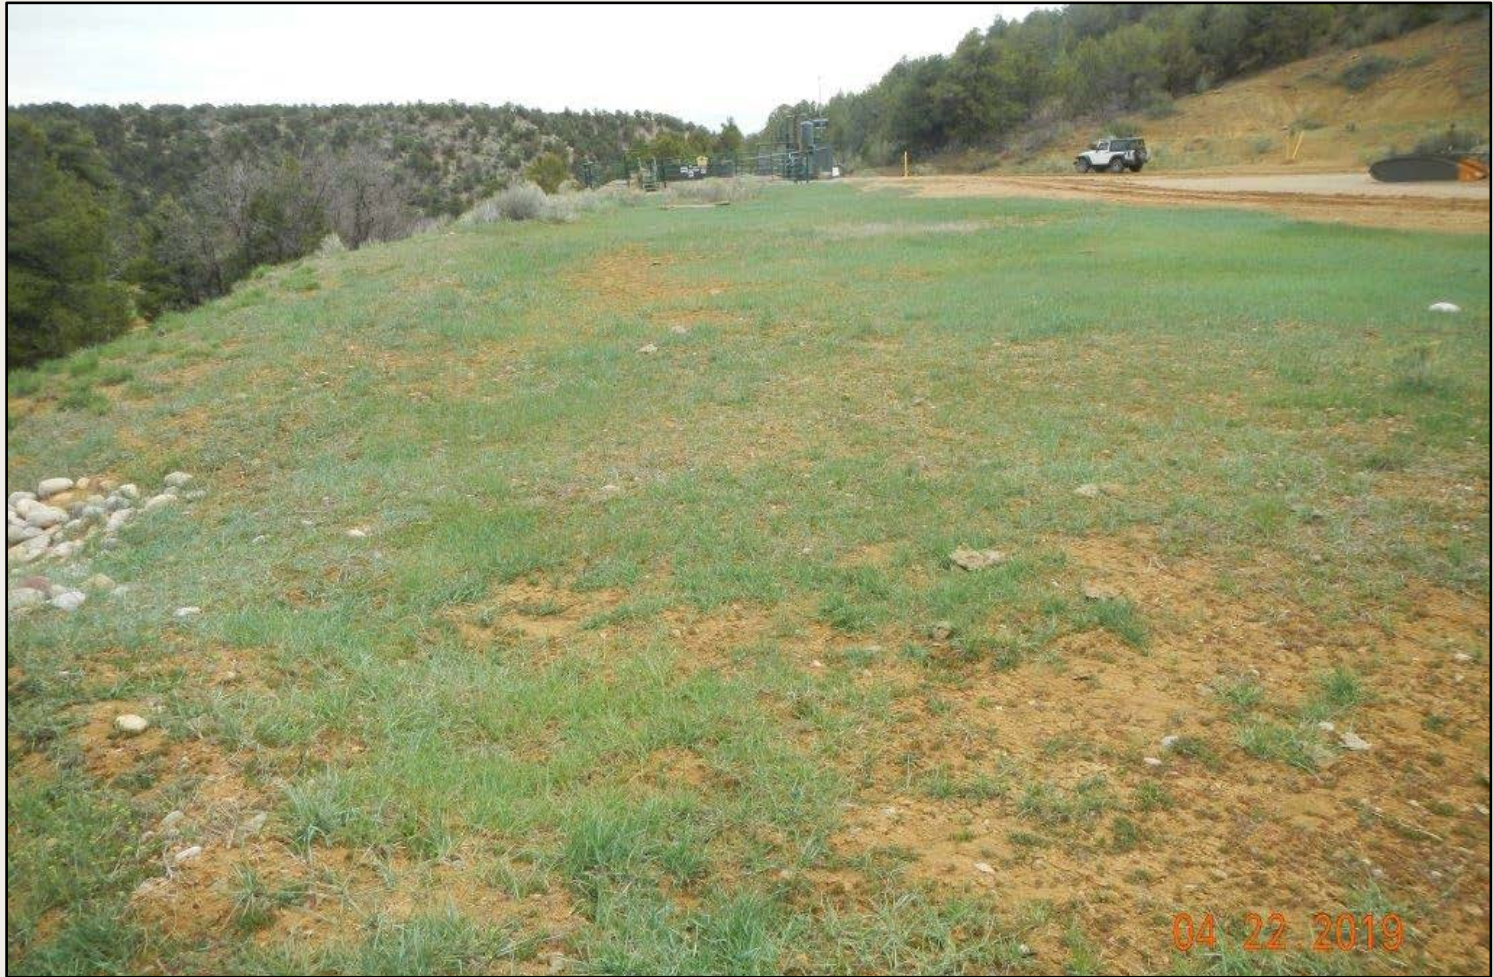
Photo 1. View of the northern project area from the northwestern corner facing eastward.

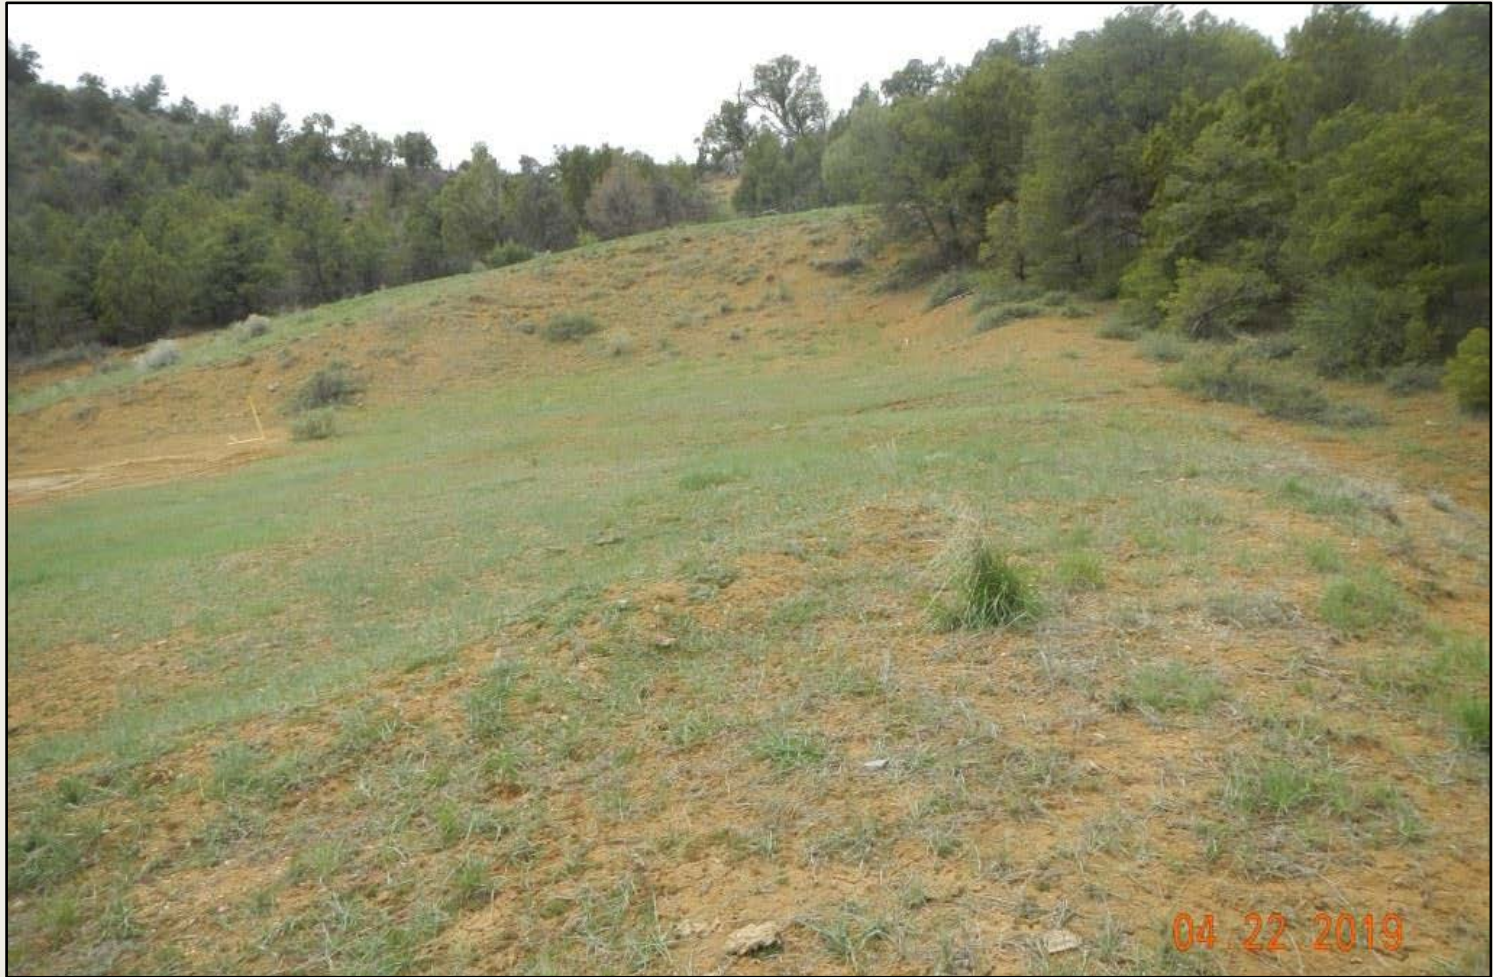
Photo 2. View of the western project area from the northwestern corner facing southward.

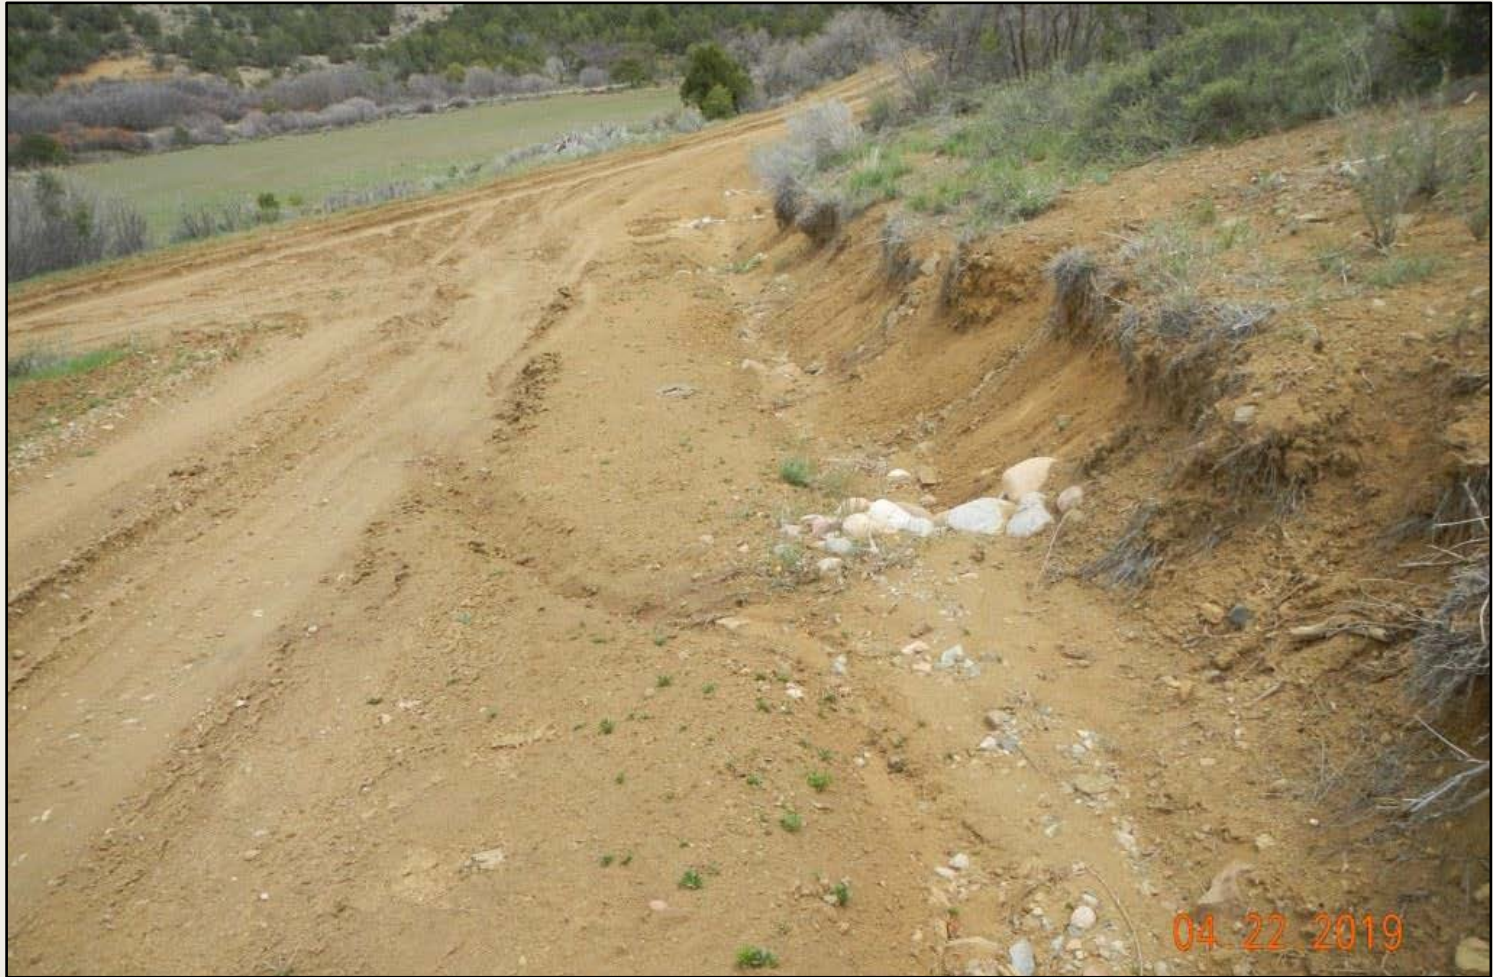
Photo 3. View of erosion, sedimentation, and insufficient stormwater controls along the access road.
