Inspection Photos

Operator: Enduring Resources
Location/API #: 067-08647
Date: 4-22-2019

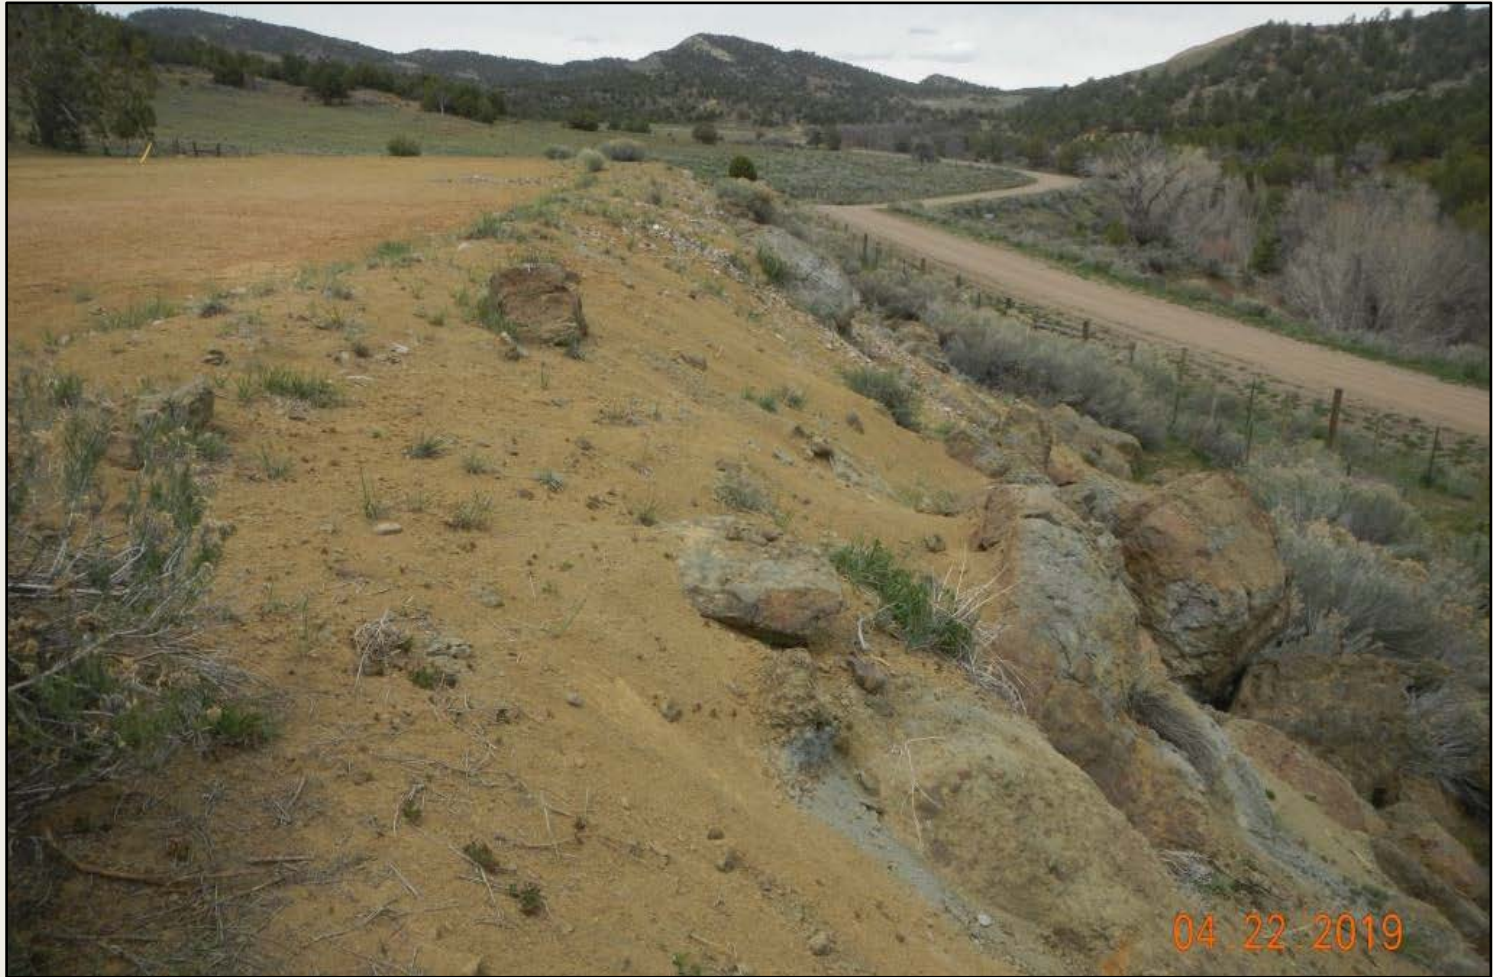
Photo 1. View of the eastern fill slope from the southeastern edge facing northward.

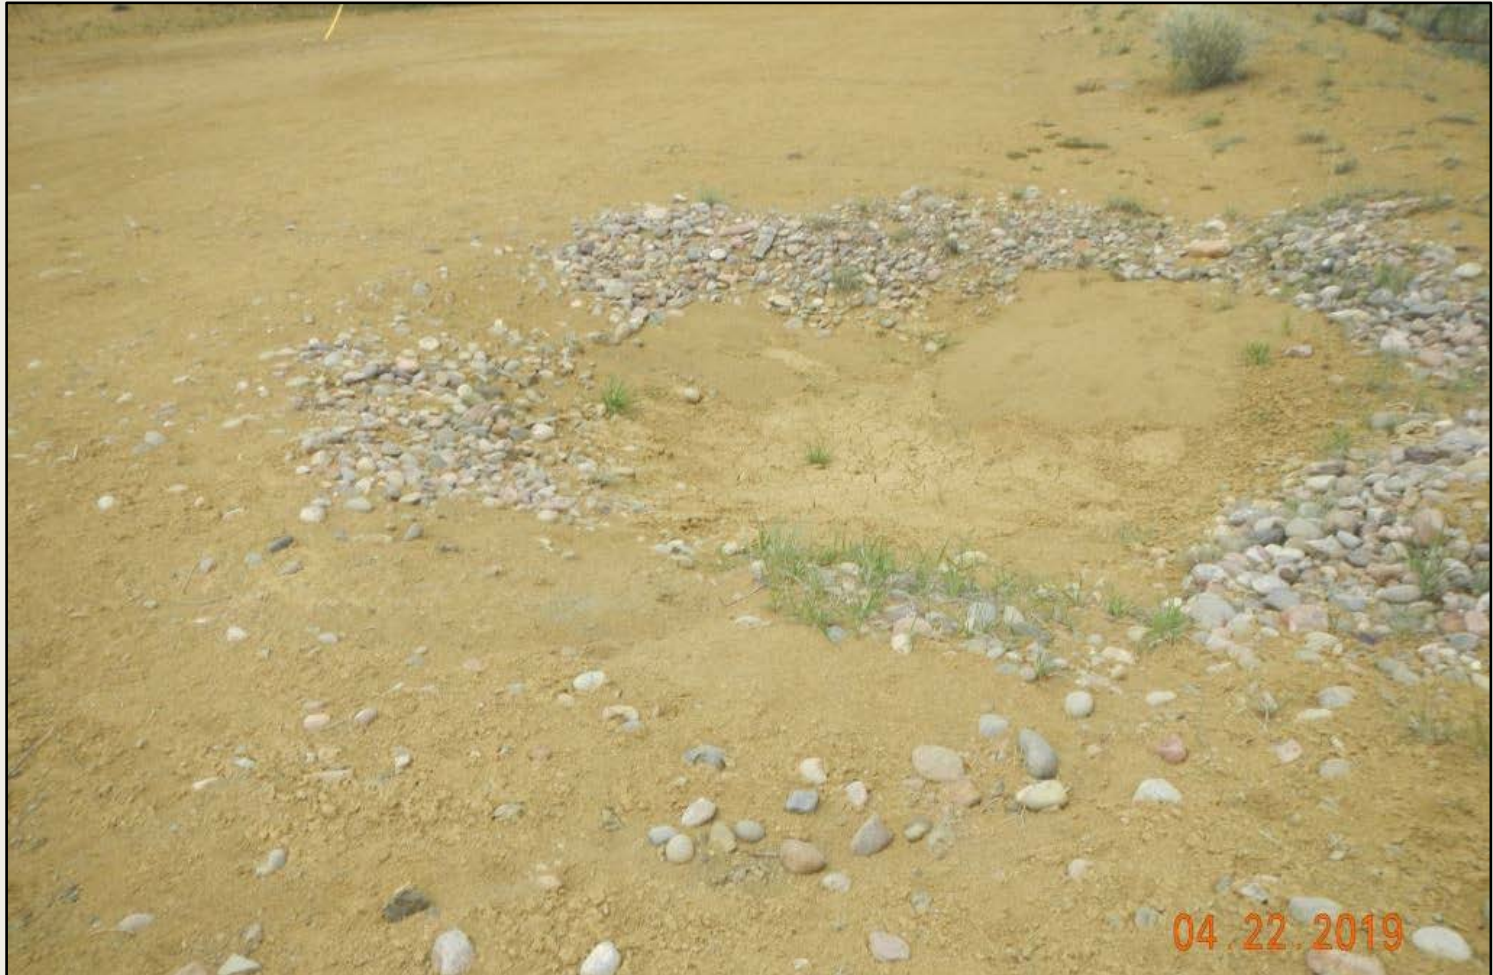
Photo 2. View of silt trap in the eastern project area that is full of sediment.

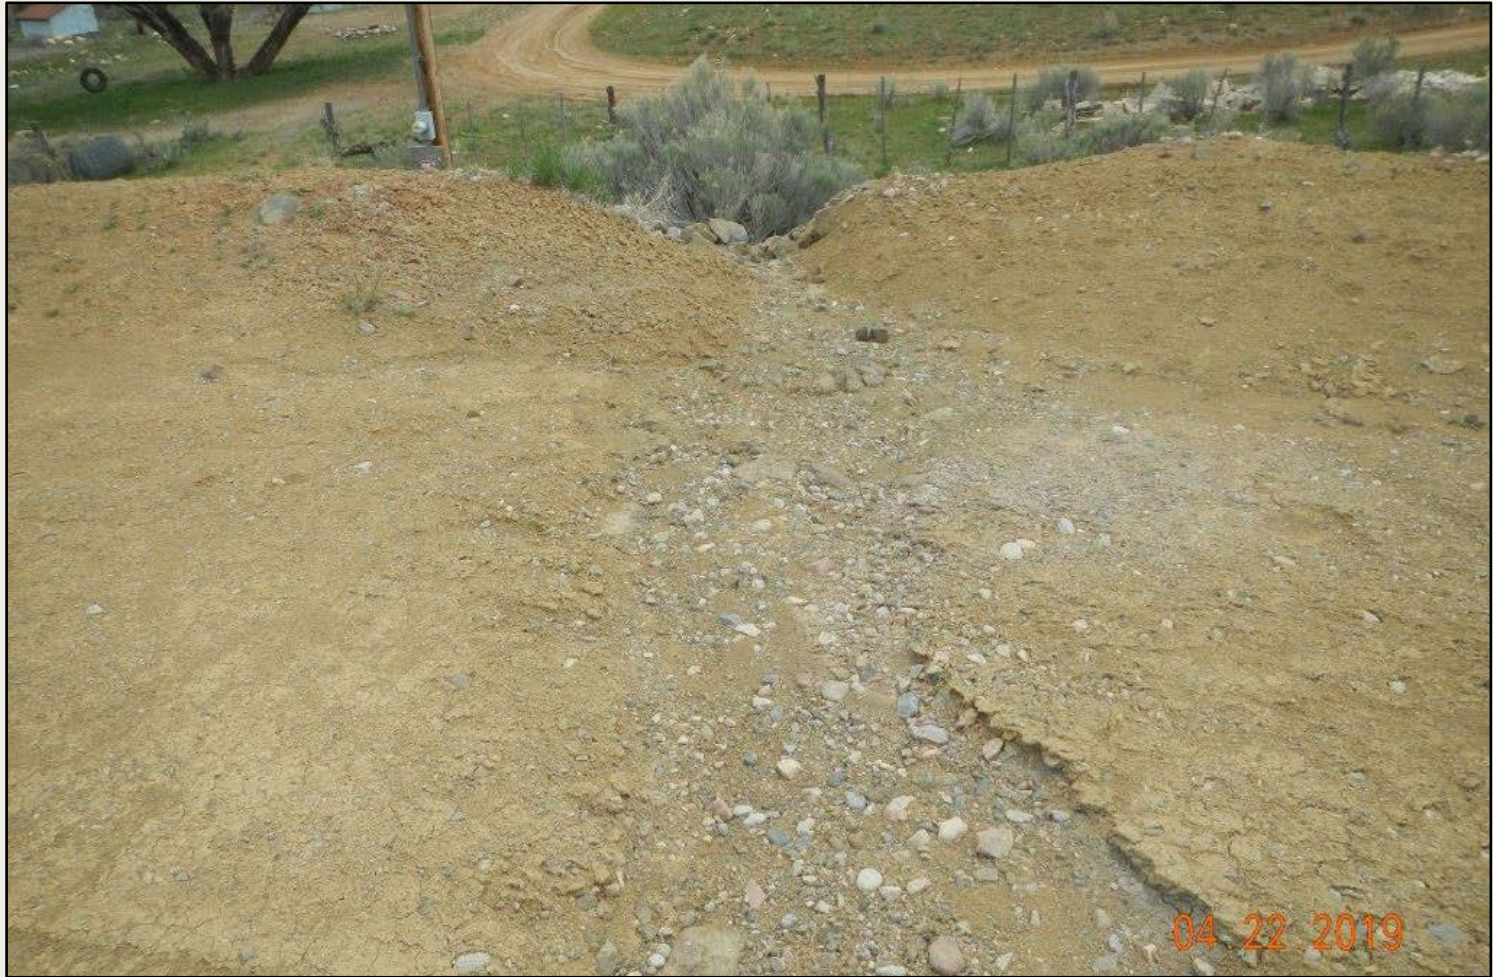
Photo 3. View of erosional scouring in the southern project area where concentrated stormwater flows off of the well pad.

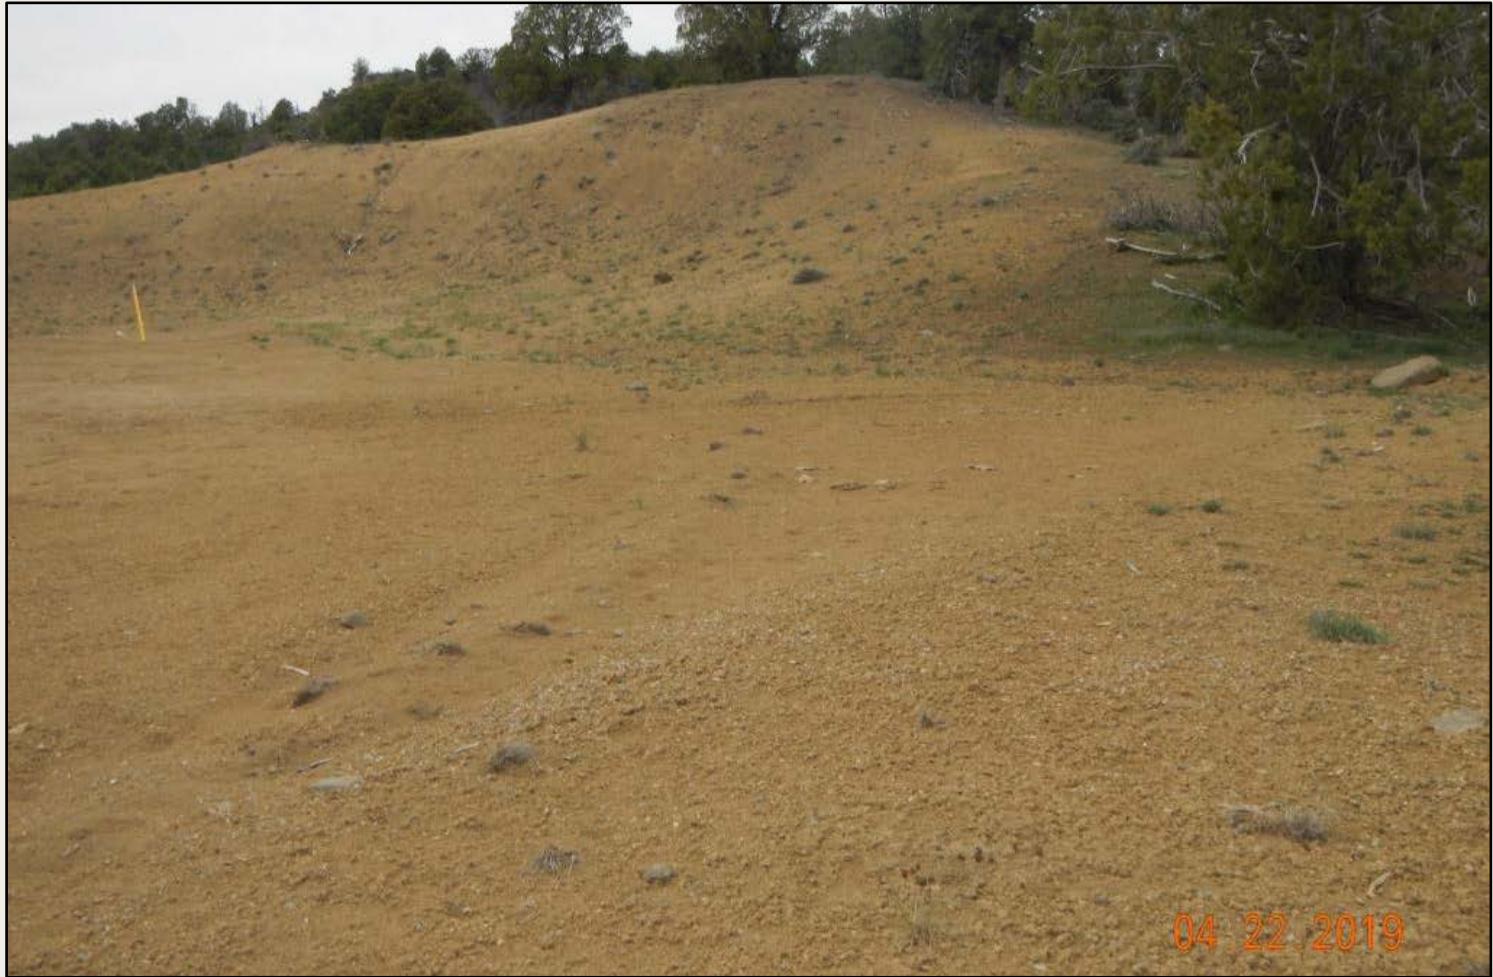
Photo 4. View of the northwestern cut-slope that is not properly stabilized.
