Inspection Photos  
Location Name: Parker #44-15  
Location ID: 332886

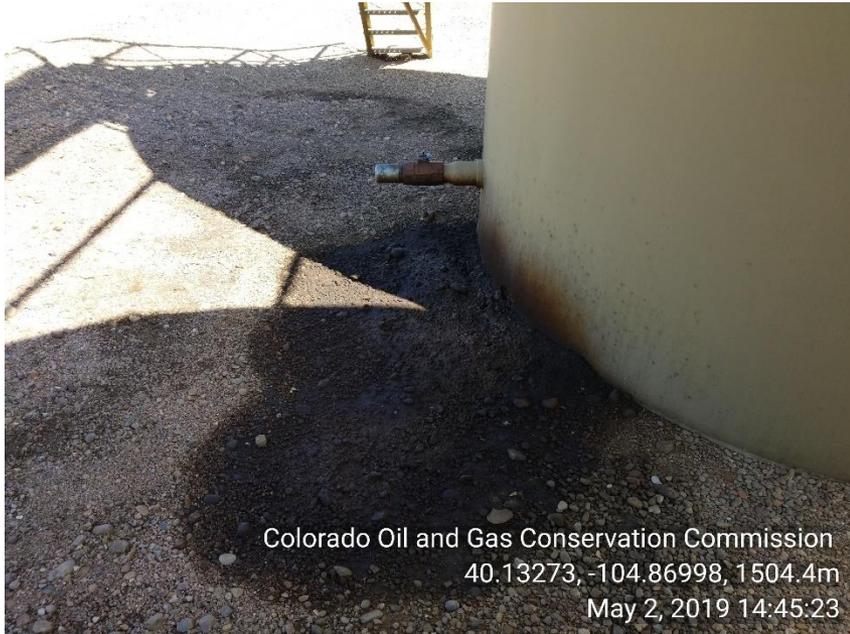
**Photo 3 Stained soil around produced water tank**

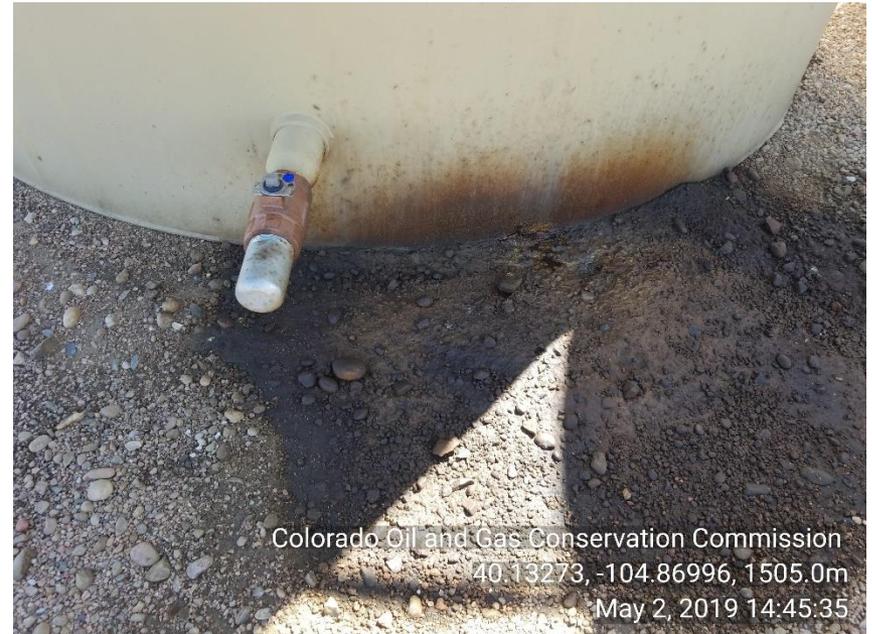
**Photo 4 Ground saturated from what appears to a leak at bottom of produced water tank. Mechanical issue: leak on tank.**

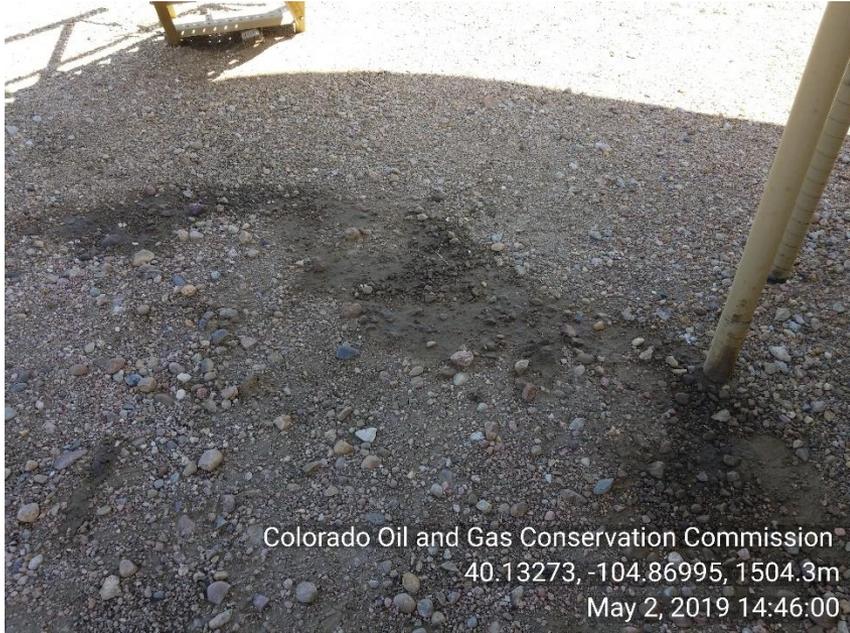
**Photo 5 Stained soil around produced water tank**

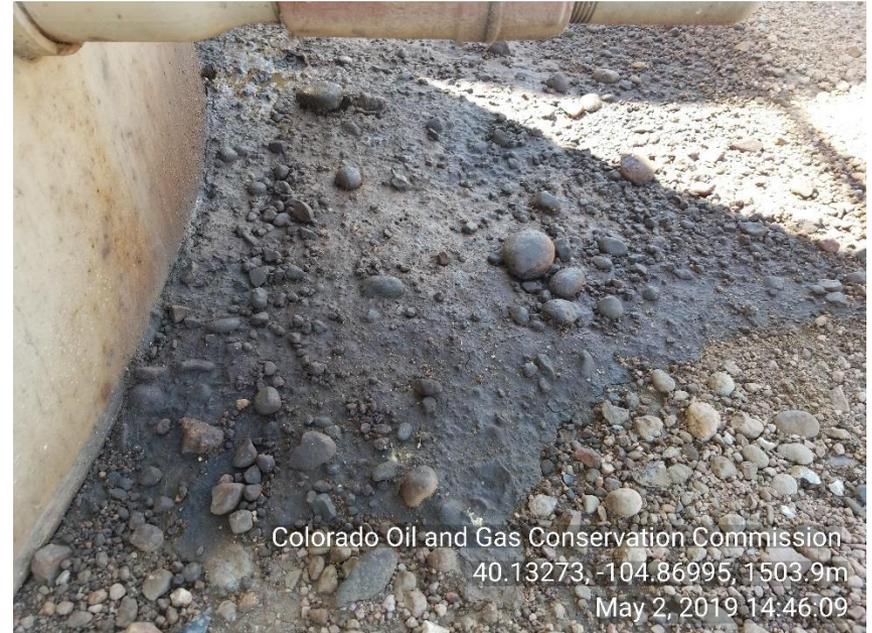
**Photo 6 Ground saturated from what appears to a leak at bottom of produced water tank.**

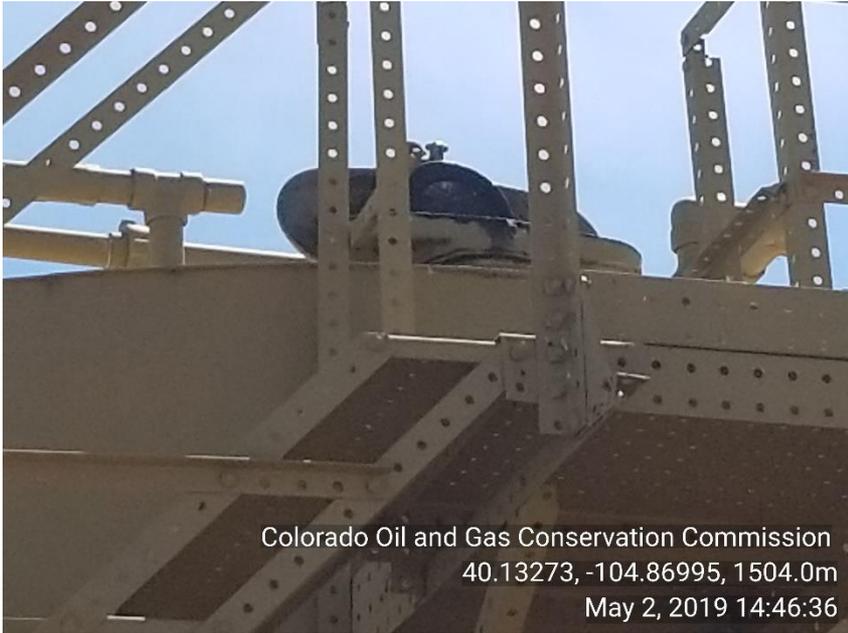
**Photo 7 Gage hatch open**

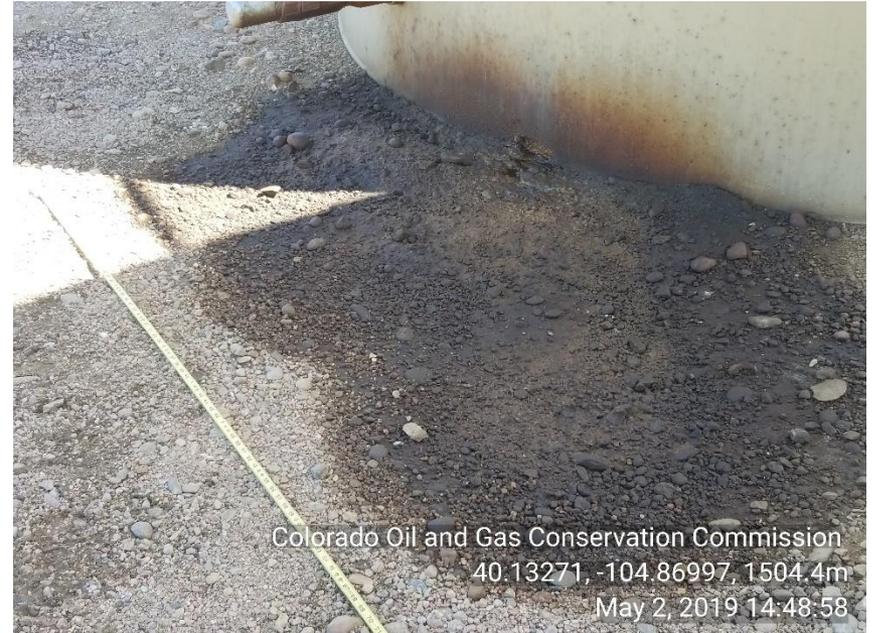
**Photo 8 Affected area soil approx. 8 feet long**

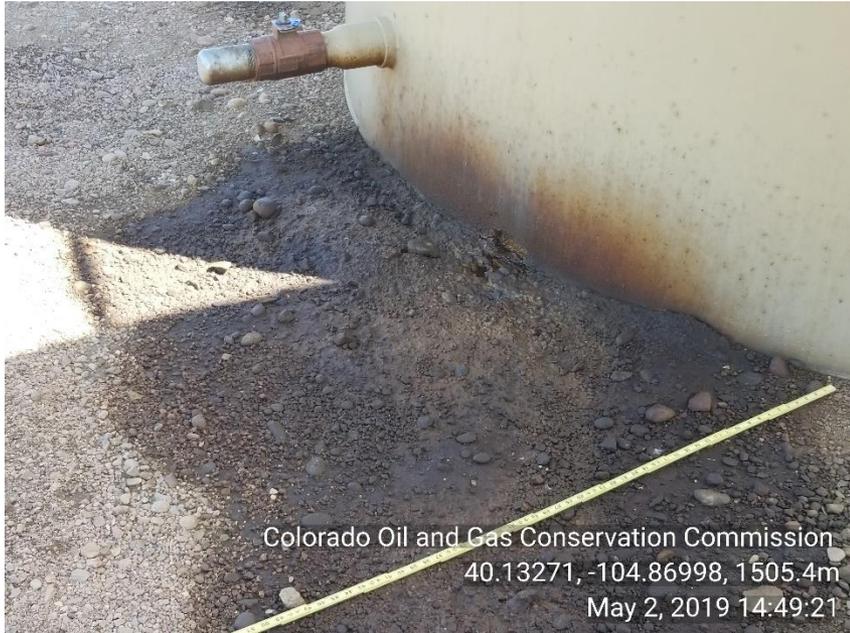
**Photo 9 Affected area approx. 5ft wide.**

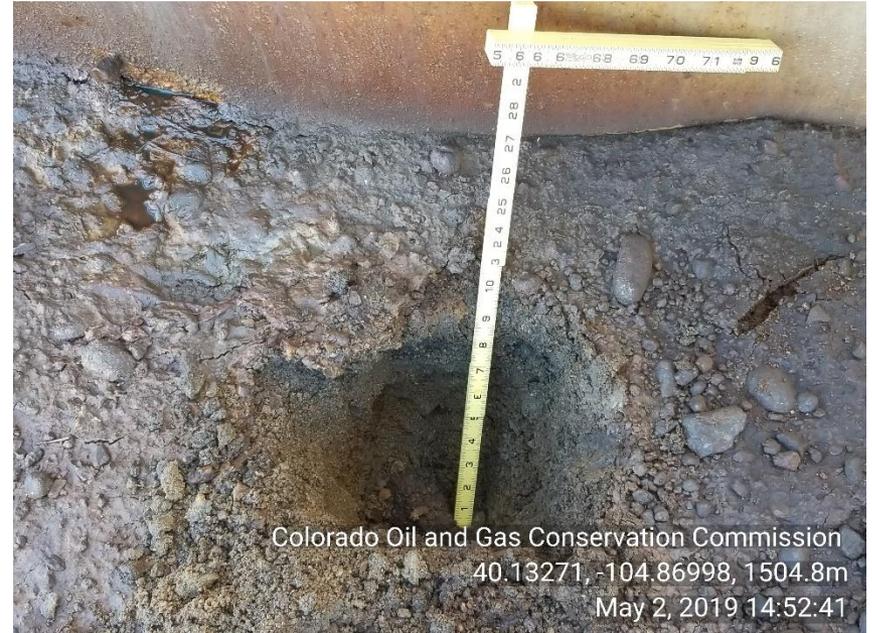
**Photo 10 Dug down approx. 12 in ground still saturated.**
