API: 05-055-06165

Operator: PETROGLYPH OPERATING CO

Inspection Date: 5/1/2019

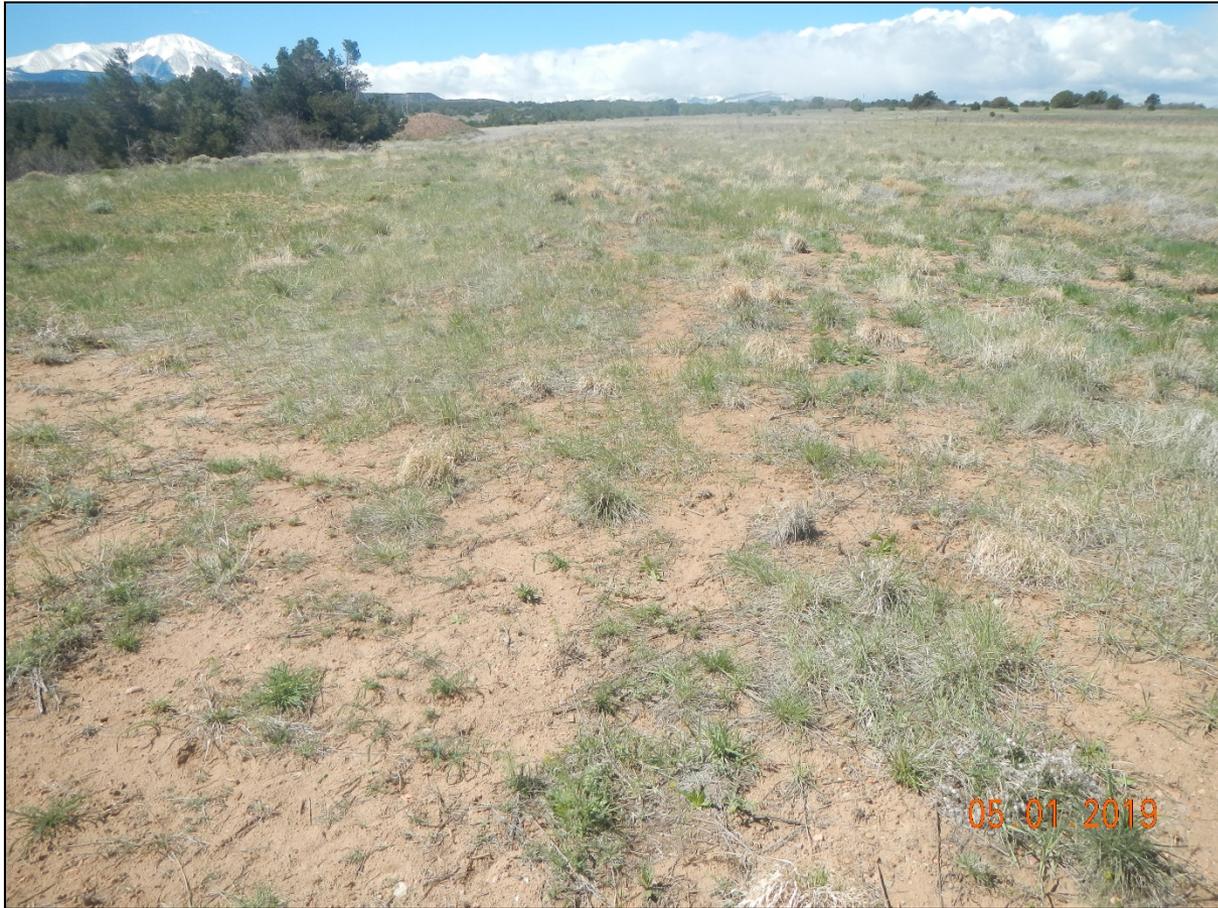
Photo 1. Facing southwest toward the access road.

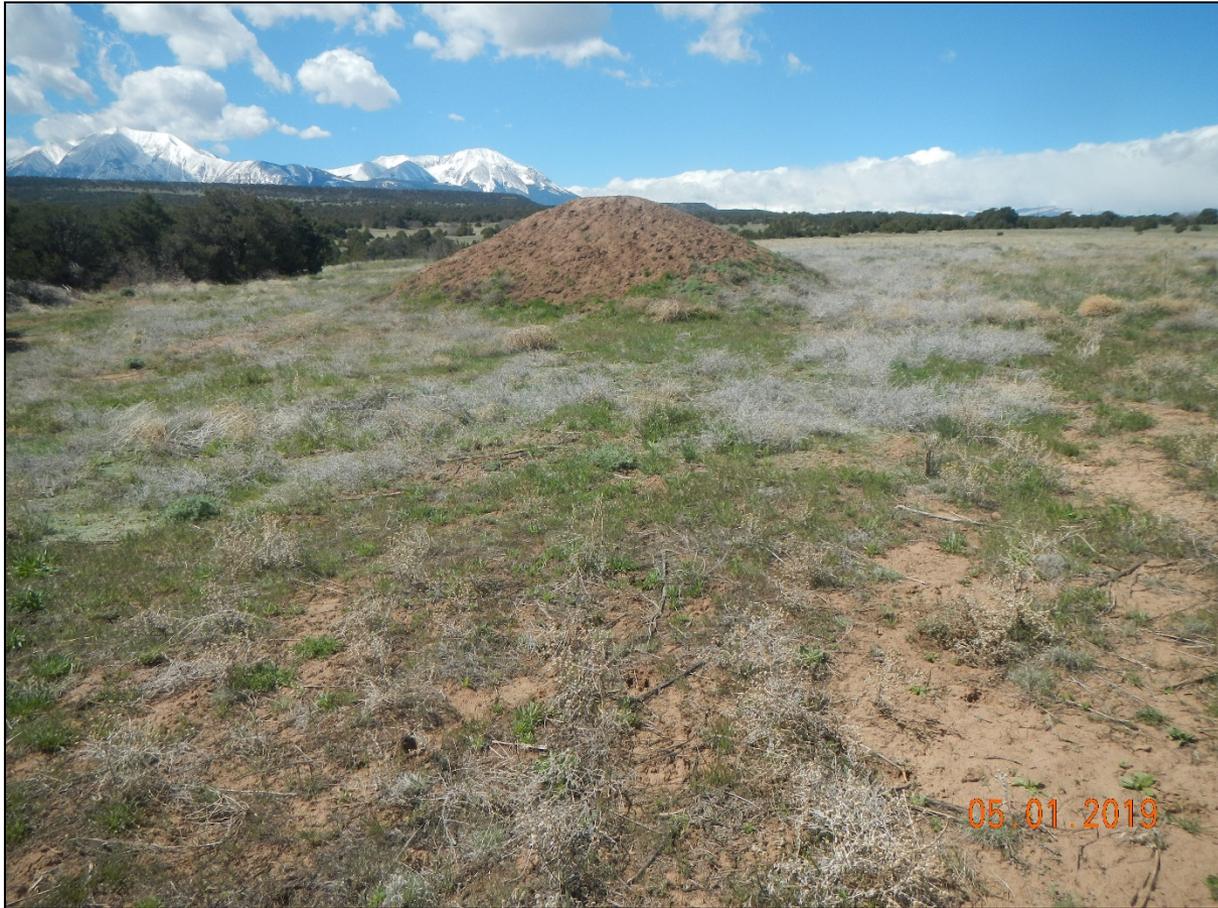
Photo 2. There is a soil pile near the location along the access road. This area around the soil pile does not have adequate vegetation cover.

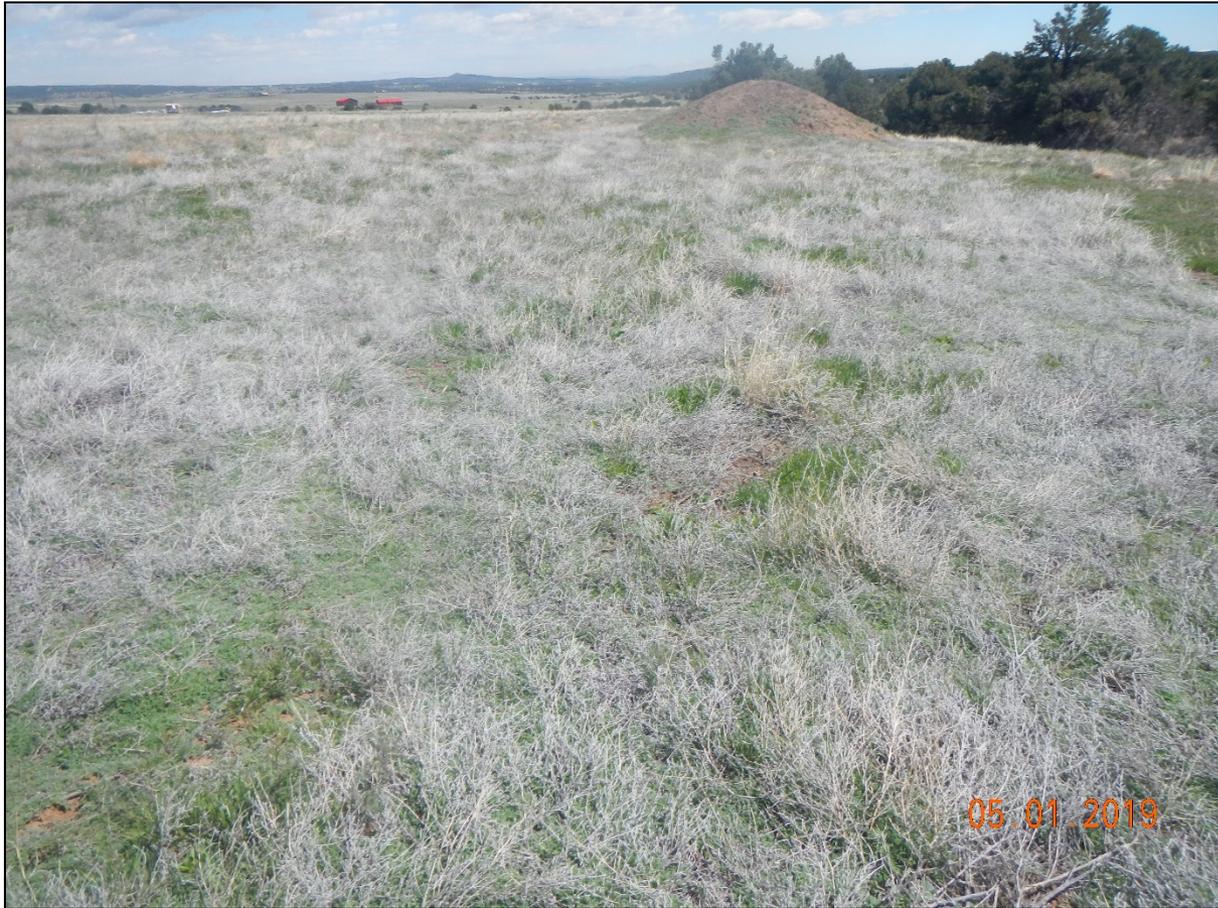
Photo 3. Facing back toward the northeast. The greyish area toward the soil pile is undesirable weeds (Kochia).

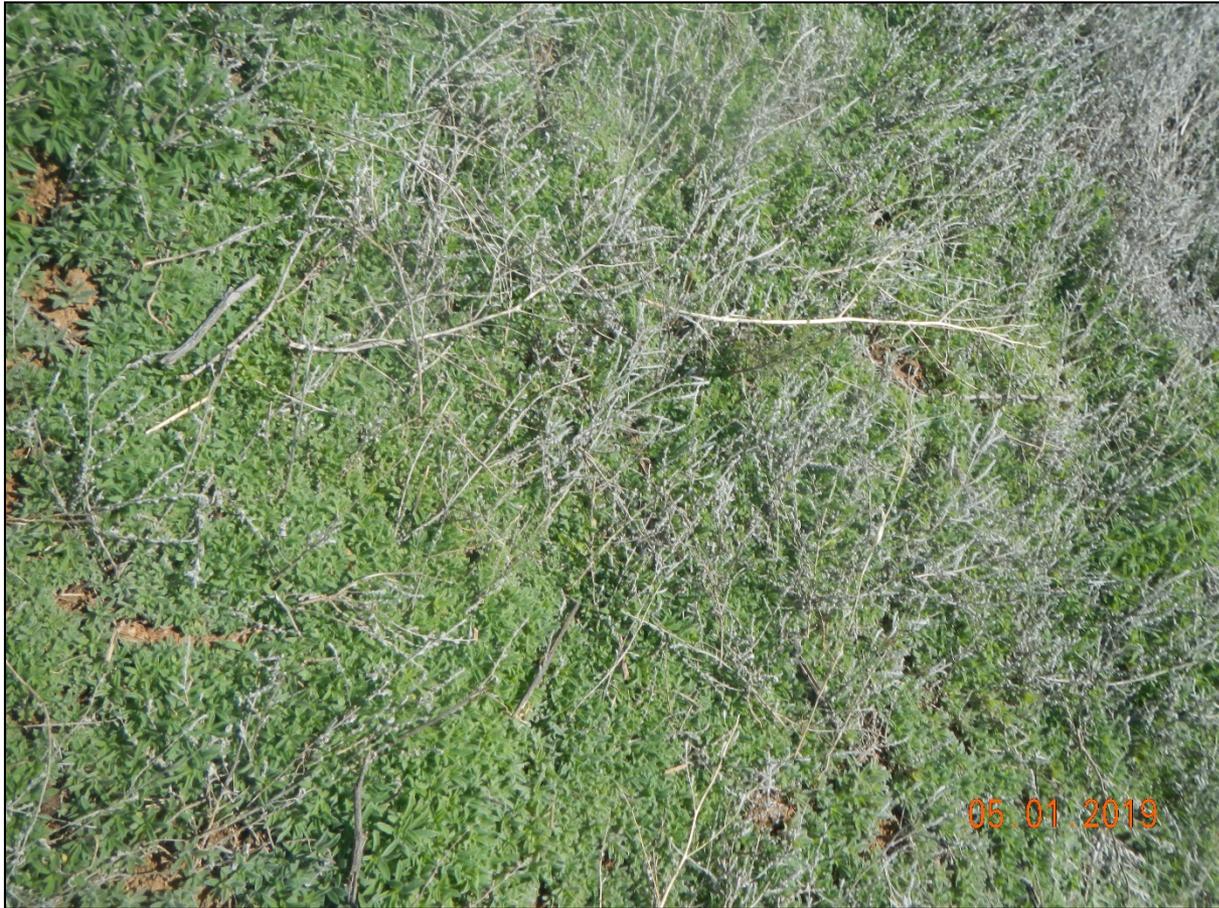
Photo 4. Weeds shown in previous photo 3 are beginning to germinate.

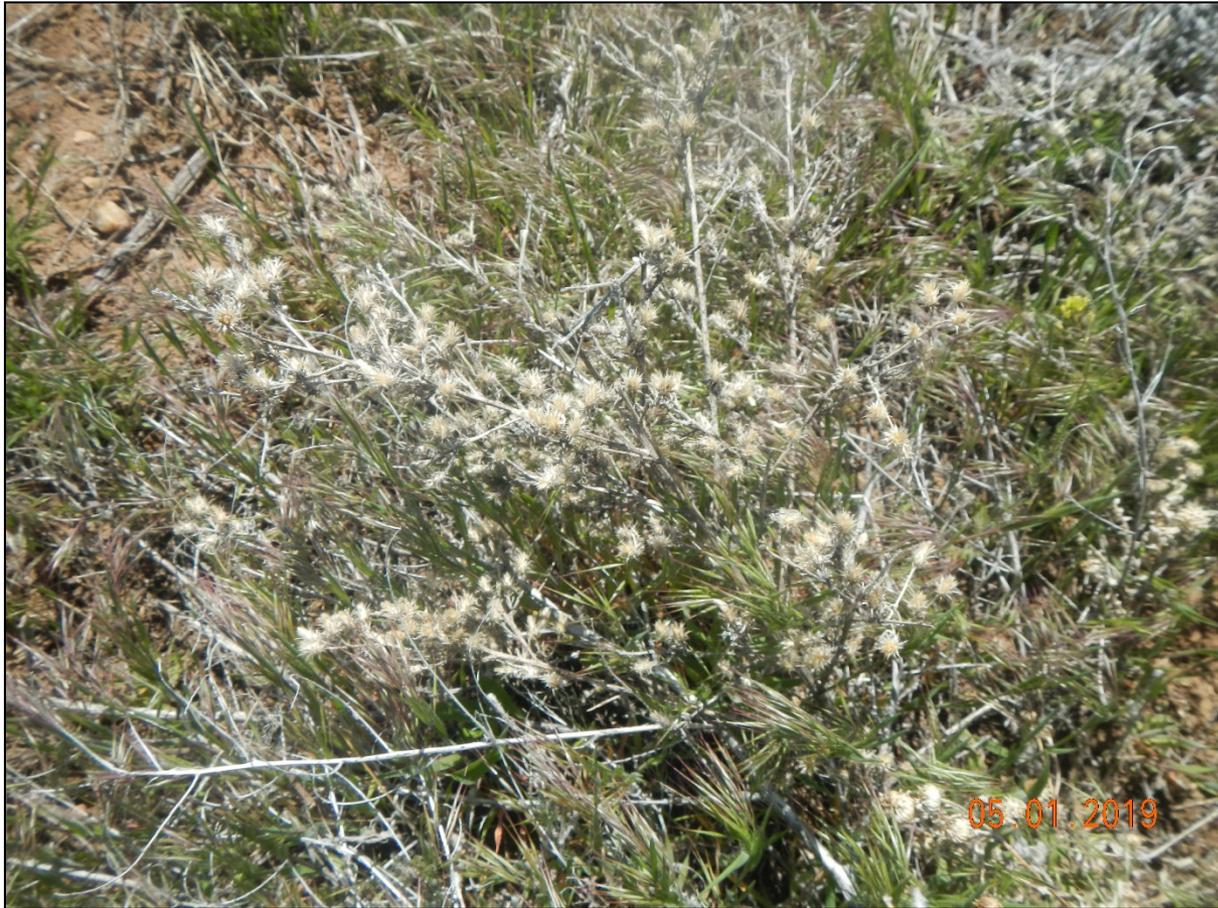
Photo 5. There are a few List B noxious weeds (Diffuse knapweed) in the area near the soil pile.

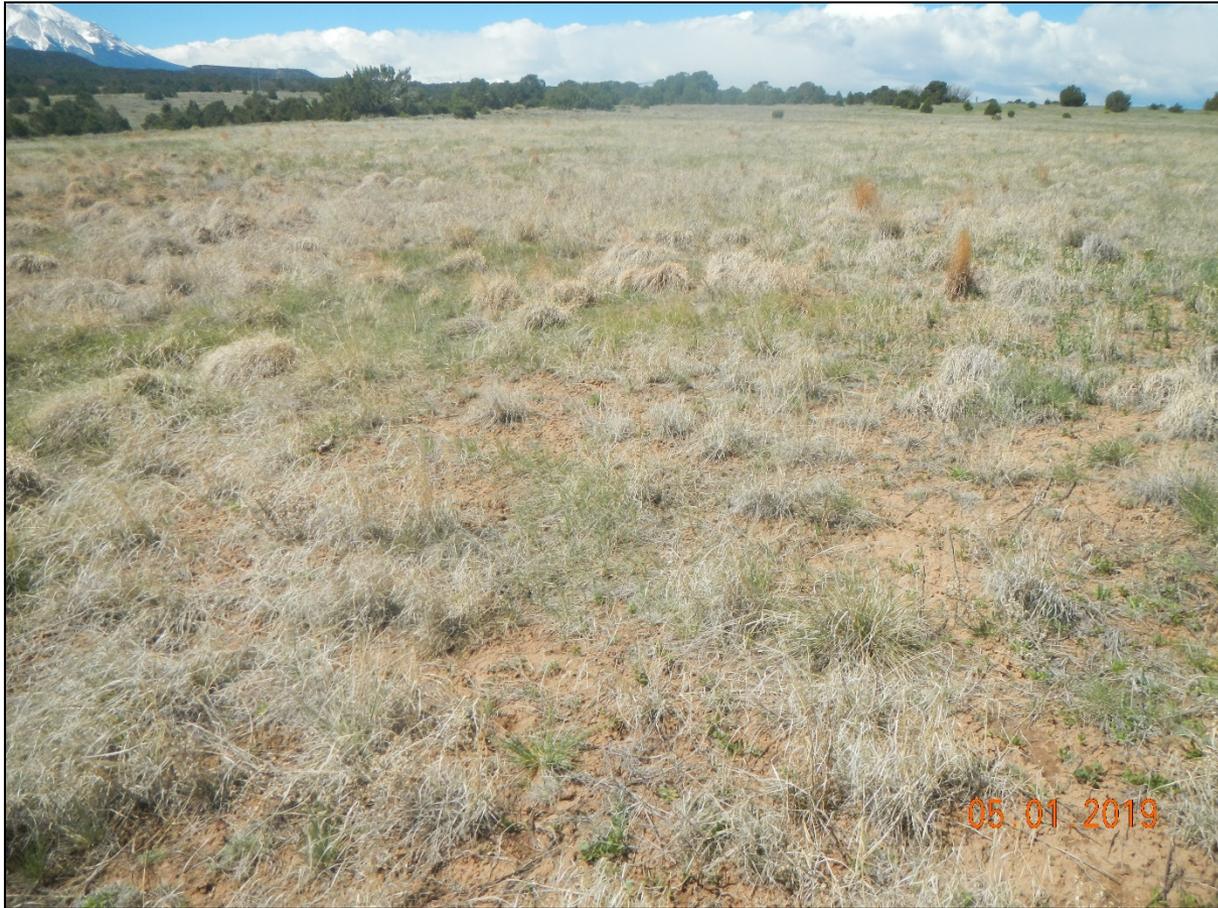
Photo 6. Facing southwest toward the location. Vegetation appears to be fully established.

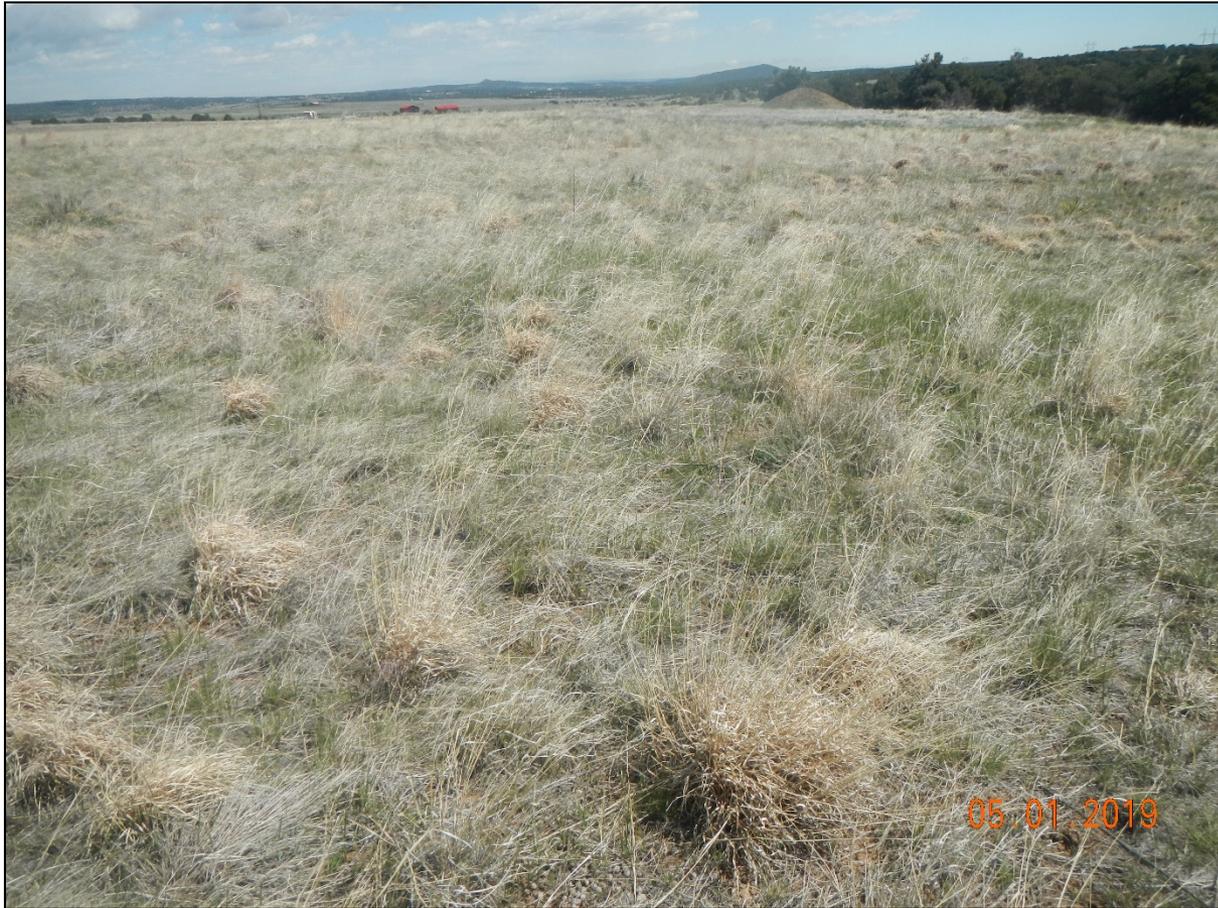
Photo 7. Facing northeast toward the location. Vegetation appears to be fully established.

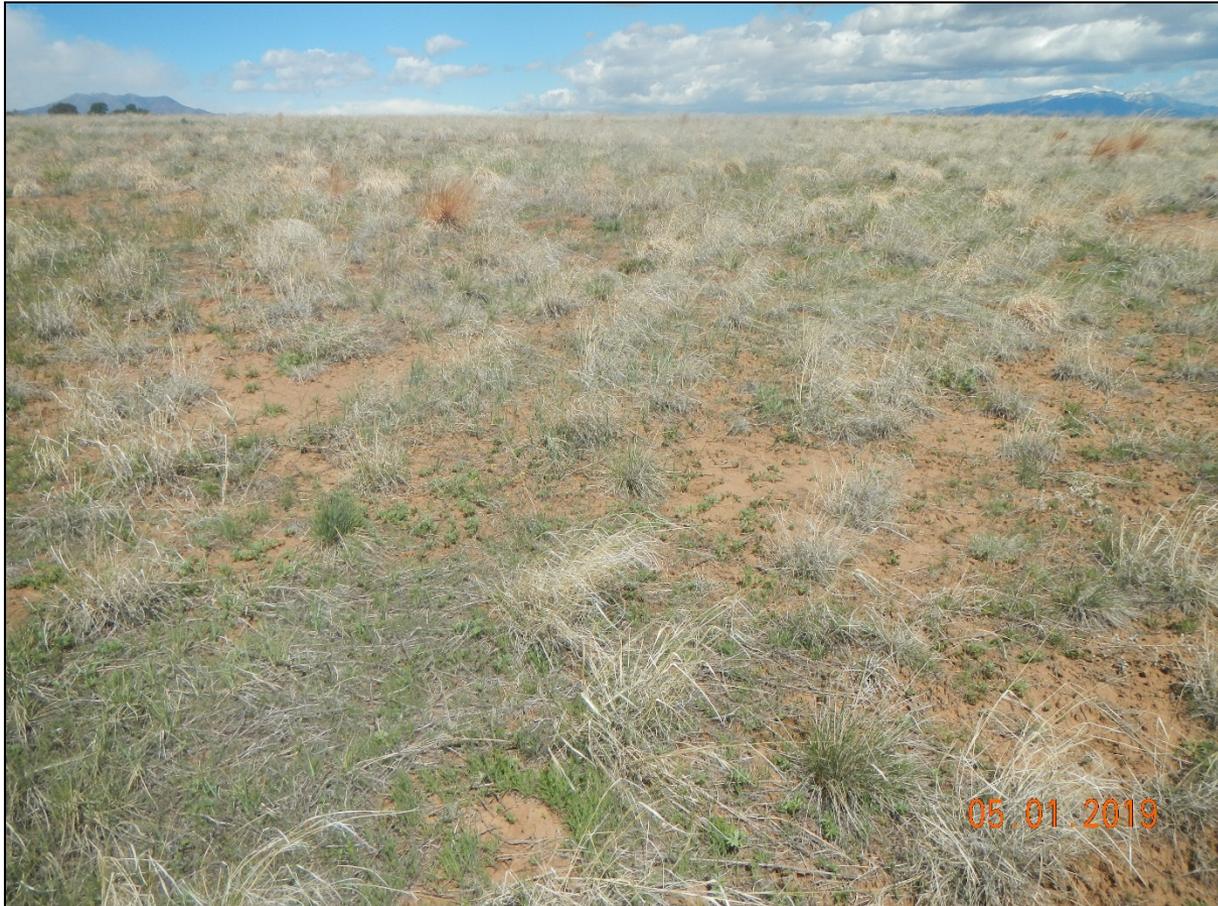
Photo 8. Facing northwest toward the location. Vegetation appears to be fully established.
